UNITED STATES  
DEPARTMENT OF LABOR  
MINE SAFETY AND HEALTH ADMINISTRATION  
COAL MINE SAFETY AND HEALTH

REPORT OF INVESTIGATION

Noninjury Impoundment Failure/Mine Inundation Accident  
October 11, 2000

Big Branch Refuse Impoundment, I. D. No. 1211KY60035-01  
Preparation Plant, I. D. No. 15-05106  
1-C Mine, I. D. No. 15-03752  
Martin County Coal Corporation  
Inez, Martin County, Kentucky

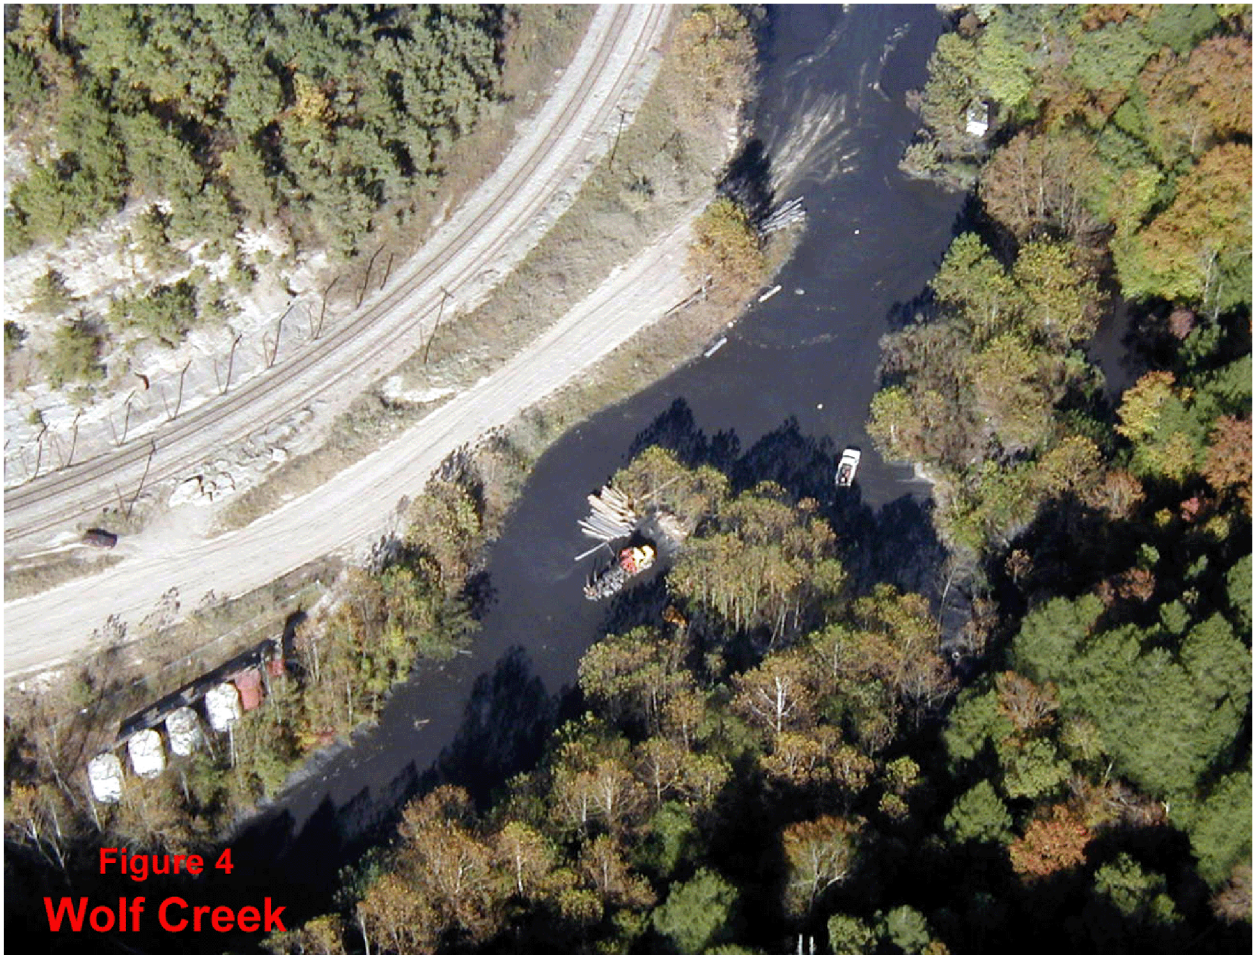
**Figure 4**  
**Wolf Creek**

The flow of slurry out of the mine resulted in flooding and downstream "black-water" contamination of Wolf Creek and Coldwater Fork (Figure 4). No fatalities or personal injuries resulted from the breakthrough or mine inundation; however, extensive environmental damage occurred in these waterways and successive downstream areas.

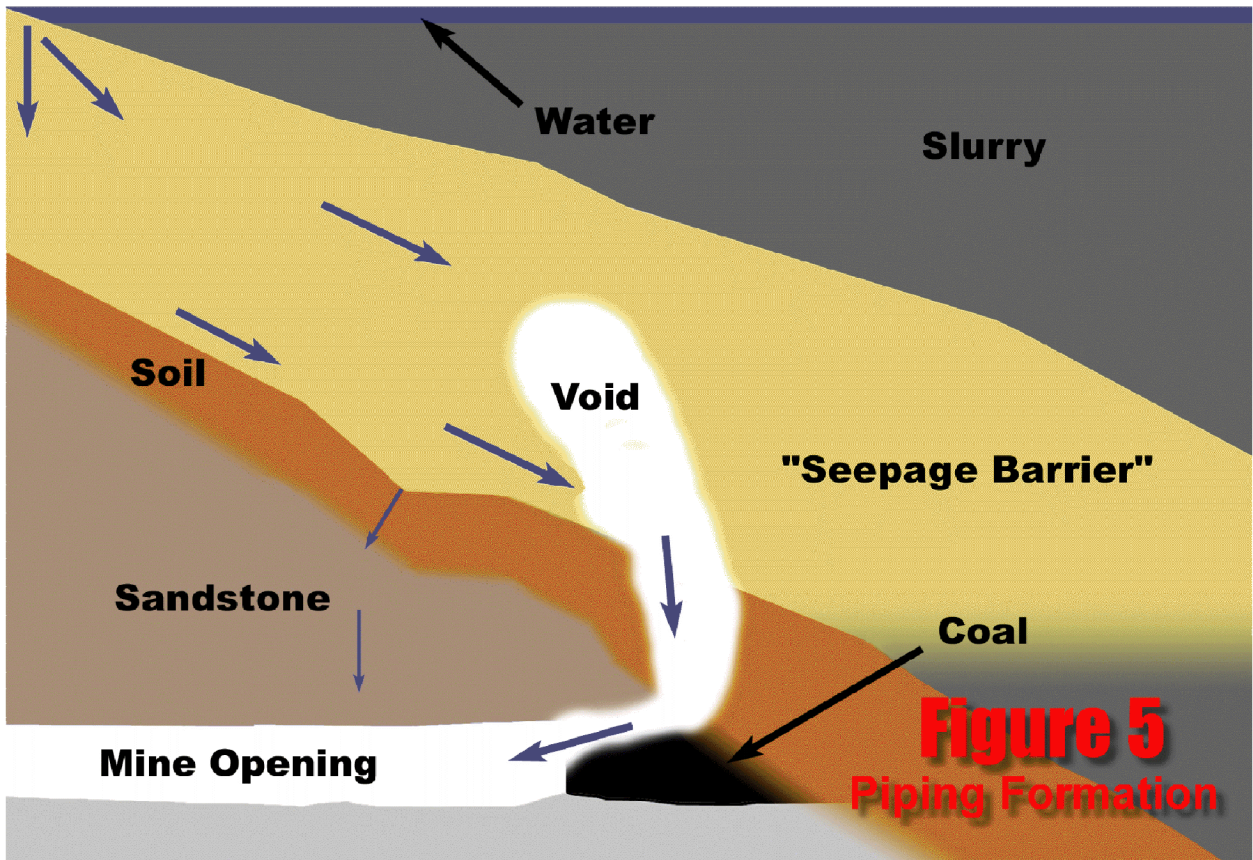
**Figure 5**  
**Piping Formation**

The approved plan included provisions to reduce seepage from the impoundment into mine workings. Failure to fully comply with these provisions resulted in internal erosion (piping) of the material between the impoundment and the mine workings. Over a period of time, the seepage into this area began to carry sand (weathered material) into the mine opening (Figure 5).

As this material was carried away, a "pipe" (void) formed and worked its way toward the impoundment. As more material was carried into the mine, a larger seepage path was created allowing additional and larger particles to be carried away. This process continued until the void developed close enough to the impoundment that the remaining plug of material failed suddenly, allowing the contents of the impoundment to discharge uncontrolled into the mine.

One possible scenario is that, over a period of time, seepage at the end of the 50-foot long entry began to carry sand (weathered material) into the mine opening (Figure 5). As material was carried away, a “pipe” (void) formed and worked its way back toward the impoundment. As more material was carried into the mine, a larger seepage path was created allowing more and larger particles to be carried away. This process could have continued until the void developed close enough to the impoundment that the remaining plug of material failed suddenly, allowing the contents of the impoundment to discharge uncontrolled into the mine.

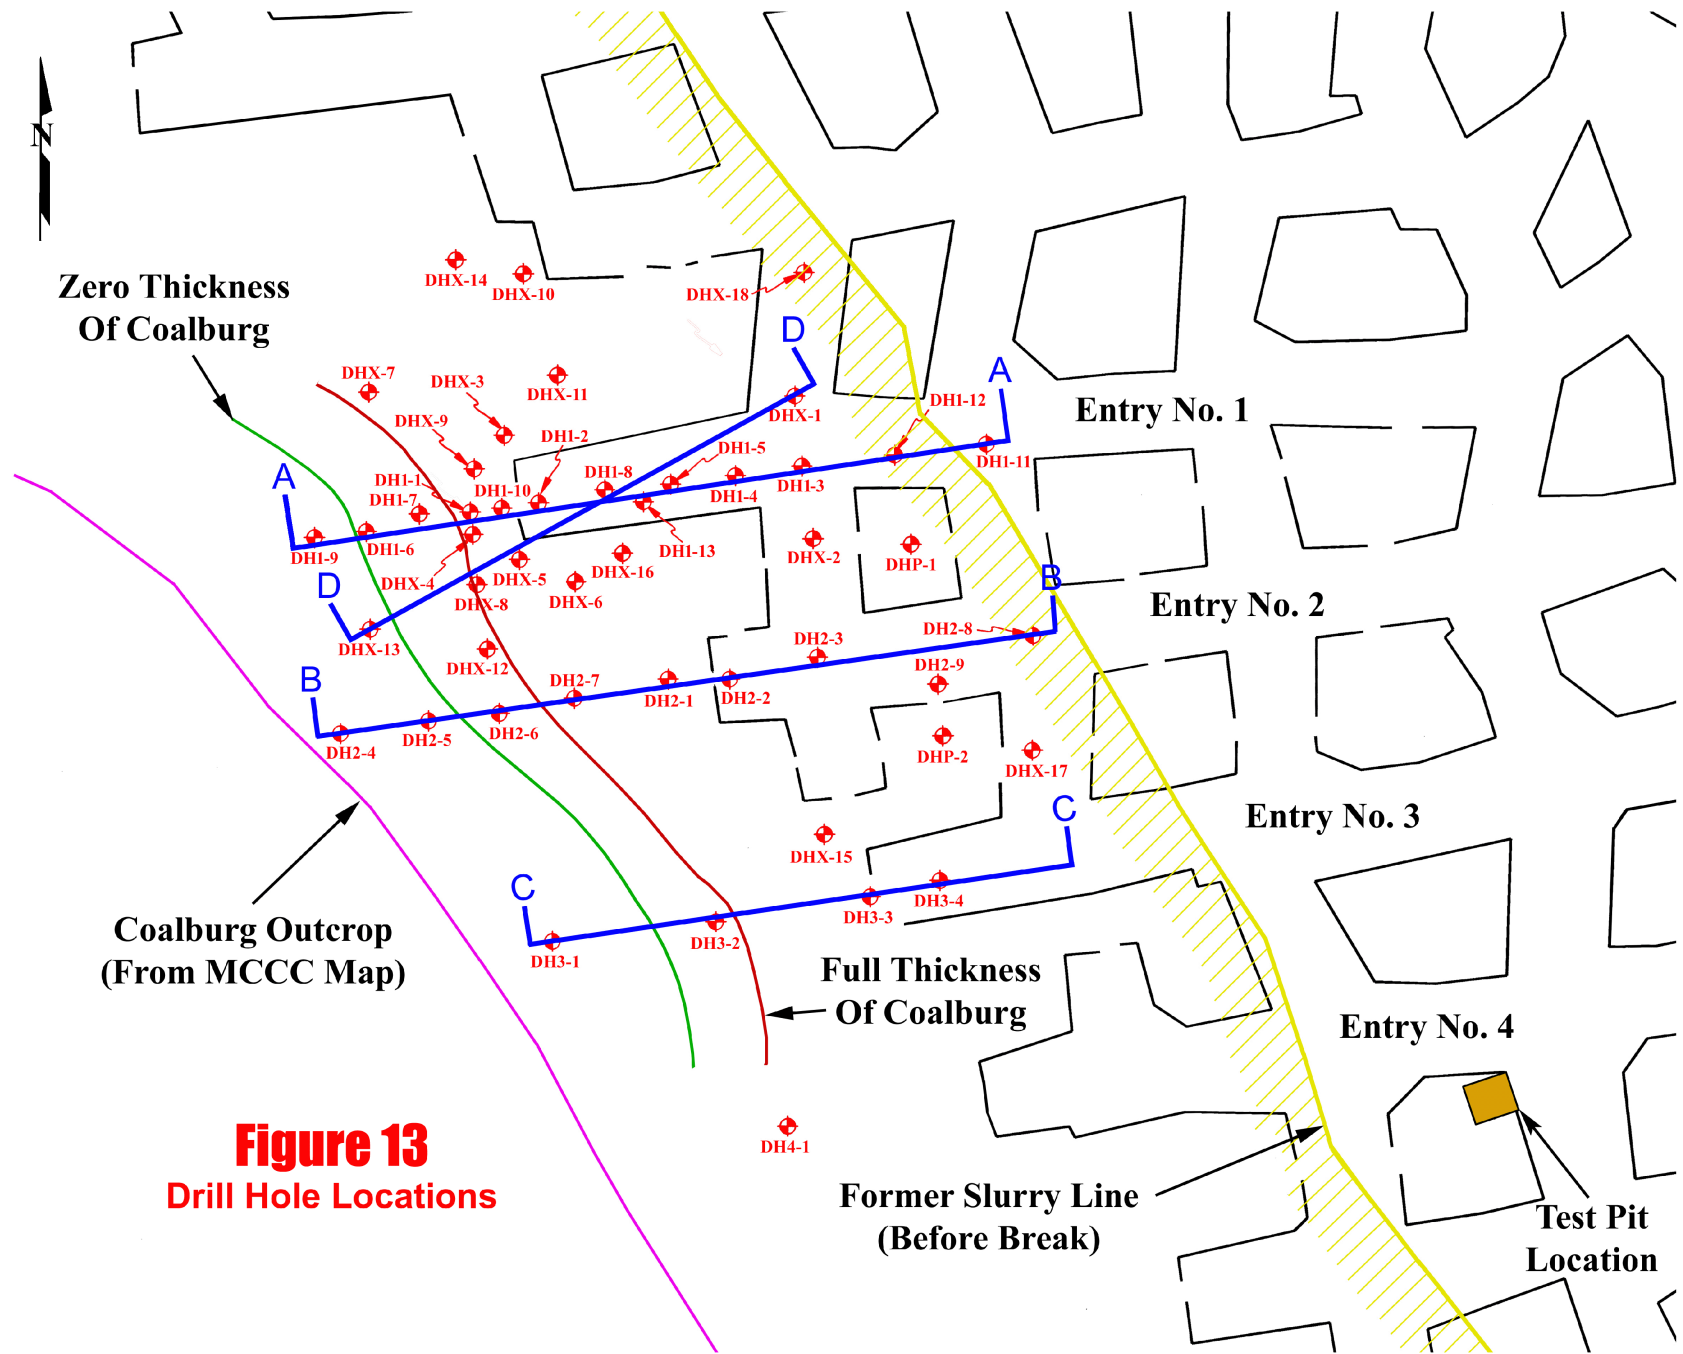
**Figure 13**  
**Drill Hole Locations**

It was determined that MCCC's mapping of the 1-C Mine as it applied to the orientation of the mine entries and the locations of the coal pillars in the area of the breakthrough, was accurate with the exception of Drill Holes DHX-10 and DHX-15. Mine voids were found at these two locations where the mine map showed no mining (Figure 13).

As shown in [Figure 13](#), two of the sampling holes were drilled into pillars to gain information on the condition of the pillars and to obtain samples of the coal. One hole, DHP-1, was drilled into the smallest pillar located near the breakthrough. Compressive strength testing on ten samples of coal core indicated a range of strengths from 1330 to 4870 pounds per square inch (psi) with an average of 3535 psi. Without making any adjustments for the shape of the coal samples, their average strength converts to an in-situ coal strength of 780 psi. This value is conservative because it was not adjusted to the equivalent strength for a coal cube. The coal strength of 780 psi compares to an in-situ strength of 900 psi, which is now commonly used by the coal industry in pillar design.

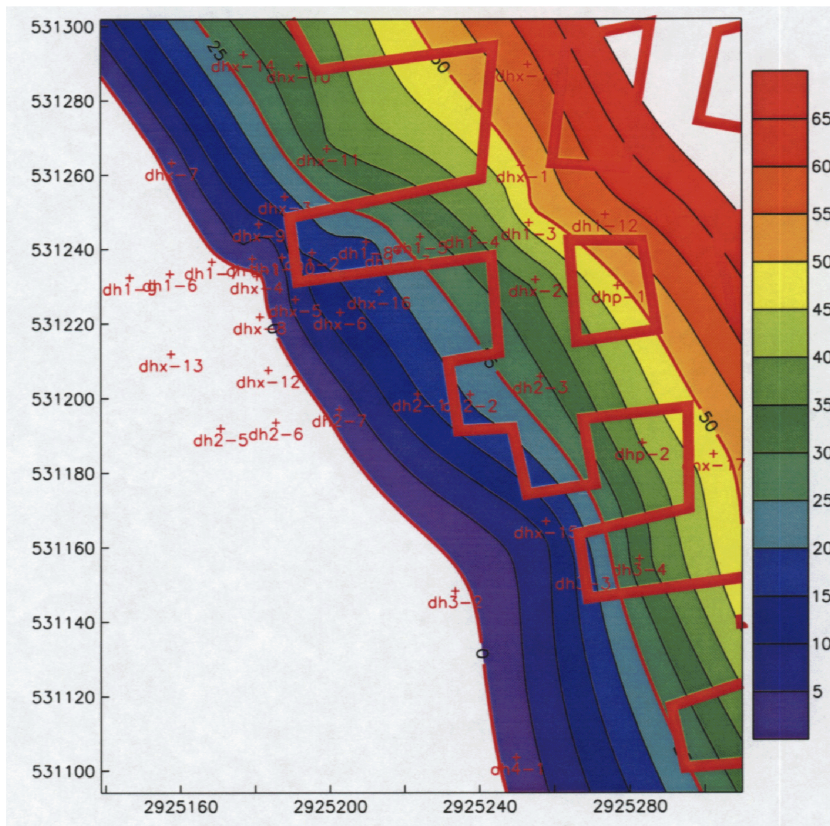
**Figure 34**  
**Sandstone Isopach Map**

Based on the results of the test borings, Figure 34 is an isopach map depicting the sandstone thickness overlying the 1-C Mine. The map shows the range of thickness of the sandstone from the 65-foot interval to where it was not found (zero-foot interval). This map shows an area at the end of the 50-foot long entry where the sandstone has thinned, due to the washout effect during the breakthrough.

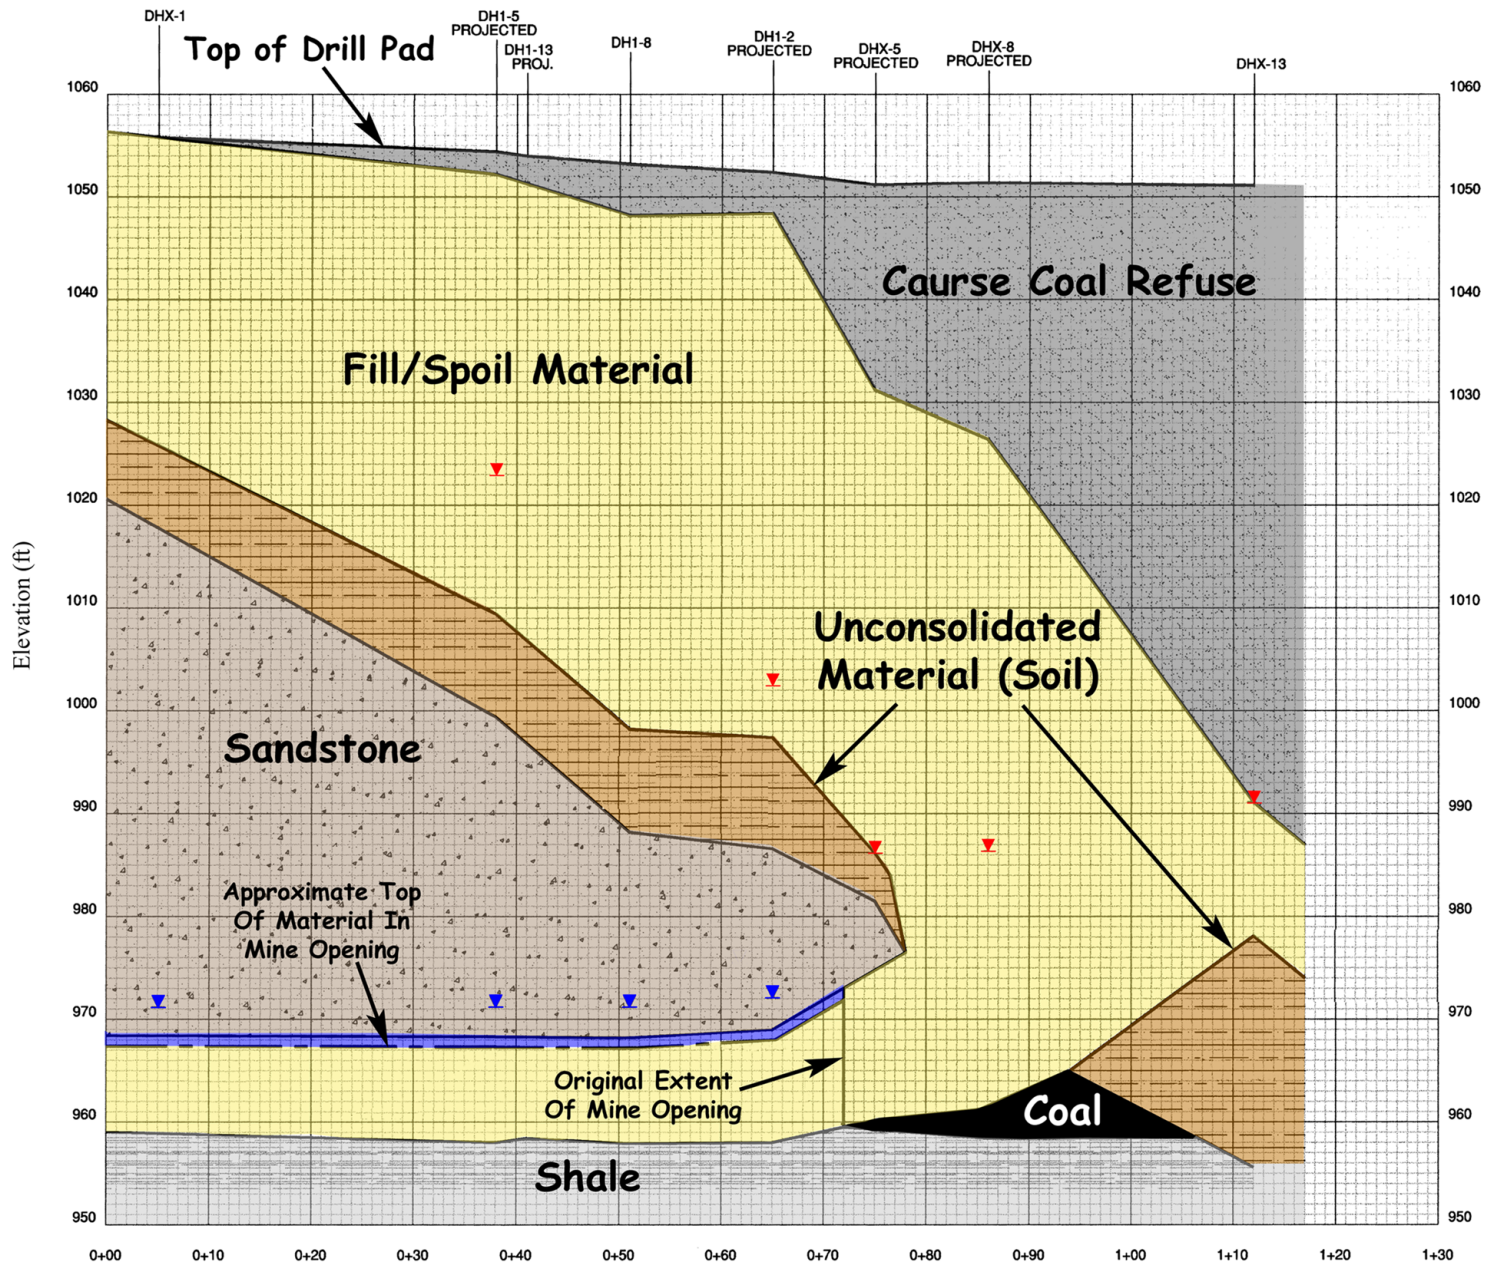
In test borings beyond the 50-foot long entry, specifically DHX-4 and DHX-8, the layer of natural ground and sandstone above the Coalburg seam, as well as a portion of the Coalburg seam, were absent (Figure 36). Test borings DHX-5, DH1-1, and DH1-10 also revealed a portion of the Coalburg seam to be absent, although the overlying sandstone and the layer of natural ground were present. Additional test borings (DHX-3, DHX-6, DHX-12, DHX-13, DHX-16, DH1-6, and DH1-7) were drilled to define the extent of missing coal and/or strata. The ground generally appeared intact in these borings.

Internal erosion or piping as a failure mechanism is consistent with the findings of the drilling program as shown on [\(Figure 36\)](#).
