MNMM Fatal 2008-11

- Fall of Back Accident
- May 31, 2008 (New York)
- Zinc Operation
- Driller
- 40 years old
- 2 years experience

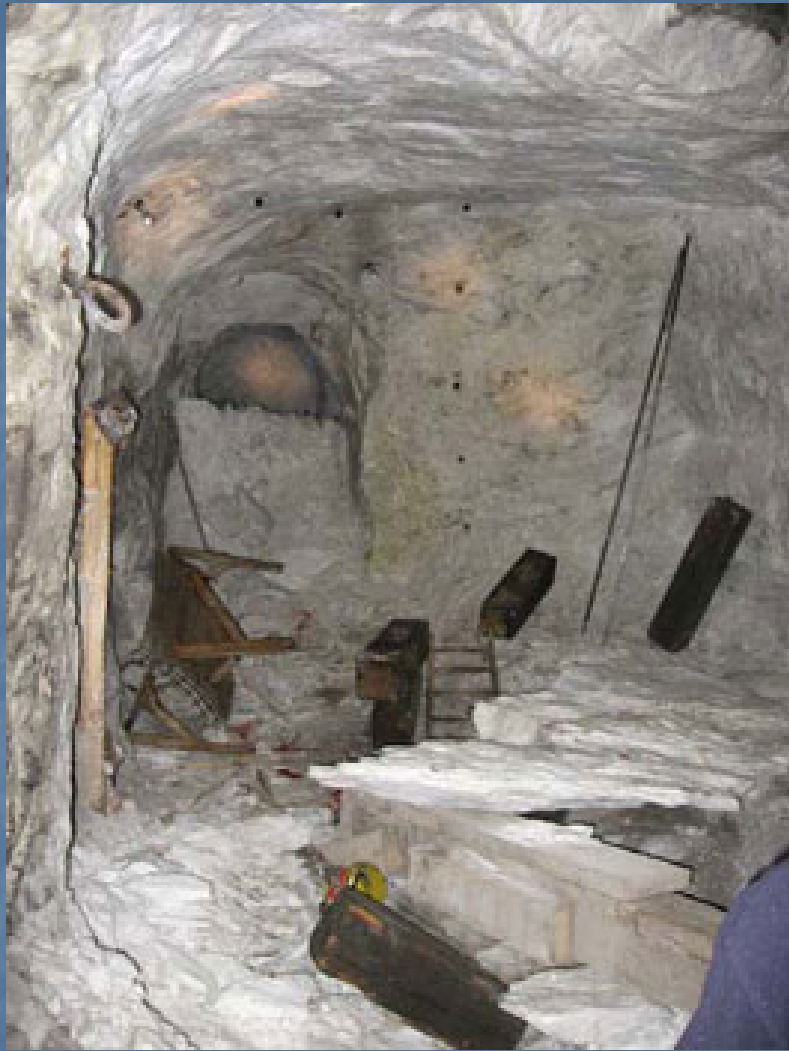
The victim was fatally injured when a large rock fell and struck him. He and a coworker were drilling a round at the face in a vent drift. The victim was attempting to retrieve a drill bit from a hole at the face when the rock fell from the back. The other miner was on the outby side of the drift and was not injured.

- Ground support was not installed in the vent drift on the 2100 level.
- Management policies, procedures, and controls were not being followed. Specifically, the ground was not supported in the vent drift on the 2100 level as specified by the company's ground support policy to protect persons where they worked or traveled.

- Examine and test ground conditions in areas where work is to be performed prior to work commencing and as ground conditions warrant during the shift.
- When ground conditions create a hazard to persons, install ground support before other work is permitted in the affected area.
- Be alert to any change of ground conditions.
- Identify and scale loose ground from a location which will not expose persons to falling material.
