REPORT OF INVESTIGATION

Underground Metal Mine
(Gold)

Fatal Fall of Back Accident
April 21, 2008

Getchell Mine
Small Mine Development, LLC
Golconda, Humboldt County, Nevada
Mine ID No. 26-02233

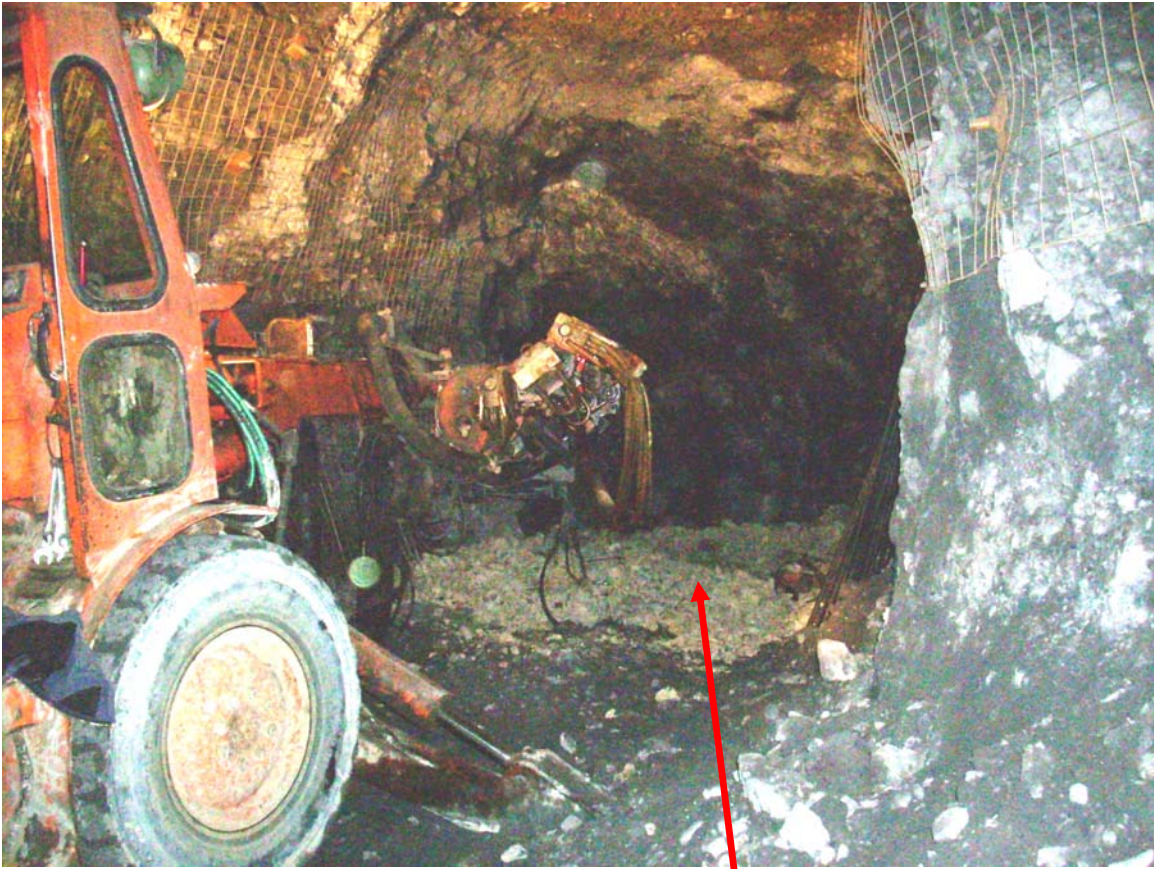
4715-182 Access Drift

Location of victim

The accident occurred in the 4715-182 access drift that had been driven underneath the CRF. The face of the drift was approximately 37 feet from the front of the roof bolter. The drift was approximately 14.9 feet wide and 14.5 feet high.
