REPORT OF INVESTIGATION

Surface Nonmetal Mine  
(Cement)

Fatal Fall of Person Accident  
January 21, 2008

Robertson's Transport  
Contractor I.D. No. T363  
at  
Oro Grande Quarry  
Riverside Cement Company  
Oro Grande, San Bernardino County, California  
Mine I.D. No. 04-00011

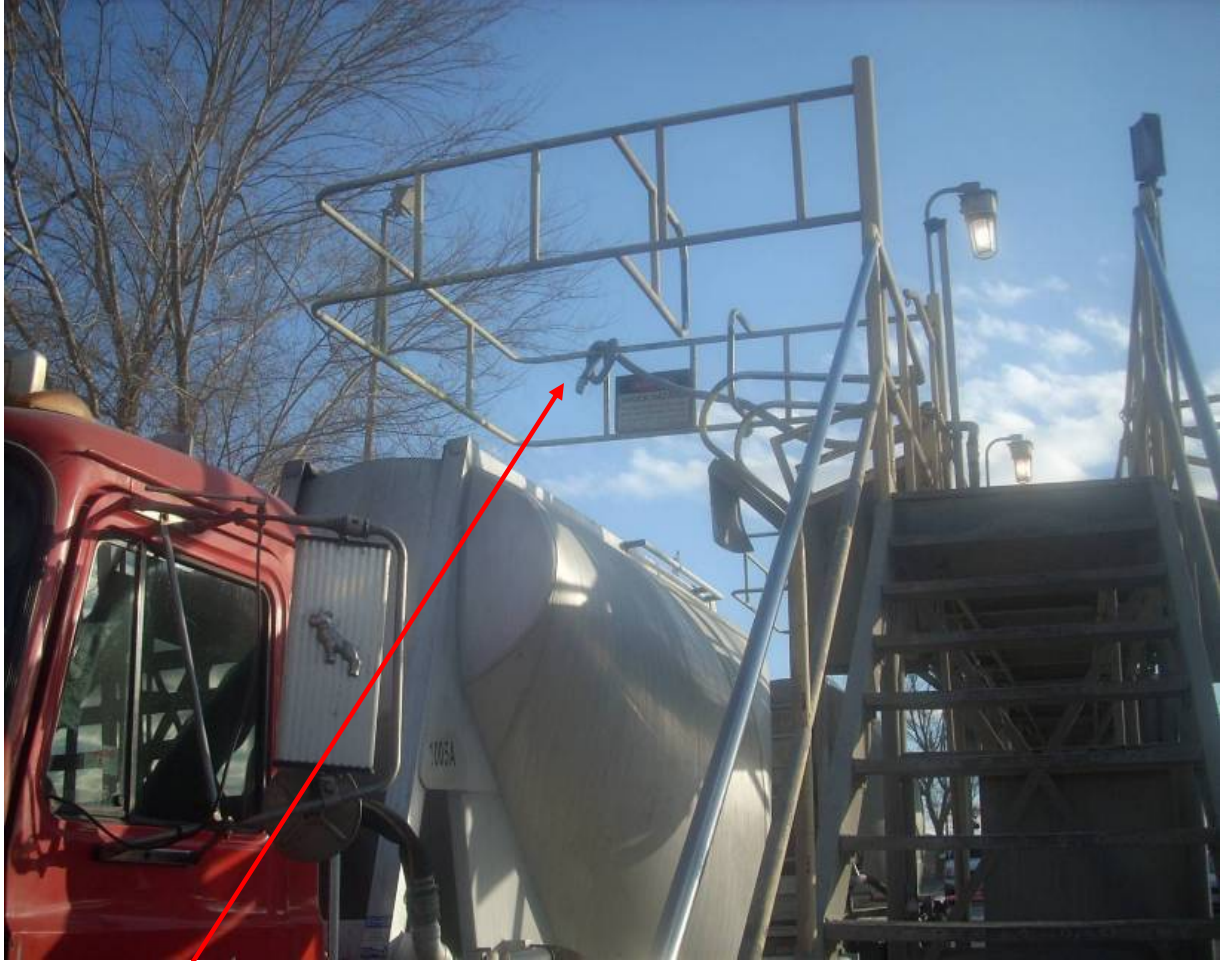
**Victim fell from this area**

Each lid rack was provided with a rectangular enclosure constructed of two steel pipe handrails spaced 24 inches apart vertically, cantilevered in a fixed position over the trailer parking area, and enclosing an area 110 inches long by 62 inches wide. The bottom rail of the enclosure was 14 feet 9 inches from ground level. This height accommodated trailers ranging in height from 10 feet to 13 feet 6 inches. The enclosure had a 39-inch opening at the access ramp point. The distance between the bottom rail of the rectangular enclosure and the trailer parked beneath it varied from a minimum of

36 inches to a maximum of 53 inches. Due to the curvature of the trailer, the vertical gap increased as horizontal distance increased from the centerline of the trailer. No manufacturer's name or date could be found on the lid racks, but management estimated they were installed in the early 1970s.

A fatal accident occurred at this mine on January 21, 2008, when a truck driver fell from the top of a bulk cement trailer. The victim had accessed the top of the cement trailer to close the cover of the hatch opening located at the top of the trailer. There were open areas between the trailer and the lowest handrails which presented fall hazards. Fall protection was not provided to truck drivers who were required to access this area.

**Corrective Action:** Management should establish policies and procedures to ensure that truck drivers wear fall protection where there is a danger of falling. Persons should be monitored to ensure that the policies and procedures are followed.

This citation was terminated on June 12, 2008. The structure where the fall hazard existed has been dismantled and the fall hazard no longer exists. A new structure has been provided.
