MNMM Fatal 2008-13

- Electrical Accident
- August 15, 2008 (Arizona)
- Copper Operation
- Electrician Apprentice
- 41 years old
- 14 years experience

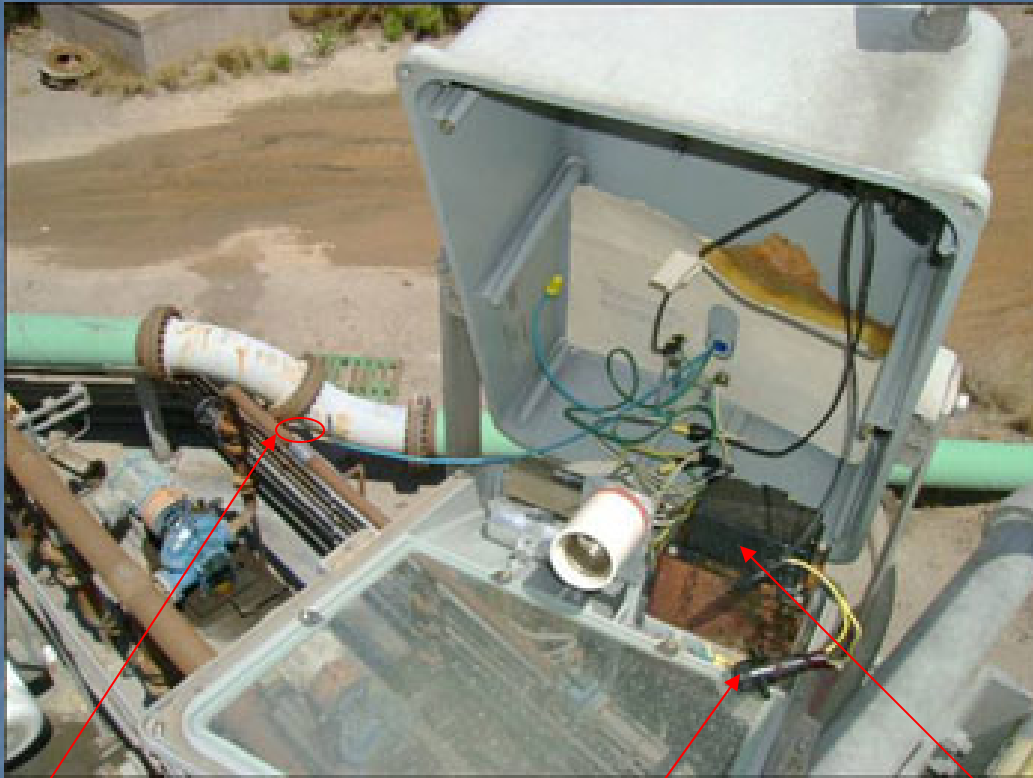
The victim was fatally injured when he contacted a 480-volt electrical conductor. He was replacing the ballast in a floodlight.

Energized conductor contacted by victim

In-line fuse
(the other fuse is inside box and out of view)

Ballast

Management policies and controls were inadequate and failed to ensure that the electrical circuit was deenergized, locked-out, tagged, and tested before work was performed on the circuit.

- De-energize power from the circuit and lock out/tag the switch.
- Verify that the circuit is de-energized by testing the circuit for voltage using properly rated test equipment.
- Closely supervise and monitor persons with limited electrical experience.
- Establish and follow safe work procedures when working with less experienced miners.
