UNITED STATES
DEPARTMENT OF LABOR
MINE SAFETY AND HEALTH ADMINISTRATION

REPORT OF INVESTIGATION

Non-Injury Mine Fire Accident
September 16, 2002

#3 Mine
Fairfax Mining Co., Inc.
Clarksburg, Harrison County, West Virginia
I. D. No. 46-08633

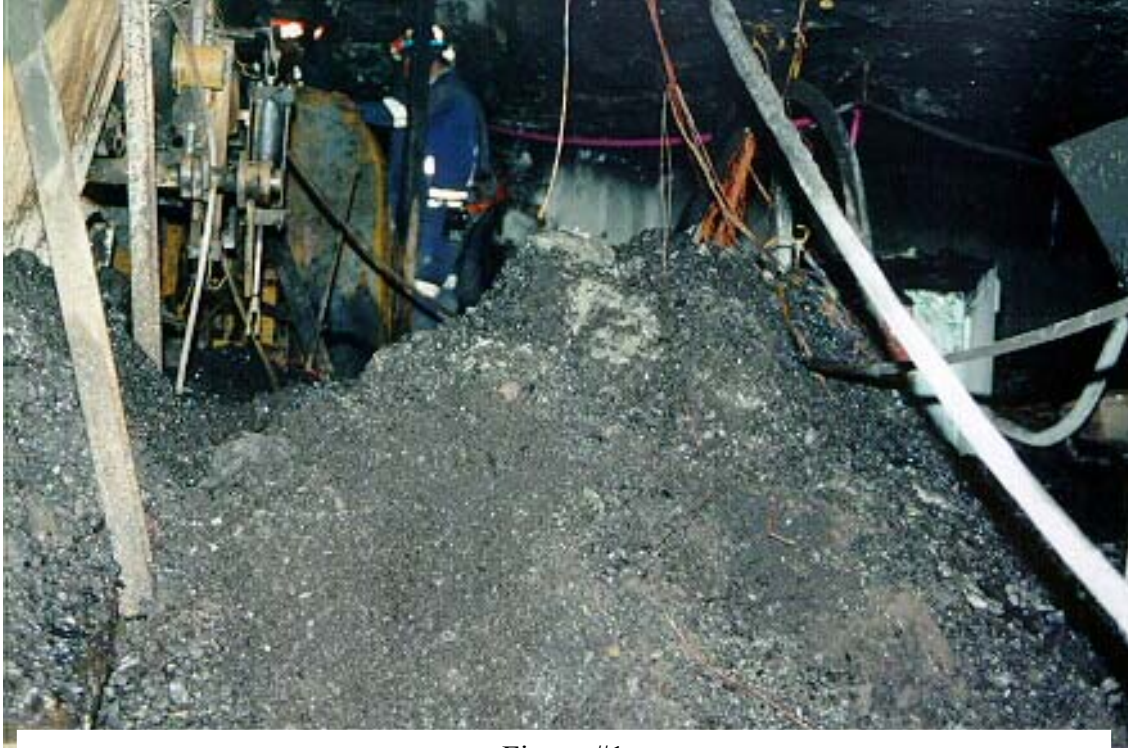
Fuel for the fire was provided by conveyor belting, lagging on the head and drive rollers, coal spillage, and wooden roof support material. Coal spillage (due to a disabled sequence switch) extended up from the floor to and around the head roller. Additional spillage extended along both sides of the belt structure, in and around the drive rollers and motors. The spillage, on the right side of the belt structure facing inby, was 4 feet wide by 18 feet long and up to 4 feet deep. The spillage on the left side of the belt structure facing inby was 16 feet long by 5 feet wide and up to 4 feet deep.

Figure #1
Coal Spill from Discharge Roller of #2-3NW Belt onto the #1-3NW Belt

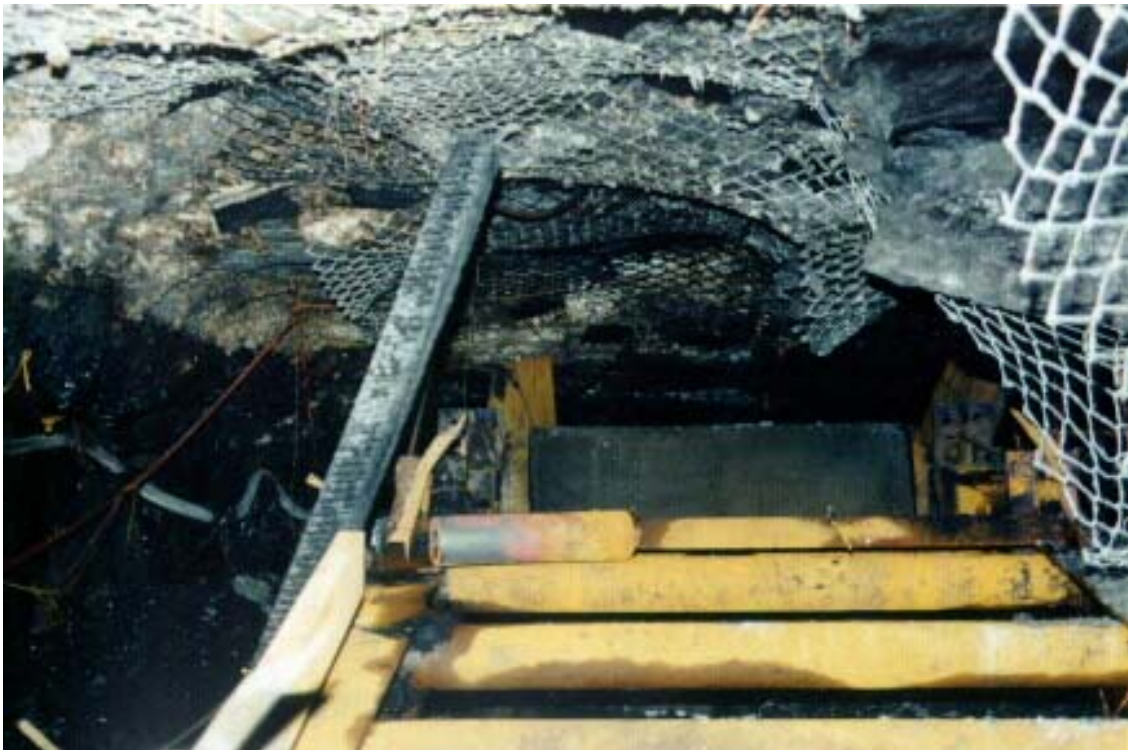
The flames extended inby from the #2-3NW Belt head roller for a distance of 30 feet, to the take-up unit, and across the full width and height of the entry (15' x 7'-2"). The heat of the fire melted the plastic light covers on the belt starter box (four feet from the drive area), charred the cap pieces on the roof bolts (a distance of 30 feet), and charred wood posts alongside the belt (See Appendix B, Figure #2). In addition, heat from the fire melted fire suppression and water supply hoses, communication lines, and electrical cables. Testing indicated that the melting point of the fire suppression hose was 329-343 °F. The insulation on the fire sensor wire was melted off; which, when tested, showed a melting point of 365-385° F.

Figure #2
Fire Damage to the Top Area of the #2-3NW Belt

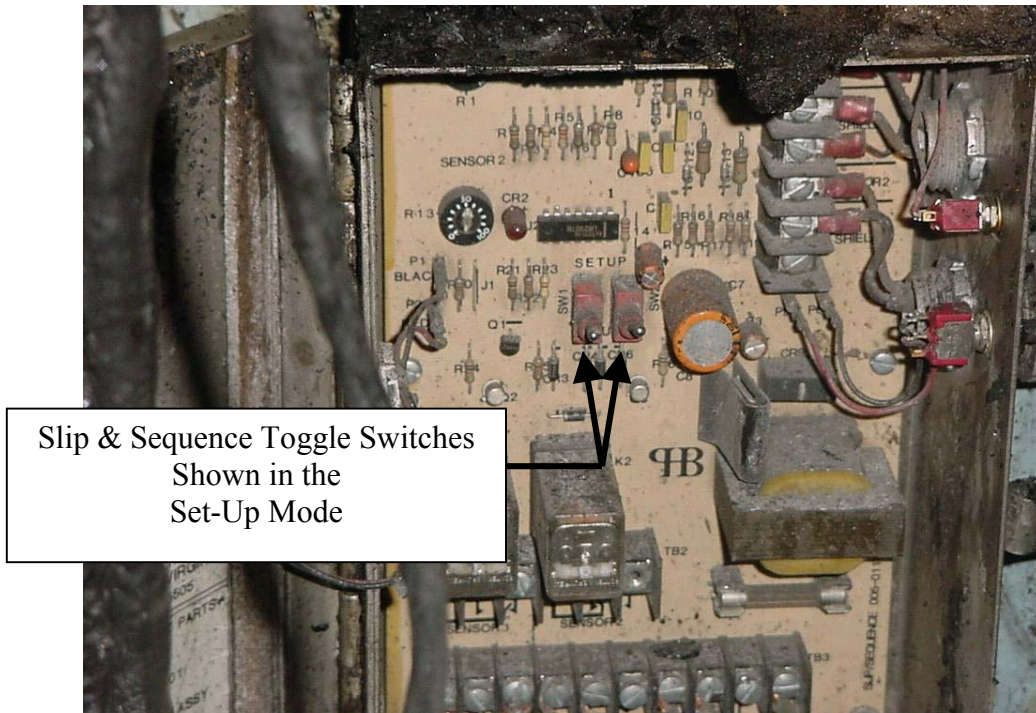
After the fire, both toggle switches were found in the Set-Up mode ([See Appendix B, Figure #3](#)). Therefore, neither the Slip nor the Sequence Controllers would have been able to shut down the #2-3NW Belt at the time of the accident. No system was in place on the surface of the #3 Mine to alert the operator that the automatic functions of the Slip/Sequence Controllers were disabled. A green LED on the outside of the Controller box, mounted on the outby side of the #2-3NW Belt starter box, was normally lit when both switches were in the Run position and was the only means for visually determining if the automatic system functions were activated (other than opening the box and looking at the toggle switches). The only time persons were routinely in close proximity of the light was during preshift and on-shift examinations of the belt haulage entry.

Causal Factor: The #2-3NW Belt Slippage and Sequence protection was disabled. Toggle switches for the Slippage and Sequence Controller were found in the electrical test mode, causing the Controller to ignore the speed probe signals.

Figure #3
Slip/Sequence Control Box for the #2-3NW Belt
Both Slip & Sequence Switches were found in the Set-Up Position

Corrective Action: The Slippage and Sequence protection toggle switches must be returned to the Run position prior to normal operation of the belt. After the accident, the operator installed spring-loaded toggle switches in the Control Box of the Slippage and Sequence Protection System. These replacement switches require constant finger pressure to keep the switch in the Set-Up Mode. Without pressure, the toggle switches would spring back to the Run Mode.

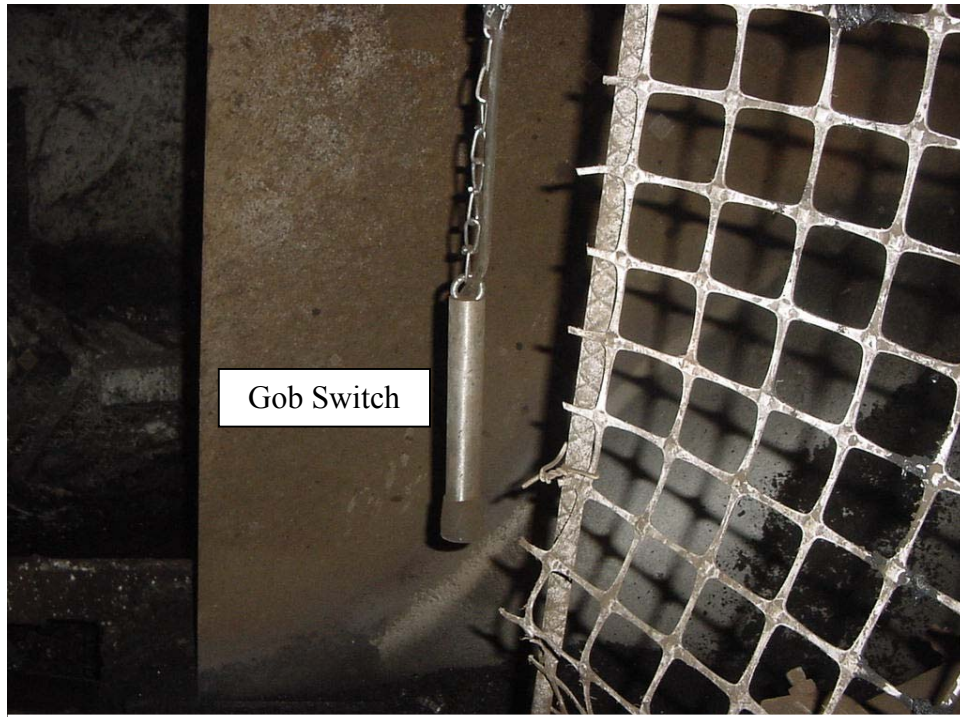
Figure #4
Gob Switch installed after the Fire

Corrective Action: The operator installed a "gob" switch at each belt transfer point (See [Appendix B, Figure #4](#)). This switch was installed to detect a build-up of coal at the transfer point, shut down the inby belt when such a condition occurs, and restart the belt after the coal build-up clears.

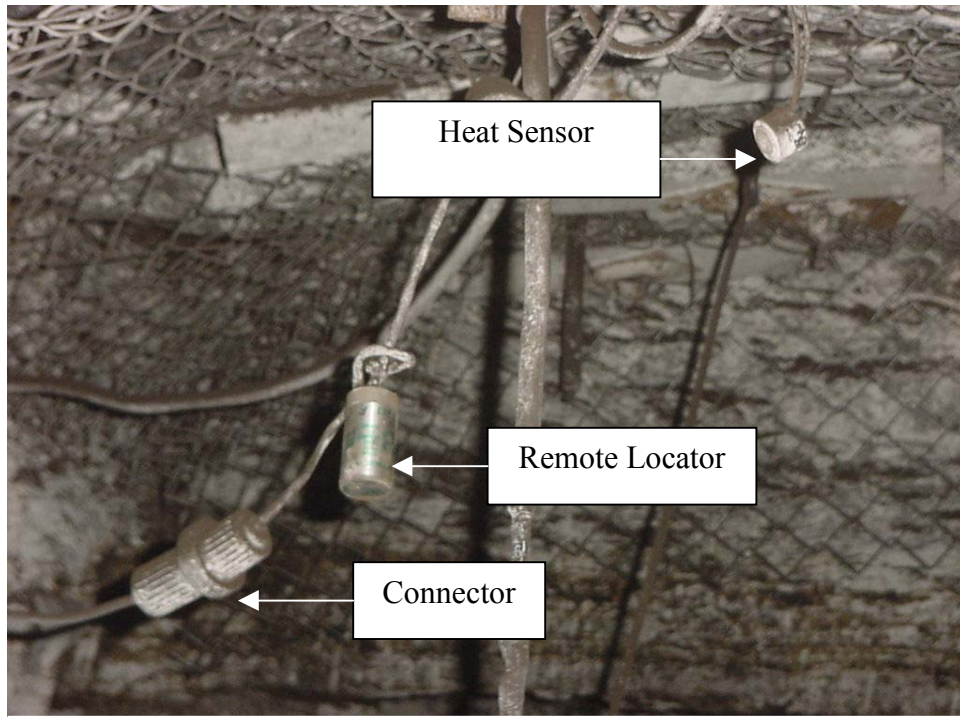
Figure #5
Fire Detection System Components
Shown are Connector, Remote Locator, & Heat Sensor

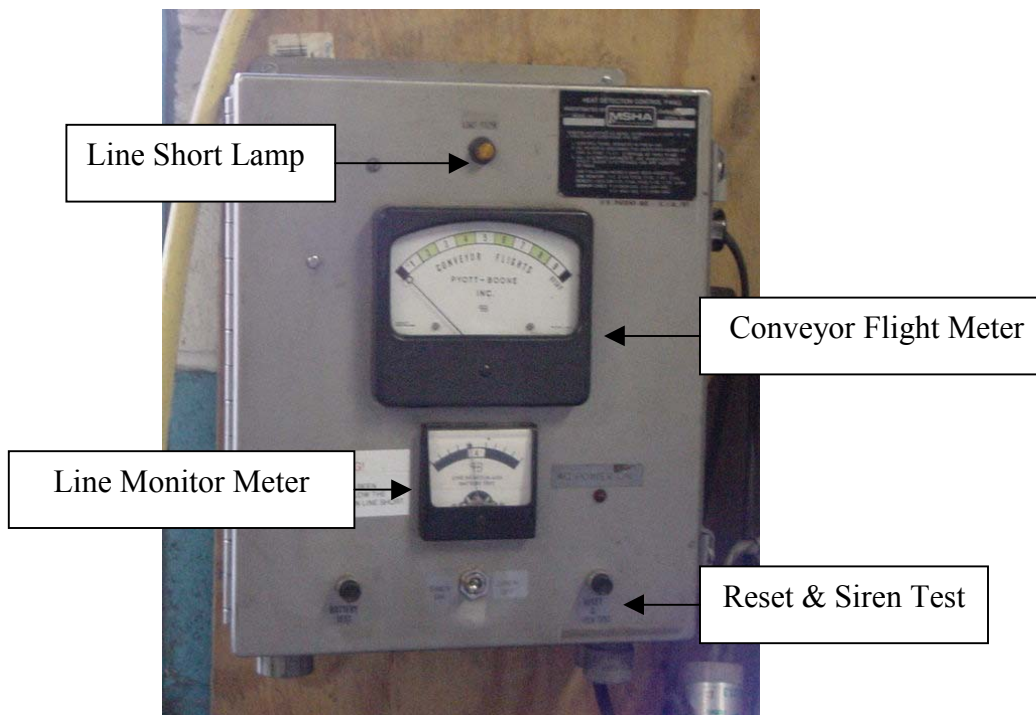
Line monitors were connected at the end of each branch network cable (near each section loading point), which paralleled the branch cables within the network circuit. The internal resistors of each line monitor were adjusted so that the total network resistance measured at the Control Panel equaled 15,000 ohms. During normal operating conditions, the line monitors permitted a small current to flow through the network so that the Control Panel's monitoring circuit could determine the system's ability to detect a fire. For example, when an open circuit condition occurred, the current flow should have dropped to zero and the Control Panel's line monitor meter would display a zero indication (See Appendix B, Figure #6).

- *Phase 4, Wait for a Reset* - A “Reset and Siren Test” Switch is mounted on the Control Panel (See Appendix B, Figure #6). If the condition has cleared, this manual switch will reset the fire audible alarm or turn off the Line Short lamp. Also, this switch can test the siren.

The operator did not provide a means for rapidly evaluating electrical short and open circuit problems on the Fire Detection System, as required by 30 CFR 75.1103-5(b). The Control Panel was designed to initiate an audible alarm for a fire only, while the system’s problem warning devices gave only visual displays. These displays were located on the Control Panel in the maintenance foremen’s office, which was not a normally manned duty post. By manufacturer’s design, this Fire Detection System was also disabled from detecting fire until the problem condition was corrected. As a result, miners were not alerted of a system problem affecting operational capability or warned of a belt fire at the #2-3NW Belt drive until after smoke was observed, prompting the mine superintendent to look at the Control Box.

Figure #6
Control Panel for the Fire Detection System
Located on the Surface
In the Maintenance Foremen's Office

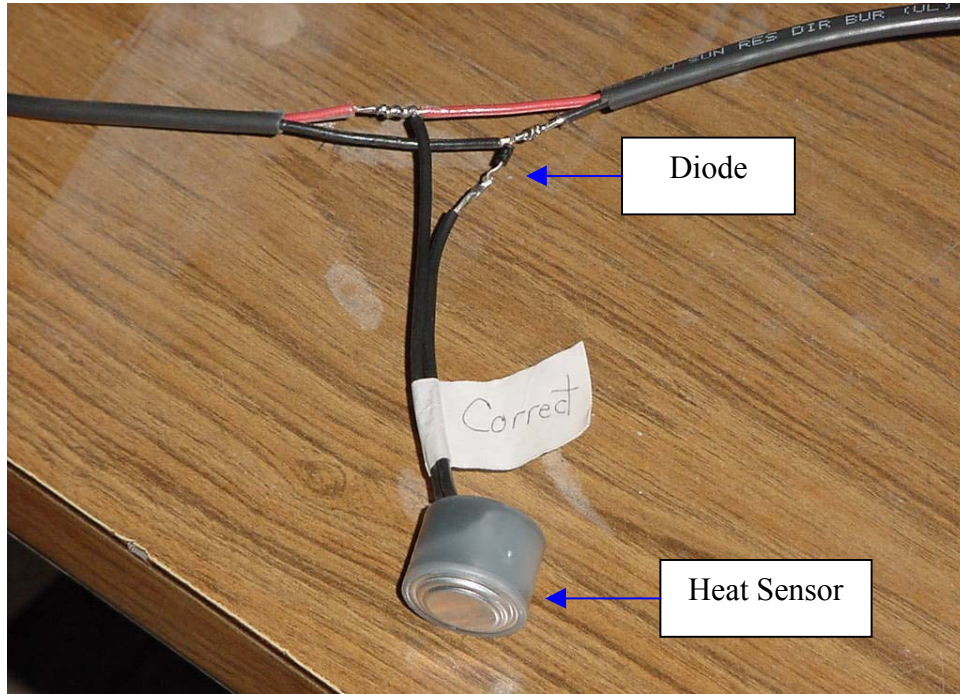
- *A diode for the heat sensor at the #2-3NW Belt Drive Pulley may have been missing or improperly installed* - A diode was not found installed to one unattached lead of the network heat sensor nearest the drive pulley, which was near the most likely origin of the fire. If the diode was not properly installed in the sensor that first detected the fire, the Fire Detection System would have detected the reversed current flow and assumed that a short circuit had occurred, energizing the Line Short Lamp and disabling the Fire Detection System from sounding a fire alarm. Although the fire could have destroyed evidence of the diode’s plastic case, interviews indicated that persons installing these sensors at the #3 Mine did not understand the diode’s function and may have improperly installed them.

Figure #7
Heat Sensor for the Fire Detection System
Shown is the Diode with the Correct Polarity in Series with the Sensor

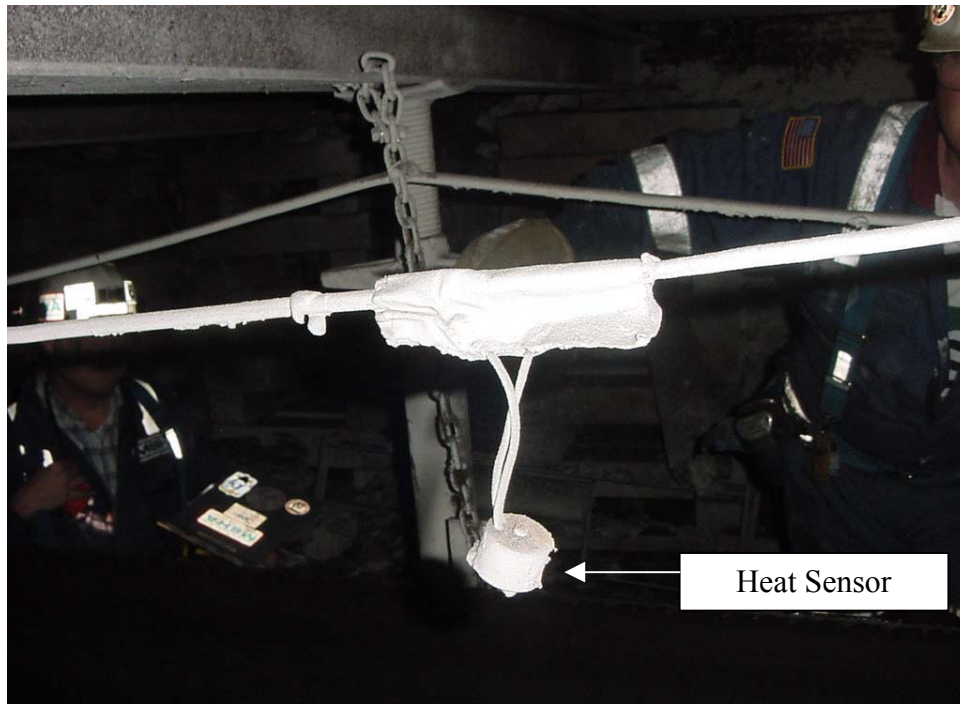
individual sensors. Sensors should be tested by applying heat to each sensor. Corroded electrical connections between a sensor and the network cable or faulty electrical contacts within the sensor would affect the system's detection capability. Also, a coating of rock dust on a heat sensor can act as a thermal insulator, delaying the reaction time of the heat sensor's electrical contacts ([Appendix B, Figure #8](#) shows such a heat sensor at another location in the #3 Mine). If this condition was present near the fire's origin, it may have delayed the reaction time of the sensor until after the network cable insulation melted.

Figure #8
An Example of a Heat Sensor Coated with Rock Dust

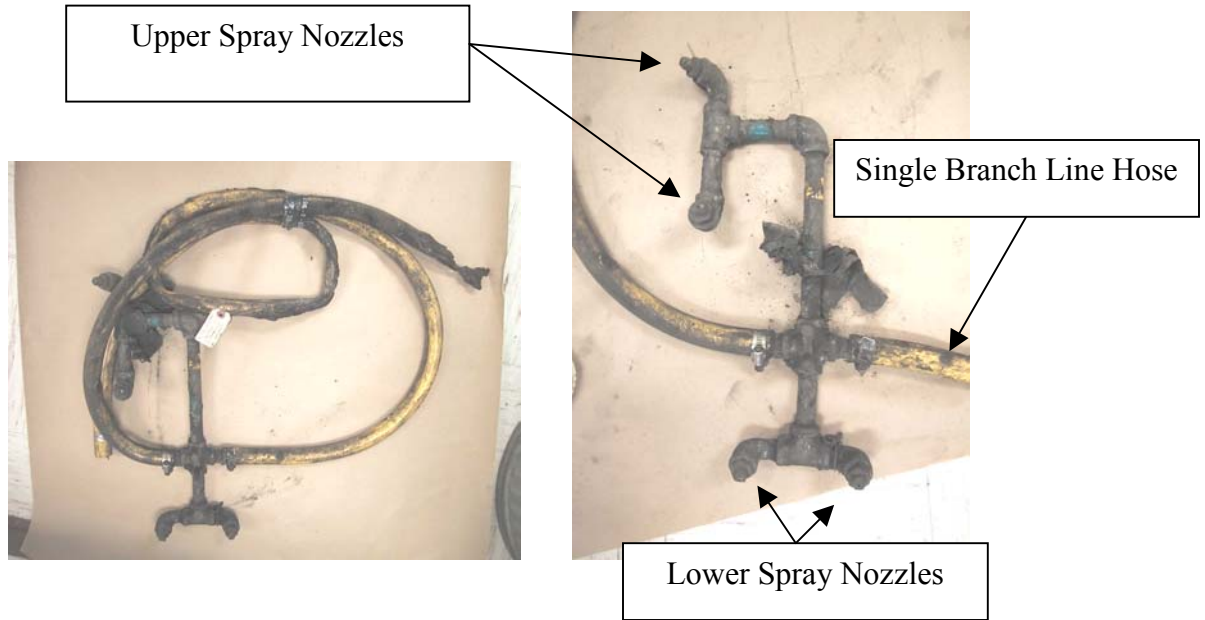
- *Proper water sprays were not installed on the branch line.* Section 30 CFR 75.1101-1(b) states that "Nozzles attached to the branch lines shall be full cone, corrosion resistant and provided with blow-off dust covers. The spray application rate shall not be less than 0.25 gallon per minute per square foot of the top surface of the top belt and the discharge shall be directed at both the upper and bottom surfaces of the top belt and to the upper surface of the bottom belt." The nozzles installed at the time of the fire were 60-degree cone sprays, rated for 1.0 gpm at 10 psi. A typical full cone nozzle has a 120-degree water spray.

The single branch line of sprays provided for the #2-3NW Belt Drive Fire Suppression System could not supply sufficient water flow to extinguish the fire. Total failure of the Fire Suppression System occurred when the branch line hoses were destroyed by the fire. Failure of the Fire Suppression System to automatically extinguish the fire exposed persons to hazards associated with fire-fighting activities and contributed to its size and duration.

Figure #9
Piping Tees with 1/2" Pipefittings and Spray Nozzles
3/4" Single Branch Line being utilized for Fire Suppression at the
#2-3NW Belt Drive Area

Corrective Action: When using deluge-type fire suppression systems, appropriate design standards should be used for sizing branch water lines. Water pressure losses and cone spray nozzle angles should also be considered to ensure proper coverage. After the accident, the operator replaced the #2-3NW Belt deluge system with a sprinkler system, which utilized 1 inch diameter piping. Testing verified that the water flow requirements were satisfactory for the sprinkler system.
