[Docket No. 98–NM–300–AD; Amendment 39–14355; AD 2005–22–11]

Airworthiness Directives; Mitsubishi Model YS–11 Airplanes, and Model YS–11A–200, YS–11A–300, YS–11A–500, and YS–11A–600 Series Airplanes

2005-22-11 Mitsubishi Heavy Industries, LTD.: Amendment 39-14355. Docket 98-NM-300-AD.

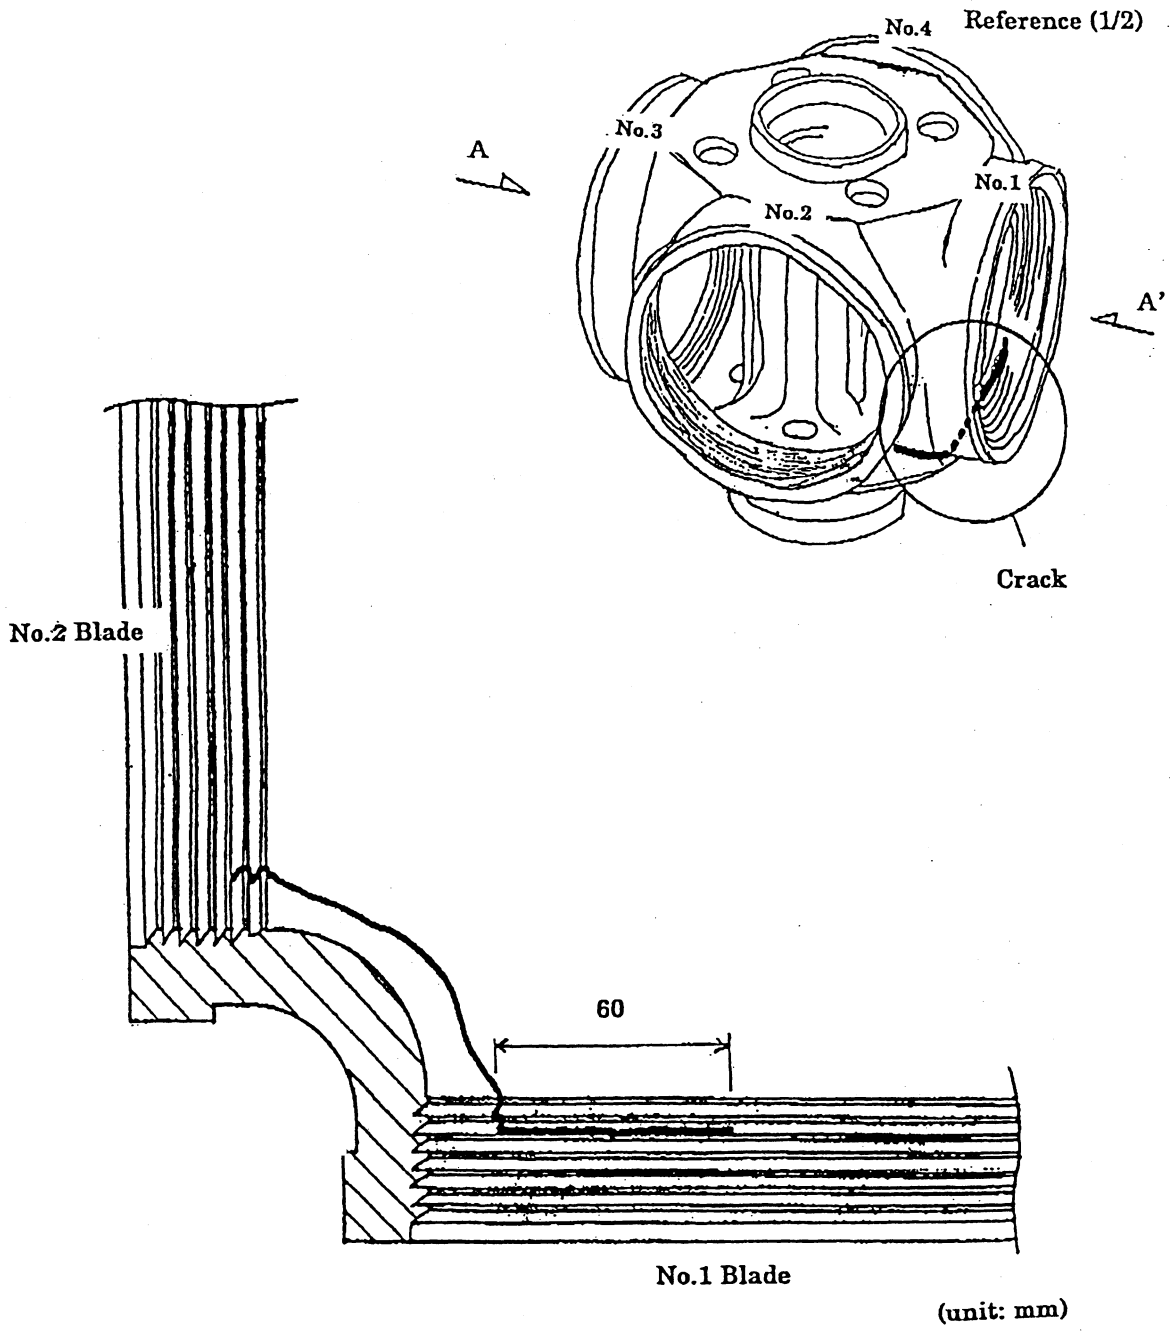
(a) Within 25 flight hours or 30 days after the effective date of this AD, whichever occurs first, remove the spinner and perform a detailed inspection for cracking of the propeller hub in the crack area shown in Figure 1 of this AD.

HUB CRACK - VIEW FROM TOP

(Cut A-A')

(1) If no crack is found, repeat the actions required by paragraph (a) of this AD thereafter at intervals not to exceed 25 flight hours.

(2) If any crack is detected, prior to further flight, replace the hub with a new hub according to a method approved by either the Manager, Los Angeles Aircraft Certification Office (ACO), FAA; or the Japan Civil Aviation Bureau (JCAB) (or its delegated agent). Chapter 61 of the Nihon Aeroplane

Manufacturing Company YS-11 and YS-11A Aircraft Maintenance Manuals is one approved method. Repeat the actions required by paragraph (a) of this AD thereafter at intervals not to exceed 25 flight hours.

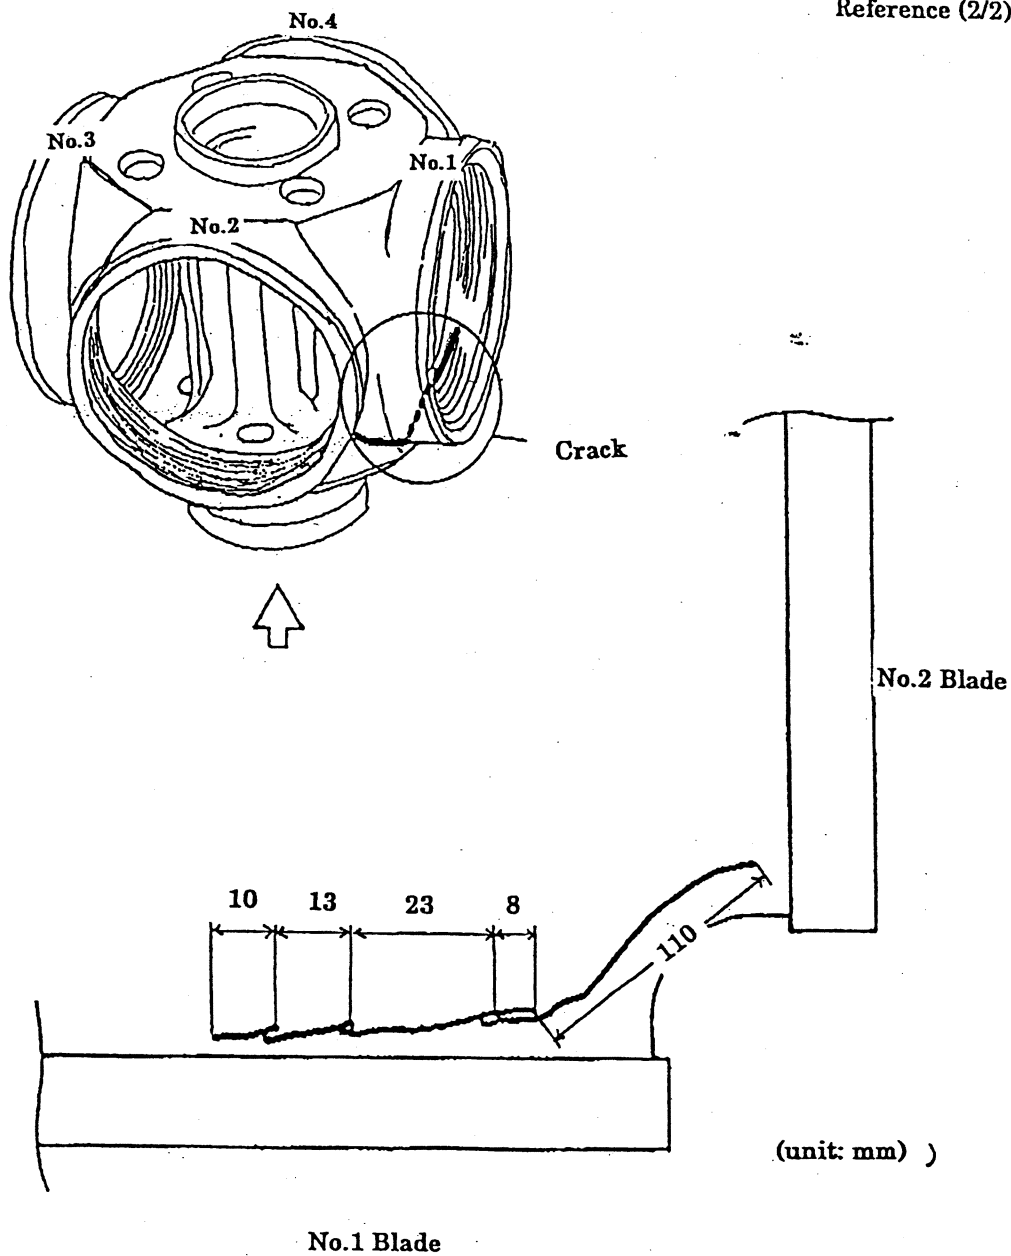
HUB CRACK - VIEW FROM BOTTOM
