[Docket No. 2001-SW-40-AD; Amendment 39-13022; AD 2002-13-05 R1]

Airworthiness Directives; MD Helicopters, Inc. Model 369D, 369E, 369F, and 369FF Helicopters

2002–13–05 R1 MD Helicopters, Inc.: Amendment 39–13022, Docket No. 2001–SW–40–AD. Revises AD 2002–13–05, Amendment 39–12793.

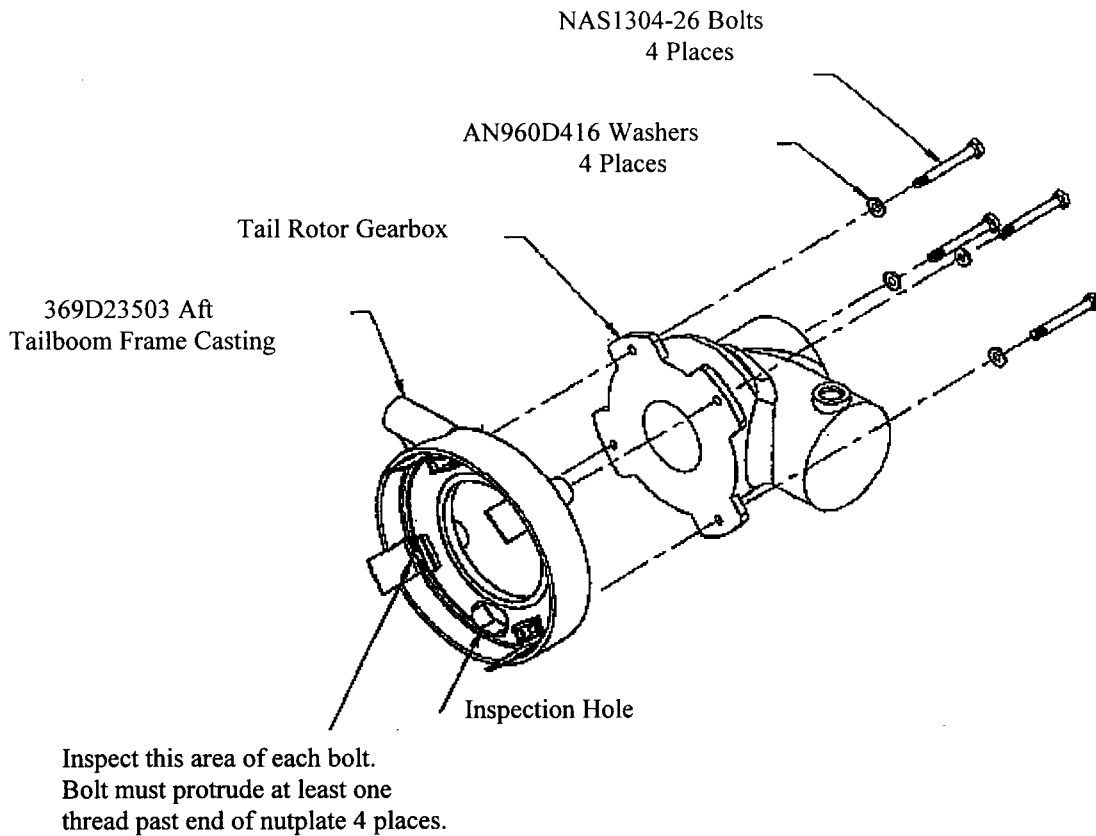
Figure 1 - Inspection Location

To prevent loss of the tail rotor gearbox due to attaching bolts of inadequate grip length and subsequent loss of control of the helicopter, accomplish the following:

(2) Remove the tailboom control rod and determine the number of bolt threads protruding from each nutplate on the internal surface of the aft tailboom frame casting, P/N 369D23503, as shown in Figure 1 of this AD. At least one thread must protrude. If more than four threads protrude, add an additional washer, P/N AN960D416, under the bolt head. Torque the bolt to 100–110 in-lbs, and reapply a slippage mark. *See Figure 1:*

(b) Between 2 and 10 hours TIS after accomplishing the requirements of paragraph (a) of this AD, inspect the torque on each bolt by applying 100 in-lbs. If any bolt movement occurs, retorque the bolt to 100–110 in-lbs. Reapply a slippage mark to the bolt regardless of the outcome of the torque test. Reinspect the torque between 2 and 10 hours TIS thereafter until no bolt movement occurs.
