[Docket No. 2001-SW-53-AD; Amendment 39-13079; AD 2003-05-03]

#### Airworthiness Directives; Bell Helicopter Textron Canada Model 407 Helicopters

**ACTION:** Final rule.

**SUMMARY:** This amendment adopts a new airworthiness directive (AD) for the specified Bell Helicopter Textron Canada (Bell) model helicopters that requires preflight checking and repetitively inspecting for a crack in certain tailbooms that have not been redesigned and replacing the tailboom if a crack is found; modifying and re-identifying certain tailbooms and installing an improved horizontal stabilizer assembly; and assigning a 5,000 hour time-in-service (TIS) life limit. This amendment is prompted by cracking discovered in other areas of certain tailbooms and introduction of a redesigned tailboom with a chemically milled skin, which does not require the current inspections. The actions specified by this AD are intended to prevent separation of the tailboom and subsequent loss of control of the helicopter.

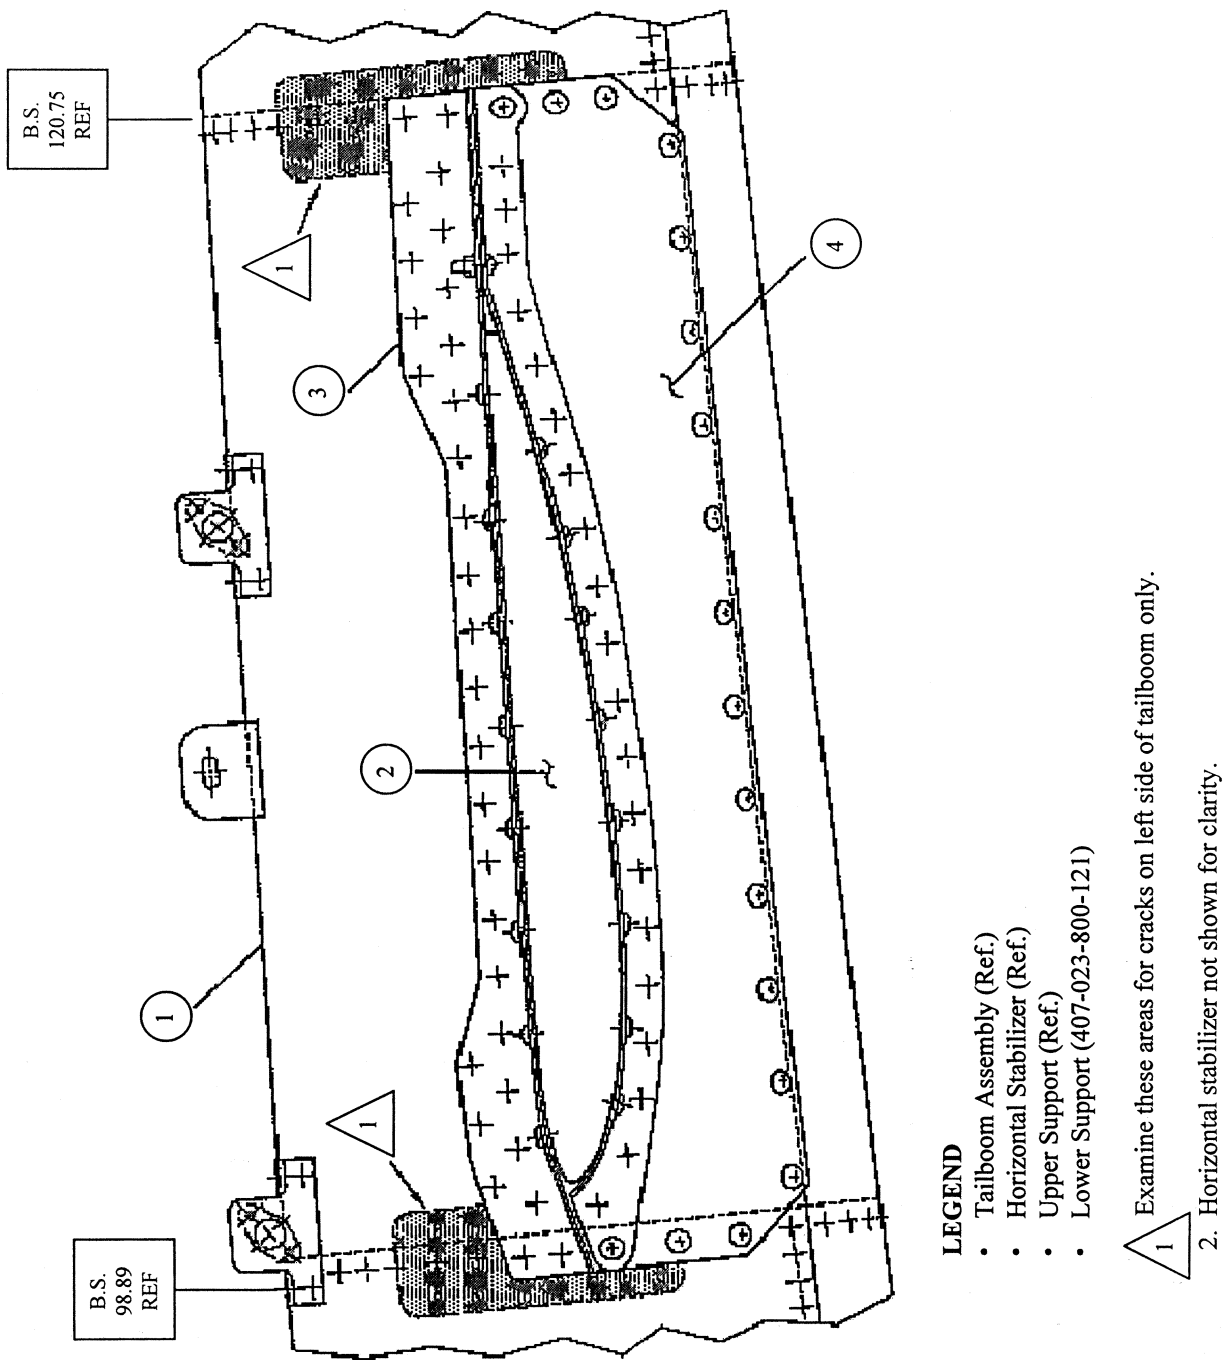
Figure 1. Preflight Check of the Tailboom

Applicable tailboom	Compliance time	Actions	In accordance with
(a) Tailboom, P/N 407-030-801-101 and -105, that have not been modified in accordance with Bell ASB 407-01-048, Revision B, dated April 25, 2002.	Before the first flight of each day	Visually check the tailboom for cracks. An owner/operator (pilot) holding at least a private pilot certificate may perform the visual check required by this paragraph, but must enter compliance with this paragraph into the helicopter records in accordance with 14 CFR 43.11 and 91.417(a)(2)(v).	Figure 1 of this AD.

(f) All applicable part-numbered tailbooms.	Before further flight .....	If a crack is found, replace the tailboom.	The applicable maintenance manual.
