Federal Register

Wednesday, December 3, 2003

[Docket No. 2003-NE-52-AD; Amendment 39-13381; AD 2003-24-12]

Airworthiness Directives; Pratt & Whitney JT9D-3A, -7, -7A, -7F, -7H, -7AH, and -7J Turbofan Engines

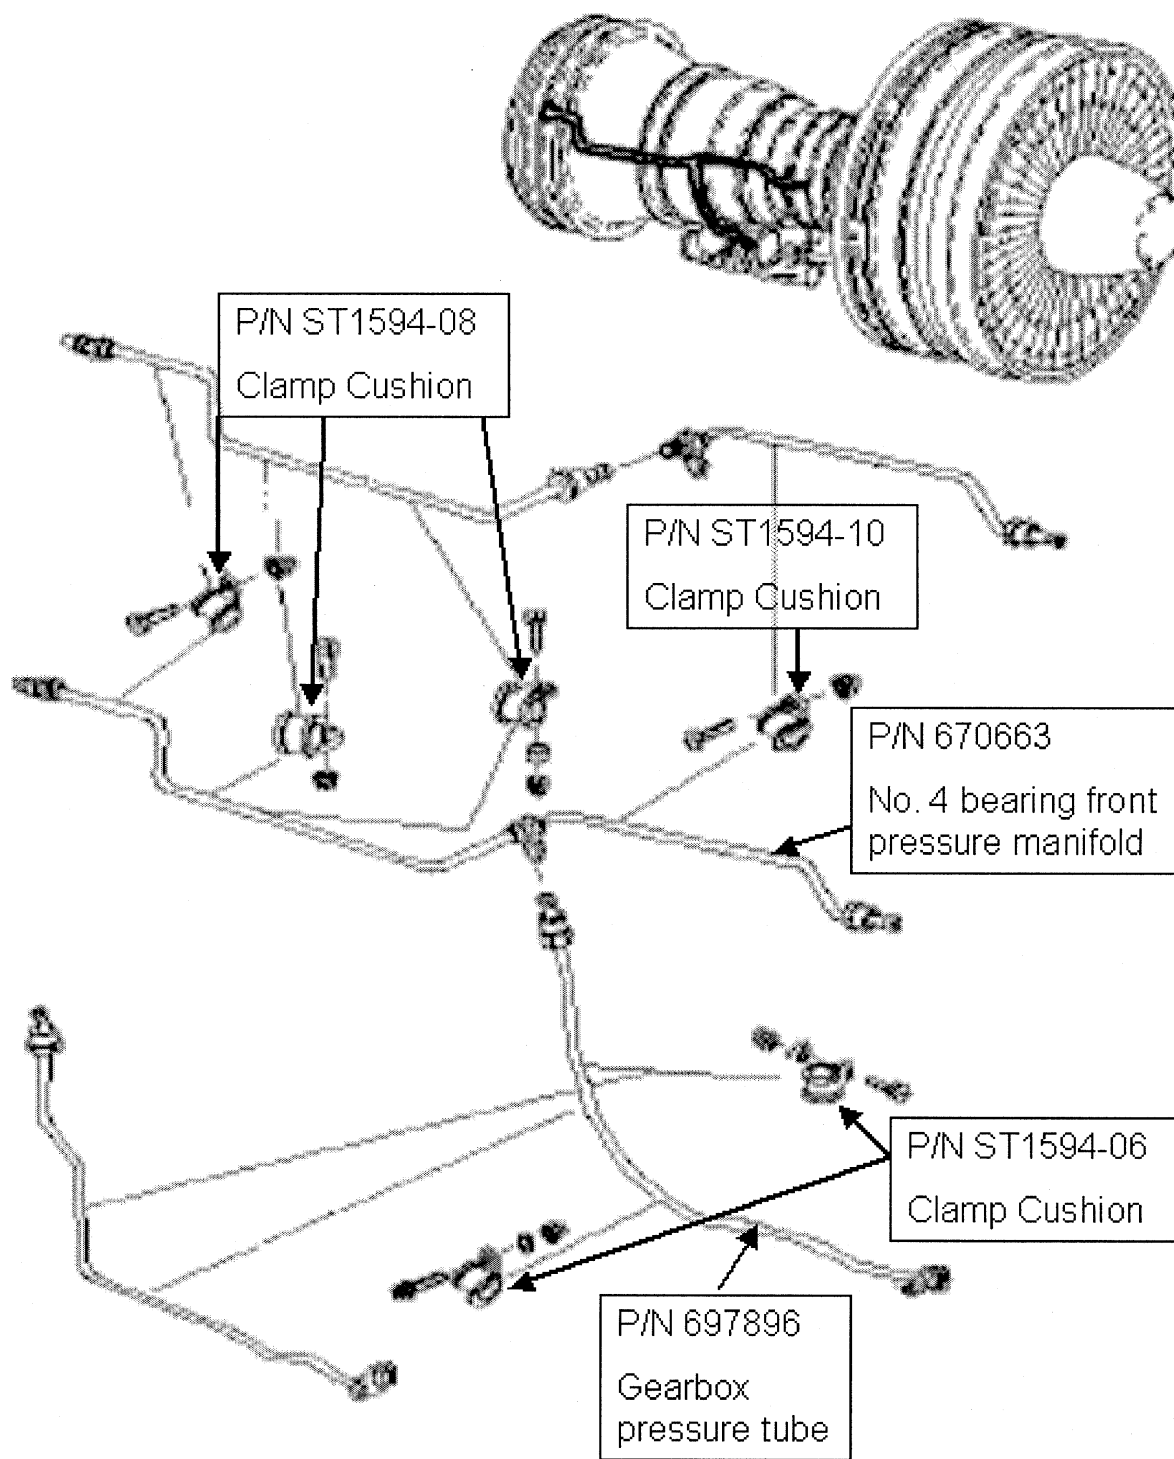
SUPPLEMENTARY INFORMATION: In June of 2003, we became aware that a PW JT9D-7 series turbofan engine gearbox pressure tube failed and caused an engine fire. Investigation revealed that several clamp assemblies that secure the No. 4 bearing front pressure manifold were broken, including some that were missing clamp rubber cushions. Without the clamp rubber cushions, the No. 4 bearing front pressure manifold moved freely due to engine vibration, causing the gearbox pressure tube to fracture, and caused an oil-fed engine fire. A similar failure was reported in 1996, but did not result in a fire.

- (1) Droop in the No. 4 bearing front pressure manifold.
- (2) Cracks, wear, or distortion in clamp metal.
- (3) Clamp cushions that are worn, compacted, cracked, coming apart in chunks, deteriorated, or missing. A reddish powder found around the clamp is an indication of deterioration.

- (1) Nicks, chafing, scratches, and or pitting 0.003 inch or greater in depth.
- (2) Dents within 0.25 inch of the ferrules or will not permit free passage of a ball having a diameter slightly greater than 80% of the tube or manifold tubing inner diameter.
- (3) Corrosion that is unable to be removed by a light polishing.
- (4) Tube or manifold is leaking oil.

(h) If the gearbox pressure tube, No. 4 bearing front pressure manifold, or clamp assemblies are not properly positioned, then correctly position them before further flight, as shown in the following Figure 1 of this AD.
