[Docket No. FAA-2005-22696; Directorate Identifier 2005-SW-22-AD; Amendment 39-14877; AD 2007-01-06]

#### **Airworthiness Directives; Bell Helicopter Textron Canada Model 206A, B, L, L-1, L-3, and L-4 Helicopters**

**ACTION:** Final rule.

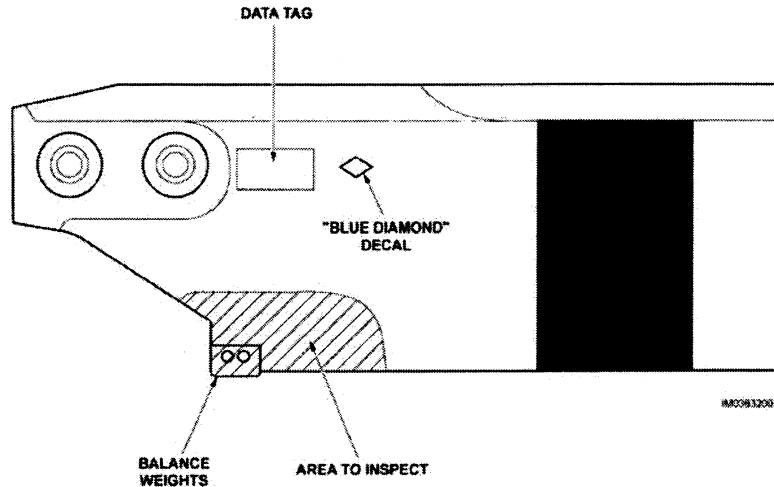
**Figure 1. Tail rotor blade inspection.**

(a) Before further flight, unless accomplished previously, and before installing any blade with a P/N and S/N listed in the applicability section of this AD, clean the blade. Using a 10X or higher magnifying glass, inspect both sides of each

blade for a deformation, a crack, and a bent or deformed weight in the area shown in Figure 1 of this AD.

**Note 1:** Paint irregularities on the blade may indicate a crack.

(1) At intervals not to exceed 12 hours time-in-service (TIS), using a 10X or higher magnifying glass, inspect both sides of each blade for a deformation, a crack, and a bent or deformed weight in the area shown in Figure 1 of this AD, or

(2) Inspect and check both sides of each blade for a deformation, a crack, and a bent or deformed weight in the area shown in Figure 1 of this AD as follows:

(c) Before further flight, replace any blade that has a deformation, a crack, or a bent or deformed weight with an airworthy blade.
