[Docket No. 2004-SW-04-AD; Amendment 39-13812; AD 2004-20-07]

#### Airworthiness Directives; Bell Helicopter Textron Canada Model 222, 222B, 222U, and 230 Helicopters

**ACTION:** Final rule.

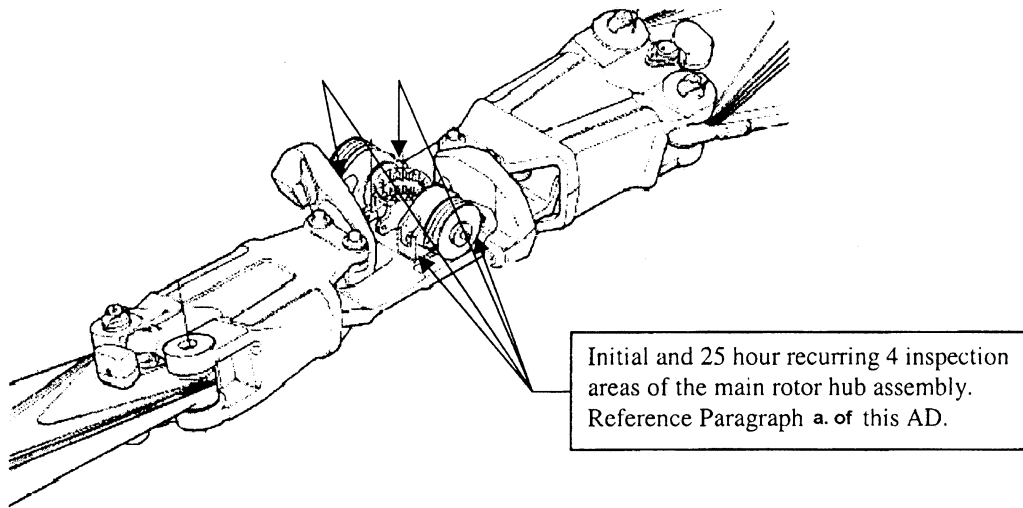
**Figure 1. Main Rotor Hub Assembly**

(a) Within 50 hours time-in-service (TIS) or by the next scheduled inspection for the hub assembly, whichever occurs first, and thereafter at intervals not to exceed 25 hours TIS, using a 10X or higher magnifying glass, visually inspect the main rotor yoke (yoke)

for a crack, fretting or buffer deterioration in the four areas around the flapping bearing attachment bushings as shown in the following Figure 1 of this AD:

(1) If a crack is found, before further flight, replace the yoke with an airworthy yoke.

(2) If fretting or buffer deterioration is found on the yoke in the areas shown in Figure 1 of this AD, before further flight, disassemble the hub assembly and further

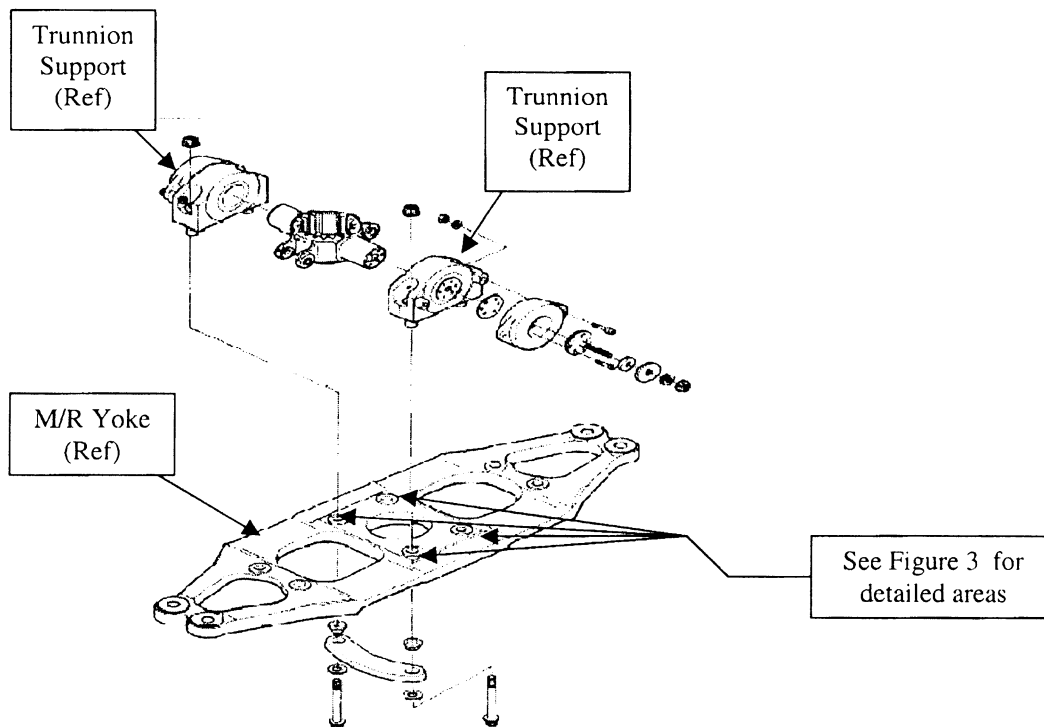
**Figure 2. Main Rotor Yoke**

inspect the yoke with a 10X or higher magnifying glass in the four areas shown in Figures 2 and 3 of this AD.

(i) If a crack is found on any part, before further flight, replace the part with an airworthy part.

(ii) If fretting or buffer deterioration is found on any part, before further flight, repair any unairworthy part or replace the part with an airworthy part.
