[Docket No. FAA-2004-18850; Directorate Identifier 2004-SW-19-AD; Amendment 39-13771; AD 2004-16-15]

**Airworthiness Directives; Eurocopter France Model AS-365N2, AS 365 N3, EC 155B, EC155B1, SA-365N and N1, and SA-366G1 Helicopters**

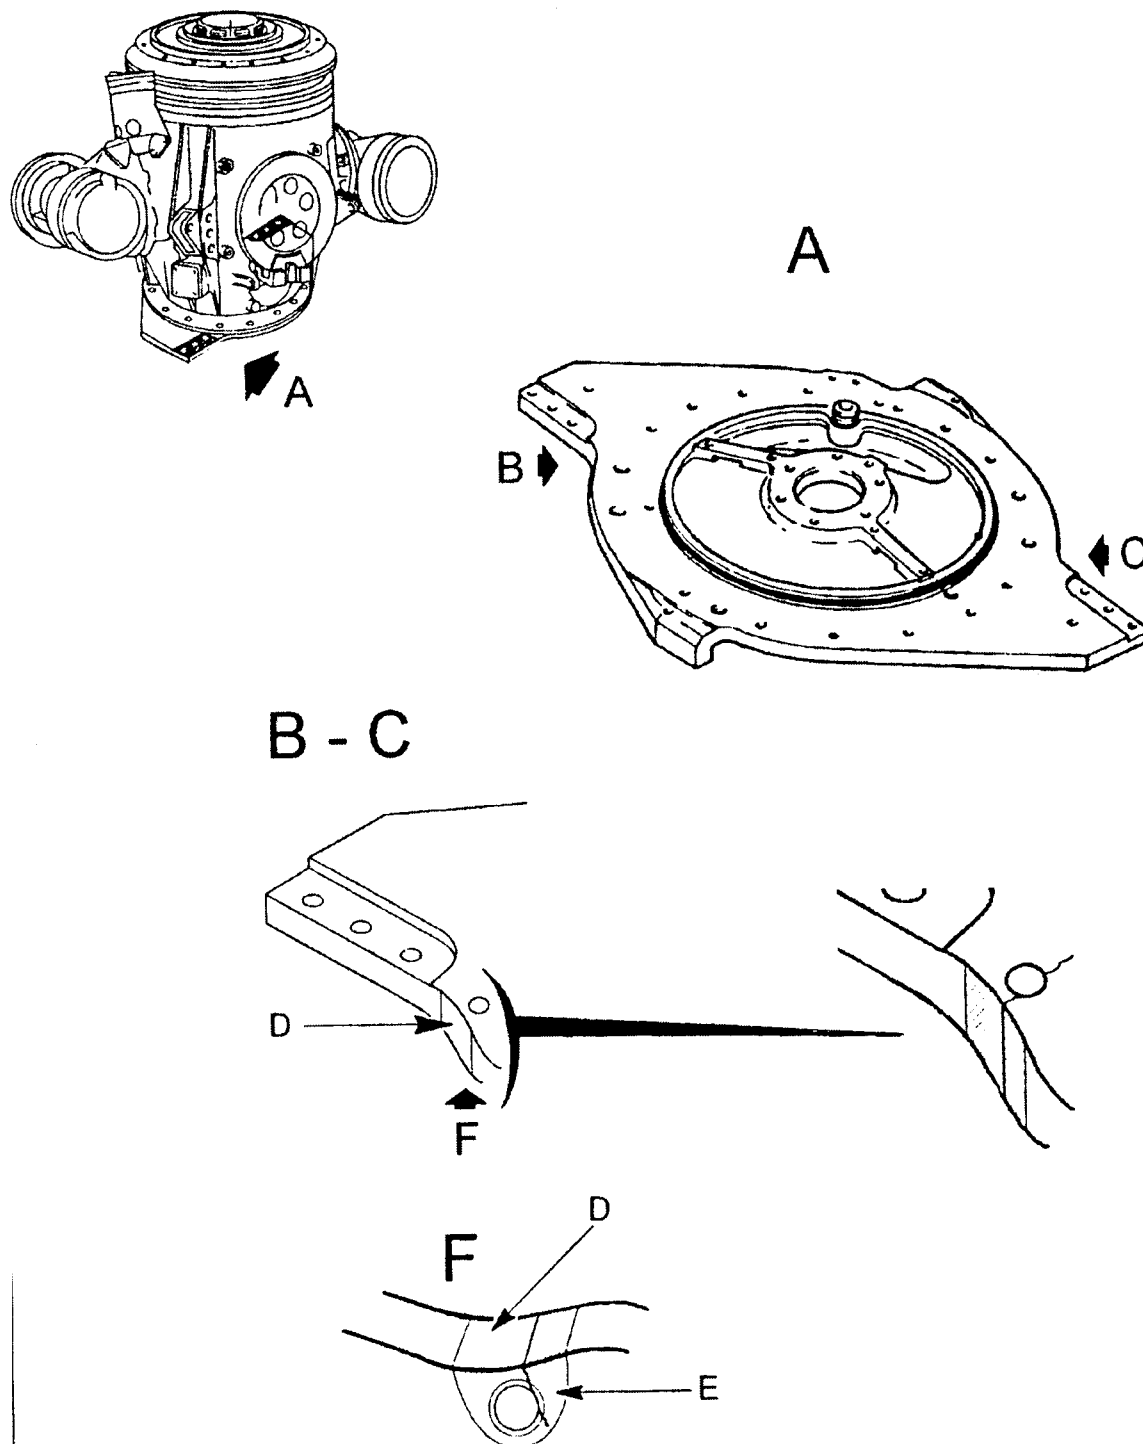
Figure 1

(MGB) baseplate for a crack and replacing the MGB if a crack is found in the MGB base plate. This amendment is prompted by the discovery of a crack in a MGB base plate. The actions specified in this AD are intended to detect a crack in a MGB base plate and prevent failure of one of the MGB attachment points to the frame, which could result in severe vibration and subsequent loss of control of the helicopter.

paint from area "D" on both sides ("B" and "C") of the MGB base plate as depicted in Figure 1.

(b) At the times indicated in the compliance table, inspect area "D" of the MGB base plate for a crack using a 10x or higher magnifying glass.

(c) If a crack is found in a MGB base plate, remove and replace the MGB with an airworthy MGB before further flight.
