[Docket No. FAA–2006–25760; Directorate Identifier 2006–CE–48–AD; Amendment 39–14757; AD 2006–18–51]

**RIN 2120–AA64****Airworthiness Directives; Raytheon Aircraft Company Models 1900, 1900C, and 1900D Airplanes****AGENCY:** Federal Aviation Administration (FAA), DOT.**ACTION:** Final rule; request for comments.

##### Inspection Instructions—Raytheon Aircraft Company 1900 Series Wing Rear Spar

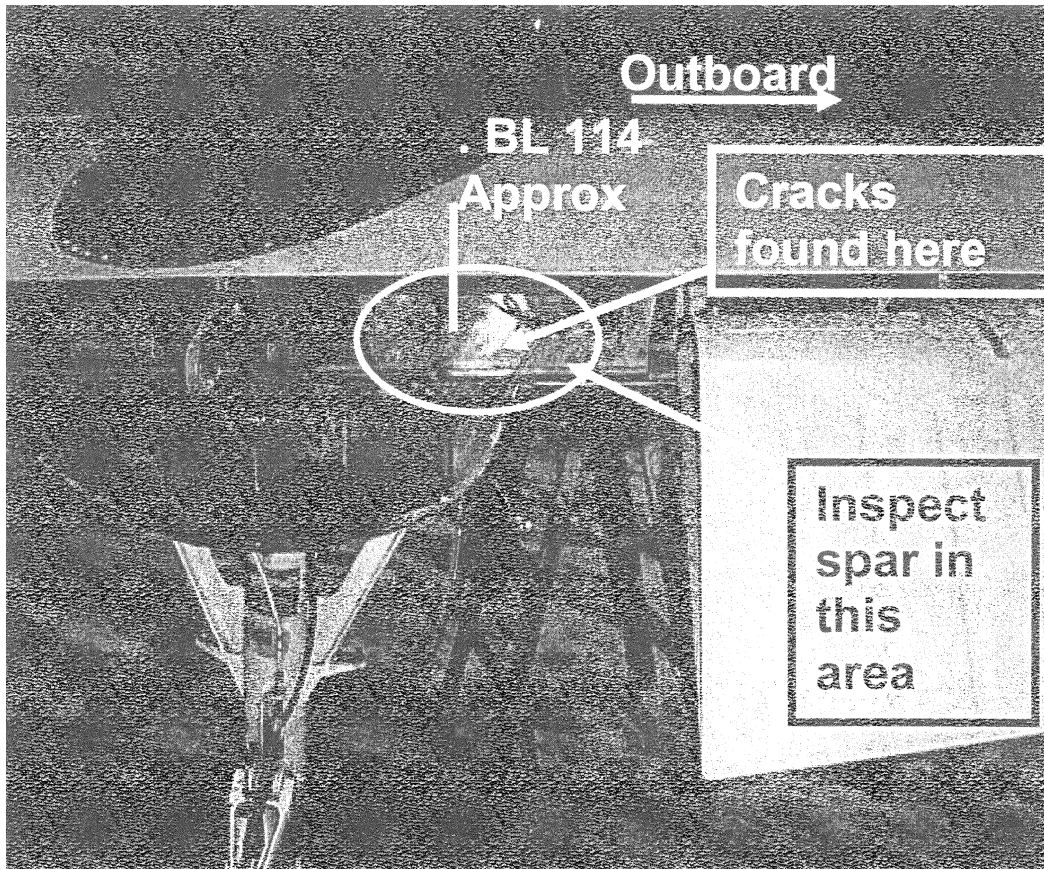
identified in Figure 1. There is ample visually visual access from above the upper surface of the flap. Look for cracks (like those shown in Figures 2 and 3) and loose or missing fasteners.

Figure 1: View of R/H wing rear spar at BL 114 area looking forward (The inboard flap is removed in this figure, but removal of the flap is not required to do the inspection).

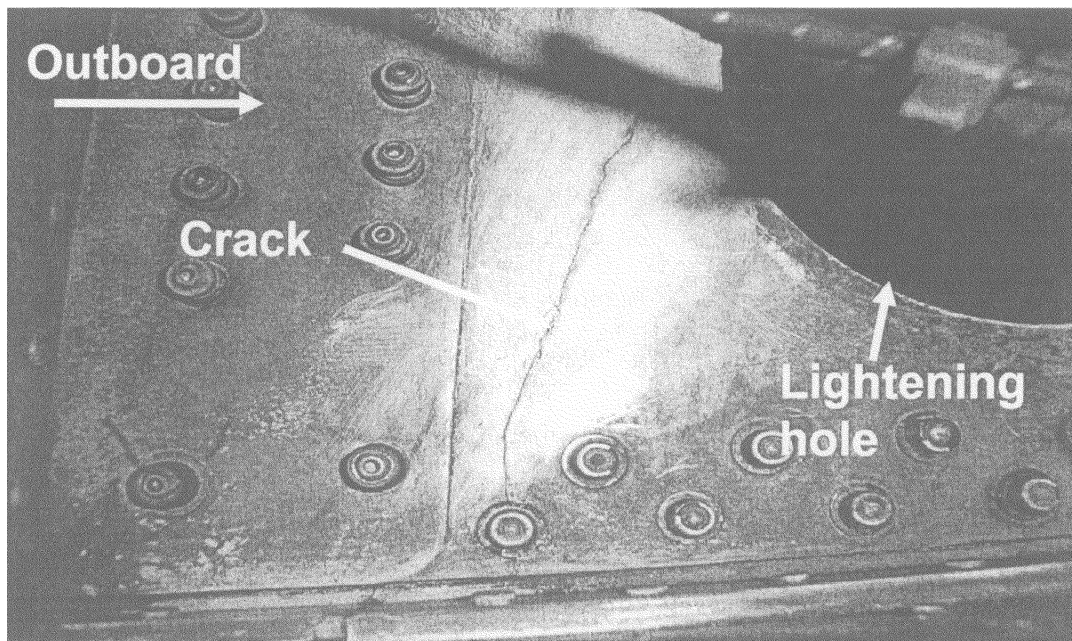
One airplane had 19,126 hours TIS when cracks were found. The cracks were in the lower aft spar cap flange, but the cracks extended upward into the web and terminated at the lightening hole in the spar web. Fasteners were also found missing in the spar cap and wing cove splice plate. There were no discrepancies recorded from the initial inspection at 17,500 hours TIS on this airplane.

Figure 2: Closeup view of R/H wing rear spar web crack at BL 114 area looking forward (The inboard flap is removed in this figure, but removal of the flap is not required to do the inspection).

(3) Repair any cracks or other damage such as loose or missing fasteners found during the inspection required in paragraph (e)(1) of this AD. Do this by obtaining and incorporating an FAA-approved repair scheme from RAC.	Before further flight after the inspection required by paragraph (e)(1) of this AD.	Contact RAC at Post Office Box 85, Wichita, Kansas 67201-0085; phone: 316-676-8366; fax: (316) 676-8745; e-mail: <a href="mailto:tom_peay@rac.ray.com">tom_peay@rac.ray.com</a> .

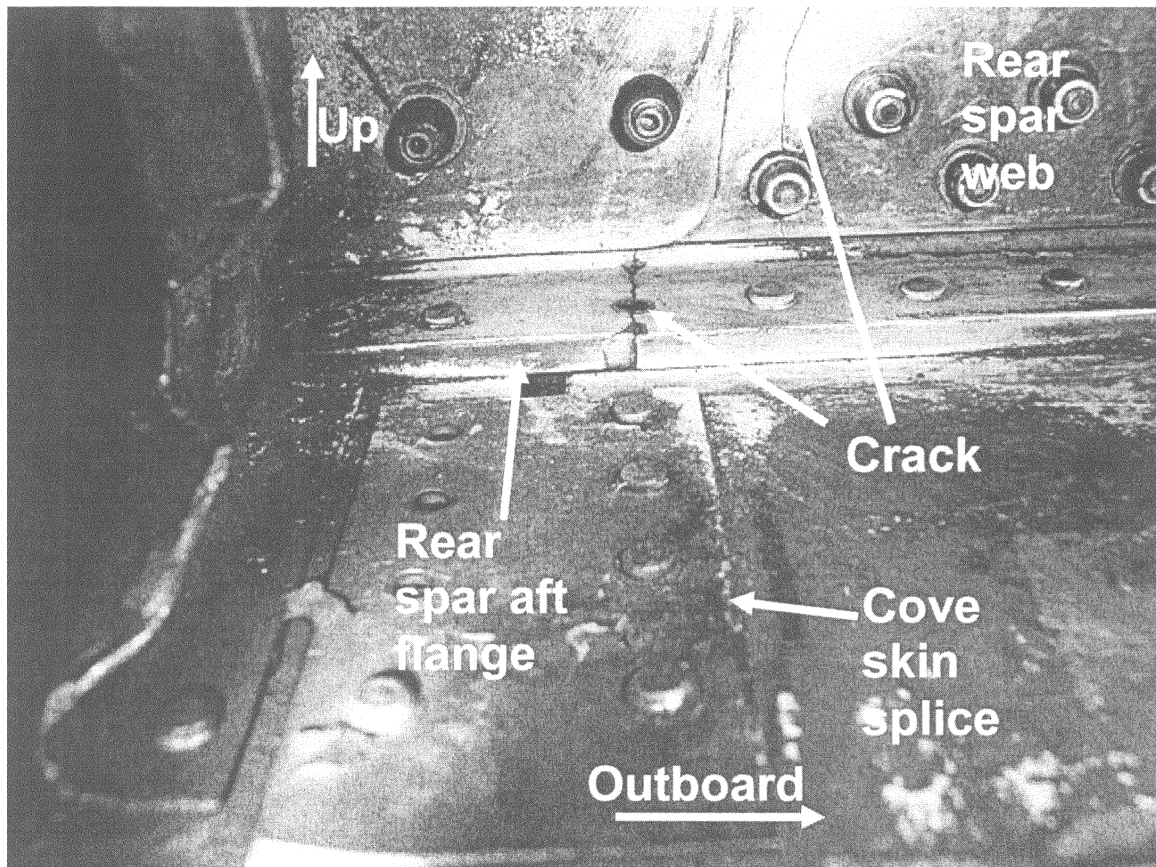
Figure 3: Closeup view of R/H wing rear spar cracks at BL 114 area looking forward (The inboard flap is removed in this figure, but removal of the flap is not required to do the inspection).
