**REPORT ON FAA'S ACTIONS TO ADDRESS  
MOLD AT THE DETROIT METROPOLITAN AIR  
TRAFFIC CONTROL TOWER FACILITY**

*Report Number: AV-2006-055*

*Date Issued: July 11, 2006*

Subject: **ACTION**: Report on FAA's Actions To Address Mold at the Detroit Metropolitan Air Traffic Control Tower Facility  
Federal Aviation Administration  
AV-2006-055

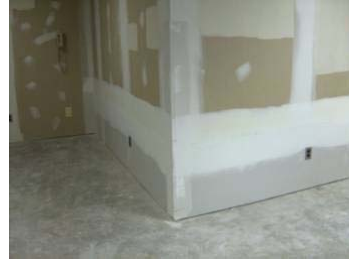
- January 2006 – Remediation was conducted on the third floor in response to mold identified during the November monthly moisture inspection. The photo at right depicts this completed remediation that replaced the lower two feet of gypsum wallboard from the wall bordering the elevator shaft.

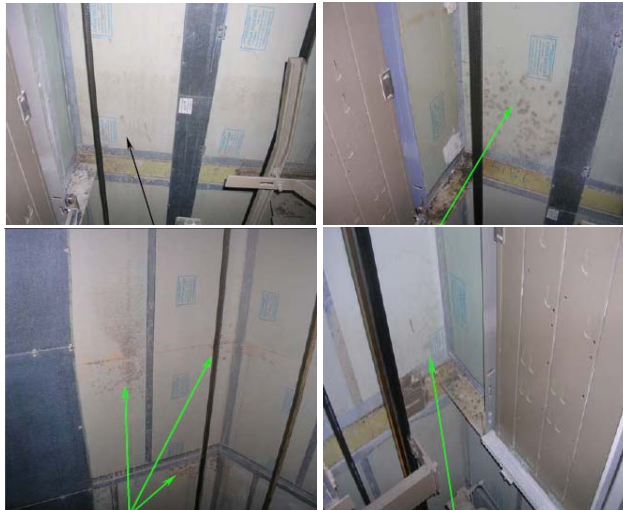
## What did the mold in the elevator shaft look like?

- **Top Left:** Spots of visible mold growth on east wall of shaft of the third floor.
- **Top Right:** Visible mold growth on shaft on west wall of seventh floor.
- **Bottom Left:** Visible mold growth on shaft on west wall of eighth floor.
- **Bottom Right:** Visible mold growth on east wall of shaft of sixth floor.

- May 2006 – Mold in the elevator shaft was remediated by HEPA vacuuming and damp wipe-down with detergent and water. FAA continues to conduct monthly moisture inspections of the facility (including the elevator shaft) to identify mold or moisture issues.
