[Docket No. 2002-SW-48-AD; Amendment 39-12982; AD 2002-21-51]

Airworthiness Directives; Eurocopter France Model AS355E, F, F1, F2, and N Helicopters

2002-21-51 Eurocopter France:

Amendment 39-12982. Docket No. 2002-SW-48-AD.

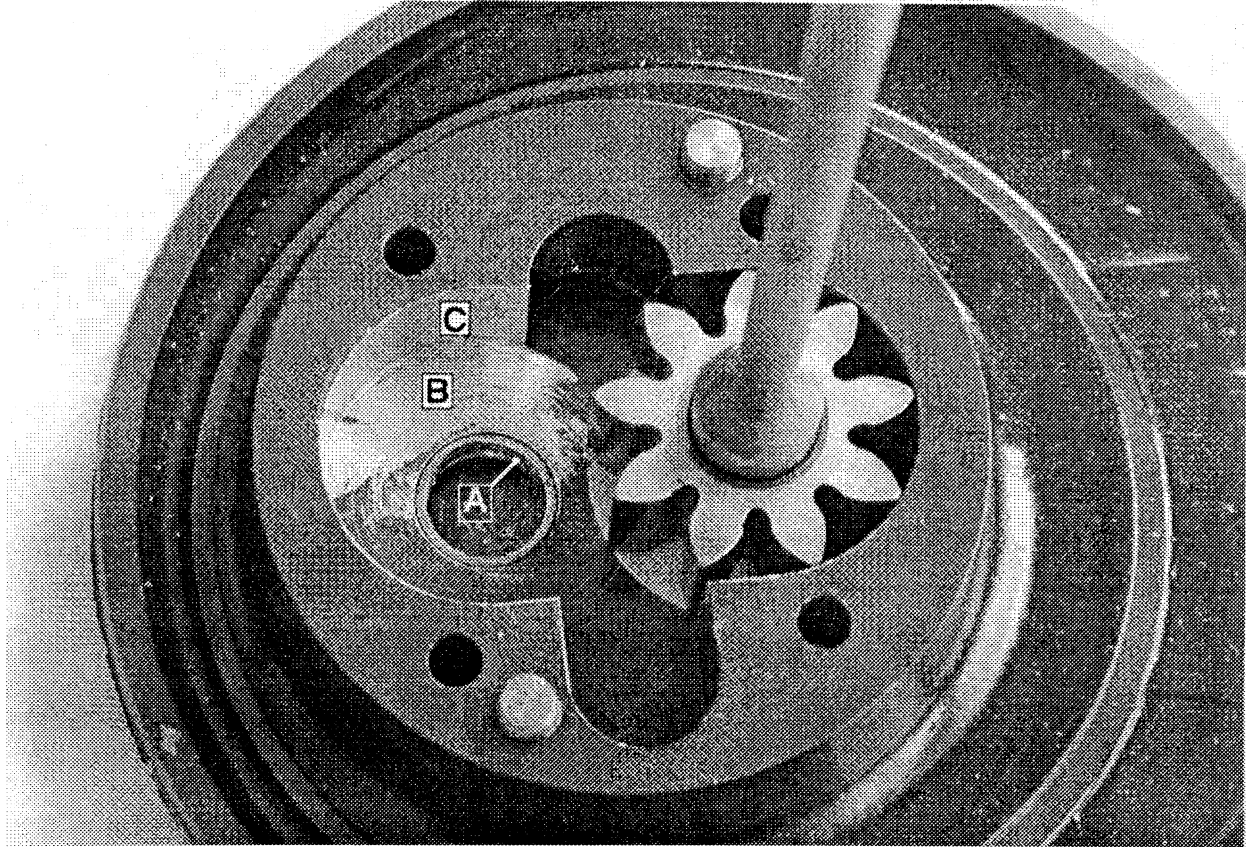
Figure 1

- (i) Crank pin play,
- (ii) Out of round bronze bushing (A of Figure 1),

- (iii) Offset of the driven gear pinion,
- (iv) Metal chips, or
- (v) Wear (C of Figure 1).

Note 3: If wear occurs in B only in Figure 1, replacing the MGB and the pump is not necessary.

(3) While inspecting the pump, if you find any of the following, replace the MGB and the pump with an airworthy MGB and pump before further flight:
