Office of Compliance **Report on Occupational Safety and Health Inspections**

Conducted in the Legislative Branch during the 108th
Congress pursuant to the Congressional
Accountability Act

October 2005

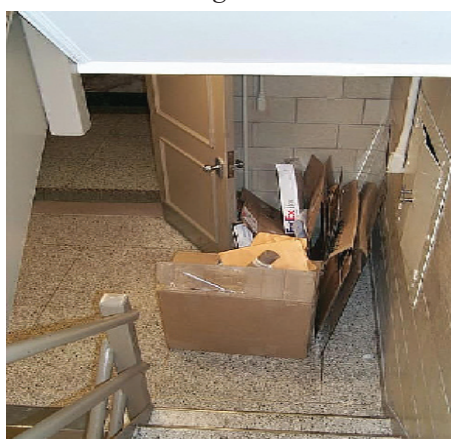
The inspectors found that stairwells in the Supreme Court Building that serve as emergency exit routes for AOC employees were partially blocked by cardboard boxes and paper files stored within a metal file cabinet. This created a dual hazard - blockage and combustible materials.¹⁶

Combustible materials being stored in an exit stairwell.

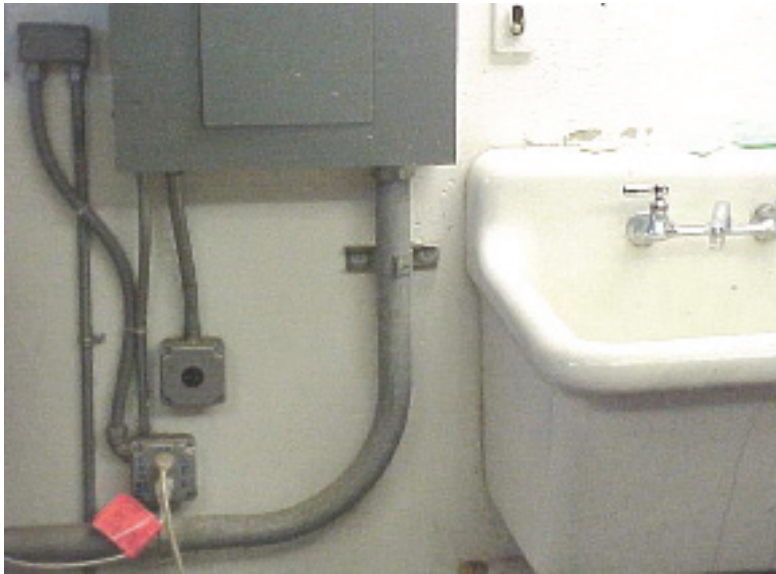
Ground fault circuit interrupters (GFCI) protect employees from electrical shock hazards when working around or near wet or damp locations. Without a GFCI, a faulty electrical appliance could deliver a fatal shock. The installation of GFCIs on outlets is relatively simple and inexpensive. However, the 2004 inspections found that 120 locations needed the installation or replacement of faulty ground fault circuit interrupters. Three Serious Deficiency Needing Prompt Attention Notices were issued to the AOC in this regard.

Electric outlet near sink is not a ground fault circuit interrupter (GFCI).

The 2002 Report addressed the importance of installing GFCIs throughout Legislative Branch buildings. The 2004 inspection revealed an overall increase in their number. However, the number of hazard findings indicates that further improvement is necessary. In particular, all employing offices must incorporate periodic inspection and maintenance of these important safety devices.

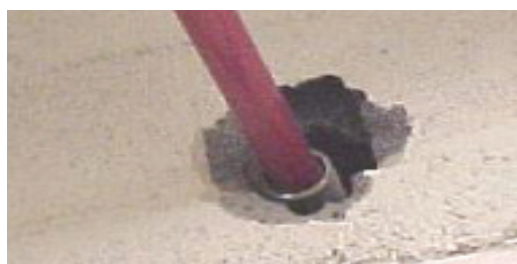
Breaches into fire walls negate the efficacy of the protection afforded by the barrier by allowing smoke and toxic gases to pass through the holes. On the positive side, the number of penetrations decreased substantially from the time the last comprehensive fire safety inspection was conducted in the Dirksen Building in 1999. However, the OGC inspection team discovered eight holes and penetrations in various fire walls throughout the building that were apparently caused by contractors installing security or other devices, such as cable, and then failing to fire-stop the openings when the project was completed.

Holes or penetrations through fire wall.

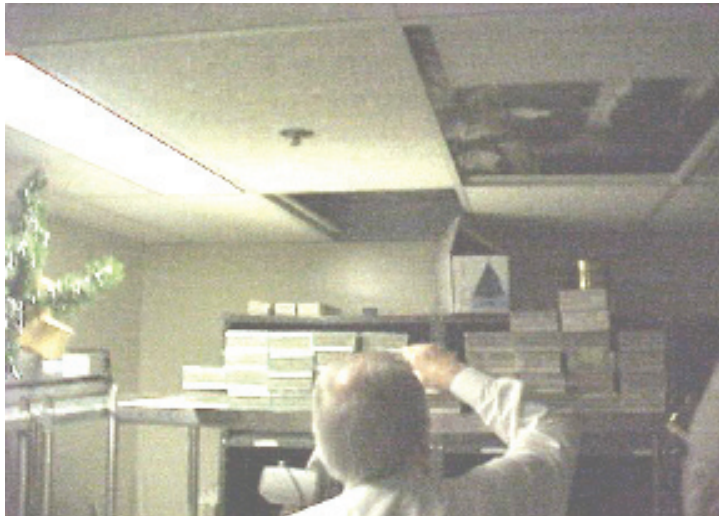
Several deficiencies were noted in the Dirksen Building's sprinkler system. The building itself has extensive coverage, but several areas, including the cafeteria, emergency generator room, and several sub-basement shop areas, lack any coverage. The sprinkler heads in another area, the Southside Sundae Shop, were found to be non-functional because they were located above a false ceiling. In eight other locations throughout the building, the sprinkler heads were found to be blocked by the storage of cardboard boxes and other combustible materials stored too close to the heads. The OSHA standards require a minimum clearance of eighteen inches between the sprinkler head and any other object. See 29 C.F.R. §1910.159(c)(10); NFPA #25, §2-2.1.2.

Missing ceiling tiles interfere with activation of sprinkler heads.

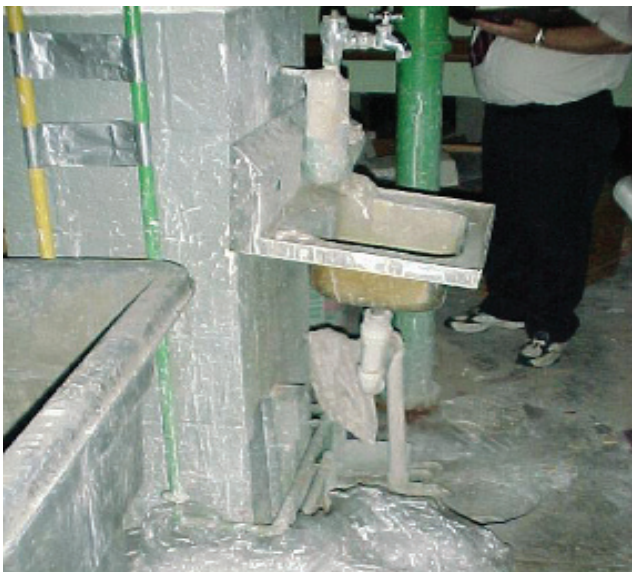
The number of electrical hazards documented in the Dirksen Building is exceptionally high as compared to other buildings. Hazards of an electrical nature constituted 116 of the 193 total violations documented in the Dirksen Building. The most serious resulted in the General Counsel issuing a Serious Deficiency Needing Prompt Attention Notice to the AOC on October 17, 2004, due to an undersink outlet lacking a ground fault circuit interrupter. The damp surfaces surrounding the sink area created a significant risk of electrical shock for employees working in this area.

Outlet below sink without GFCI protection.

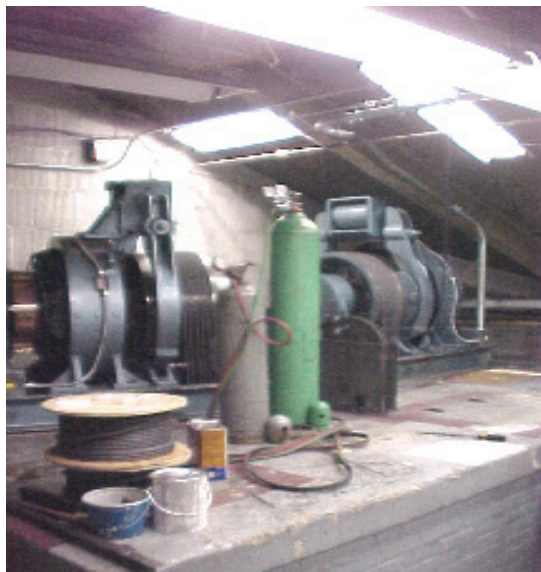
The significant risks associated with unsecured compressed cylinders is discussed in detail below. See Section V.A. The OGC inspection team found three instances in which compressed gas cylinders were not secured.

Cylinders are not secured and will fall over easily.

One cylinder contained acetylene, which is a highly volatile chemical. Another had its regulator attached which adds to the risk of valve damage should the cylinder fall. When valves are damaged, they frequently begin to leak. Damaged cylinders have been known to explode or to become missiles causing extensive damage and physical injury.

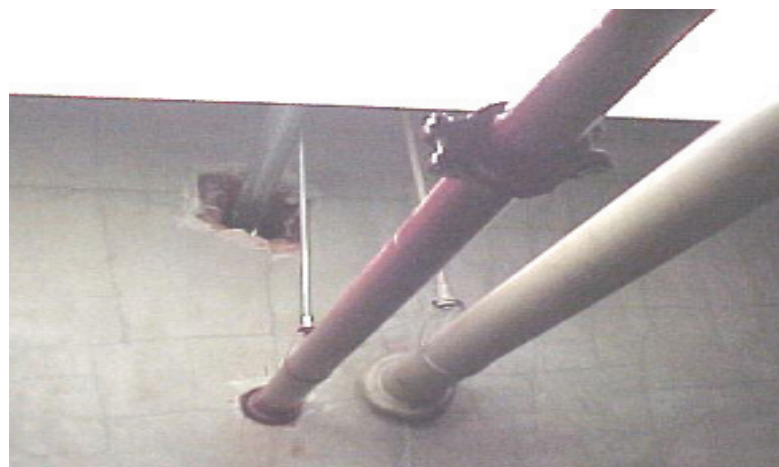
Holes were also found in nineteen fire barrier walls throughout the Rayburn Building. The locations include the Penthouse, basement garage, sub-basement, and three levels of the Rayburn Garage.

Hole in fire wall allows penetration of toxic smoke.

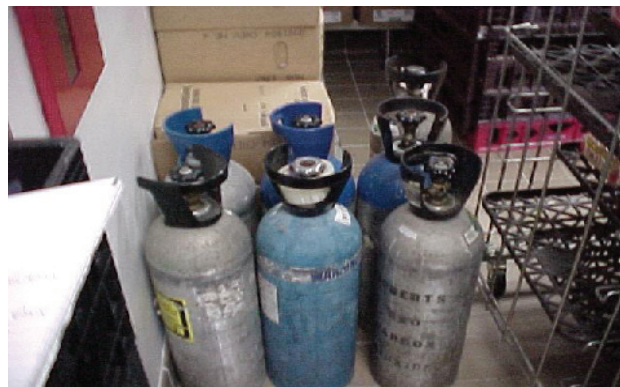
The inspection team found four instances of pressurized cylinders that were unsecured.

Unsecured pressurized gas cylinders.

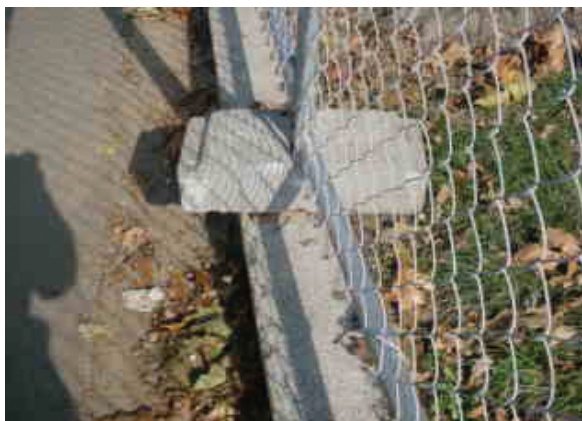
The other two incidents involved temporary security barriers surrounding a construction site at the Adams Library of Congress Building. Installing the security barriers around the building required the contractor to construct a temporary chain link fence around the construction area and the sidewalk along the edge of Second Street S.E. The first incident occurred in late October 2004. The fence blew over on an LOC employee who received cuts, abrasions, and torn clothing as a result of the accident.

Temporary fence that fell over and injured people held up by cement block.
