SUBJECT: "Cobra" Gas Appliance Hoses

SUBJECT: Cobra Gas Connectors - Cobra Metal Hose - Chicago, Illinois

Flexible Brass Range Connector Failures.

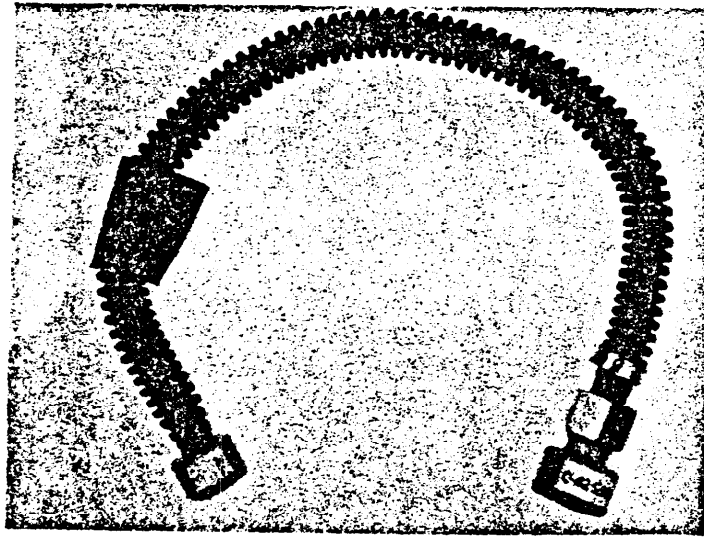
Photo .18: Brass/Aluminum Double-Jacketed Connector
Specimen [REDACTED]

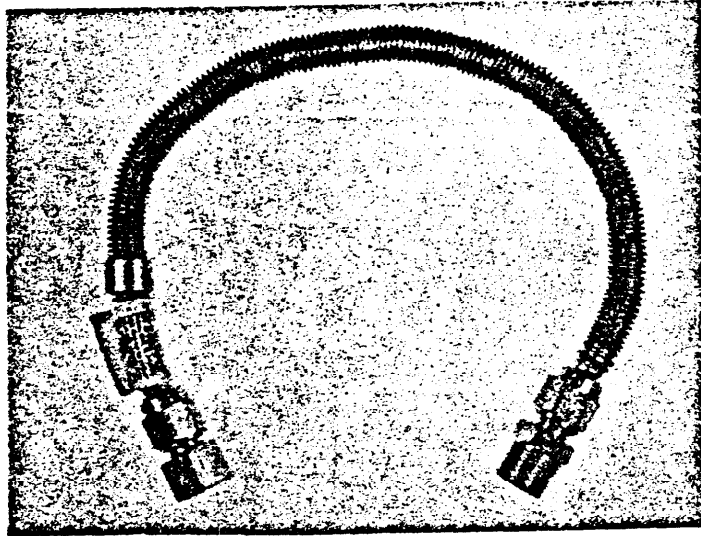
Photo 19: Stainless Steel Connector
Specimen [REDACTED]

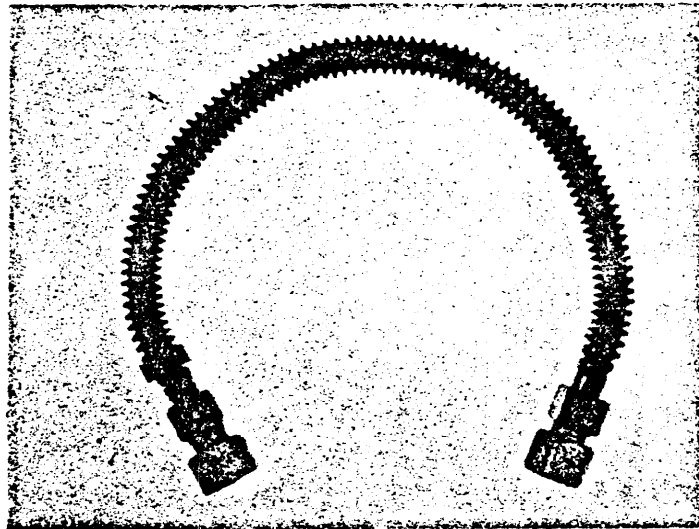
Photo 20: Polymer Coated Connector
Specimen [REDACTED]

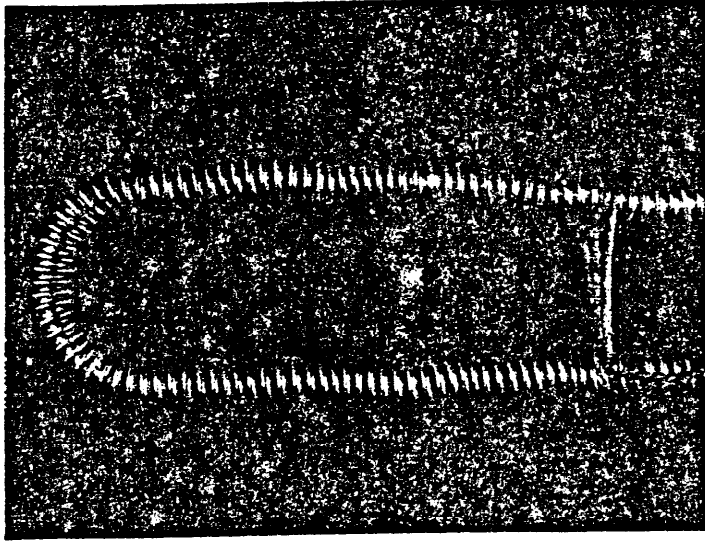
Photo 22: Brass Connector
Specimen [REDACTED]

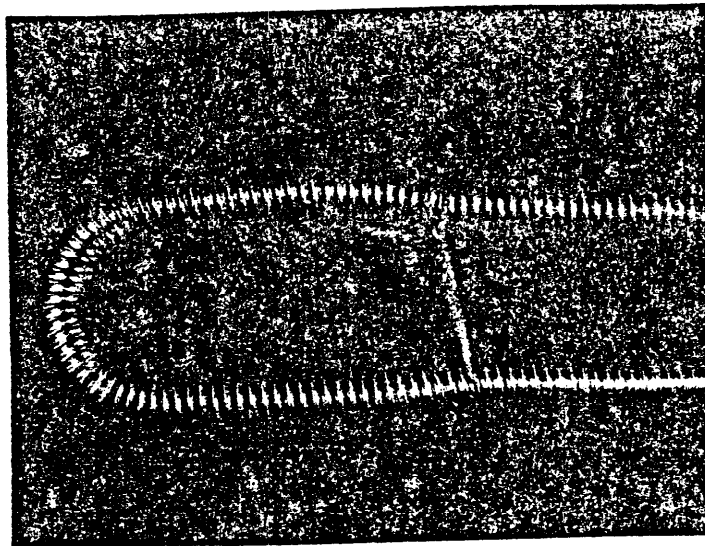
Photo 21: Brass Connector
Specimen [REDACTED]

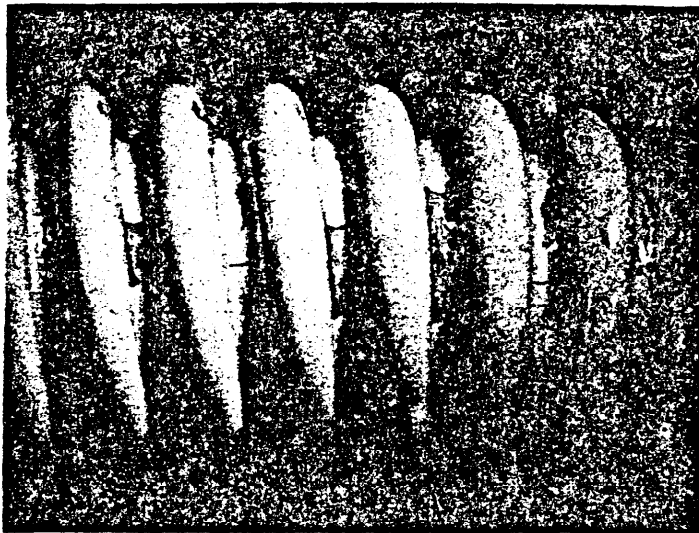
Photo 23: Damaged Epoxy Polymer Coating
As Received by BESL
Specimen [REDACTED]

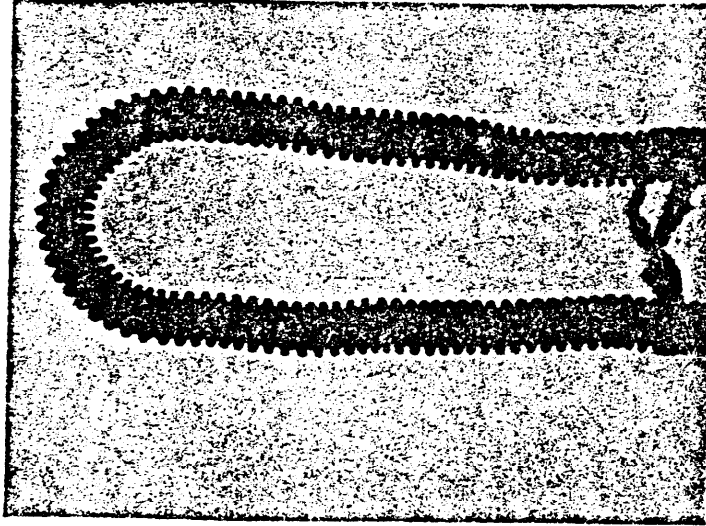
Photo 25: Brass Connector After
Ammonia Vapor Exposure
Specimen [REDACTED]

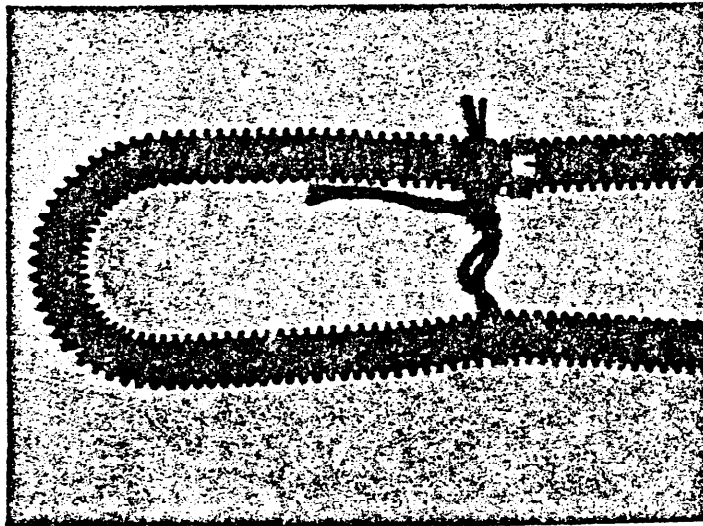
Photo 24: Brass Connector After
Ammonia Vapor Exposure
Specimen [REDACTED]

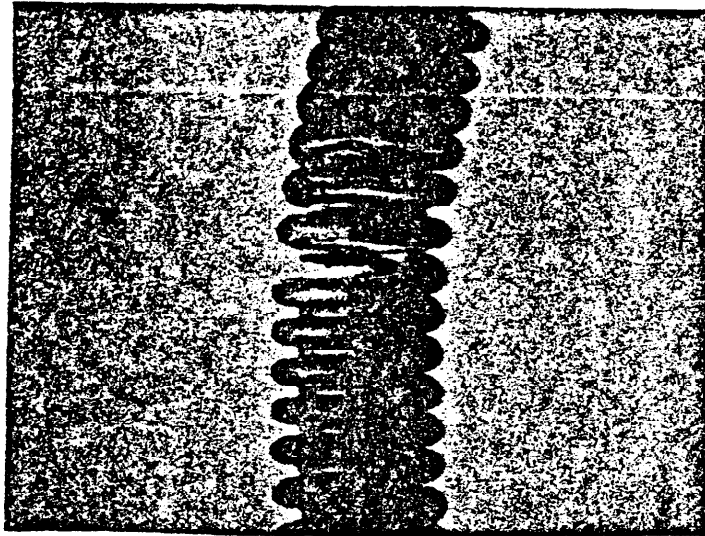
Photo 26: Stress Corrosion Cracking
Induced by Ammoniacal Environment
Specimen [REDACTED]

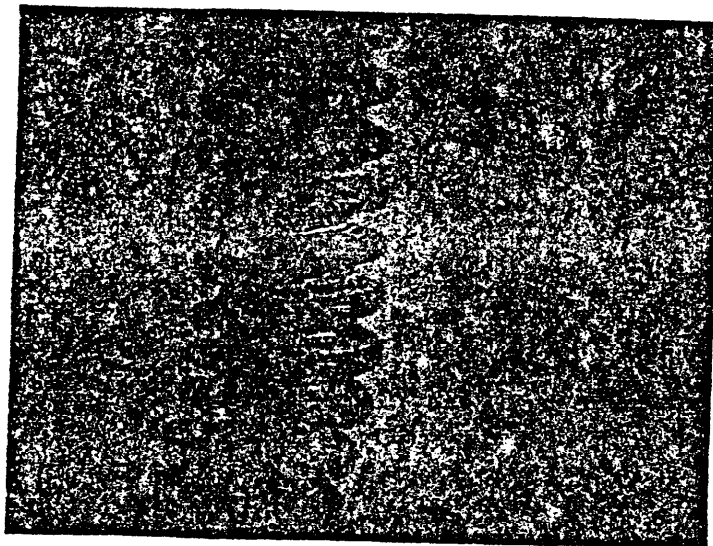
Photo 27: Stress Corrosion Cracking
Induced by Ammoniacal Environment
Specimen [REDACTED]

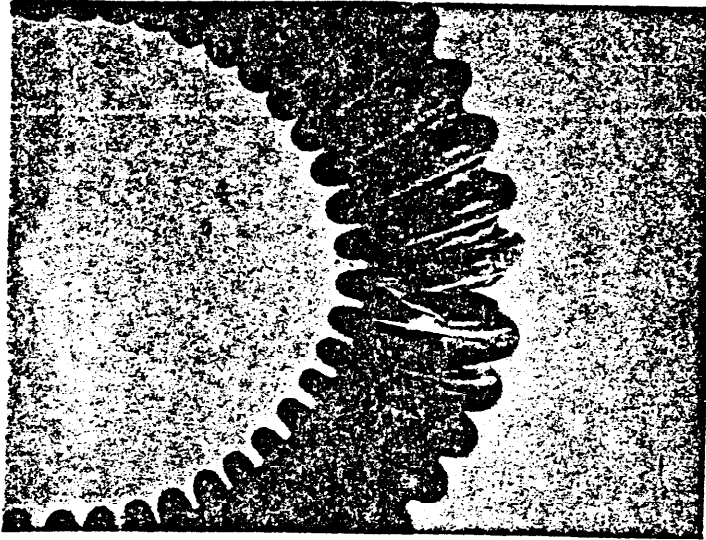
Photo 28: Stress Corrosion Cracking
Induced by Ammoniacal Environment
Specimen [REDACTED]

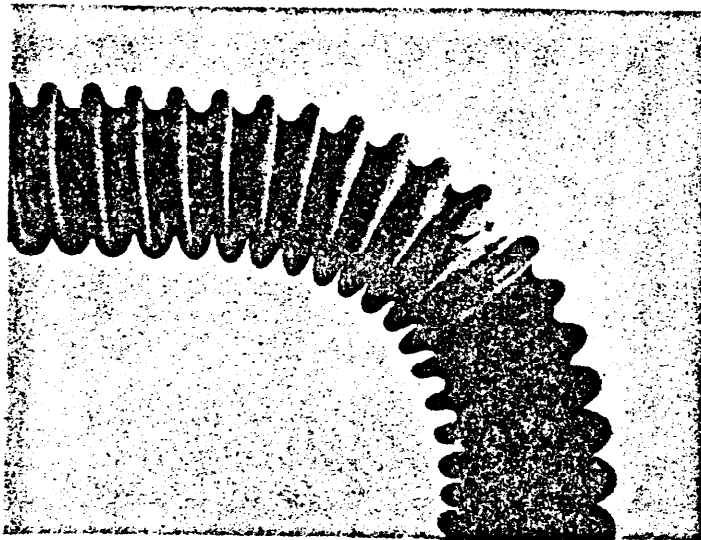
Photo 29: Stress Corrosion Cracking
Induced by Ammoniacal Environment
Specimen [REDACTED]

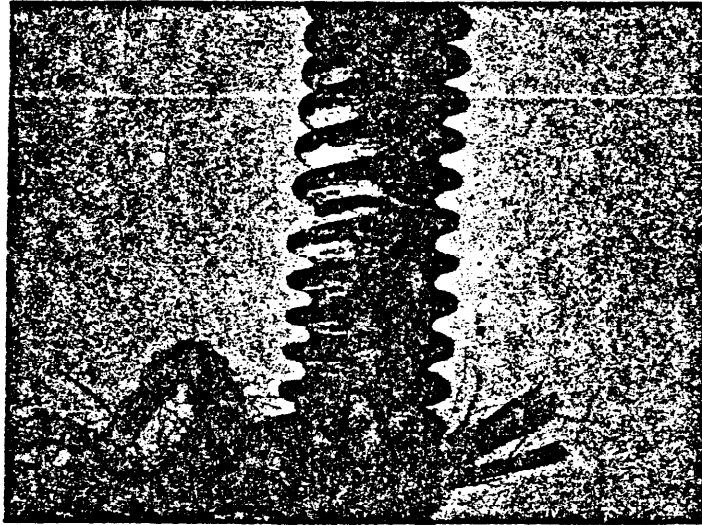
Photo 30: Stress Corrosion Cracking
Induced by Ammoniacal Environment
Specimen [REDACTED]

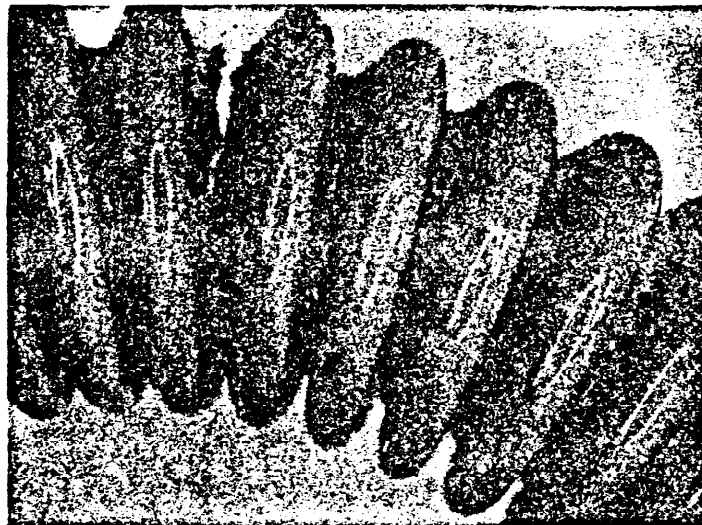
Photo 31: Stress Corrosion Cracking
Induced by Ammoniacal Environment
Specimen [REDACTED]

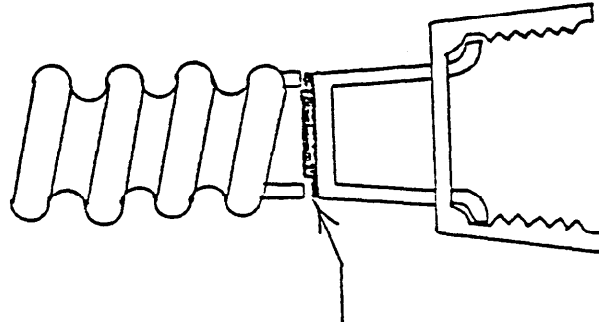
Cross Sectional View

The connectors in question all share the common construction feature which provides for the end ferrules being soldered to the bellows section by only its wall thickness, which allows only a minimum of strength. (See diagram below.)

Soldered Surface

If connectors with this type of construction are encountered while on the job, the customer should be made aware of its history of failure, due to its end ferrule separating from the corrugated main section of the connector.

It should be recommended to them, that a new connector be installed in its place, and the details of this warning noted on your order. Obtaining the customer's signature on your order, in regard to this warning, would be further protection for the employee and the Company in case the warning is ignored and an accident were to occur in the future.

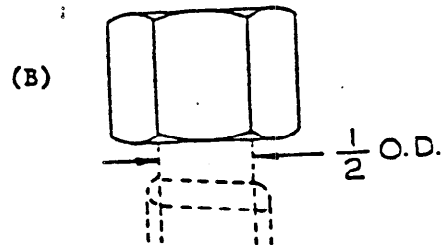
We have discovered that some steel flare nuts used on our model 4G series gas connectors from March 9 through April 17, 1979, may cause the flared tubing to be sheared off or weakened when the nut is tightened onto the adaptor.

Nut on recalled connectors with red ring stamped '79

Nut on connector NOT subject to recall

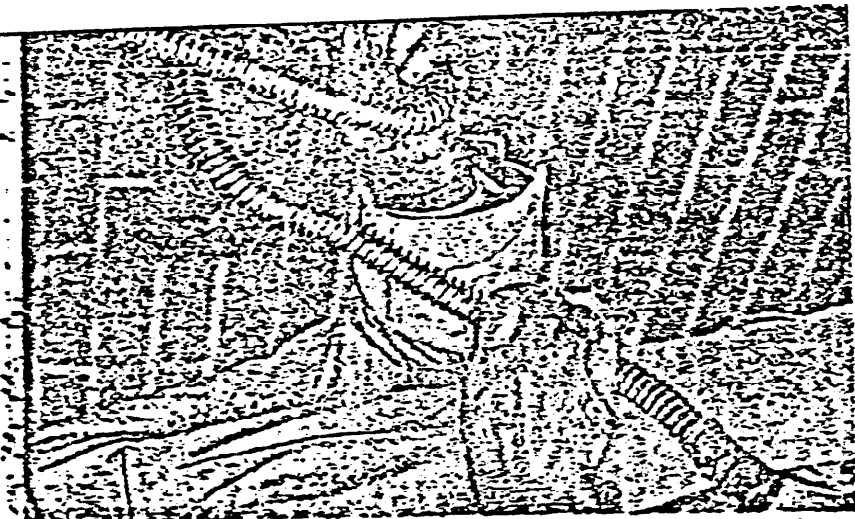
[redacted] holds the flex hose to her furnace broke off Aug. 17, allowing gas to leak into her house. Such pipes are no longer allowed on gas furnaces and water heaters in Broomfield's new homes.
