# NATIONAL LP-GAS ASSOCIATION

SAFETY BULLETIN

Additional Reports of Potentially Defective Gas Connectors  
for Appliances

Flexible Brass Range Connector Failures

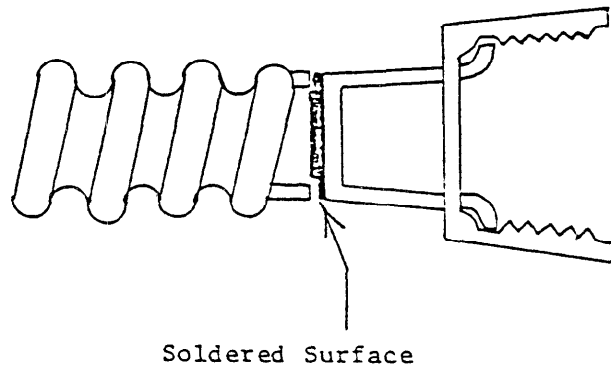
Cross Sectional View

Common Construction Feature of Potentially  
Defective Connectors

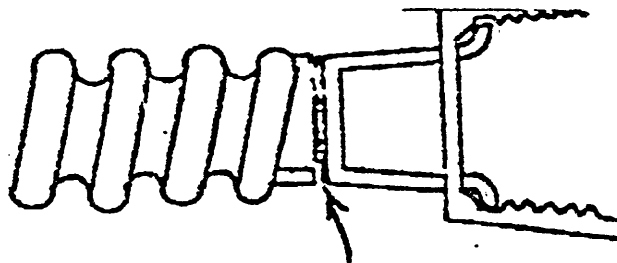
The connectors in question all share the common construction feature which provides for the end ferrules being soldered to the bellows section by only its wall thickness, which allows only a minimum of strength. (See diagram below.)

If connectors with this type of construction are encountered while on the job, the customer should be made aware of its history of failure, due to its end ferrule separating from the corrugated main section of the connector.

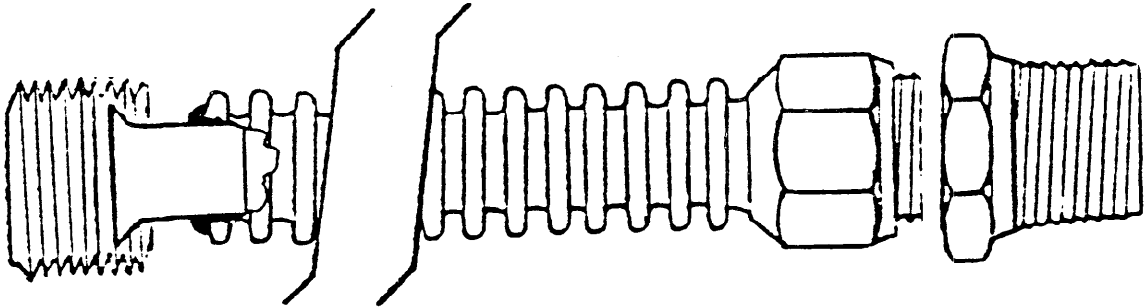
Soldered sleeve joint

Note that the sleeve as shown in Figure 2A may be either internal or external to the body of the connector.

While sleeve joint construction was recognized as superior to butt joint in terms of mechanical strength, both butt joint and sleeve joint type construction proved susceptible to failure if fabricated using solder containing phosphorus.

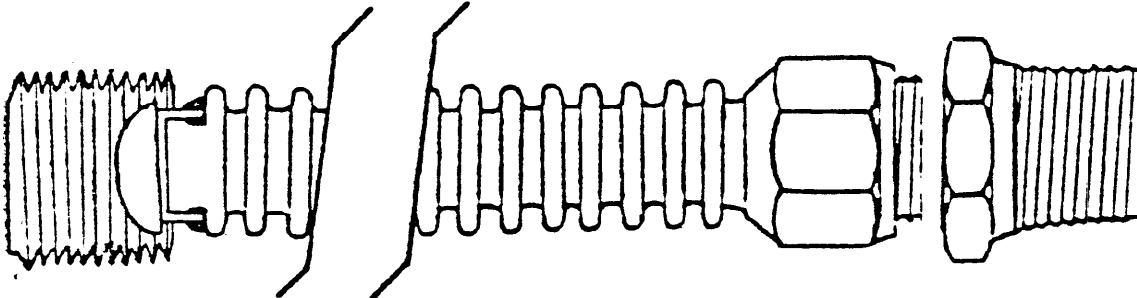
Figure 2B

Soldered sleeve joint

Butt joint construction was prohibited effective in 1959 for connectors design certified under ANS Z21.24 because of reported field failures due to end separation at the soldered joint.

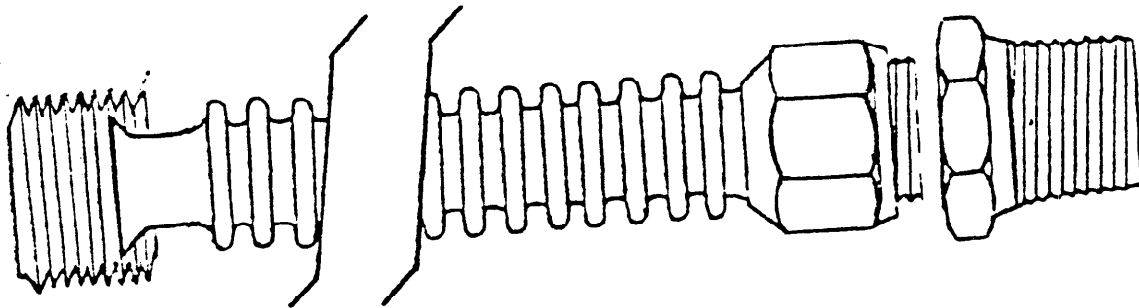
Figure 3

Potential failures have not been reported in connectors of one piece construction regardless of presence or absence of plastic coating or year of manufacture.

One Piece Construction
