1. CASE NO. <u>G658127</u> '960521CCN1210		2. INVESTIGATOR'S ID 8 0 2 9		3. OFFICE CODE 8 3 0		EPIDEMIOLOGIC INVESTIGATION REPORT	
4. DATE OF ACCIDENT 9 6 0 5 1 2		5. DATE INVESTIGATION INITIATED 9 6 0 5 2 2		YR MO DAY

6. SYNOPSIS OF ACCIDENT OR COMPLAINT <u>A complainant stated heavy smoke and soot filled rooms in his home when he built a fire in his fireplace and forgot to open the damper. Neither of his 2 battery powered smoke alarms sounded when this occurred. No injuries were involved and no fire occurred.</u>

7. LOCATION(Home, school, etc.) home (den) 1 0			8. CITY Roswell		9. STATE Georgia G A		
10A. FIRST PRODUCT battery operated smoke detector 0 7 0 2			11a. TRADE/BRAND NAME, MODEL Pittway Corporation 780 McClure Road model no. SA670 Aurora, IL 60504-2495				
10B. SECOND PRODUCT none			11B. TRADE/BRAND NAME, MODEL none

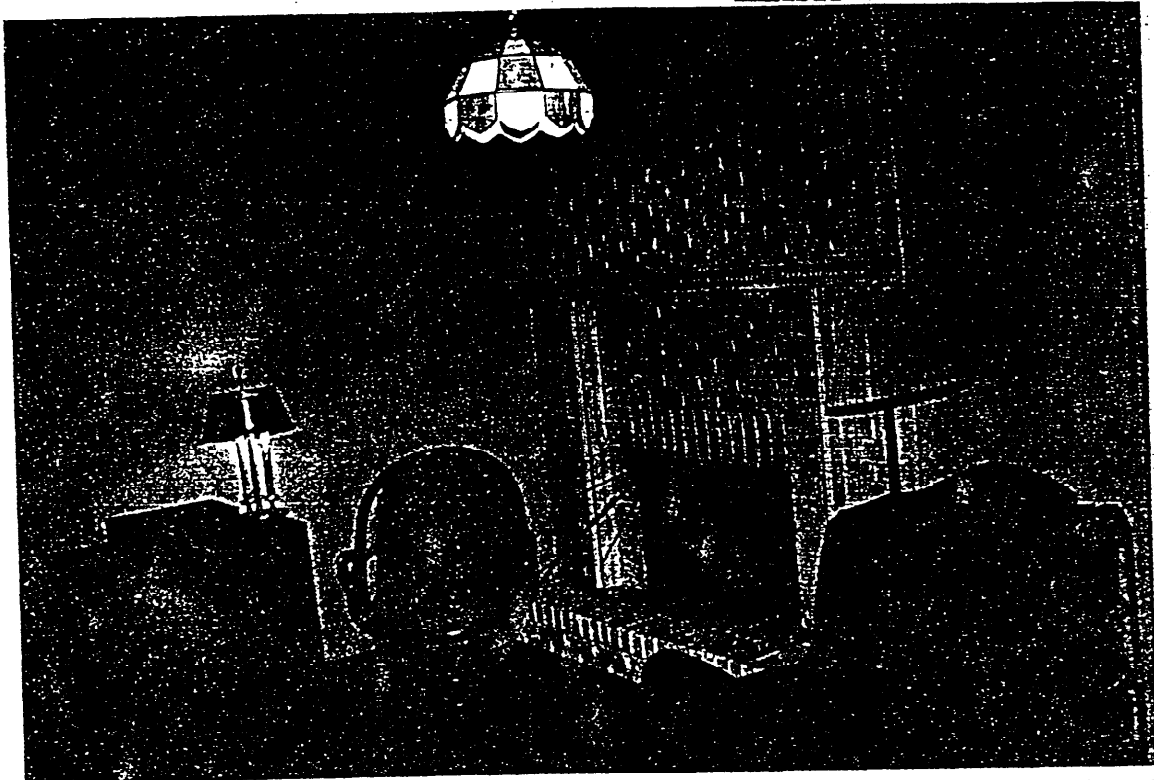
Photo 1 - View of fireplace in den area of home where complainant had built a fire prior to smoke and soot damage.

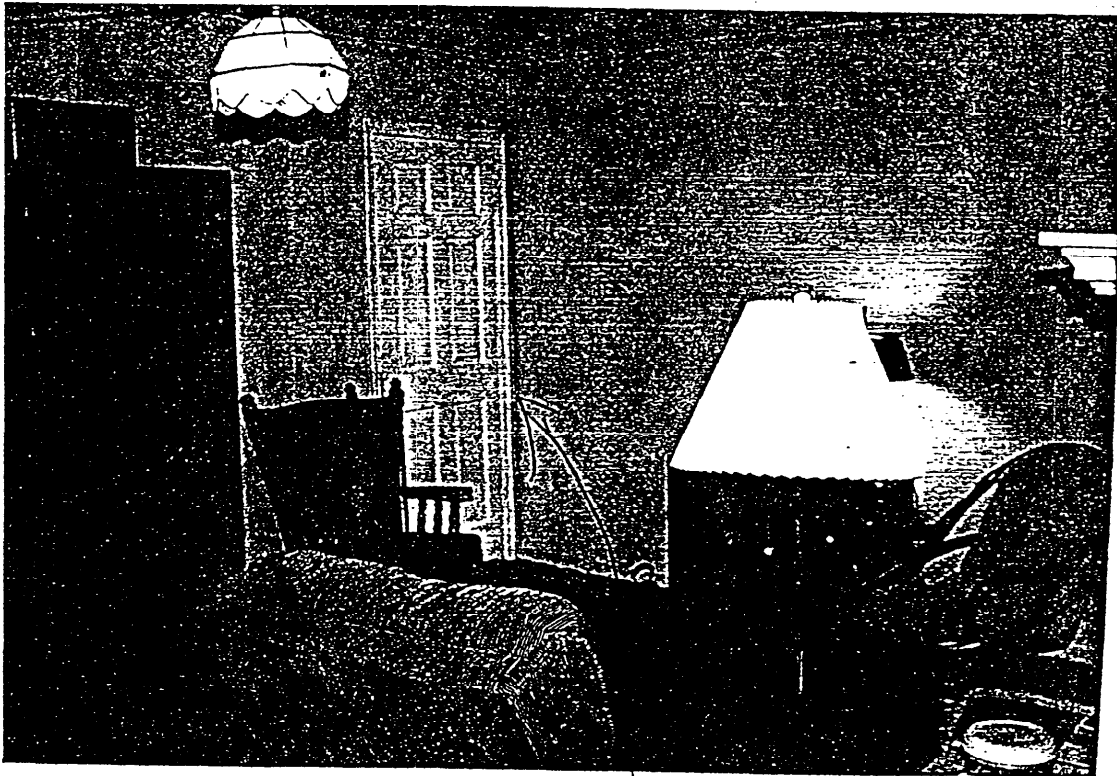
Photo 4 - View of den area showing doorway leading to the hallway where one of the smoke detectors was located at the time of the incident. (NOTE: Complainant stated doorway was closed when smoke and soot first originated but was opened when smoke filled the room and the detector in the hallway did alarm.)

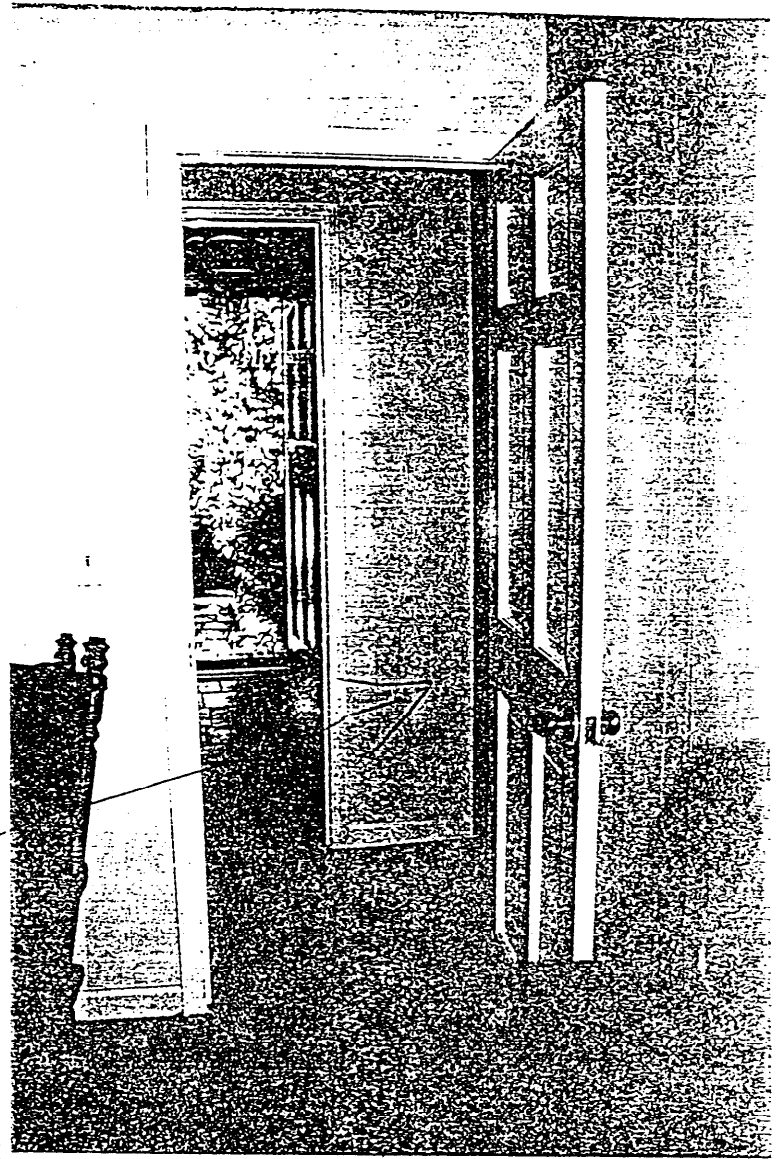
Photo 5 - View of doorway leading from the den into the hallway where one of the detectors was located. This is the same door shown in photo 4 which was in the closed position.

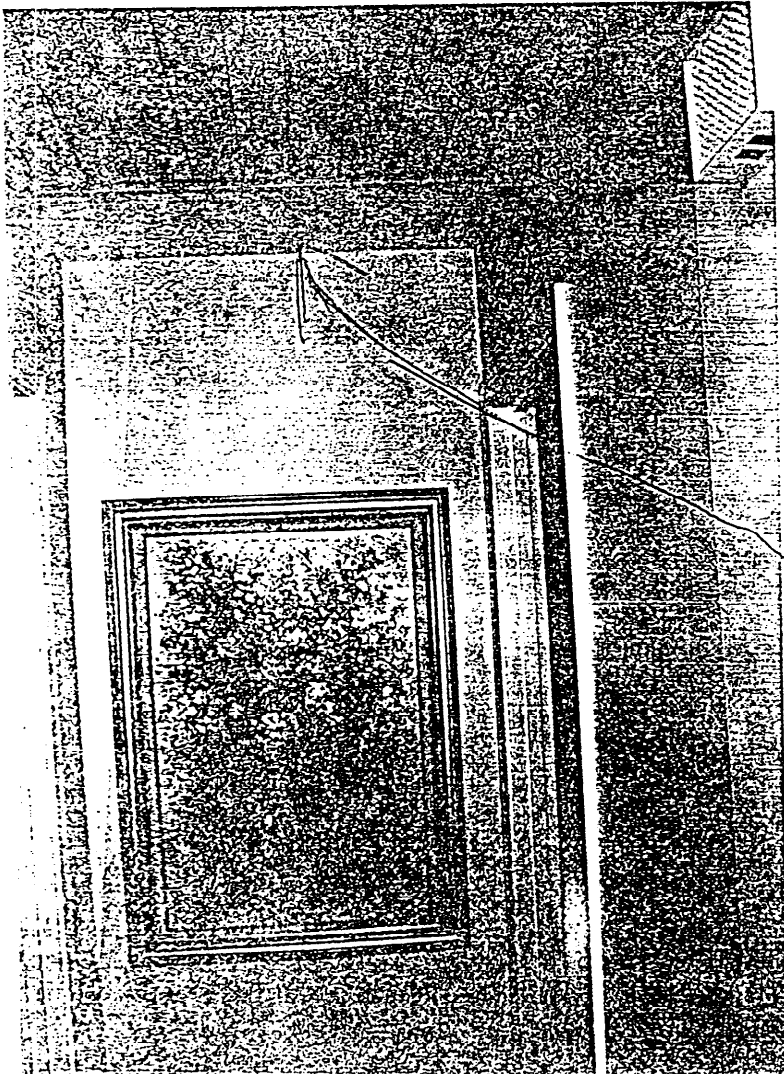
Photo 6 - View of hallway where one of the smoke detectors was located in the ceiling.

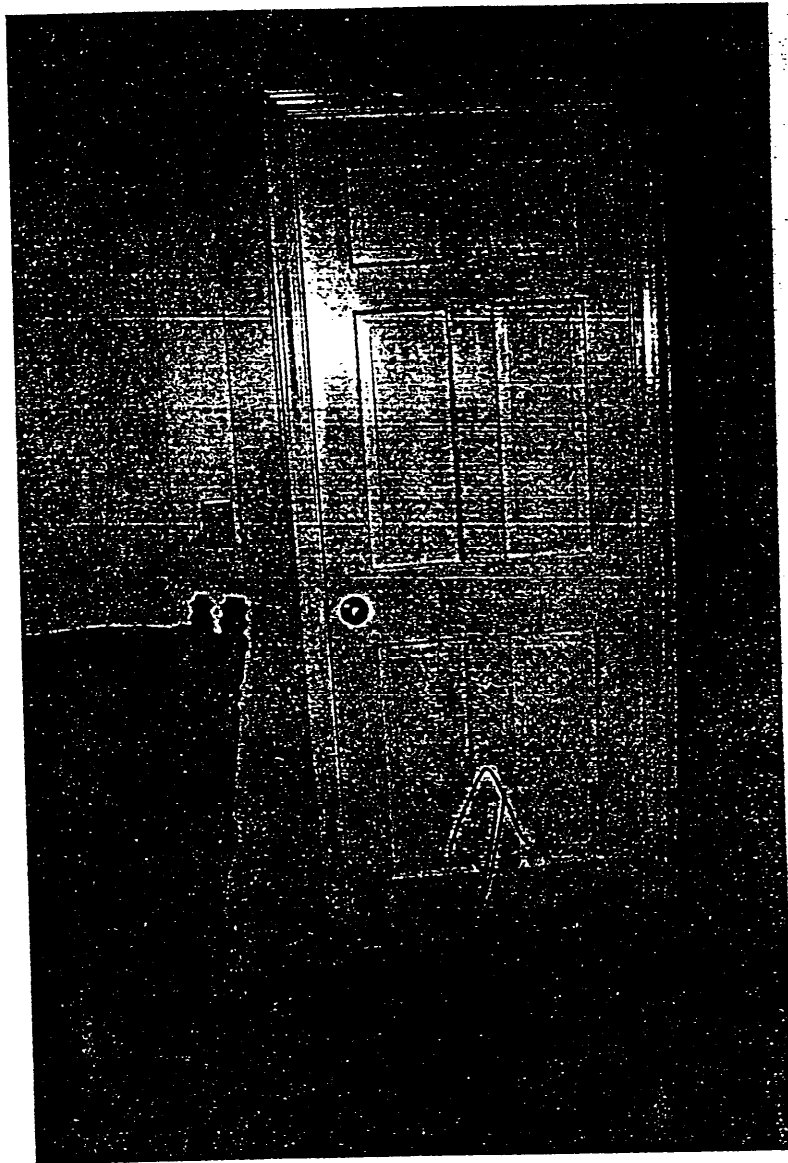
Photo 7 - View of doorway leading from the den into the hallway in the closed position.

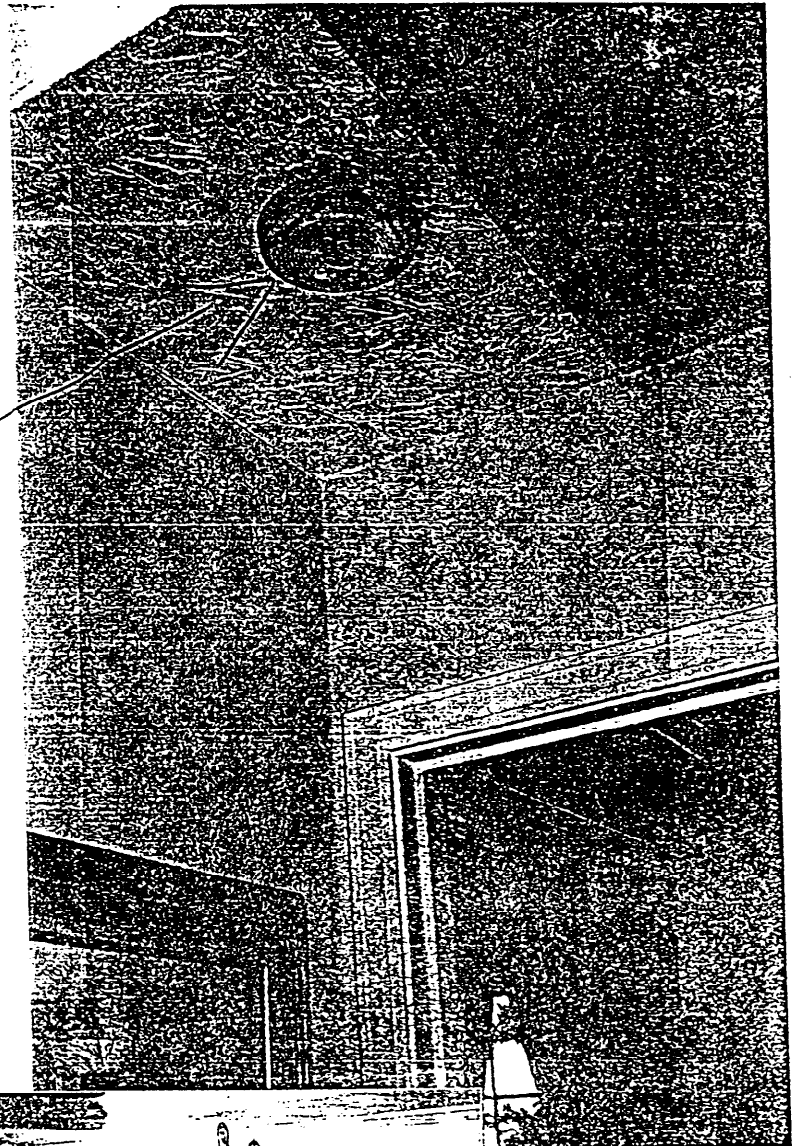
Photo 8 - Close view of detector
in ceiling portion of
hallway.

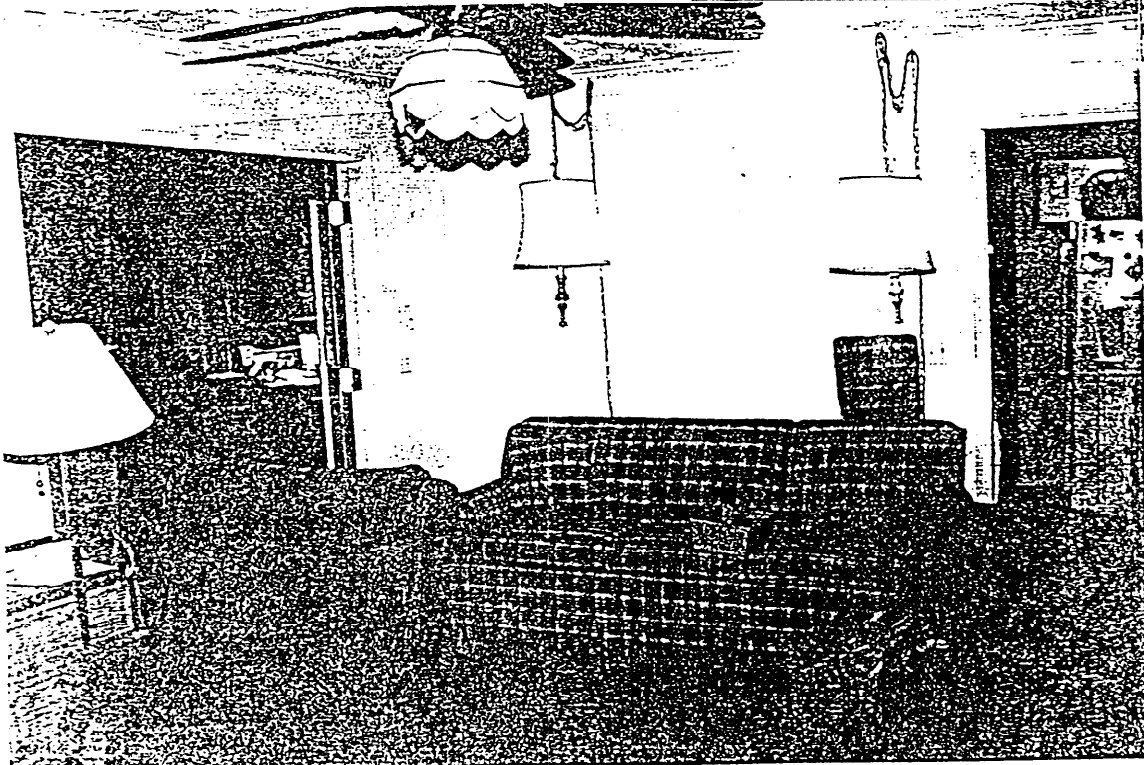
Photo 9 - View of den area where incident occurred. View also shows doorway leading to closed in porch area and doorway leading to the kitchen.

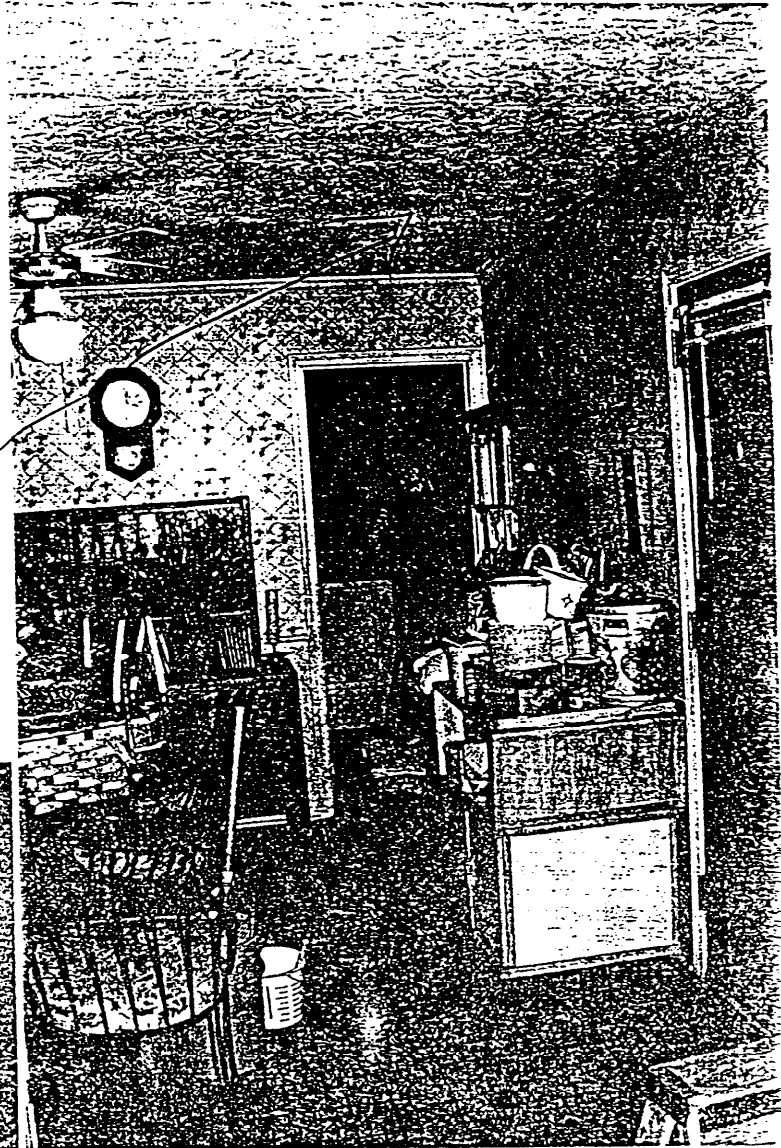
Photo 10 - View showing kitchen area where one of the detectors was located. Distance from fireplace in den to area in kitchen where detector was located measures approximately 39 feet.

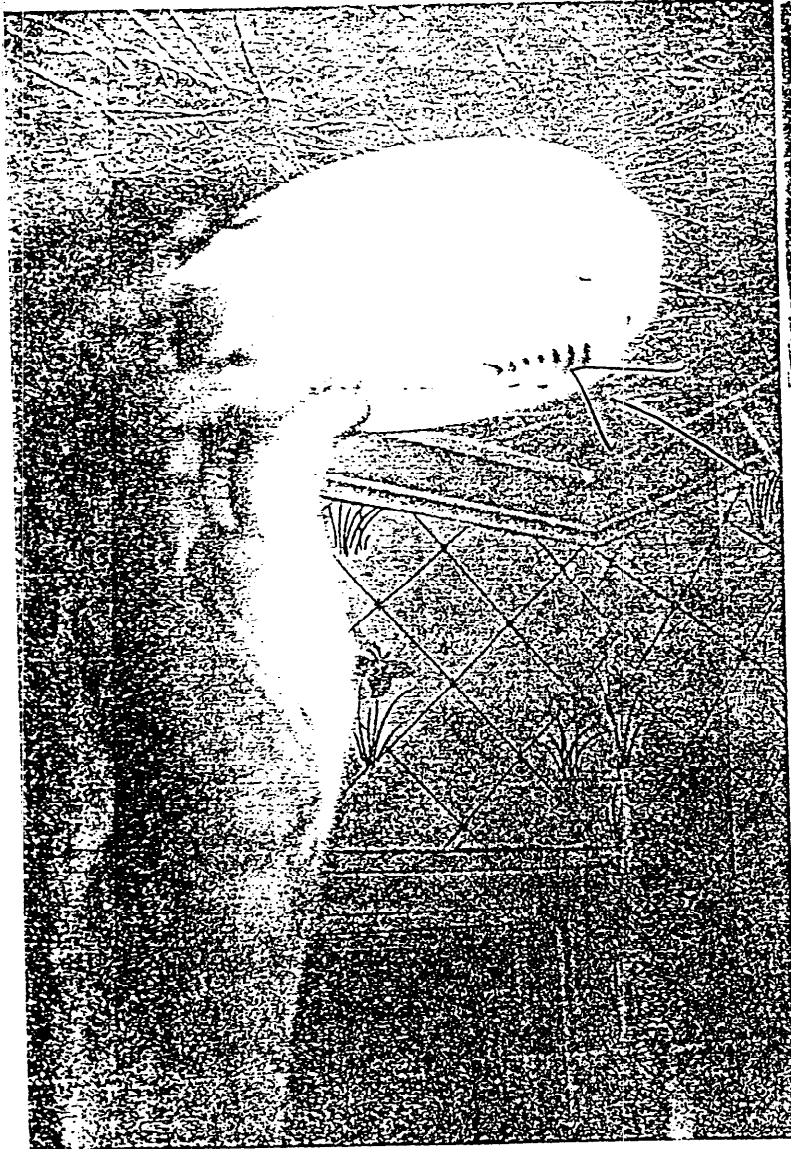
Photo 11 - View of complainant reenacting the scene to demonstrate where the detector in the kitchen (which had been removed) was originally located.

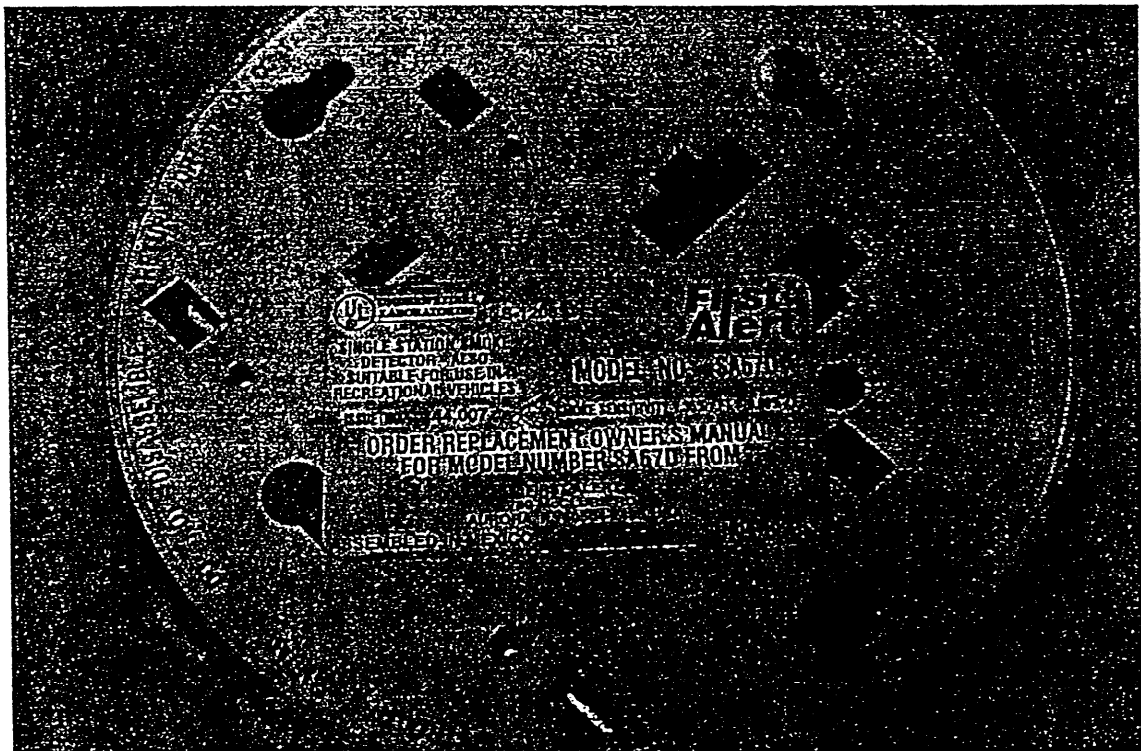
Photo 13 - View of labeling on back cover of detector that was located in the kitchen. Label states in part: "MODEL NO. SA670..FIRST ALERT... AURORA, ILL. ASSEMBLED IN MEXICO"

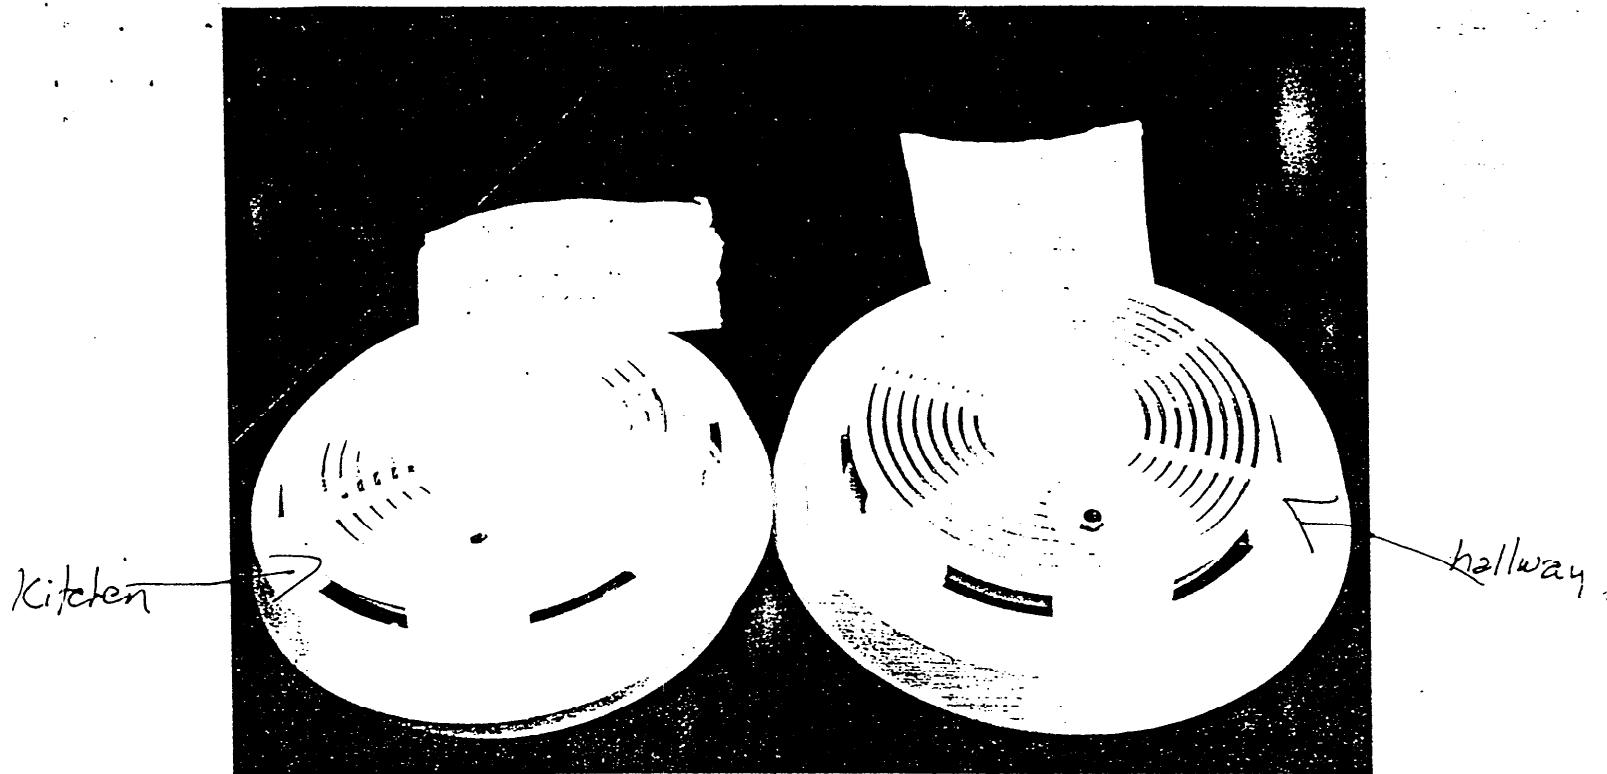
Photo 16 - Close view of detector that was located in the kitchen and hallway. The one in the kitchen was identified in SCR 96-830-4058 as Sub 2 and the one in the hallway was identified in SCR 96-830-4058 as Sub 1.

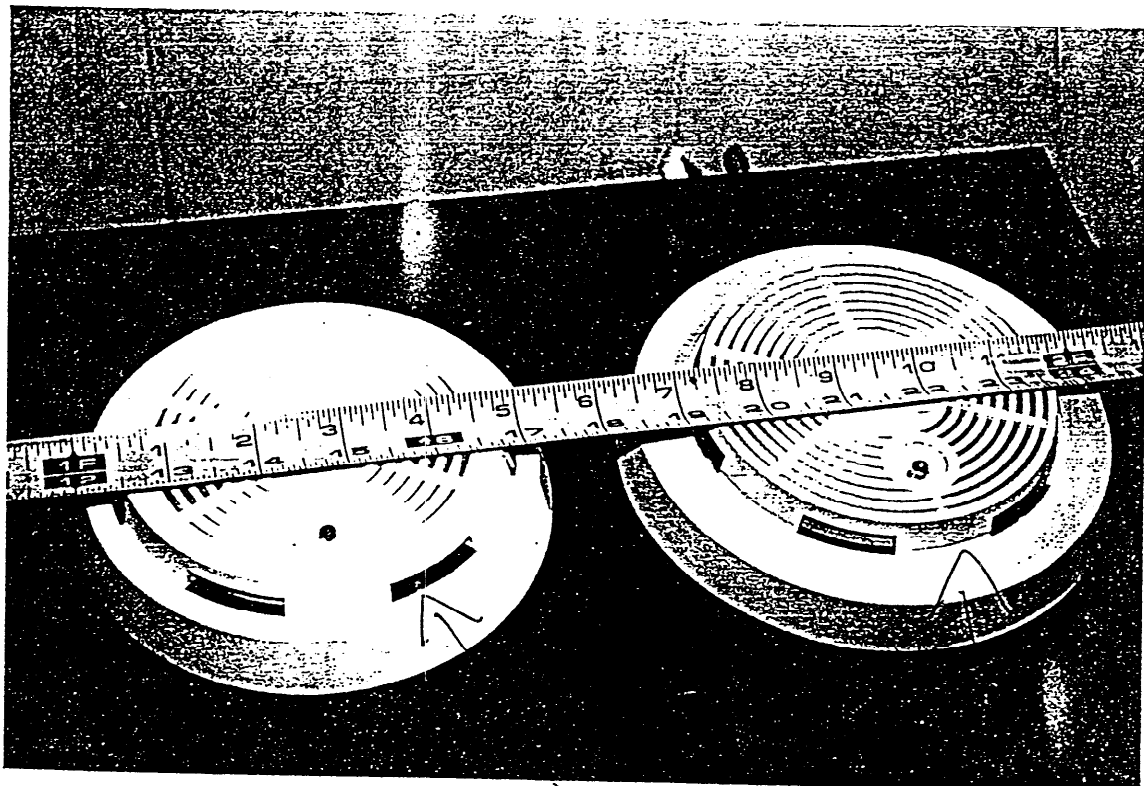
Photo 17 - View using ruler to demonstrate the approximate diameter of the detectors. The one located in the kitchen is slightly smaller. It measures approximately 5-1/4" in diameter and the one in the hallway measures approximately 6-1/4" in diameter on the top cover portion.

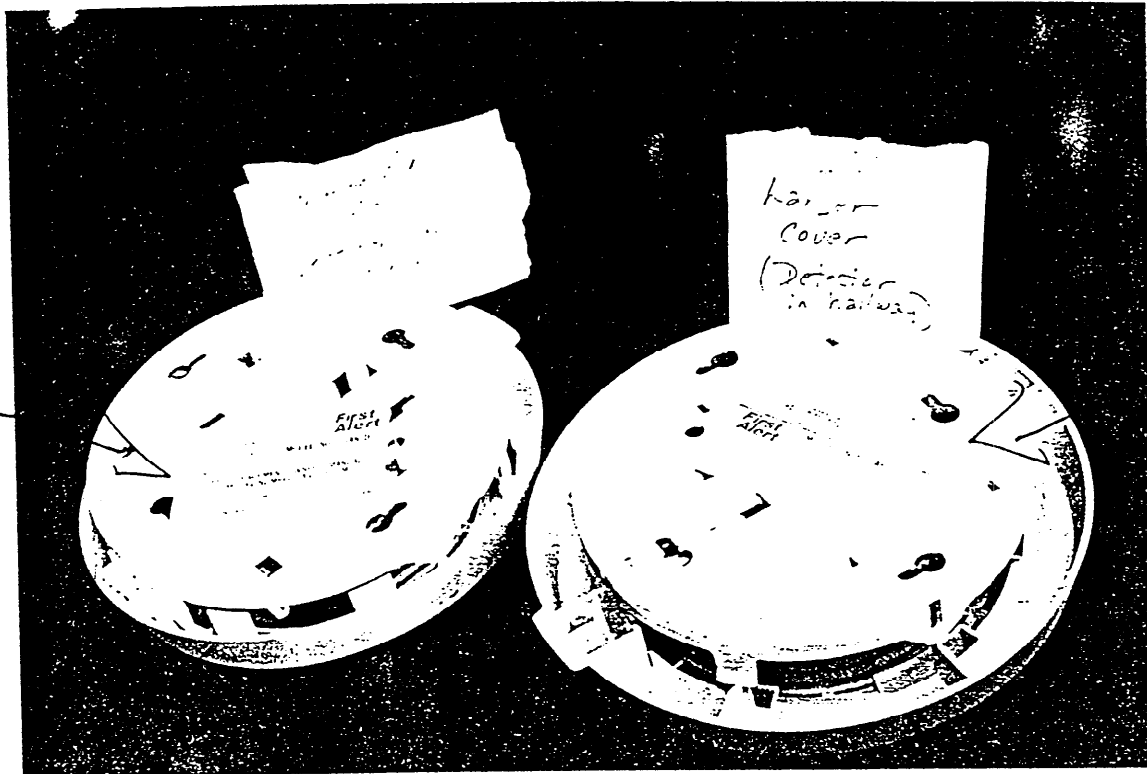
Photo 18 - Close view of bottom portion of both detectors involved in incident.

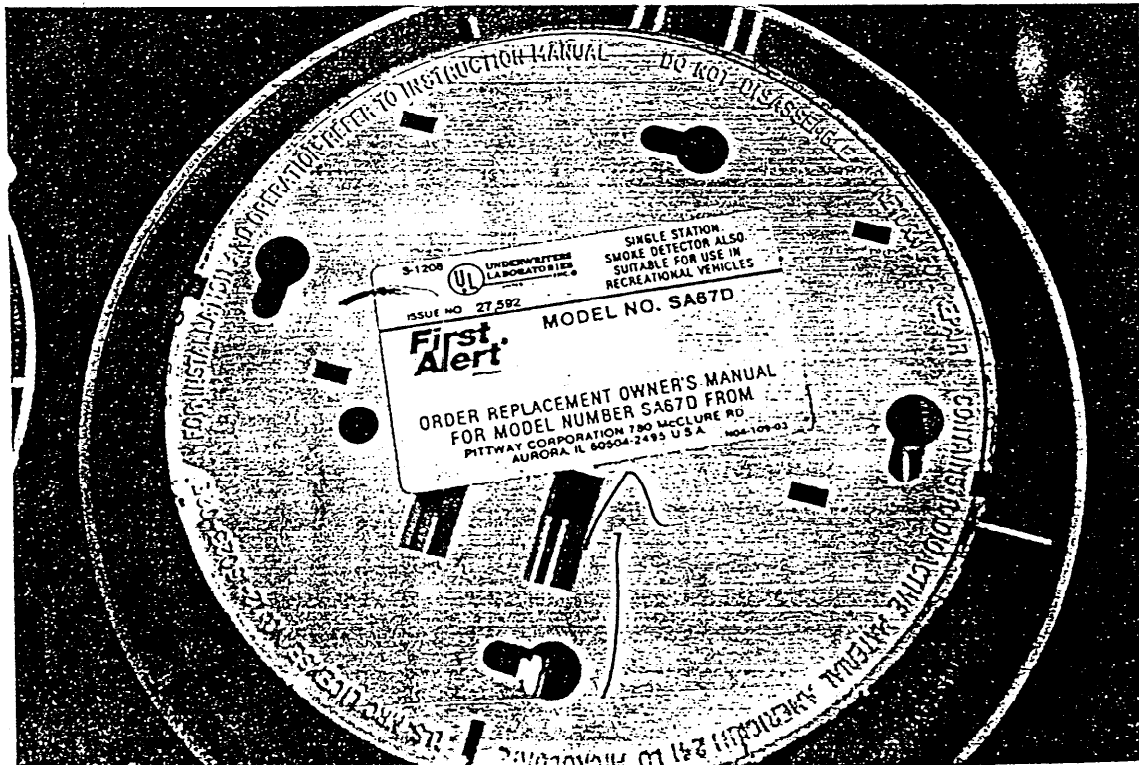
Photo 19 - View of labeling on back cover of detector in hallway indicating in part:

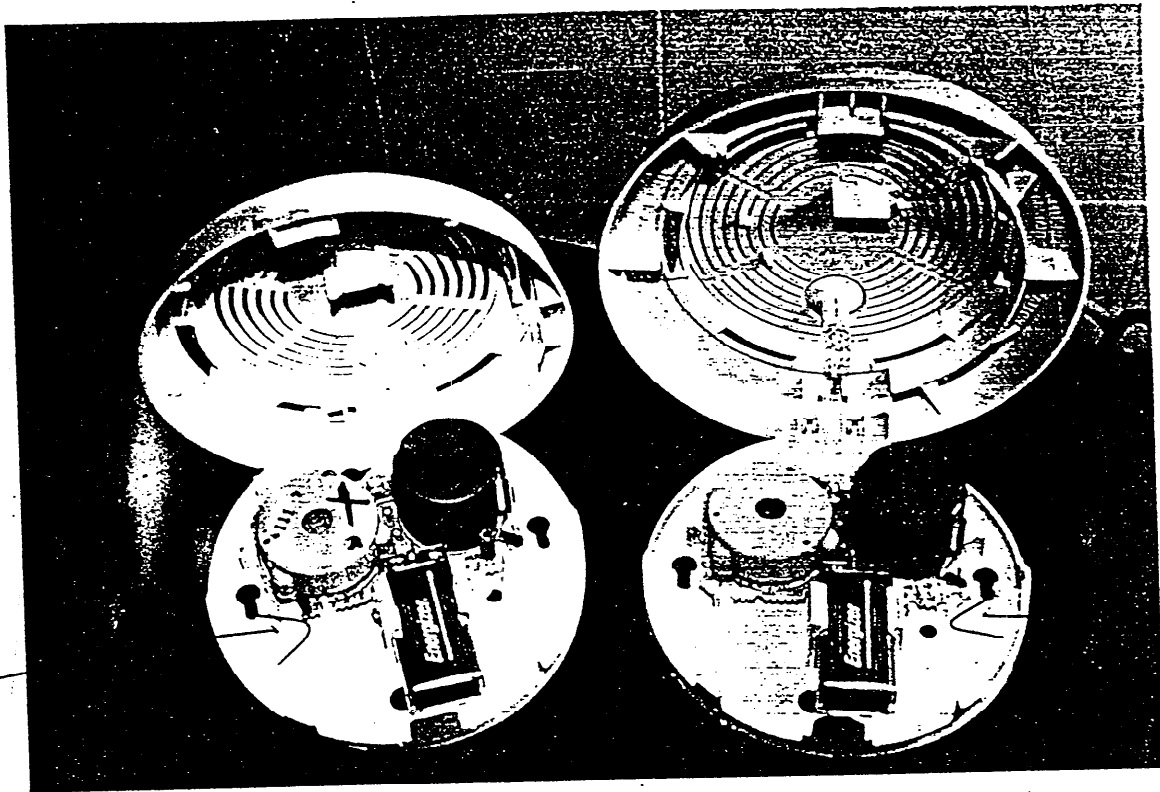
Photo 20 - Close view of inside components of detector in kitchen and hallway.
Both detectors use the same type battery.

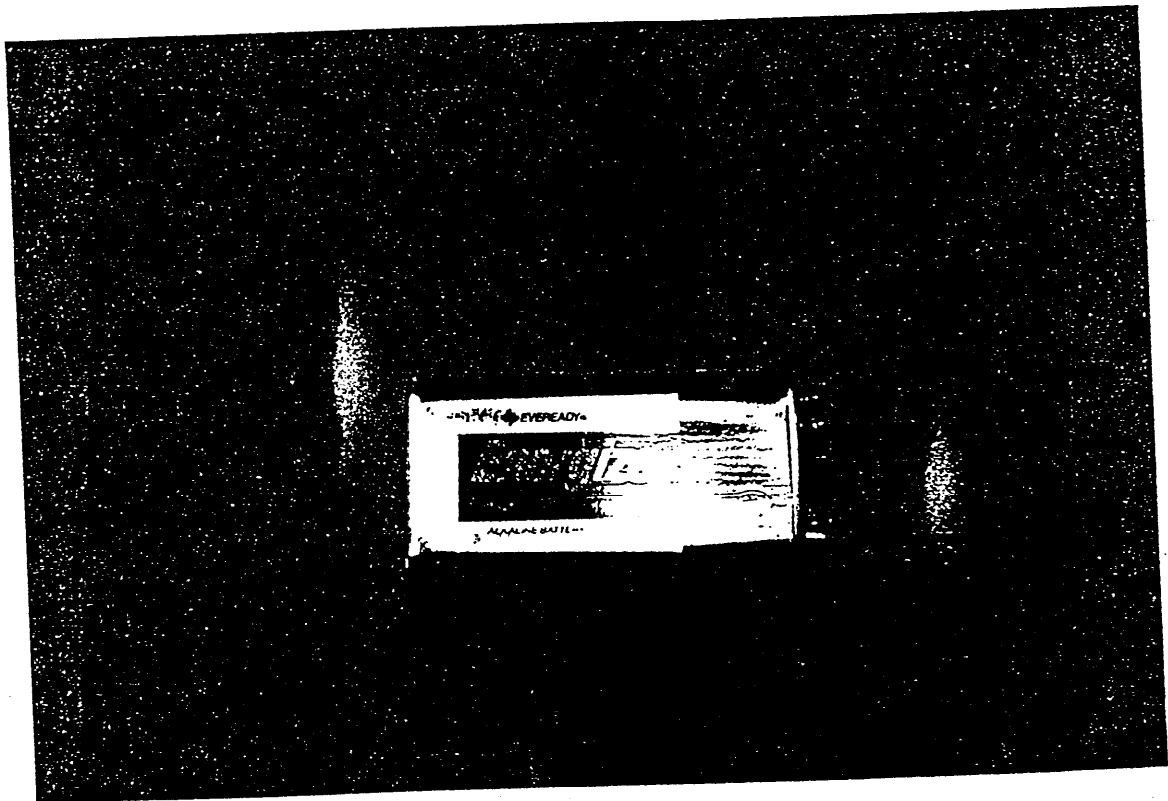
Photo 21 - Close view of labeling on battery indicating in part: EVEREADY Energizer..."

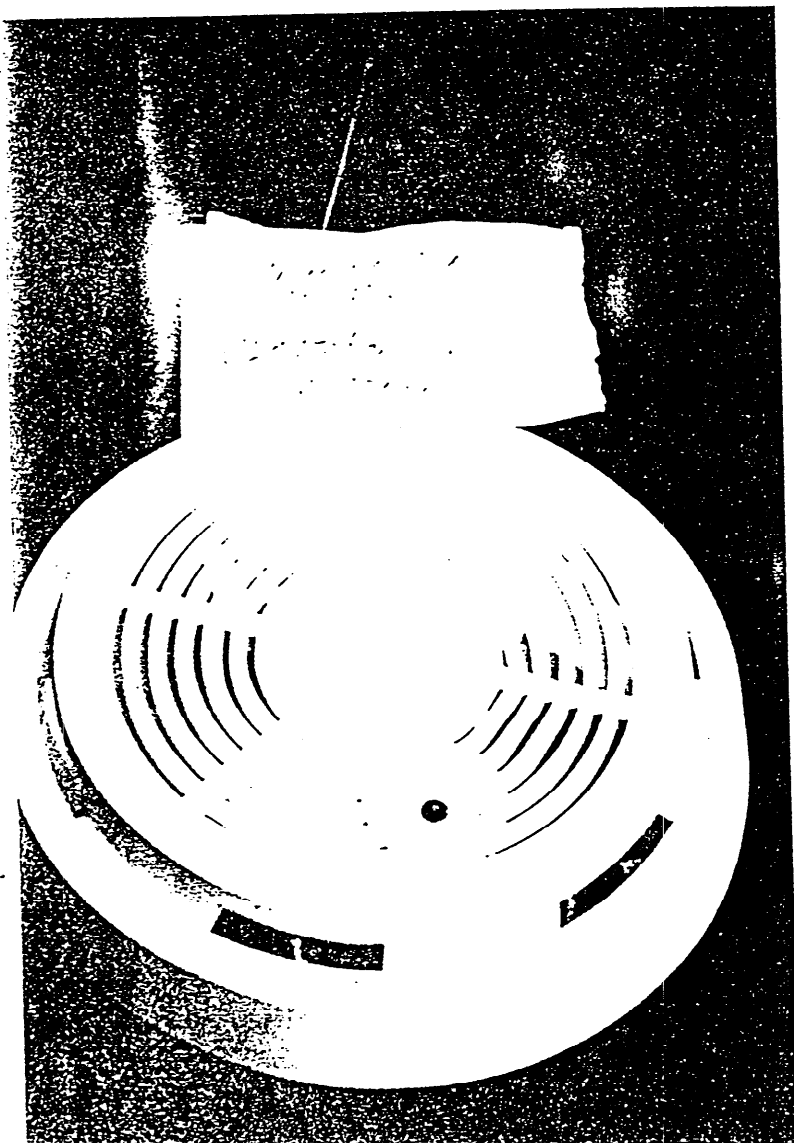
Photo 25 - Close view of battery that
was located in kitchen.

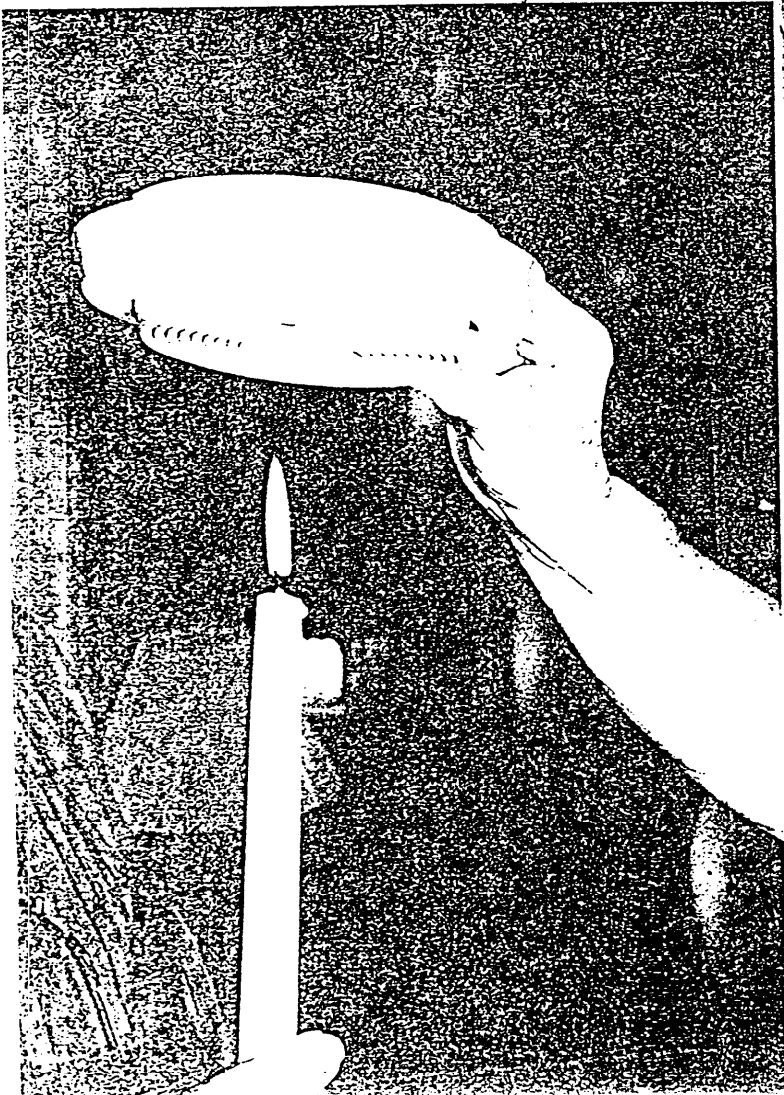
Photo 27 - Same test being conducted as the one indicated in photo 26 above using the detector located in hallway. This detector also sounded when subjected to heat.
