Post-Demolition Remedial Investigation Report

Reynolds Metals Company TROUTDALE FACILITY

CH2MHILL

June 2006

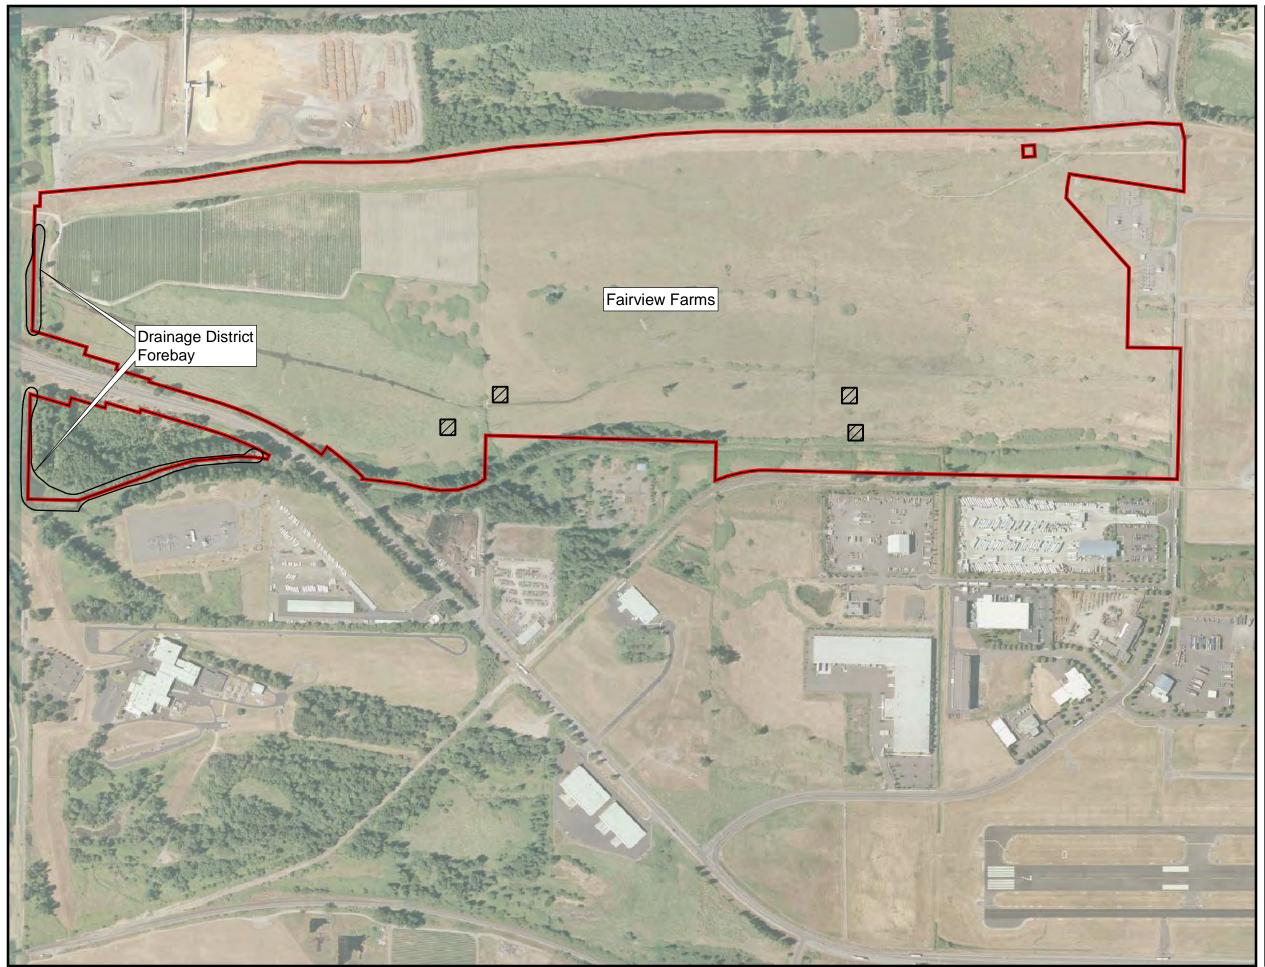
Figure 4-1 shows the areas where the removal actions were conducted. Debris stockpiles were removed in 1996. The results of the most recent investigation, when reviewed in tandem with the historical data from Salmon Creek, indicate that Fairview Farms was not significantly affected by plant operations. The Fairview Farms area has been thoroughly investigated and remediated over the last decade under the review of and approval from EPA and DEQ. No further investigation or action is considered necessary in this area.
