U.S. Department
of Transportation
**Federal Railroad
Administration**

Safety Testing of Intermodal Hazmat Configurations, Summary Report

1. Report No. DOT/FRA/ORD-88/04		2. Government Accession No.		3. Recipient's Catalog No.	
4. Title and Subtitle Safety Testing of Intermodal Hazmat Configurations, Summary Report				5. Report Date March 1988

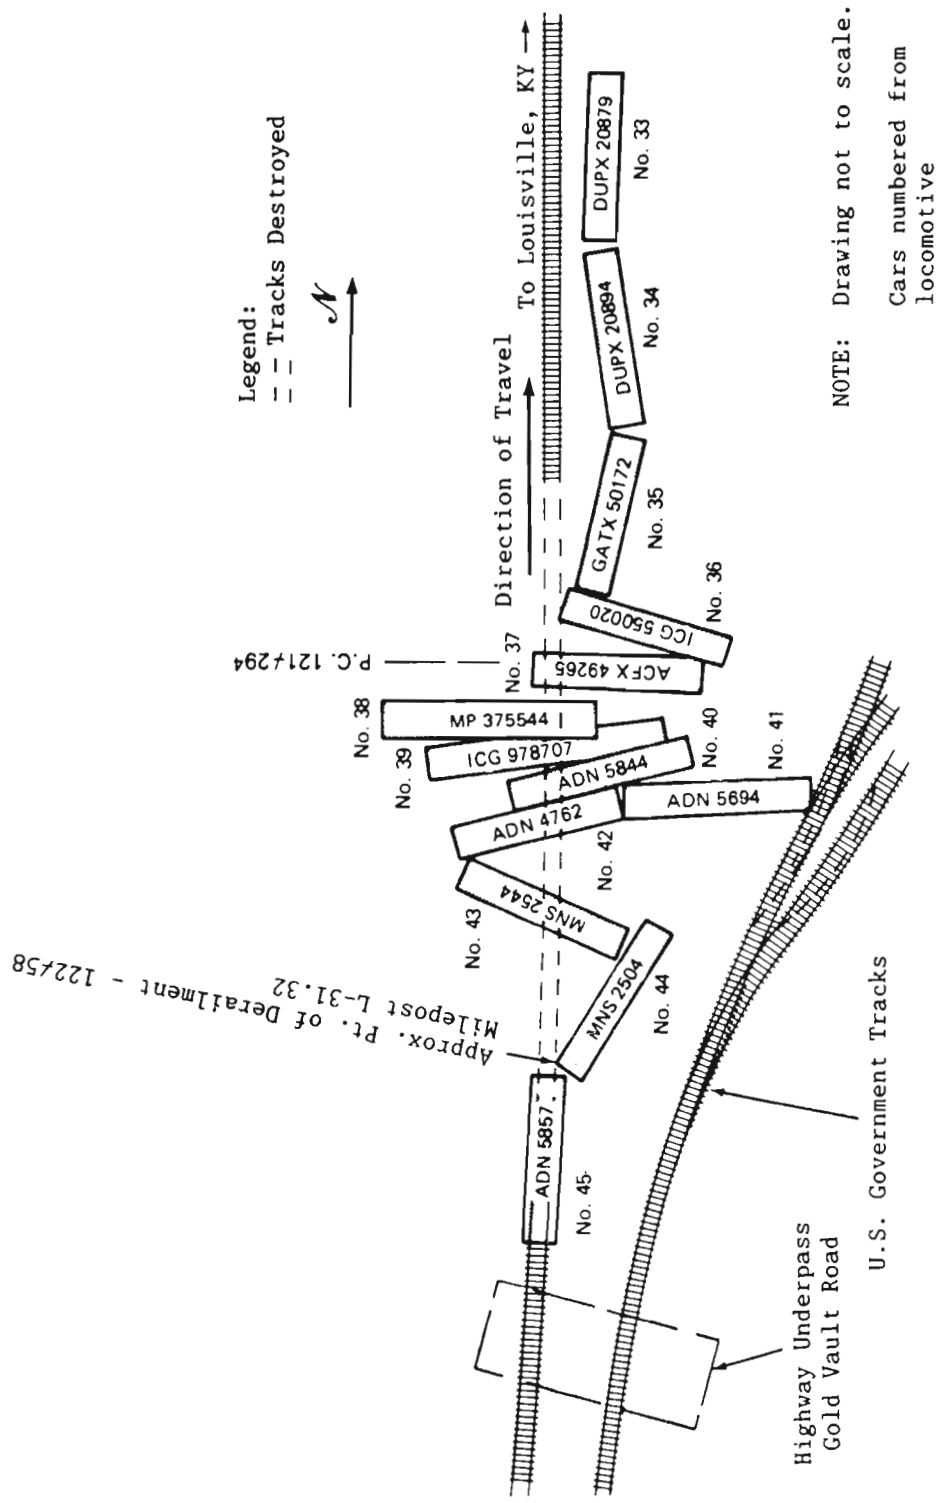
**FIGURE 5-1
 DERAILMENT OF ILLINOIS CENTRAL GULF FREIGHT TRAIN,
 LST NO. 64, AT FORT KNOX, KENTUCKY ON MARCH 22, 1983**

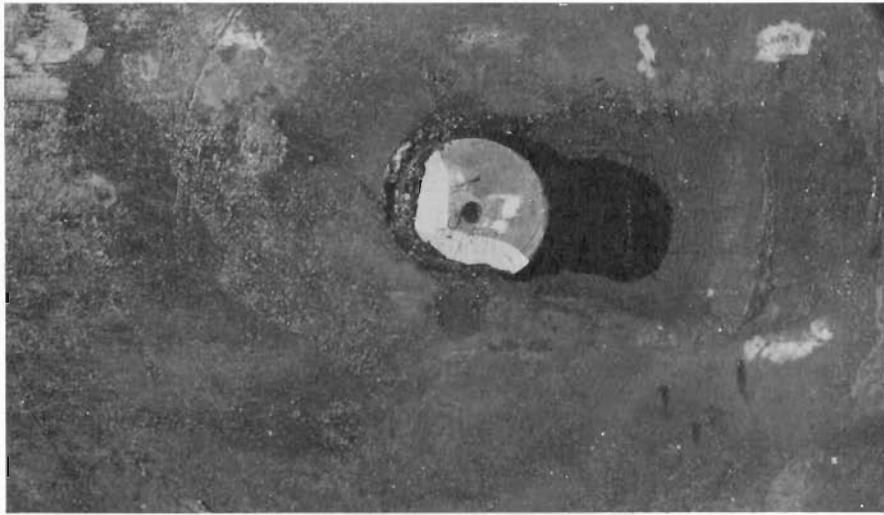
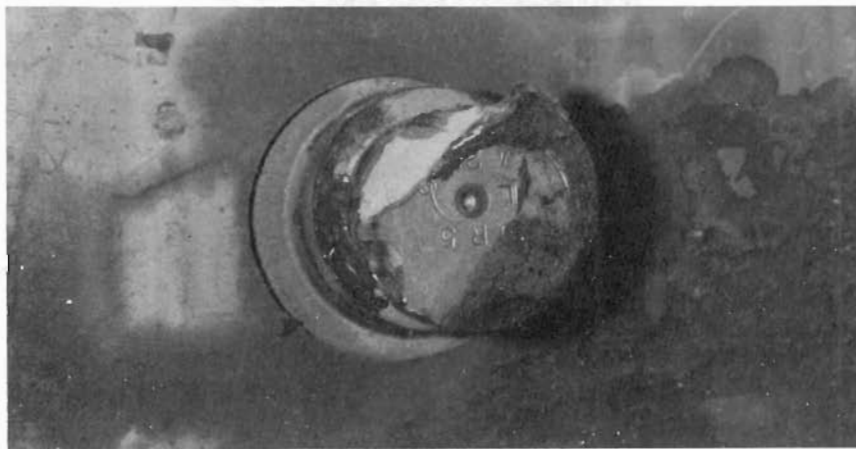
**FIGURE 5-7
MC 307 FAILED KINGPINS**

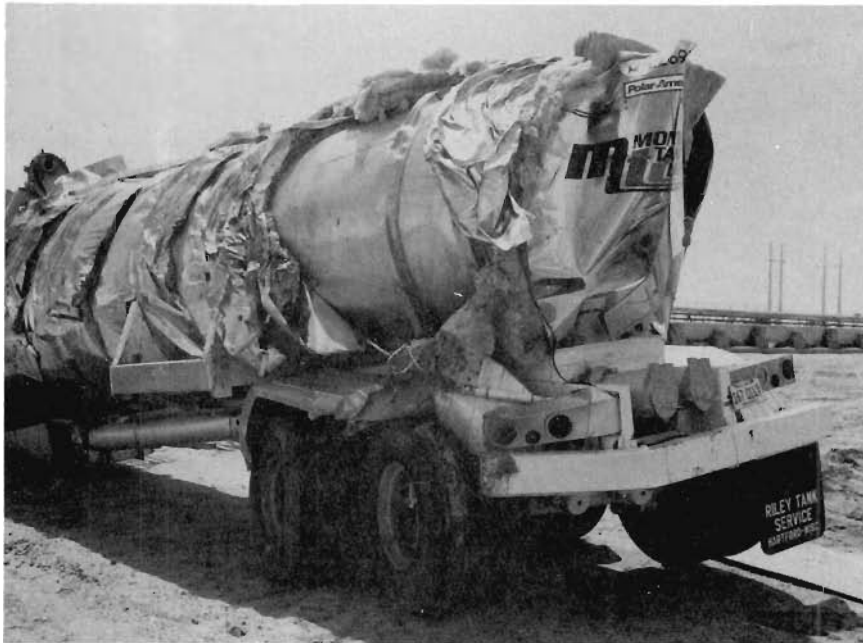
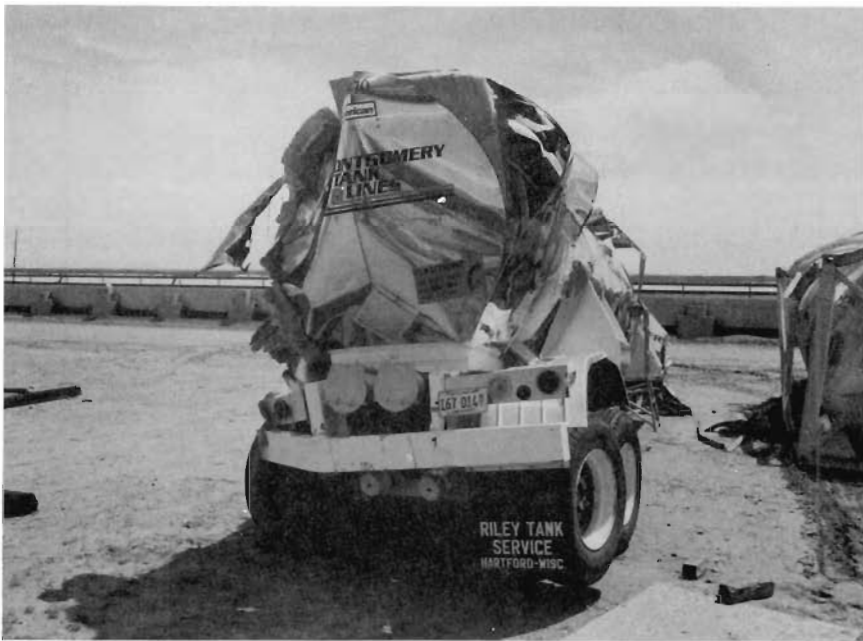
FIGURE 5-8
MC 307 MTLZ 6970 TANDEM END VIEWS OF DAMAGE AFTER
THREE BROKEN RAIL DERAILMENT TESTS

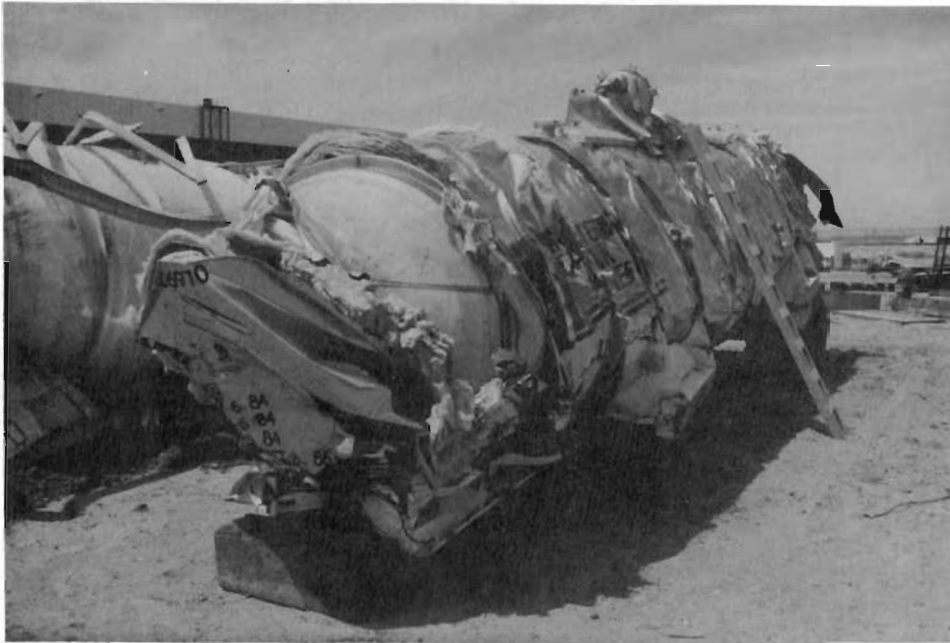
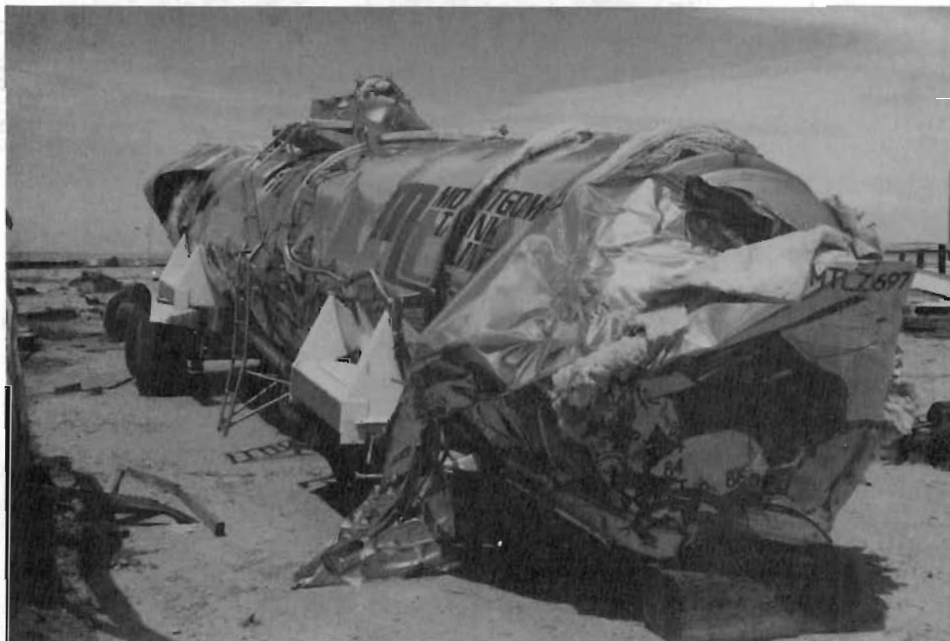
FIGURE 5-9
MC 307 MTLZ 6970 HITCH END VIEWS OF DAMAGE AFTER
THREE BROKEN RAIL DERAILMENT TESTS

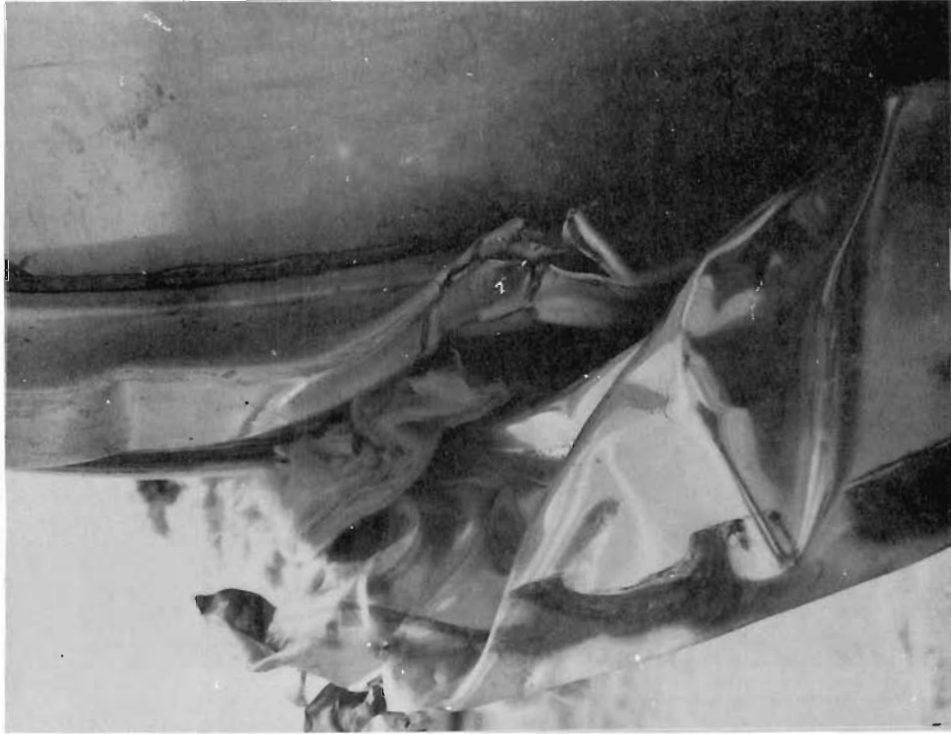
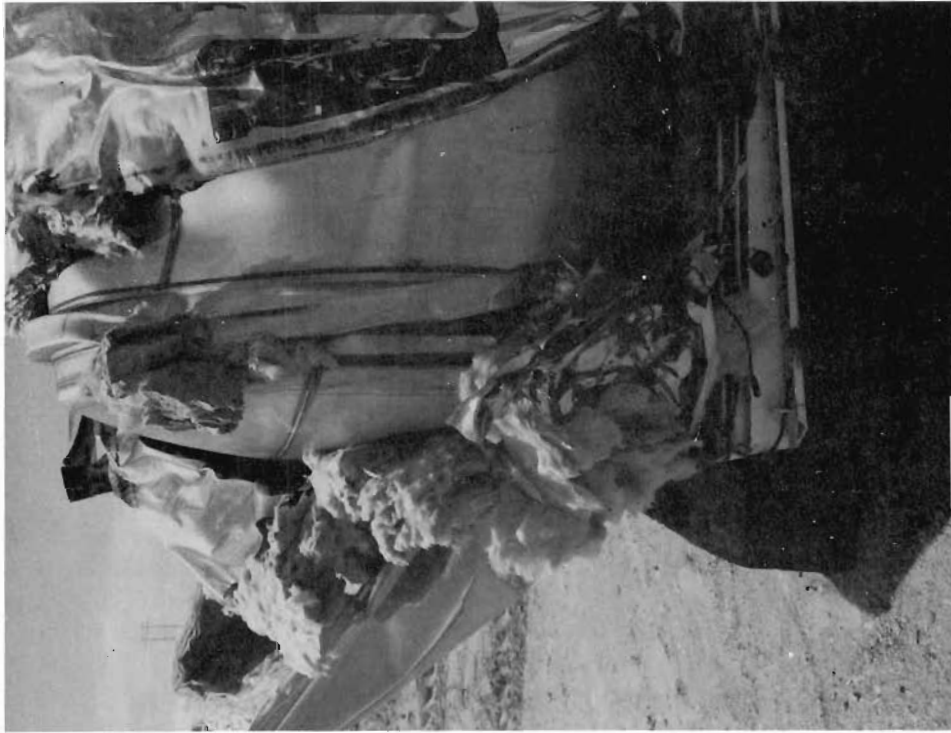
FIGURE 5-10
MC 307 MTLZ 6970 DAMAGE AT TANDEM END OF TANK AFTER
THREE BROKEN RAIL DERAILMENT TESTS

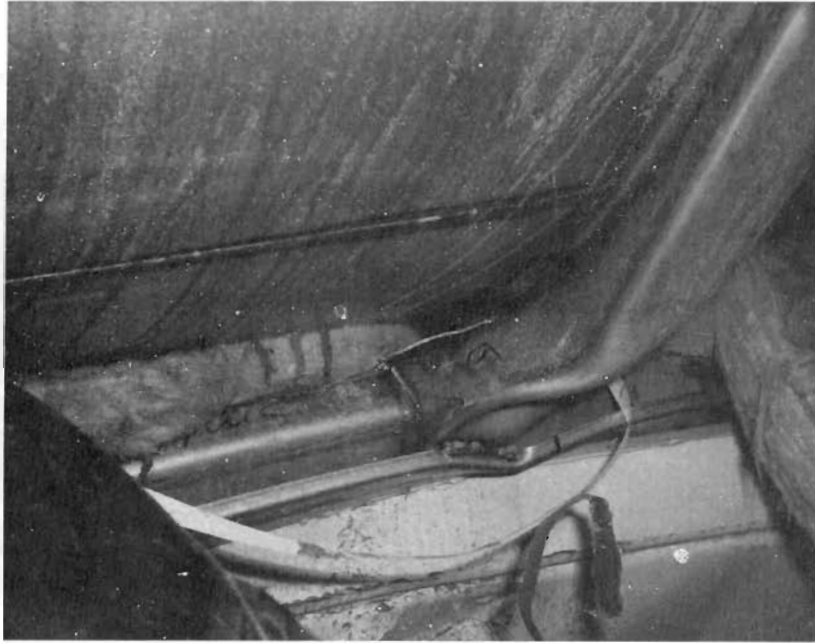
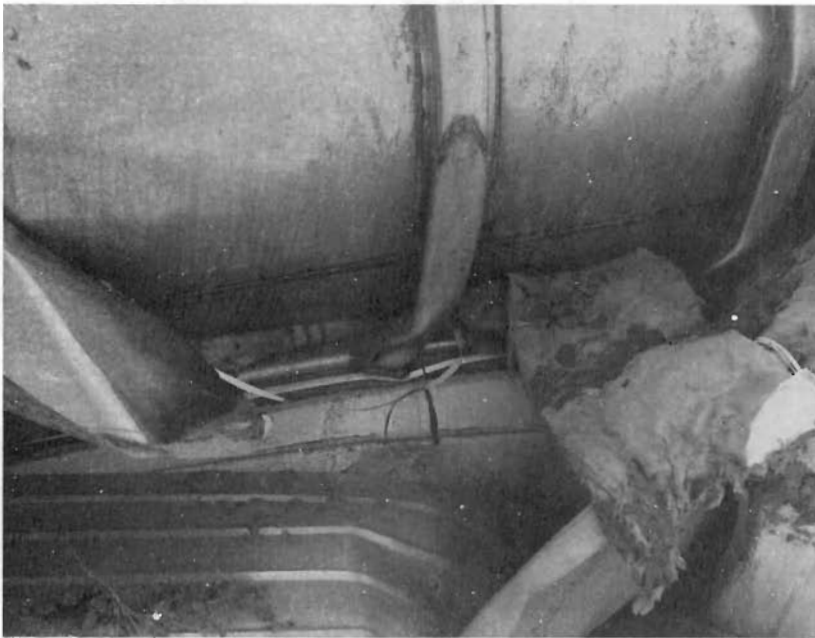
FIGURE 5-11
MC 307 MTLX 6970 DAMAGE IN LIFTING PAD AREA AFTER
THREE BROKEN RAIL DERAILMENT TESTS

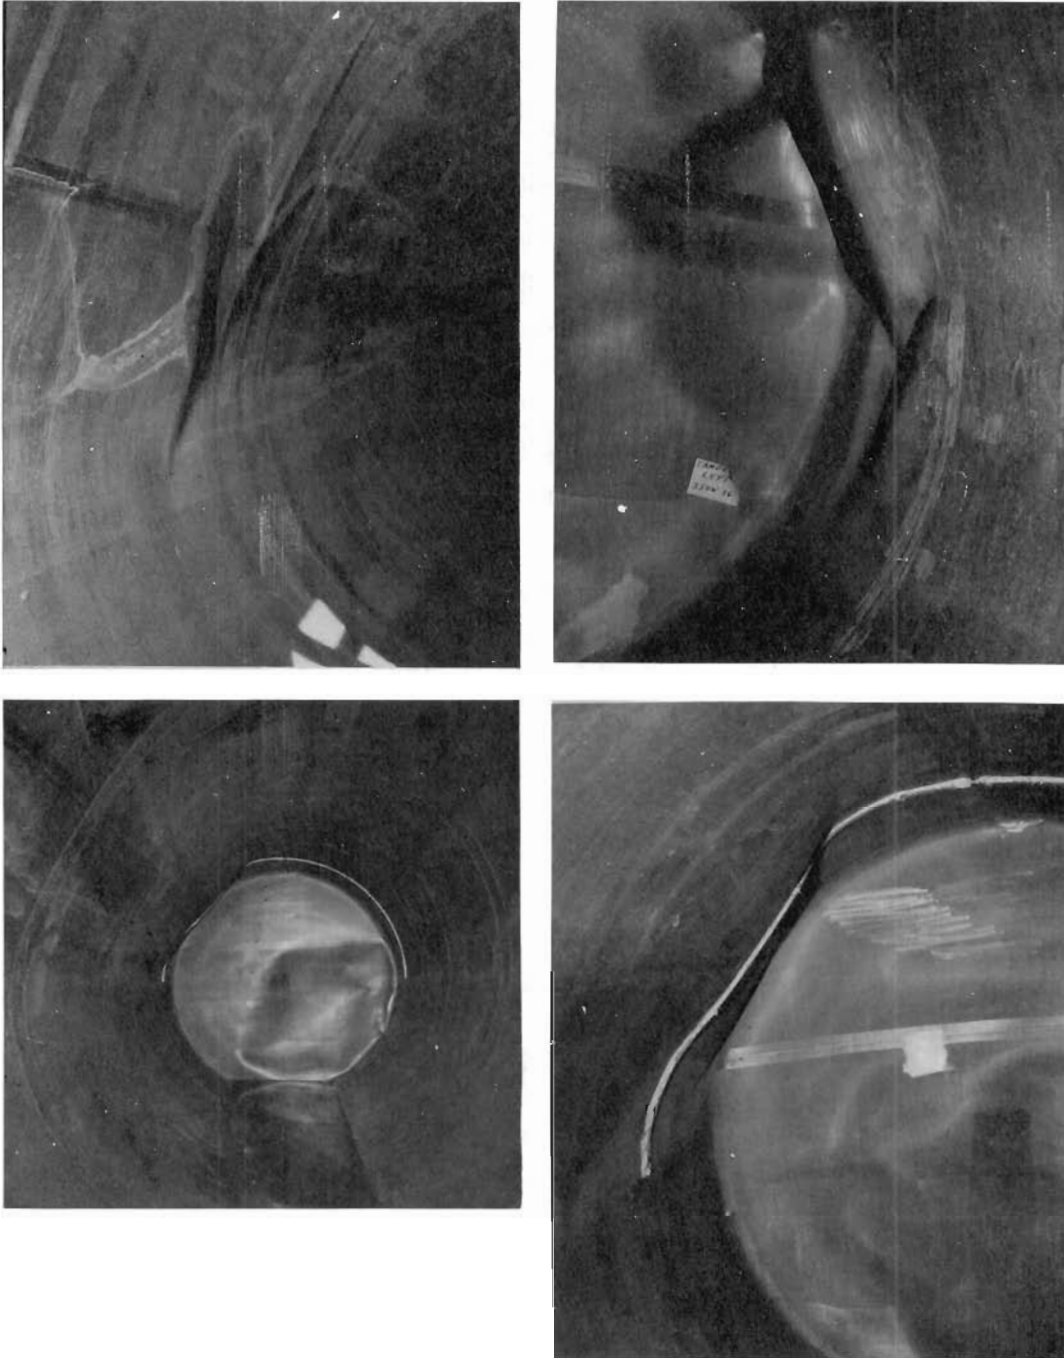
**FIGURE 5-12
MC 307 MTLZ 6970 INTERNAL VIEW OF TANK DAMAGE AFTER
THREE BROKEN RAIL DERAILMENT TESTS**

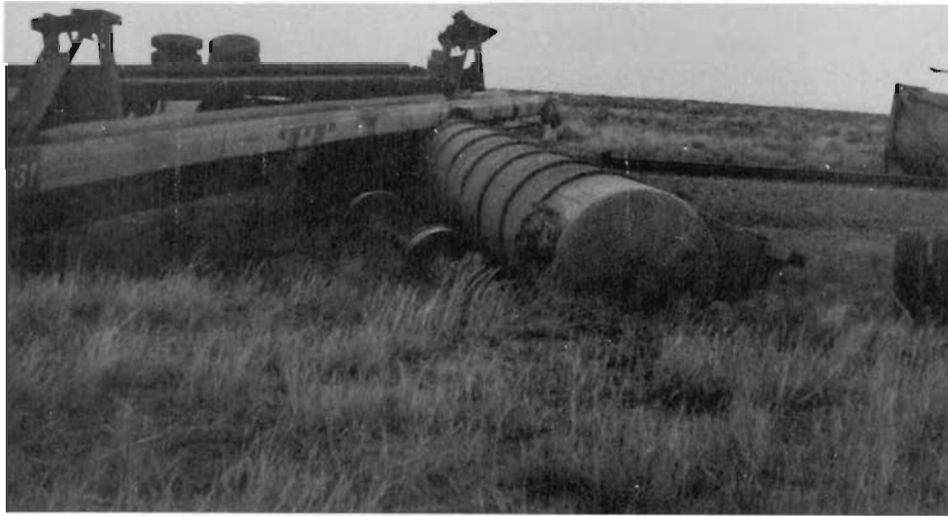
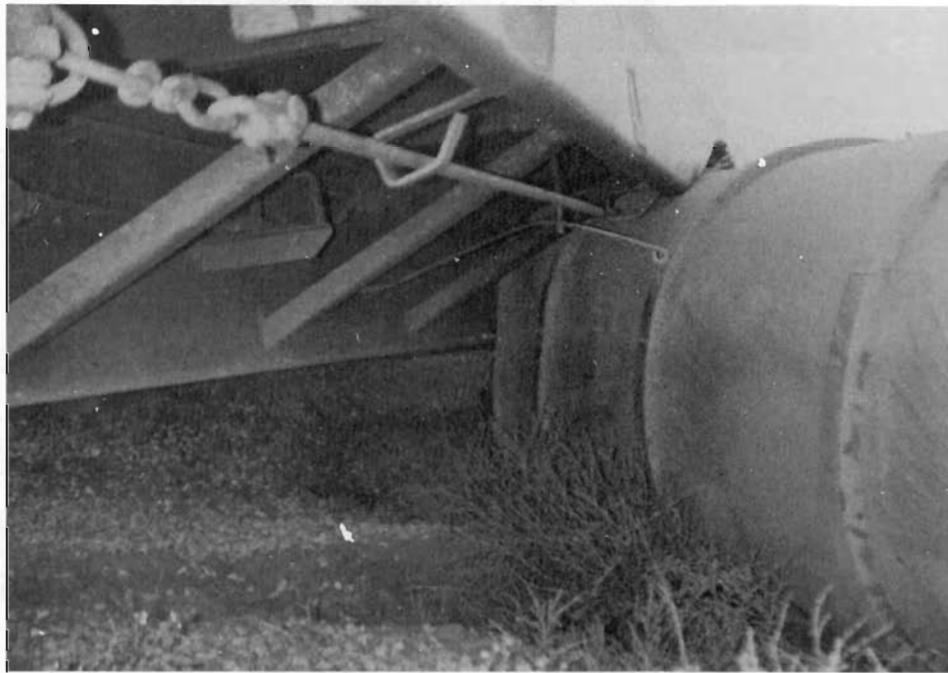
FIGURE 5-13
MC 312 TANK TRAILER FROM ACCORDION TEST
POSITION 1-A UNDER FLATCAR

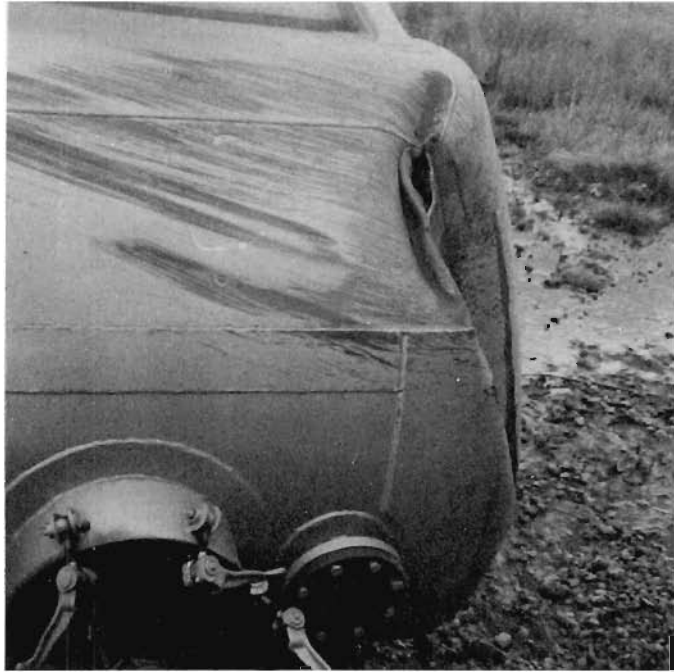
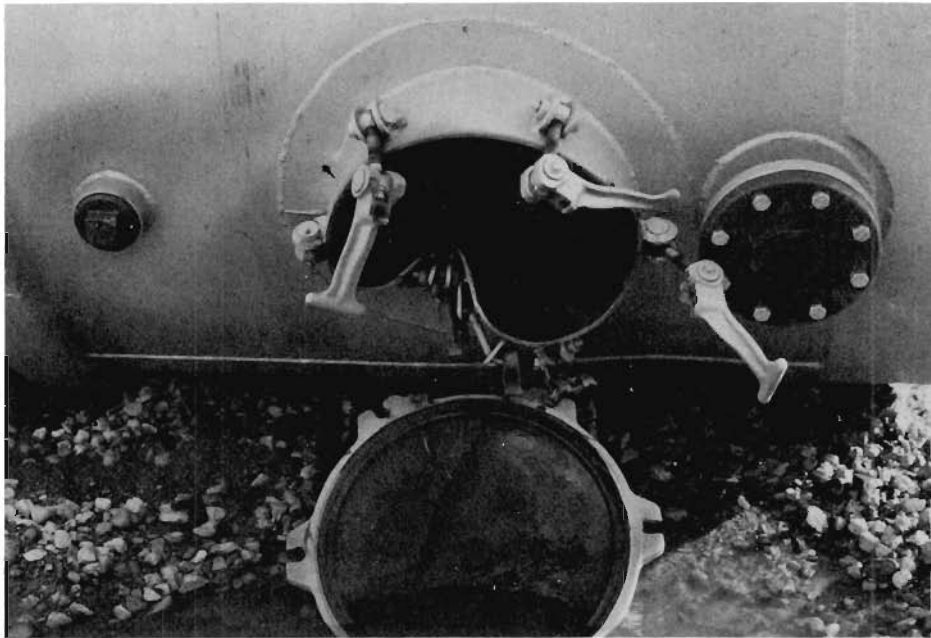
**FIGURE 5-14
MC 312 FROM ACCORDION TEST POSITION 3B
SHOWING DAMAGE TO TANK AND MANHOLE**

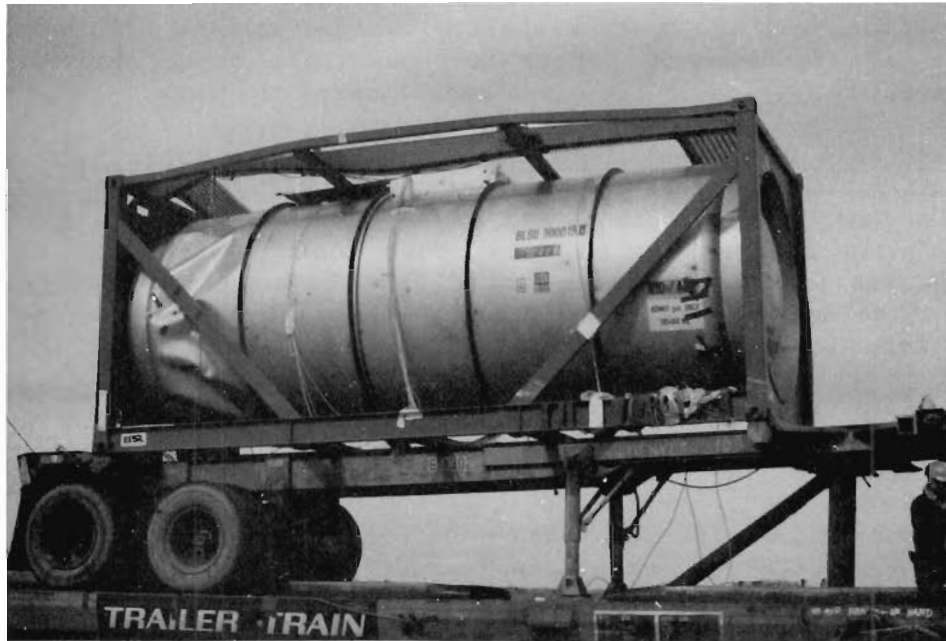
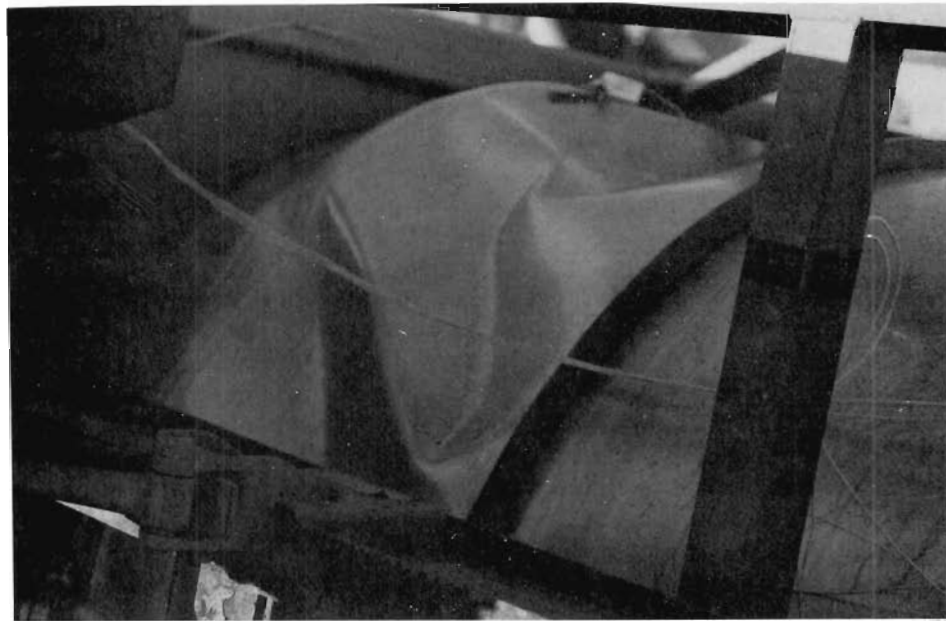
contact. The tank remained attached to the trailer. There was some bending of the frame structure but the most significant damage was deep buckling at one end of the tank shell. Two photographs of these buckles are shown in Figure 5-19. There were no leaks other than through an opening used for wiring to the slosh gages inside the tank.

**FIGURE 5-19
BLSU 300019 BUCKLED TANK, FROM BROKEN
RAIL DERAILMENT TEST 1 AT 23.4 MPH**

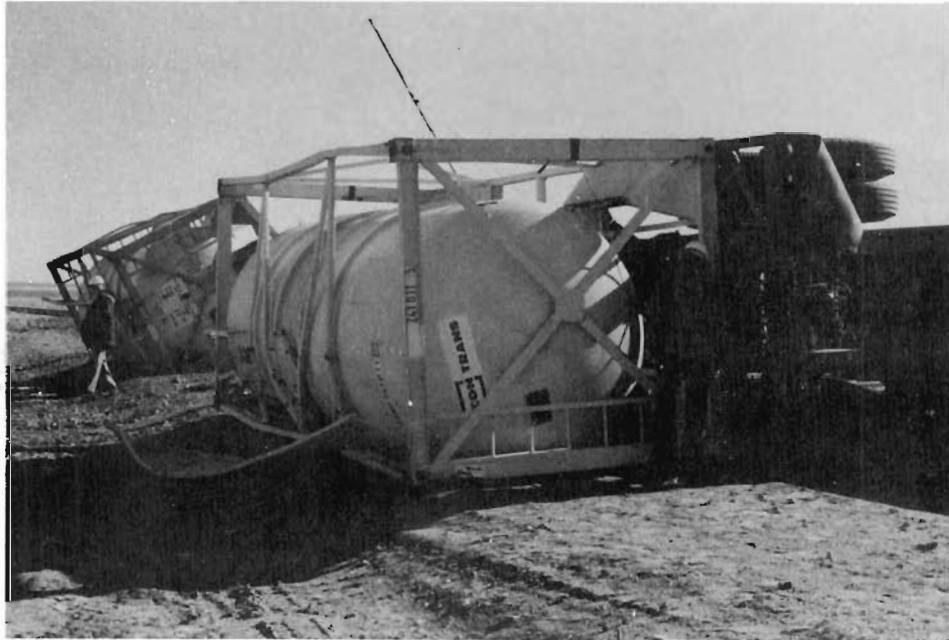
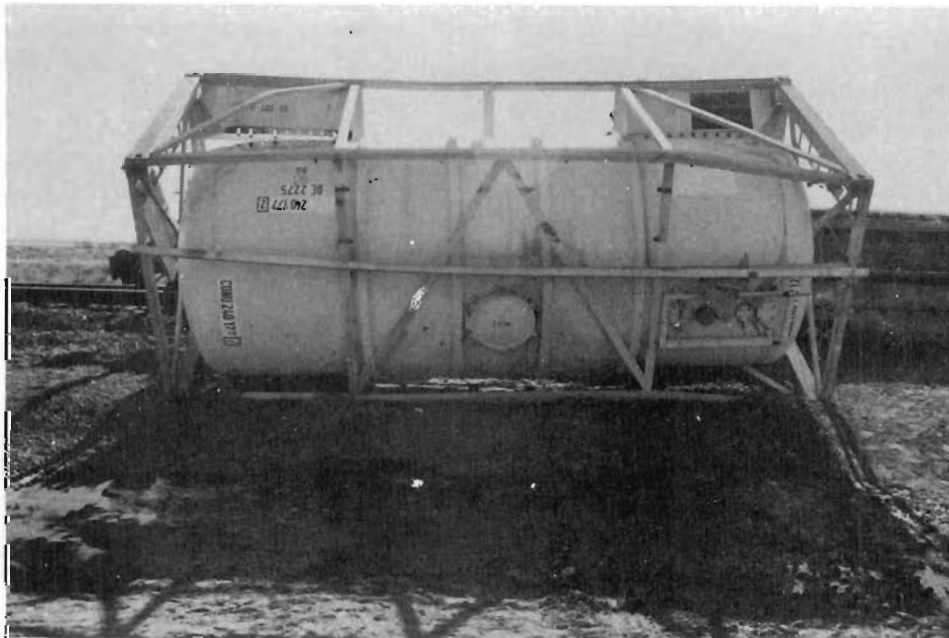
**FIGURE 5-20
DAMAGE TO PORTABLE TANKS IN BROKEN
RAIL DERAILMENT TEST 2 AT 19.0 MPH**

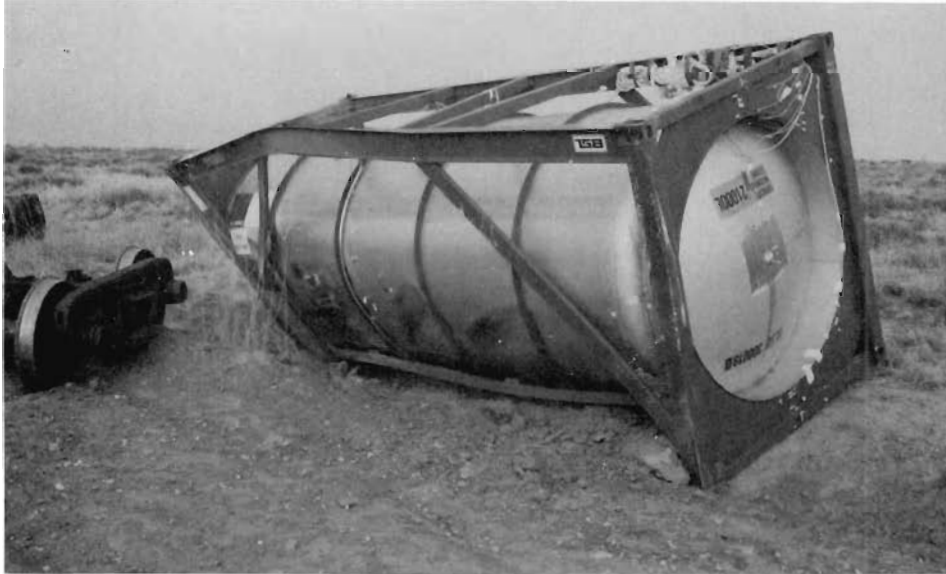
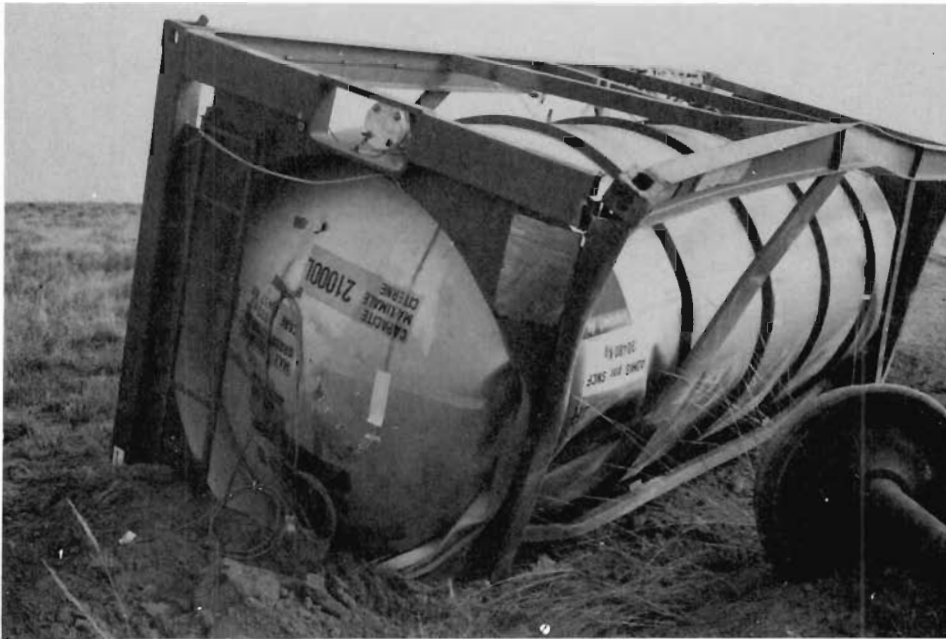
**FIGURE 5-21
DAMAGE TO BLSU 300019 AFTER BROKEN RAIL
DERAILMENT TEST 3 (ALSO USED IN TEST 1) AT 42.0 MPH**

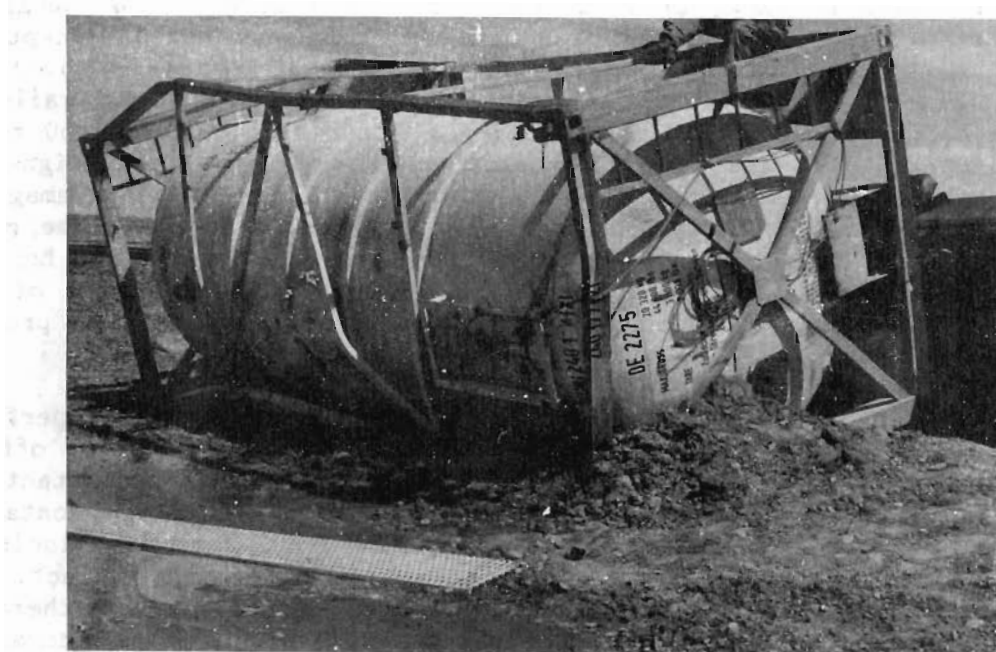
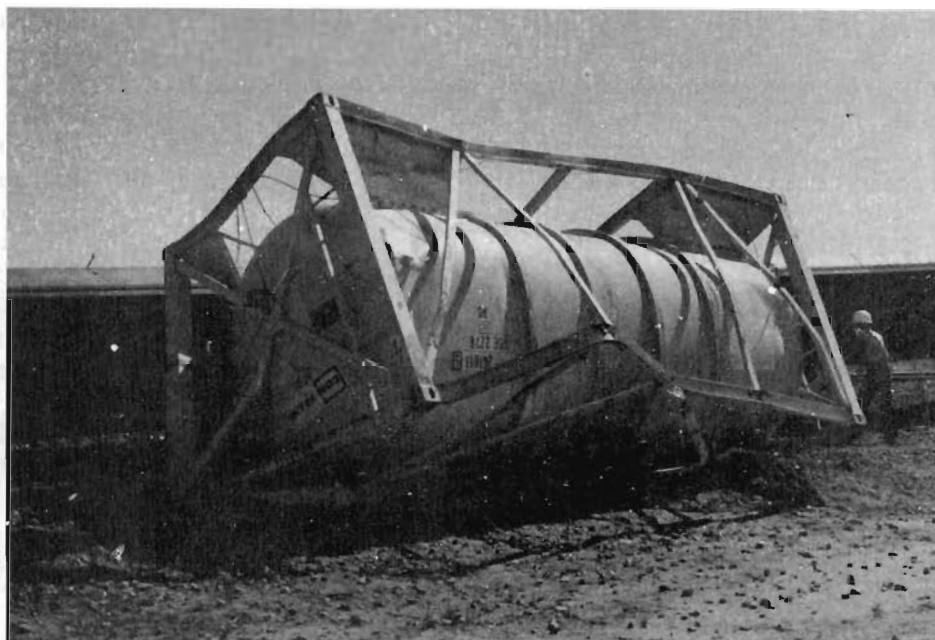
There was less damage to the tank support brackets in this test than in Test 2 but there were greater deformation and fracture of the frame structure. There was some additional buckling of the tank shells. There was no leakage except through an instrumentation port in DE 2275.

**FIGURE 5-22
DAMAGE TO PORTABLE TANKS IN BROKEN RAIL
DERAILMENT TEST 4 AT 40.0 MPH**

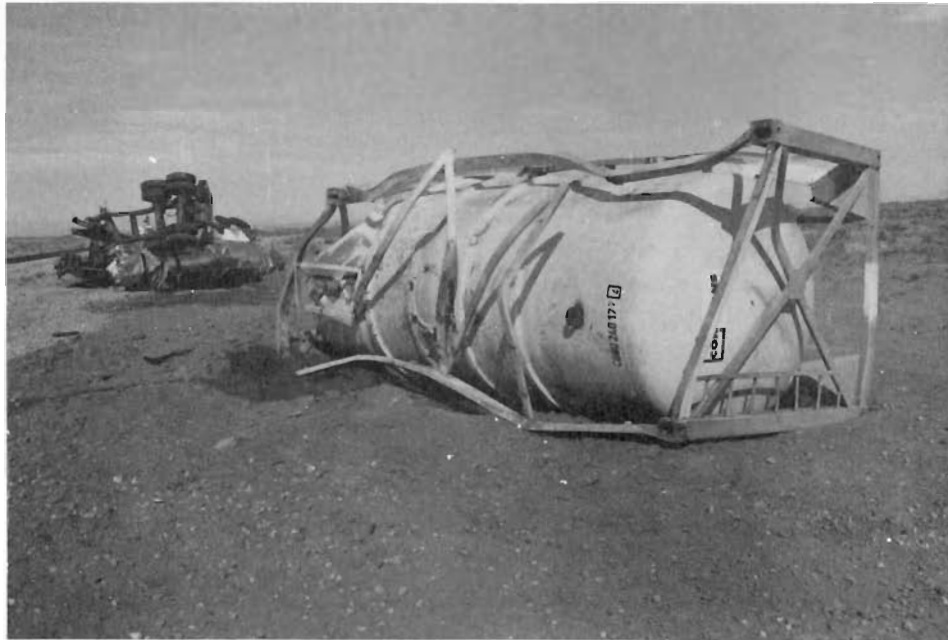
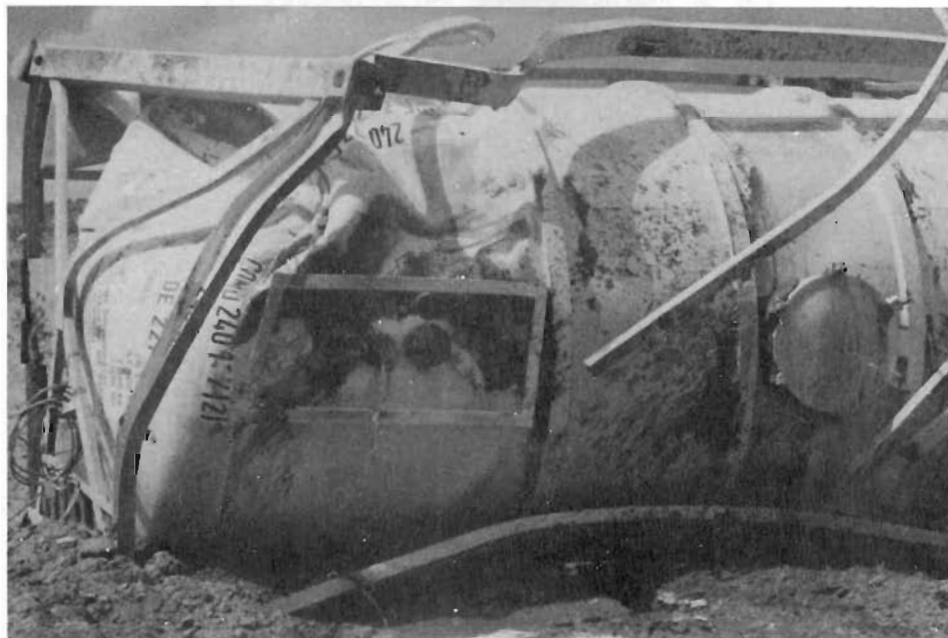
Broken Rail Derailment Test 5 was performed at 64.5 mph with DE 2275, an IM 102 portable tank, on a 20-foot chassis trailer. The damage to DE 2275 from Tests 2 and 4 had been repaired prior to Test 5, except that the tank buckles and some bends in the frames could not be removed. In this derailment the portable tank separated from the chassis trailer as the flatcar tilted. The forward velocity of the tank was about 50 mph at ground impact. The tank first contacted the ground on its top, right hand forward corner and continued to roll, bounce and slide. Major damage was done to the frame structure and tank on the first impact with the ground with bending and fracturing of the frame and large buckles in the head and shell of the tank. The photographs in Figure 5-23 show some of this damage. The bottom photograph also shows the water leak from the pressure relief valve.

**FIGURE 5-23
DAMAGE TO PORTABLE TANK IN BROKEN RAIL
DERAILMENT TEST 5 AT 64.5 MPH**

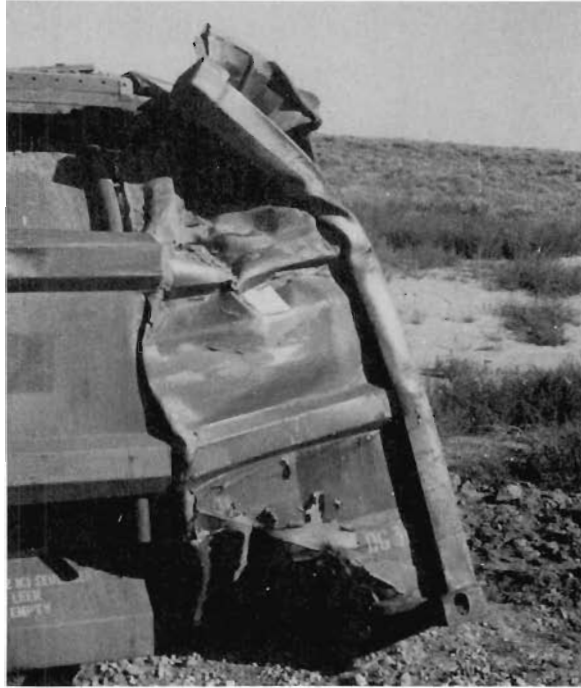
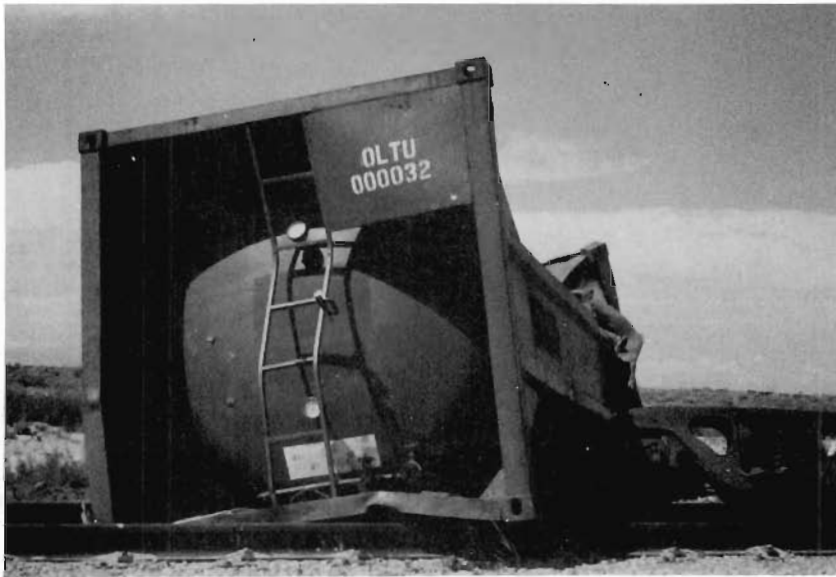
**FIGURE 5-24
DAMAGE TO PORTABLE TANKS IN BROKEN RAIL
DERAILMENT TEST 6 AT 59.5 MPH**

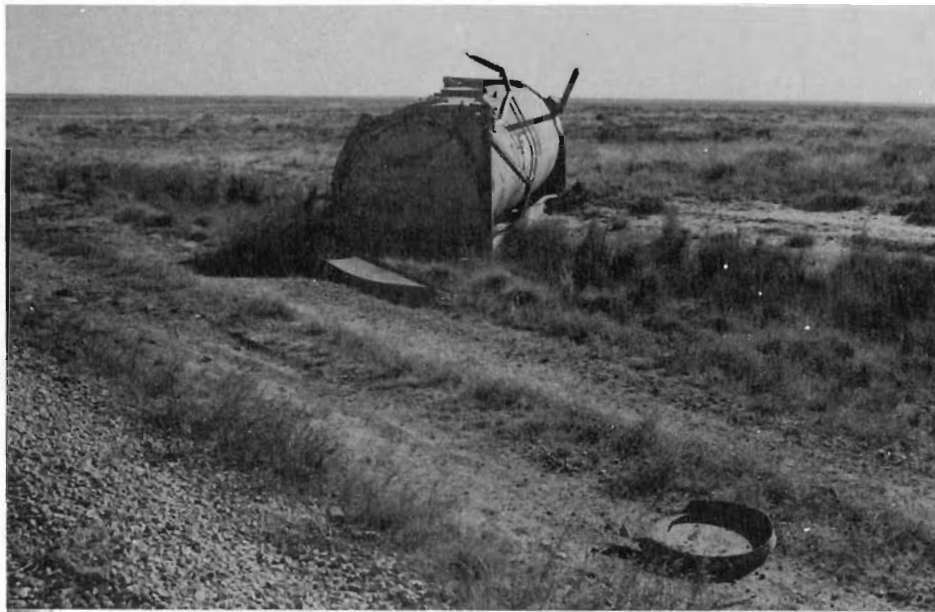
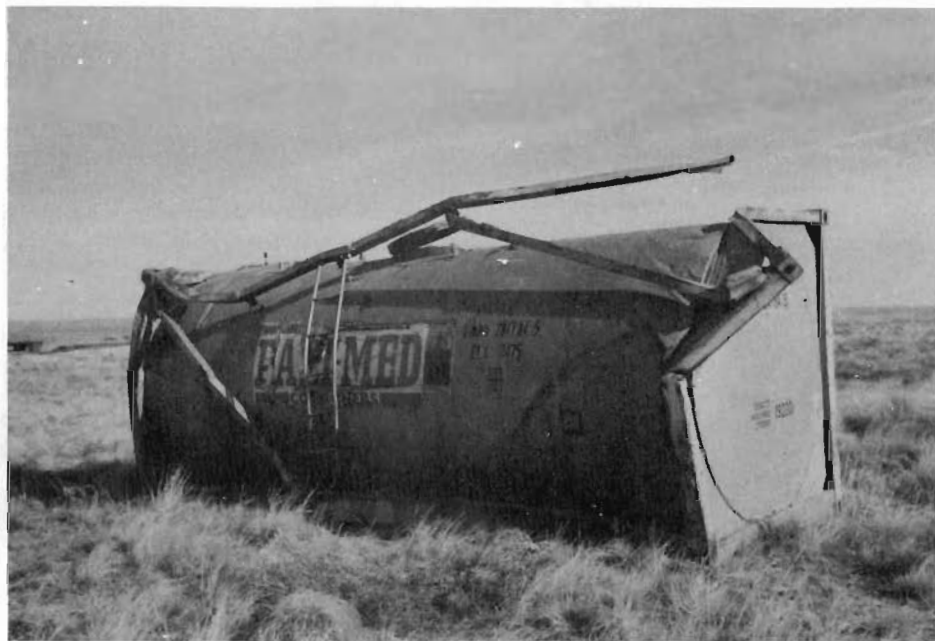
The insulated IM 102 portable tank was on the B-end of the first flatcar on a 20-foot chassis. The chassis and tank were thrown off, landing on the left side of the track. The tank landed upside down and rolled upright traveling about 50 feet further down the track than the flatcar and 50 feet to the left of the tracks. Figure 5-25 shows two views of this tank in its post-derailment positions. Figure 5-26 has a photograph of the top of the tank and one of the inside of the tank.

**FIGURE 5-25
DAMAGE TO INSULATED IM 102, EMMU 234784-5,
POSITION 1B (TOFC) ACCORDION TEST**

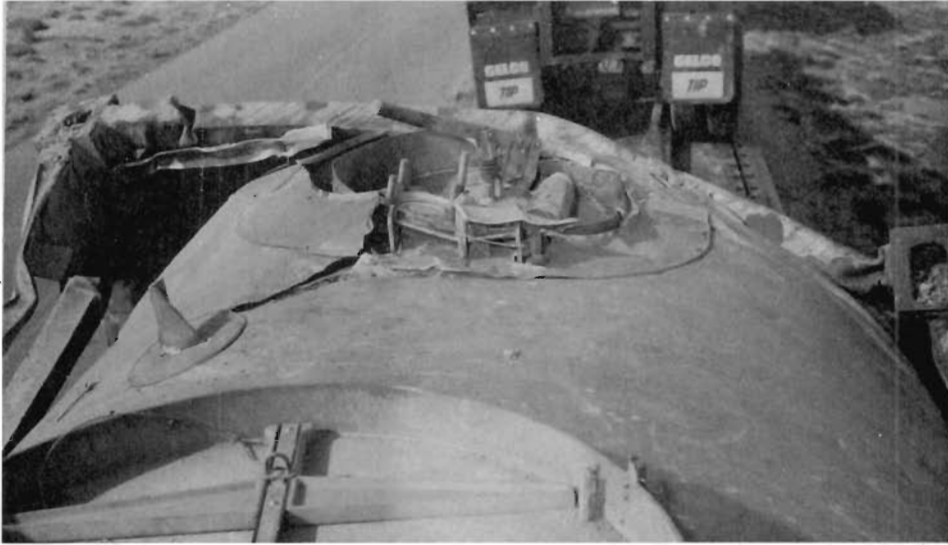
**FIGURE 5-26
DAMAGE TO VENT COVER AND INSIDE TANK,
EMMU 234784-5, ACCORDION TEST**

Two things are worthy of note in the photographs of the insulated IM 102 shown in Figure 5-26: (1) the protective cover and frame structure have been wiped clear of the valves and safety vents that access the tank, indicating how vulnerable to damage they are; and (2) the tank itself will withstand severe dents and crimps without fracture because of the tank material and thicknesses.

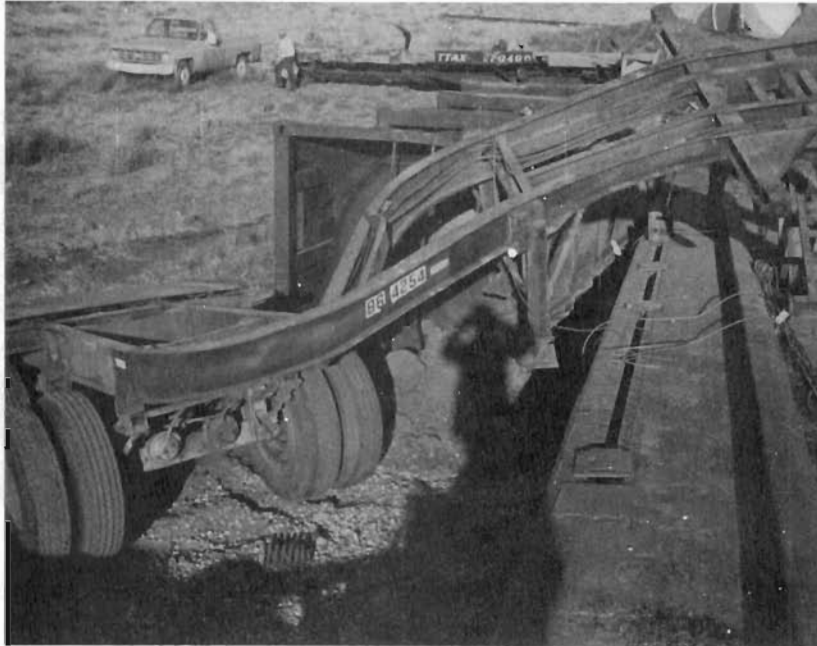
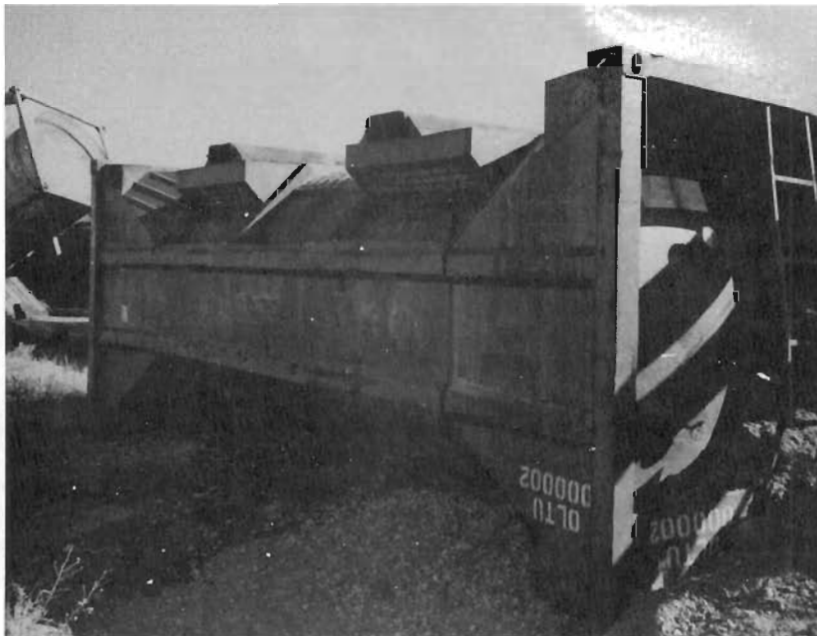
FIGURE 5-27
DAMAGE TO IM 101, OLTU 00002, POSITION 2A (TOFC),
ACCORDION TEST

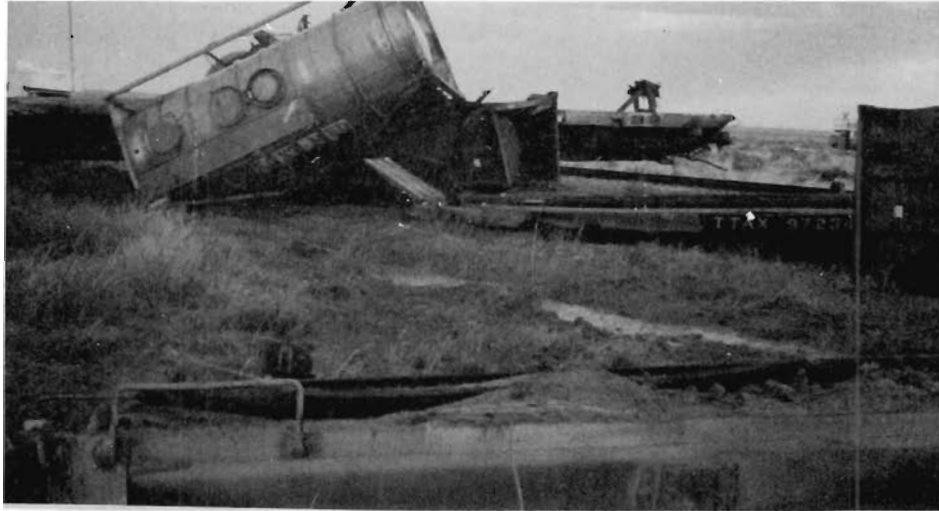
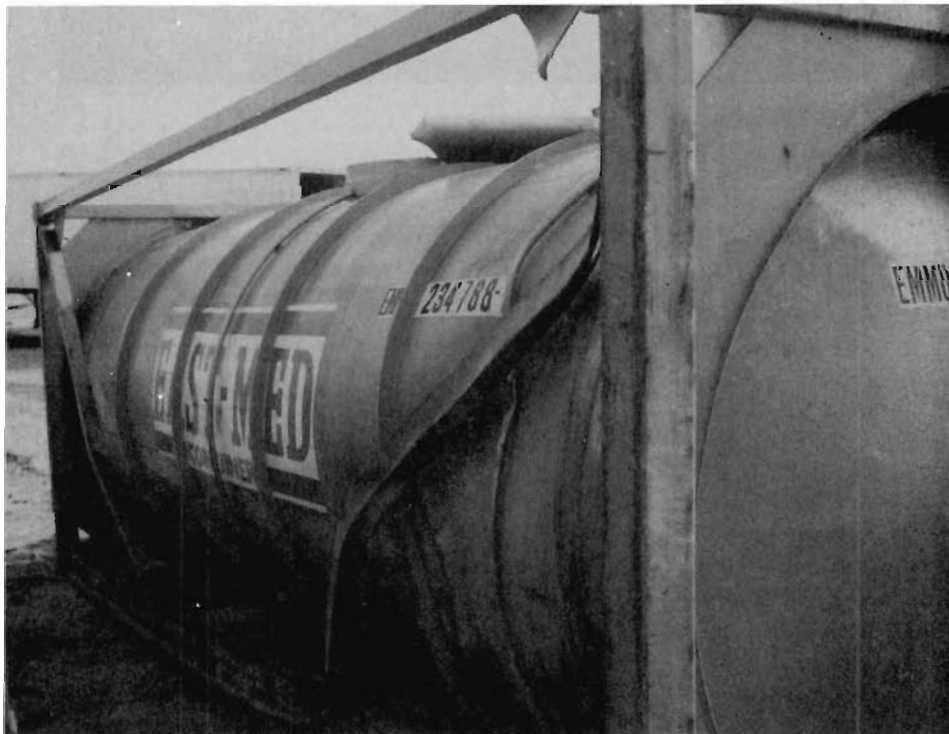
FIGURE 5-28
DAMAGE TO IM 102, EMMU 234788-7, LOCATION 2B (COFC),
ACCORDION TEST
