U.S. Department
of Transportation
**Federal Railroad
Administration**

Safety Testing of Intermodal Hazmat Configurations, Summary Report

1. Report No. DOT/FRA/ORD-88/04		2. Government Accession No.		3. Recipient's Catalog No.	
4. Title and Subtitle Safety Testing of Intermodal Hazmat Configurations, Summary Report				5. Report Date March 1988

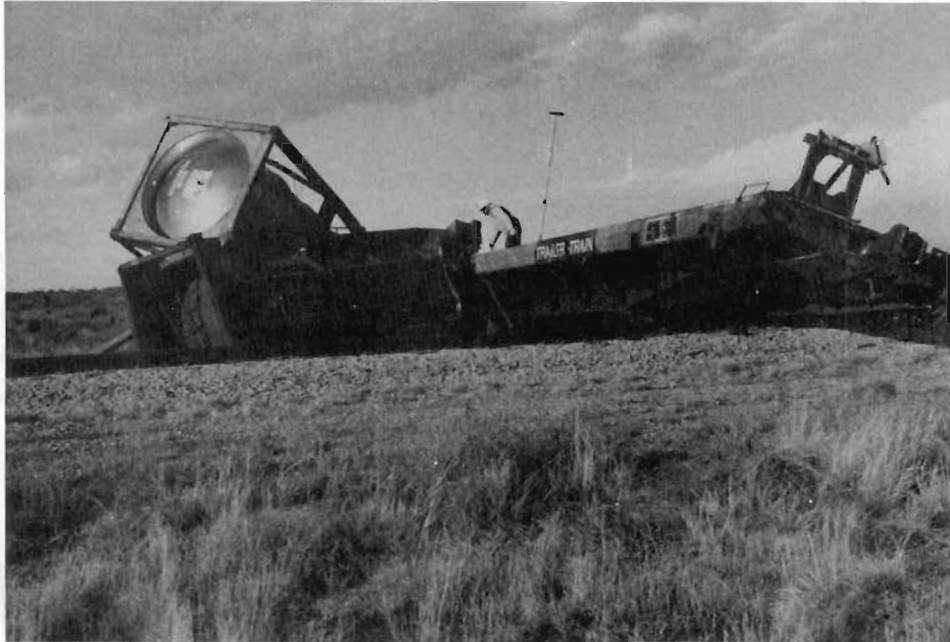
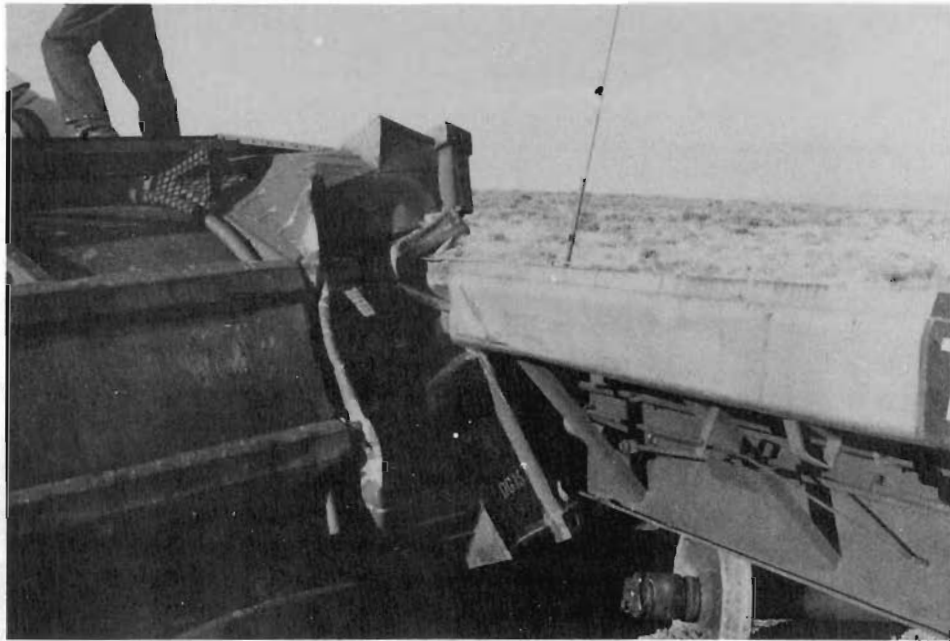
**FIGURE 5-29
DAMAGE TO IM 101, OLTU 000003, POSITION 3A (COFC),
ACCORDION TEST**

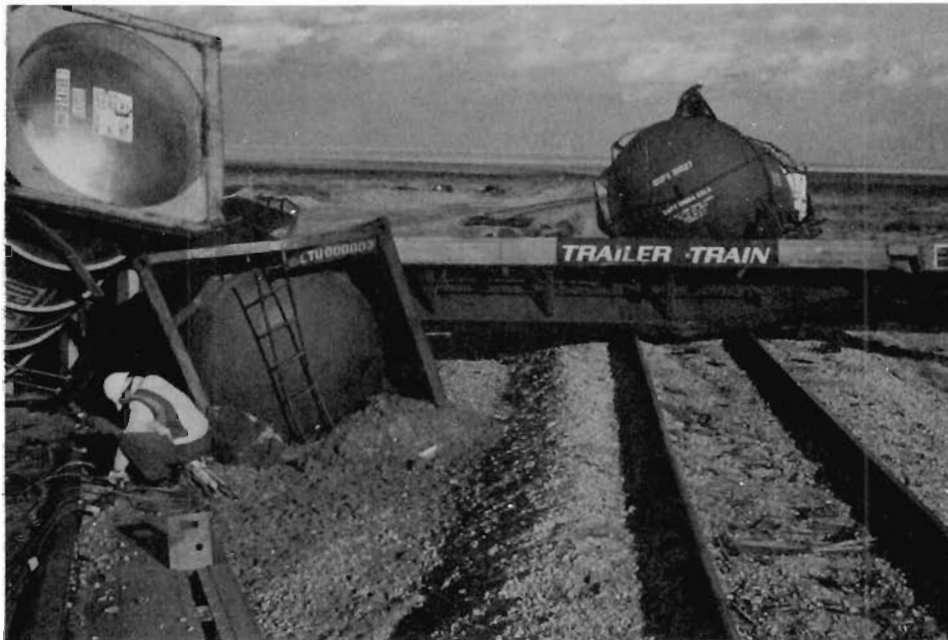
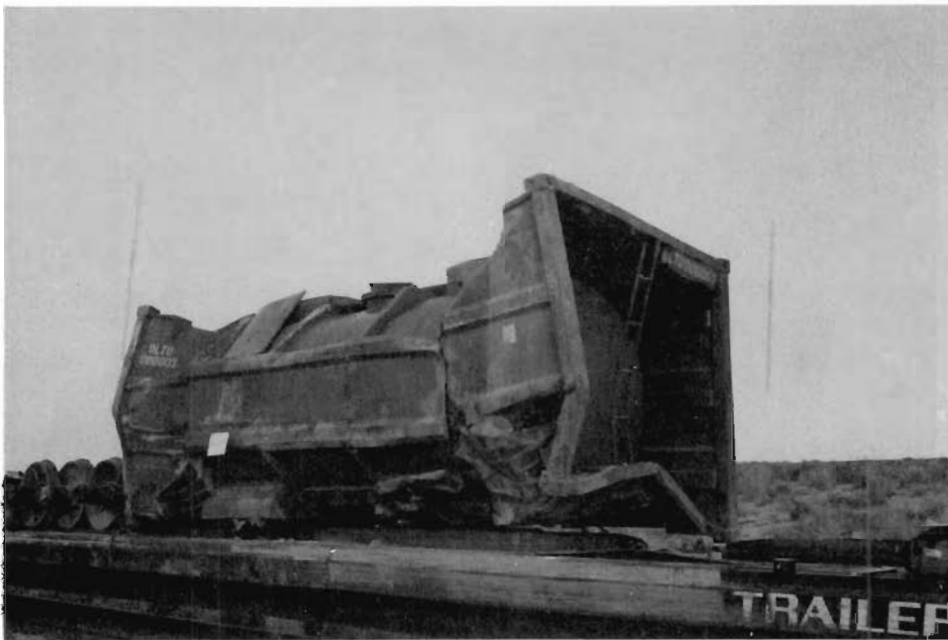
FIGURE 5-30
DAMAGE TO IM 101, OLTU 000003, ACCORDION TEST
