**U.S. CONSUMER PRODUCT SAFETY COMMISSION
WASHINGTON, D.C. 20207**

**OFFICE OF COMPLIANCE
AND ENFORCEMENT**

PRODUCT SAFETY ASSESSMENT (PSA) TECHNICAL EVALUATION REQUEST

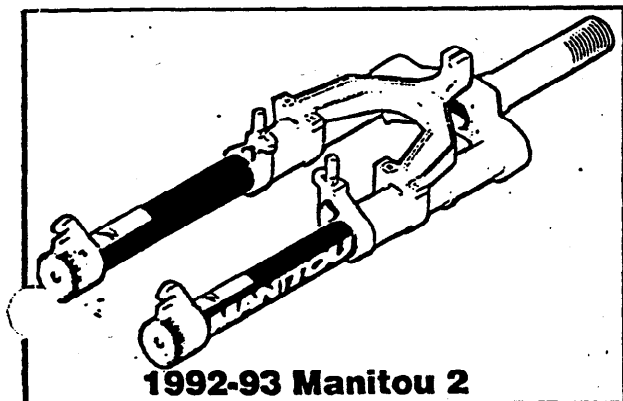
1992-93 Manitou 2

Answer Products has found that a small percentage of the 1992-93 season Manitou 2 and M-Sport fork crowns may develop cracks during use. Therefore, we are requesting that all of these forks be visually inspected by our Dealers for cracks and the crowns replaced if necessary. Manitou 1, Manitou 3, and Manitou Sport '94 forks are not subject to this inspection.

The cracks in the crown are the result of a small percentage of defective material that was used in the manufacture of the crowns. The cracks, if present, are plainly visible from the outer surface of the fork crown and require no disassembly to see. If cracks have developed and the fork continues to be used, the cracks may grow to a point where the crown may fail, completely separating the fork from the bicycle. This situation would result in loss of control of the bicycle with risk of physical injury to the rider.

1. Notify all known purchases and owners to STOP USING THE MANITOU 2 AND '92 M-SPORT FORKS IMMEDIATELY UNTIL THE CROWN CAN BE INSPECTED by the individual or by Shop Personnel if necessary. If any cracks are apparent, then the crown must be removed and Answer will replace the crown at No Charge to the dealer or the consumer.
2. Post the enclosed notice in your store(s) in a conspicuous place.
3. Visually inspect all crowns in use for presence of cracks in the areas noted in Fig. 1.
4. Remove and replace crown / steerers if any cracks are visually evident.
5. Send the cracked crown / steerer to ANSWER PRODUCTS, 27460 AVENUE SCOTT, VALENCIA, CA 91355. (Do not send the entire fork, just the crown/steerer) Write "DEFECTIVE CROWN" on the package for quick identification and turn-around. It will be replaced at No Charge.

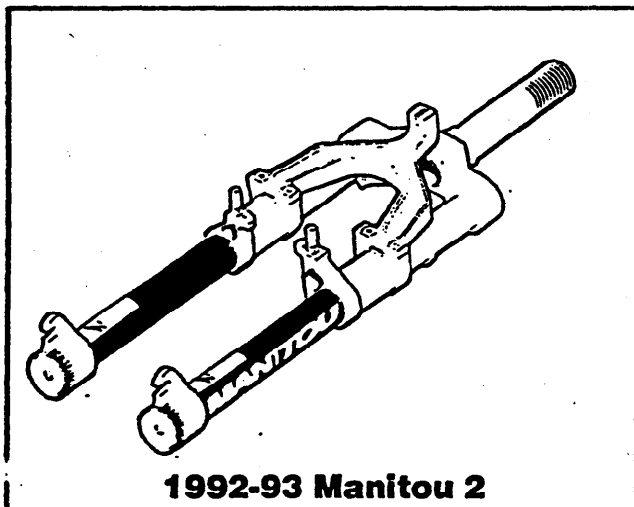
1992-93 Manitou 2

The cracks in the crown are the result of a small percentage of defective material that was used in the manufacture of the crowns. The cracks, if present, are plainly visible from the outer surface of the fork crown and require no disassembly to see. If cracks have developed and the fork continues to be used, the cracks may grow to a point where the crown may fail, completely separating the fork from the bicycle. This situation would result in loss of control of the bicycle with risk of physical injury to the rider.

If you own a Manitou 2 or 1992-93 M-Sport fork, either visually inspect your own crown for cracks in the locations noted in Fig. 1, or have your authorized dealer visually inspect your crown prior to your next ride. If any cracks are apparent, then the crown must be removed and Answer will replace the crown at No Charge to the dealer or the customer. For further information, please contact your dealer or Answer's Warranty Dept. at (800) 423-0273, Ask for Ext. 201.
