RESPONSE: Edward A. Cole, President/C.O.O., Answer Products, Inc., 17460 Avenue Scott, Valencia, California 91355; telephone number (805) 257-4411, Ext. 235.

IMPORTANT NOTICE

Re: 1992-93 Answer Manitou 2 Mountain Bike Suspension Forks
1992-93 Answer M-Sport Mountain Bike Suspension Forks

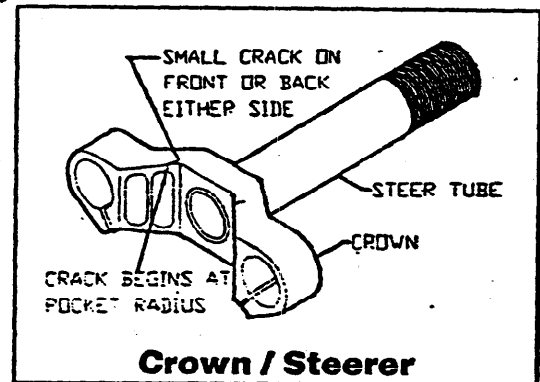
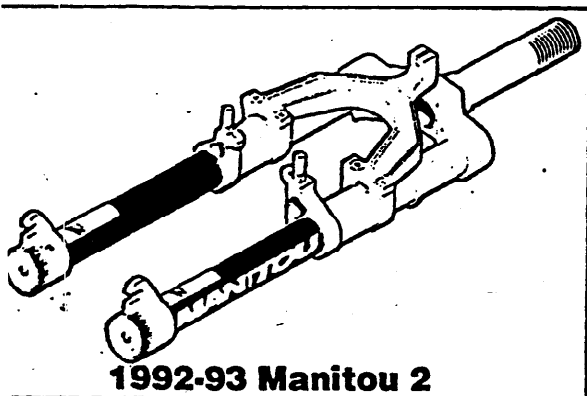
1992-93 Manitou 2

Answer Products has found that a small percentage of the 1992-93 season Manitou 2 and M-Sport fork crowns may develop cracks during use. Therefore, we are requesting that all of these forks be visually inspected by our Dealers for cracks and the crowns replaced if necessary. Manitou 1, Manitou 3, and Manitou Sport '94 forks are not subject to this inspection.

The cracks in the crown are the result of a small percentage of defective material that was used in the manufacture of the crowns. The cracks, if present, are plainly visible from the outer surface of the fork crown and require no disassembly to see. If cracks have developed and the fork continues to be used, the cracks may grow to a point where the crown may fail, completely separating the fork from the bicycle. This situation would result in loss of control of the bicycle with risk of physical injury to the rider.

1. Notify all known purchases and owners to STOP USING THE MANITOU 2 AND '92 M-SPORT FORKS IMMEDIATELY UNTIL THE CROWN CAN BE INSPECTED by the individual or by Shop Personnel if necessary. If any cracks are apparent, then the crown must be removed and Answer will replace the crown at No Charge to the dealer or the consumer.
2. Post the enclosed notice in your store(s) in a conspicuous place.
3. Visually inspect all crowns in use for presence of cracks in the areas noted in Fig. 1.
4. Remove and replace crown / steerers if any cracks are visually evident.
5. Send the cracked crown / steerer to ANSWER PRODUCTS, 27460 AVENUE SCOTT, VALENCIA, CA 91355. (Do not send the entire fork, just the crown/steerer) Write "DEFECTIVE CROWN" on the package for quick identification and turn-around. It will be replaced at No Charge.

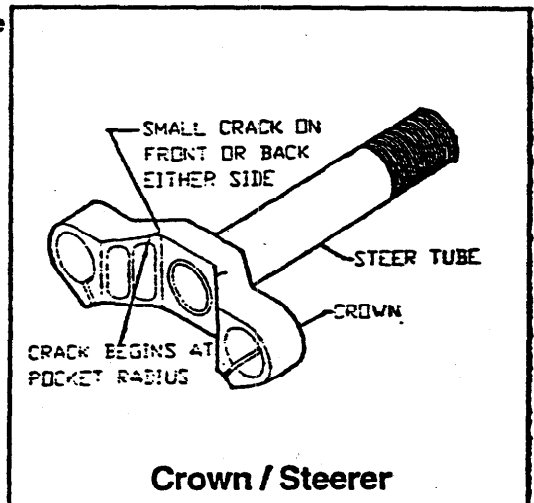
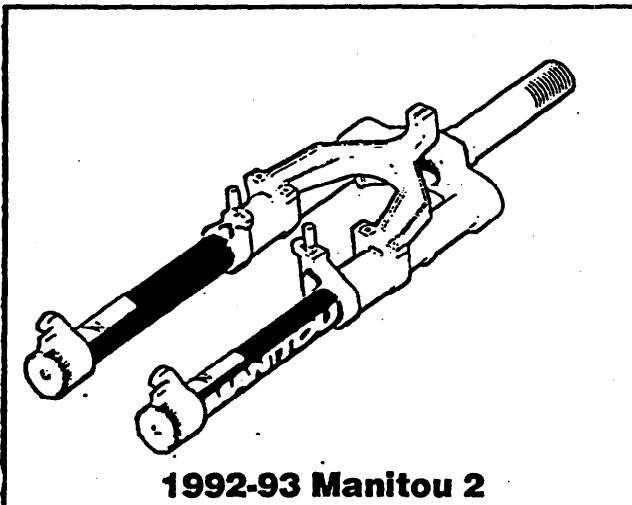
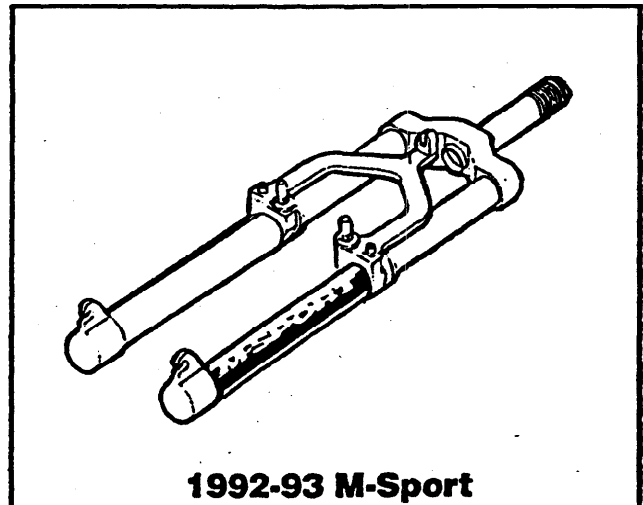
The cracks in the crown are the result of a small percentage of defective material that was used in the manufacture of the crowns. The cracks, if present, are plainly visible from the outer surface of the fork crown and require no disassembly to see. If cracks have developed and the fork continues to be used, the cracks may grow to a point where the crown may fail, completely separating the fork from the bicycle. This situation would result in loss of control of the bicycle with risk of physical injury to the rider.

If you own a Manitou 2 or 1992-93 M-Sport fork, either visually inspect your own crown for cracks in the locations noted in Fig. 1, or have your authorized dealer visually inspect your crown prior to your next ride. If any cracks are apparent, then the crown must be removed and Answer will replace the crown at No Charge to the dealer or the customer. For further information, please contact your dealer or Answer's Warranty Dept. at (800) 423-0273, Ask for Ext. 201.
