## **Damage Evaluation of the Taum Sauk Reservoir Failure using LiDAR**

**ABSTRACT:** The Taum Sauk Dam Upper Reservoir located in southeast Missouri failed on December 14, 2005. Two days after the catastrophic failure event an aerial survey were conducted to collect Light Detection and Ranging (LiDAR) data. The LiDAR data were interpreted and evaluated to a sub-meter resolution. The data were used to quantify the extent of the damage produced by the water released into a Missouri State Park. Damage consisted of washing out trees, soil, and the reservoir embankment, and scouring the ground to bedrock in places. Additionally, the data also were used in the evaluation of the reservoir damage, which consisted of a 207.3m (680ft) wide breach and scoured slopes. This paper focuses on the multiple uses of LiDAR data to assess damage to natural resources, and hydraulic and geotechnical evaluation of the failure.

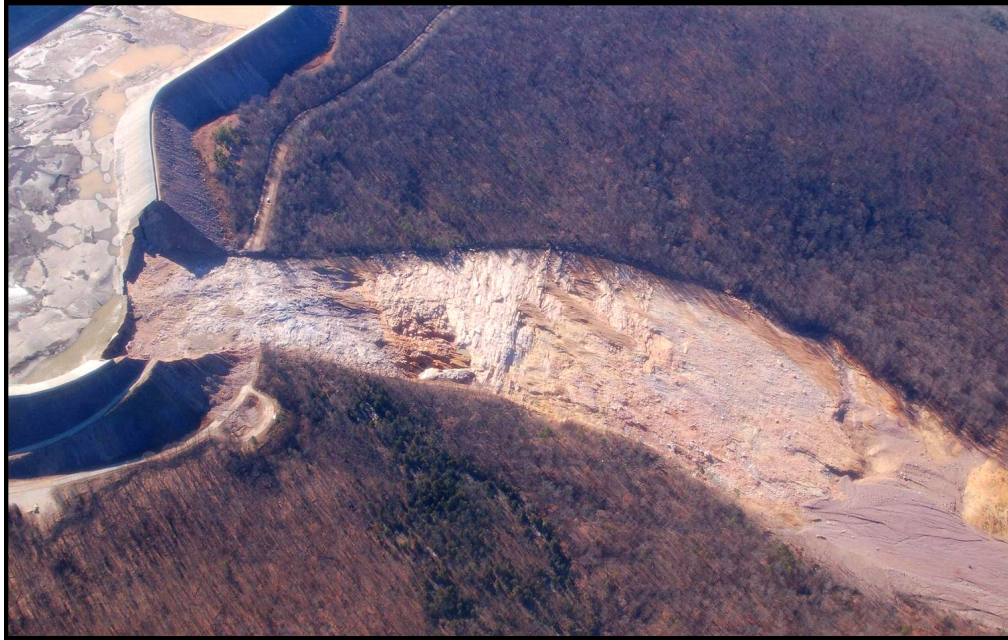
**FIG. 1.** The upper reservoir breach and a portion of the flow path  
(photo courtesy of J. Spooner, 2005)

The breach occurred along the northwest radius of the upper reservoir over a distance of about 680 feet at the crest and through the entire height of the reservoir. On the morning of the failure, water began overtopping the reservoir. This process continued until the rockfill embankment failed catastrophically, sending a torrent of water down into the Missouri Department of Natural Resources park. Another view of the damaged area at the breach location is shown in Figure 2. Here the camera points down stream towards the flow path with a closer look of the exposed bedrock and flood sediments (exposed soil/rock and embankment rockfill material). Notice the decrease in valley floor slope where sediment deposition begins.

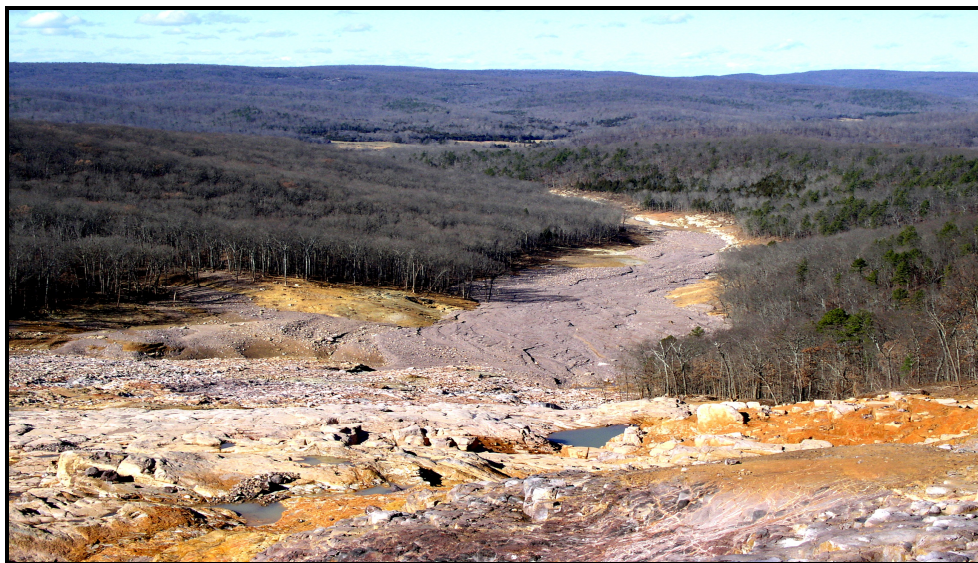
**FIG. 2.** Sedimentation and flow path looking northwest from breach location.  
(photo courtesy of D. Hoffman, 2005).

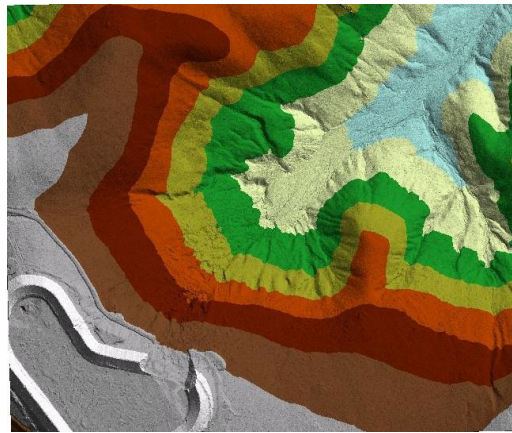
**FIG. 3.** LiDAR Image of the Taum Sauk Failure at about 25m intervals (note the upper reservoir breach in the lower left corner of the image).

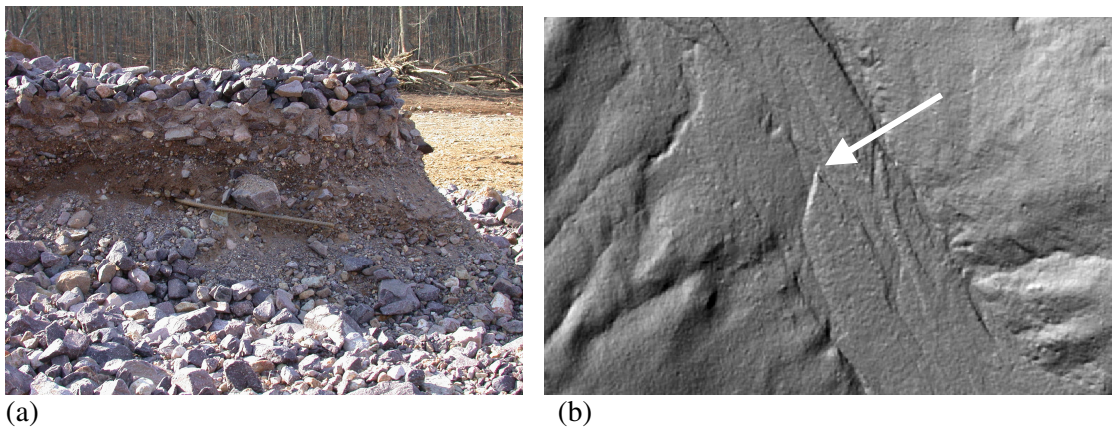
In contrast to the new bedrock exposures of the upper valley, the middle and lower valley segments were largely infilled with new sediment debris derived from the advancing flood waters. Sedimentary deposits differ in the middle and lower valley segments, being separated by a pronounced curve in the Proffit Mountain valley floor that reduced the subsequent downstream flow energy of the flood waters. In the upper segment of the valley, flood deposits are characterized by a basal layer of poorly-sorted and relatively fine grained (pebble to silt size) sediment (see Figure 4). This basal layer is overlain in sharp contact by a well-sorted layer of cobbles and boulders, from which finer grained material has been partially removed. These two layers appear to have been deposited in quick succession; the poorly-sorted basal unit by a forward advancing hyperconcentrated streamflow that was losing turbulent energy, and hence its suspended sediment load. The upper unit is interpreted to represent an advancing traction load of relatively coarse boulders and cobbles. Late stage erosion, dissection, and partial reworking of earlier deposited sediments

In the lower valley segment, cut bank and point bar deposits flank the pronounced valley curve. Near the mouth of the Proffit Mountain valley, where it enters the East Fork channel of the Black River, ripple-marked sand and silt deposits are interspersed among boulders. These fines were deposited as late-stage flood waters entered East Fork Lake, a newly formed impoundment resulting from the temporary constriction of flood waters through the Johnson's Shut-Ins valley, and the formation of a boulder debris dam across the East Fork valley. A large scour feature also formed in the East Fork valley at a location directly across from the mouth of the Proffit Mountain valley. Most of the East Fork valley, however, (including the Shut-Ins) has been affected by debris infilling rather than erosion processes.

**FIG. 4.** (a) Poorly sorted lower basal deposits and upper well-sorted boulder deposit that has been dissected and exposed by later stage “clear water” flooding. Rebar fragment located in center portion of lower basal deposit is pointing downstream. (b) LiDAR image showing flood deposits traversing from lower right to upper center. Downstream direction is to the top of figure and the arrow shows location of photograph (a).

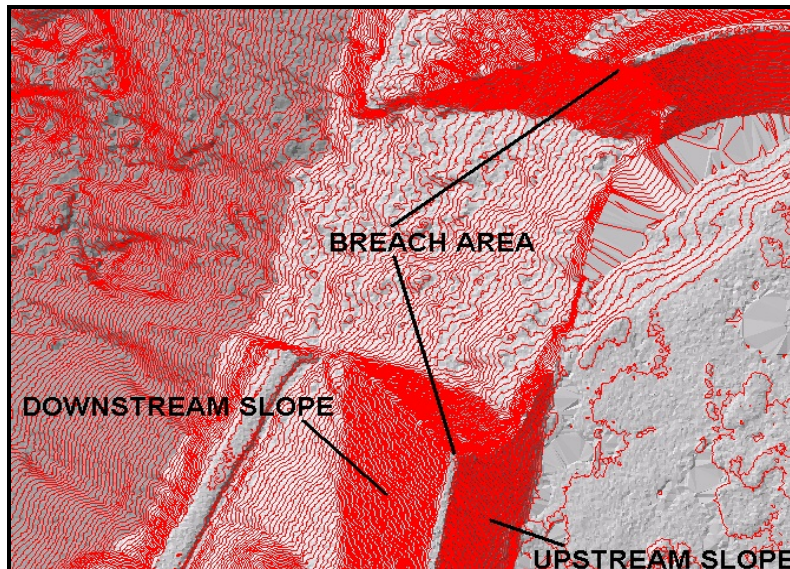
Several approximations of the Upper Reservoir rock-fill dike breach area cross section were determined using site photography from the reconnaissance activities combined with additional information from Rizzo, 2006. The LiDAR survey allowed an accurate determination of post failure terrain elevations, orthophoto development, high resolution contour production, and bare-earth surface DEM construction. The generation of existing terrain cross sections, which represent the Upper Reservoir rock-fill dike as-built conditions, allowed accurate determination of the rock-fill dike cross section in the immediate vicinity of the breach area. Using the program ArcGIS 9.0 and the available LiDAR survey data, one-half meter contours were generated for areas of interest near the breach. From the generated contours, several cross-sections were generated. The generated contours and an example of a generated terrain cross section, are shown in figures 7 and 8. Similarly, the inclination of the bedrock foundation was determined at the exposed rock of the breach area. Several cross sections in the general area of the breach were generated, including the upstream slope, the downstream slope, the bedrock inclination, the crest width, and the base width. A typical Upper Reservoir cross section used for evaluation of failure mechanisms that involved slope stability and hydraulic analyses is shown in Figure 8.

FIG. 7. Generated contours for analysis of upper reservoir breach area.

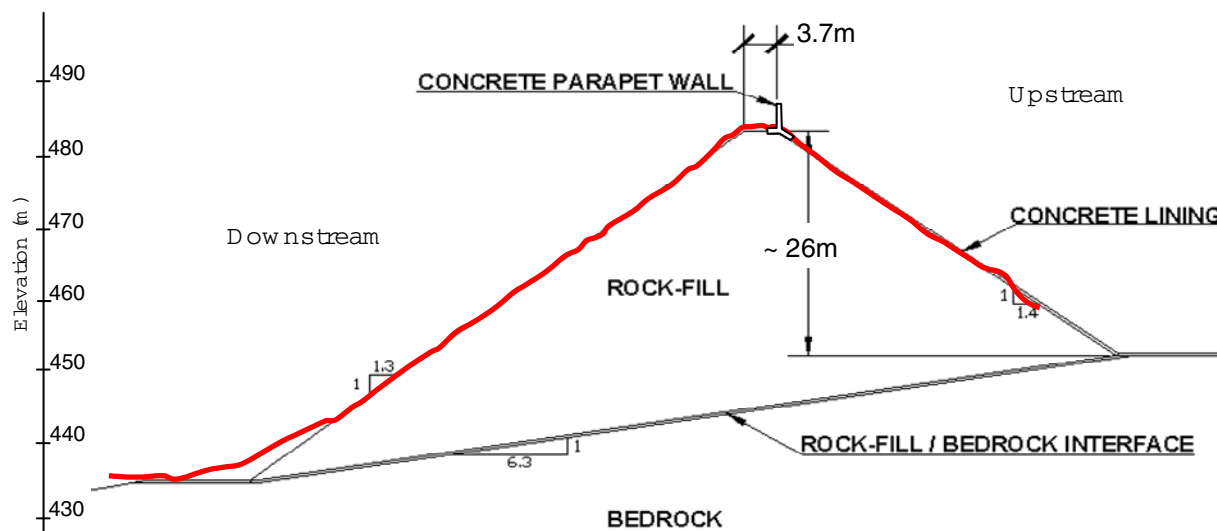
The slope stability analysis revealed a calculated factor of safety of 1.5 with the reservoir at full capacity. Several conditions of the rock-fill embankment saturation were considered by varying the phreatic surface, and it was determined that at least a 24.4m (80ft) saturated zone in the upstream side to reach marginal instability. Since the rockfill material has a high permeability the earth structure is not able to hold that

much water and it would drain out rapidly. This led the investigators to dismiss a global slope stability as a potential failure mechanism. The combination of overtopping, scouring, and undermining of the parapet wall atop the embankment appears to be the most likely mode of failure. Additional details on the evaluation of the Taum Sauk Upper Reservoir failure have been reported by others. (FERC, 2006; Rizzo, 2006; Witt and Hoffman; 2006; Gehring, 2006).

FIG. 8. Typical Upper Reservoir rock-fill dike cross-section and modeled layers based on LiDAR data (red profile line).
