Slope Stability of Proposed Ski Facilities at the Southeast Side of Snodgrass Mountain, Gunnison County, Colorado

Open-File Report 1996-701

U.S. GEOLOGICAL SURVEY

Rex L. Baum¹

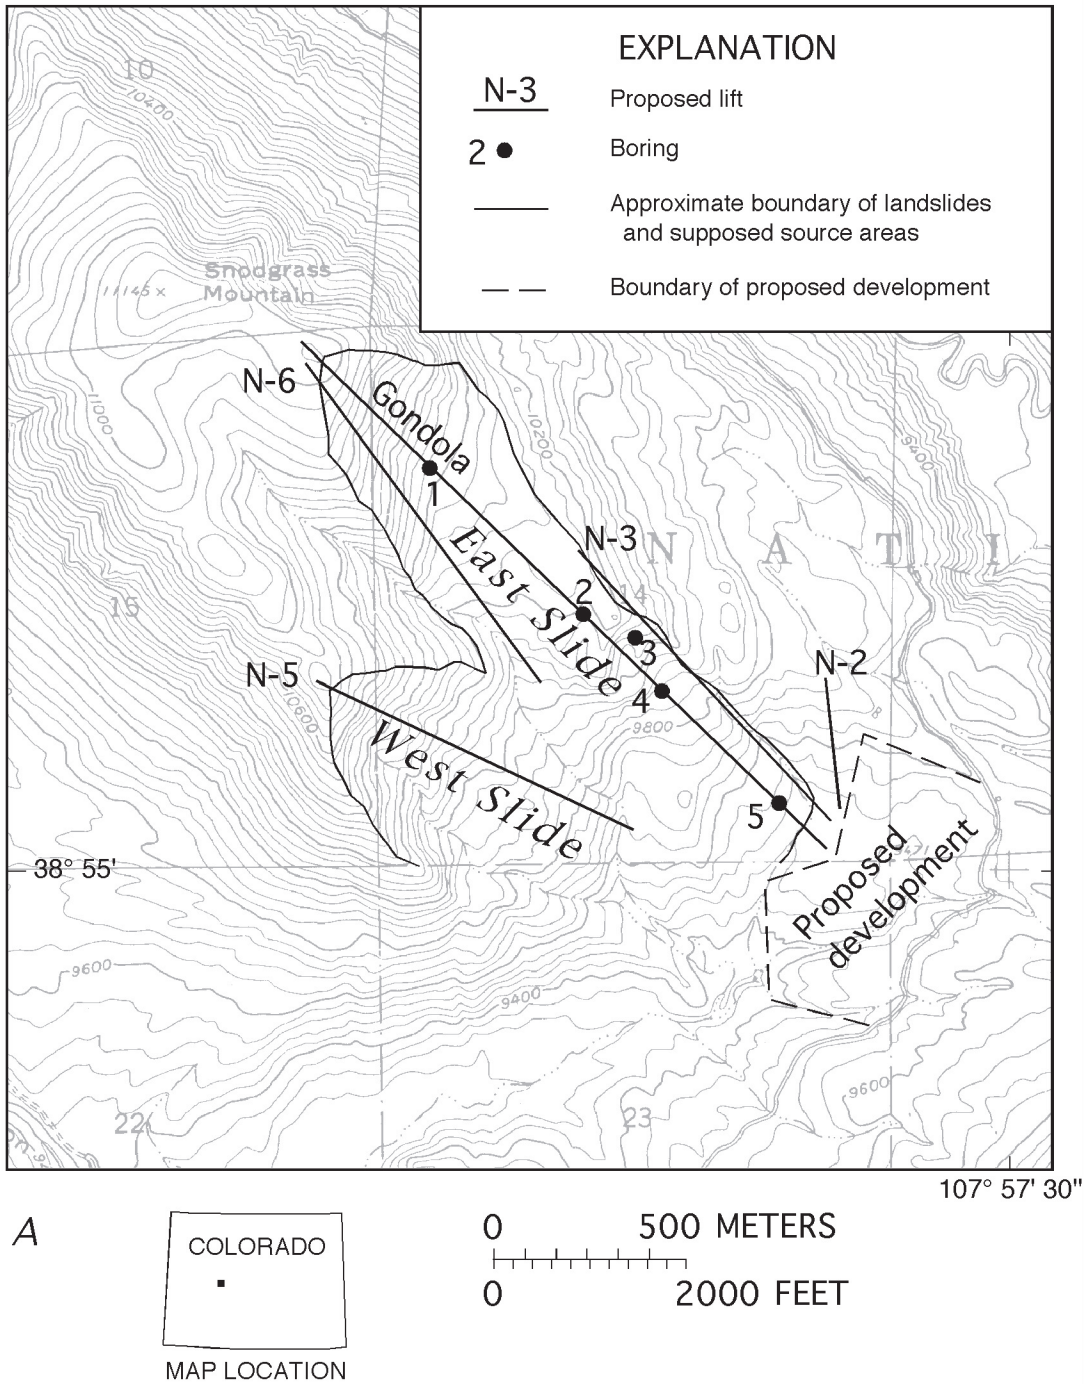
the southeast side of Snodgrass Mountain (fig 1A). RCE (1995) identified two large historic¹ landslides on the south side of Snodgrass Mountain (fig. 1A). The East Slide (fig. 1A) was considered the oldest and initiation of the West Slide was attributed to drag by the East Slide. The supposed source area of the East Slide, which extended downslope from the secondary summit of Snodgrass Mountain to about boring 2, was considered relatively stable (fig. 1A). Lifts N-3, N-5, N-6, and the gondola cross the landslide deposits or supposed source areas. RCE (1995) also mentioned a recent landslide, south of the permit area, that is in the same materials as the two large slides in the permit area.

The subsurface investigation showed the presence of medium-dense sands in the supposed source area of the East Slide (fig. 1A) and stiff clays in the slide deposits (RCE, 1995). The borings were made with 15-cm-diameter, hollow-stem augers and each boring was drilled to refusal (table 1). The standard penetration test was performed at approximately 1.5 m intervals and samples were collected but no index properties or strength measurements were reported. Borings 1 and 2 (fig. 1A) passed through clayey sands with gravel- and cobble-sized fragments of shale and granitic rock (quartz monzonite porphyry). Both borings terminated on granitic rock assumed to be in place, 7.2-8.7 m below the ground surface (table 1). Blow counts generally were consistent with a medium density for the clayey sand.

Borings 3, 4, and 5 passed through low-plasticity sandy clay of stiff to very stiff consistency and weathered shale (fig. 1A). All three terminated in hard shale that appears to be in place (table 1). In boring 3, fragments of granitic rock were present in the clay to a depth of at least 14.2 m and shale fragments were present in the clay below a depth of about 6.1 m. Boring 4 passed through low plasticity clay with

RCE (1995) concluded that the proposed development could destabilize the slide deposits (roughly the downhill half of the East Slide and the downhill two-thirds of the West Slide, [fig. 1A](#)) and that planned snow-making could contribute to failure by raising the water table. The potential hazards related to failure of the deposits included shallow creep, debris flow, small secondary slides, settlements, and slow, deep-seated movements. RCE (1995) proposed mitigating the hazards by moving the gondola and related structures off the slide to the stable ridge to the east. Alternatively, if moving the gondola were not practical, then RCE (1995) recommended providing subsurface horizontal drains and monitoring ground water, surface monuments, and inclinometers. Surface monuments have been installed and are being monitored (Jeff Burch, USFS, oral commun., 1996)

Figure 1. Approximate landslide boundaries as interpreted by previous investigators. Boundaries shown only within Gunnison National Forest, Section 23 is outside the Forest. Base from USGS Gothic 7-1/2 minute quadrangle, 1961. A. Landslides and borings of RCE (1995). B. (facing page) Landslides and Base Hill of Irish (1996).

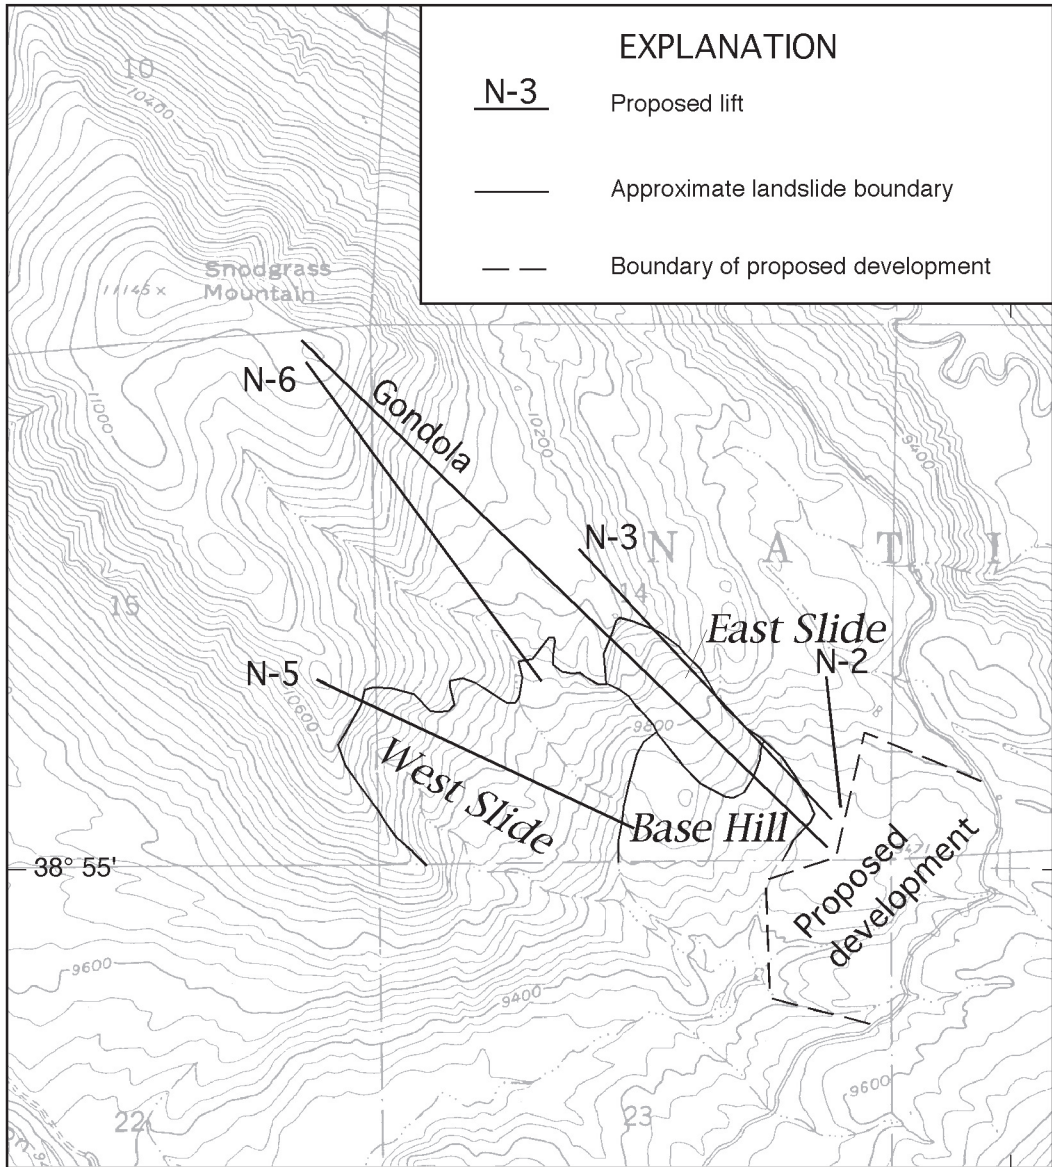
B

Irish (1996) recognized two ancient or pre-historic landslide complexes on the southeast side of Snodgrass Mountain ([fig. 1B](#)); however, he interpreted their extent and depth differently than RCE (1995). Irish (1996) recognized a West Slide ([fig. 1B](#)) that he classified as a block-slide complex. He asserted that a Base Hill of in-place Mancos Shale buttresses the West Slide ([fig. 1B](#)). His East Slide ([fig. 1B](#)) is a thin (2.7 m) mud flow and single rotational block in the alignment of the gondola and lift N3. On the basis of the following observations and ideas, Irish (1996) concluded that the probability of catastrophic reactivation of either slide complex was low: (1) No open cracks or fresh scarps were observed and the landslide features, particularly of the West Slide ([fig. 1B](#)), have been rounded by erosion. (2) The Base Hill buttresses the West Slide ([fig. 1B](#)). (3) The East Slide (mud-flow complex), appears to be thin². (4) The conditions thought to trigger the slides (glacial erosion and high precipitation) have changed or ceased. (5) Work by others (Kirkham and Rogers, 1981; Algermissen, 1983) indicates low probability of significant earthquake acceleration during the expected life of the project. Irish (1996) assigned low probability to small failures also, although he noted the presence of many small slumps and flows in the West Slide complex and uphill from the East Slide ([fig. 1B](#)). He concluded that more small slides can occur, especially if poor construction practices are followed.

Irish (1996) recommended that the hazards could be mitigated by sensible construction practices, including minimizing cut-and-fill construction, providing drainage to prevent ponding of water, revegetation of slopes after construction, and maintaining forests as much as possible. Although he did not expect the towers to affect the stability of the slides, Irish (1996) noted that the gondola and lift N-3 could be relocated to the east or west to avoid any potential problems related to putting them on the East Slide ([fig. 1B](#)). He did not expect problems for lift N-5 unless poor construction practices changed conditions. Irish (1996) stated that no houses or other major buildings should be placed on the slides and that he did not expect snow-making to affect stability of the slides.

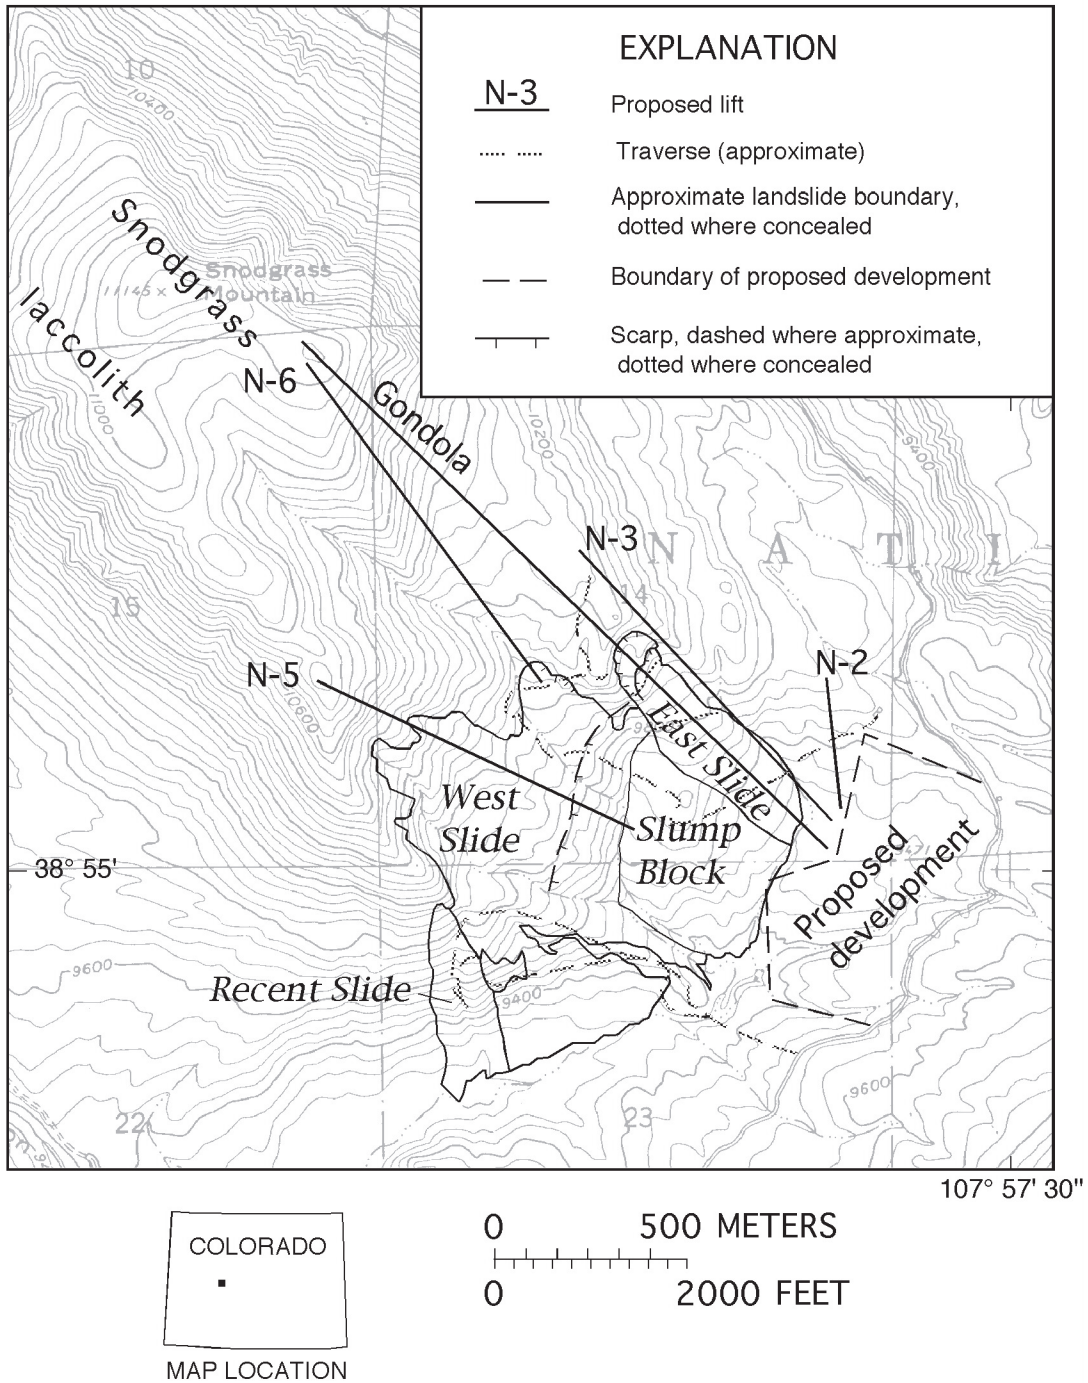
Based on examination in the field and on aerial photographs, the slide deposits in the basin at the southeast end of Snodgrass Mountain can be divided into three main units, the Slump Block, the West Slide and the East Slide (fig. 2). Movement of all three units was toward the southeast.

A low, rounded hill at the base of the complex constitutes the Slump Block. This hill is not in-place bedrock as asserted by Irish (1996), but rather a displaced mass that slid into its present position from a source area (evidenced by an eroded scarp) directly upslope. The surface of the hill is hummocky, and in aerial photographs the hill has a dark, slightly mottled tone that matches the tone of surrounding landslide debris and is different from the light, strongly mottled tone of nearby shale hills to the south and east. A 70-m-high, relatively steep scarp slope surrounds the Slump Block and marks its source area (fig. 2). Field examination confirmed a landslide origin for the Slump Block. The surface of the Slump Block, particularly south of the summit, consists of rounded hummocks, and the drainage is somewhat irregular. This contrasts sharply with the smooth slopes and dendritic drainage of the hills to the south and east. Weathered shale crops out locally on these hills, which have a thin, spotty cover of till (Gaskill and others, 1991).

A slide complex upslope (to the west and north) from the Slump Block constitutes the West Slide (fig. 2). The head of the West Slide is at the base of an arcuate scarp at the south end of the Snodgrass laccolith. Trees obscure much of the scarp and upper part of the deposits on the West Slide, however, parts of small benches and scarps are visible through the trees. The ground on the West Slide is hummocky, and drainage is irregular; intermittent ponds occur in closed depressions (fig. 2).

A slump-earth-flow complex at the east edge of the basin constitutes the East Slide (fig. 2). Two high, arcuate scarps (related to slumping) are at the top of the complex, and the surface of the earth flow, downhill from the scarps, is stepped and hummocky. The East Slide is draped over the Slump Block and 70-m-high scarp (fig. 2).

Dimensions.--The Slump Block has gentle (<10 percent) reversed (west-northwest) slopes between its west boundary and summit; slopes range from 25 to 40 percent on the downhill (east and south) faces. The Slump Block measures 580 m from head (at base of the 70-m high scarp) to toe and 700 m from north flank to south flank (including the area beneath the East Slide). The West Slide (fig. 2) has an average slope of 28 percent; slopes range from 25 to 40 percent on the 70-m-high scarp, 13 to 20 percent on the gently sloping ground above the scarp, and 25 to 60 percent near the head. The West Slide is 700 m wide from northwest flank to southeast flank and 900 m long from head to toe (at west edge of the Slump Block). The East Slide (fig. 2) slopes 22 percent; slopes locally range from 100 percent near the head to 11 percent in a gently sloping area near the toe. The slide has a volume of 1.6-million m³ based on a length of 800 m, width of 200 m, and minimum average thickness of 10 m. The minimum average thickness is estimated from the difference in elevation between the East Slide and ground at either side (fig. 2). Boring 5 (fig. 1A) (RCE, 1995), in the toe of the East Slide (fig. 2), turned up charred wood at a depth of 16.8 m and "granitic sandy gravel," which is not native to the underlying Mancos Shale, as deep as 20 m. Thus the East Slide or a combination of the East Slide and underlying Slump Block may be as much as 20 m thick; no data are available to determine the thickness of the West Slide (fig. 2). A recent slide on the south end of Snodgrass Mountain slopes 39 percent, and is about 600 m long, 200 m wide, and probably a few meters thick (fig. 2).

Ages.--Absolute ages of the three units are unknown, but the East Slide is younger than the Slump Block and West Slide (fig. 2). The East Slide overlaps the Slump Block. The West Slide and Slump Block are more deeply eroded and have more rounded features than the East Slide.

The Slump Block, East Slide, and West Slide (fig. 2) have not moved significantly in historic times. No signs of recent changes in the slide deposits are evident between photographs spanning 30 years. The vegetation is undisturbed, and the same areas that are bare on the old slide deposits and scarps in the 1958 photographs are bare in the 1988 photographs. We found no field evidence of recent activity such as fresh scarps or open cracks; however, despite the lack of evidence for significant movement, the slides can still be marginally active because small (sub-centimeter) annual movements are known to occur in some slides without cracks or other visible evidence of movement being preserved (Fleming and Johnson, 1994).

The recent slide on the south slope (fig. 2) appears to have been active in the past 40 years. Boundaries of the recent slide appear to be sharp and barren, as if it were active, in the 1958 photographs. The same boundaries in the 1988 photographs appear subdued and partly overgrown. Also, a scar in the lower part of the slide has distinct head and flank scarps and exposes fresh landslide debris. The area occupied by the scar appeared to be unvegetated in the 1988 photographs, but no scarps were apparent.

Shallow sliding or slumping can damage access roads, utilities, towers of the gondola, or towers of lifts N-3, N-5, and the south end of lift N-6. The recent activity of the shallow slide on the south side of Snodgrass Mountain demonstrates that such slides can and do occur under existing conditions. Slopes on the West Slide, Slump Block, and East Slide (fig. 2) are locally as steep as the recent slide (fig. 2). The lower 2/3 of lift N-5 is in the area of scarps mapped by Gaskill and others (1991).

Deep-seated failure and renewed movement of the entire landslide deposit (i.e. the East Slide, West Slide, and Slump Block, fig. 2) would threaten all the proposed facilities in the area (i.e. lifts N-3, N-5, N-6, the gondola, and the proposed development). Such movement might occur if the Slump Block is disturbed by excavation or erosion. The Slump Block appears to buttress higher deposits of the West Slide (fig. 2) and secure them against massive failure. Excavation of the toe or top of the Slump Block will remove part of the buttress load and increase the chances of failure. Downward erosion of the stream channel at the toe of the Slump Block (related either to a basin-wide episode of incision or a local increase in discharge) will increase the height of the slope and tend to destabilize the Slump Block.

Deep-seated failure resulting in reactivation of the East Slide (fig. 2) can damage or destroy the gondola and lift N-3. Reactivation and deep-seated movement of the East Slide is more likely than reactivation of the entire landslide complex; the East Slide rests on top of the Slump Block (fig. 2). Slides that were similar in geometry and degree of erosion of surface features were reactivated by rapid melting of a heavy snowpack during 1983 in central Utah (Baum and Fleming, 1989). The 1.6-million-m³ (or greater) East Slide (fig. 2) is too large to remove and any other methods of stabilizing it will be costly. Avoidance of any development or snow-making on the East Slide (fig. 2) may be the safest and least expensive option for reducing the potential losses. Site-specific studies are needed to evaluate other possible mitigation options.

Figure 2. Landslide deposits and proposed development on southeast side of Snodgrass Mountain, Gunnison County, Colorado. Outer boundaries of landslide deposits from Gaskill and others (1991). Internal boundaries (approximate) based on field reconnaissance and interpretation of aerial photographs (this investigation). Base from USGS Gothic 7-1/2 minute quadrangle, 1961.

The ski facilities proposed for the southeast side of Snodgrass Mountain (Crested Butte North) are subject to several geologic hazards inherent to development on large landslide deposits. Safe and economic development of facilities on the West Slide and Slump Block (fig. 2) will require detailed, site-specific studies and adequate engineering to reduce damage from expansive soils, debris flows, and shallow sliding or slumping. In addition to damage from these, facilities on and downslope from the East Slide (fig. 2) are also subject to possible damage or destruction by deep-seated sliding. Detailed field investigation and stability analysis are required to determine whether the East Slide is sufficiently stable to support the proposed facilities. Given the magnitude of the investment to develop the ski facilities and the potential losses due to deep-seated failure, detailed subsurface investigation and stability analysis should also be undertaken for the West Slide and Slump Block (fig. 2) before going ahead with development of any proposed facilities on or near the southeast side of Snodgrass Mountain.
