EPA CHEMICAL ACCIDENT INVESTIGATION REPORT

**Pennzoil Product
Company Refinery
Rouseville, Pennsylvania**

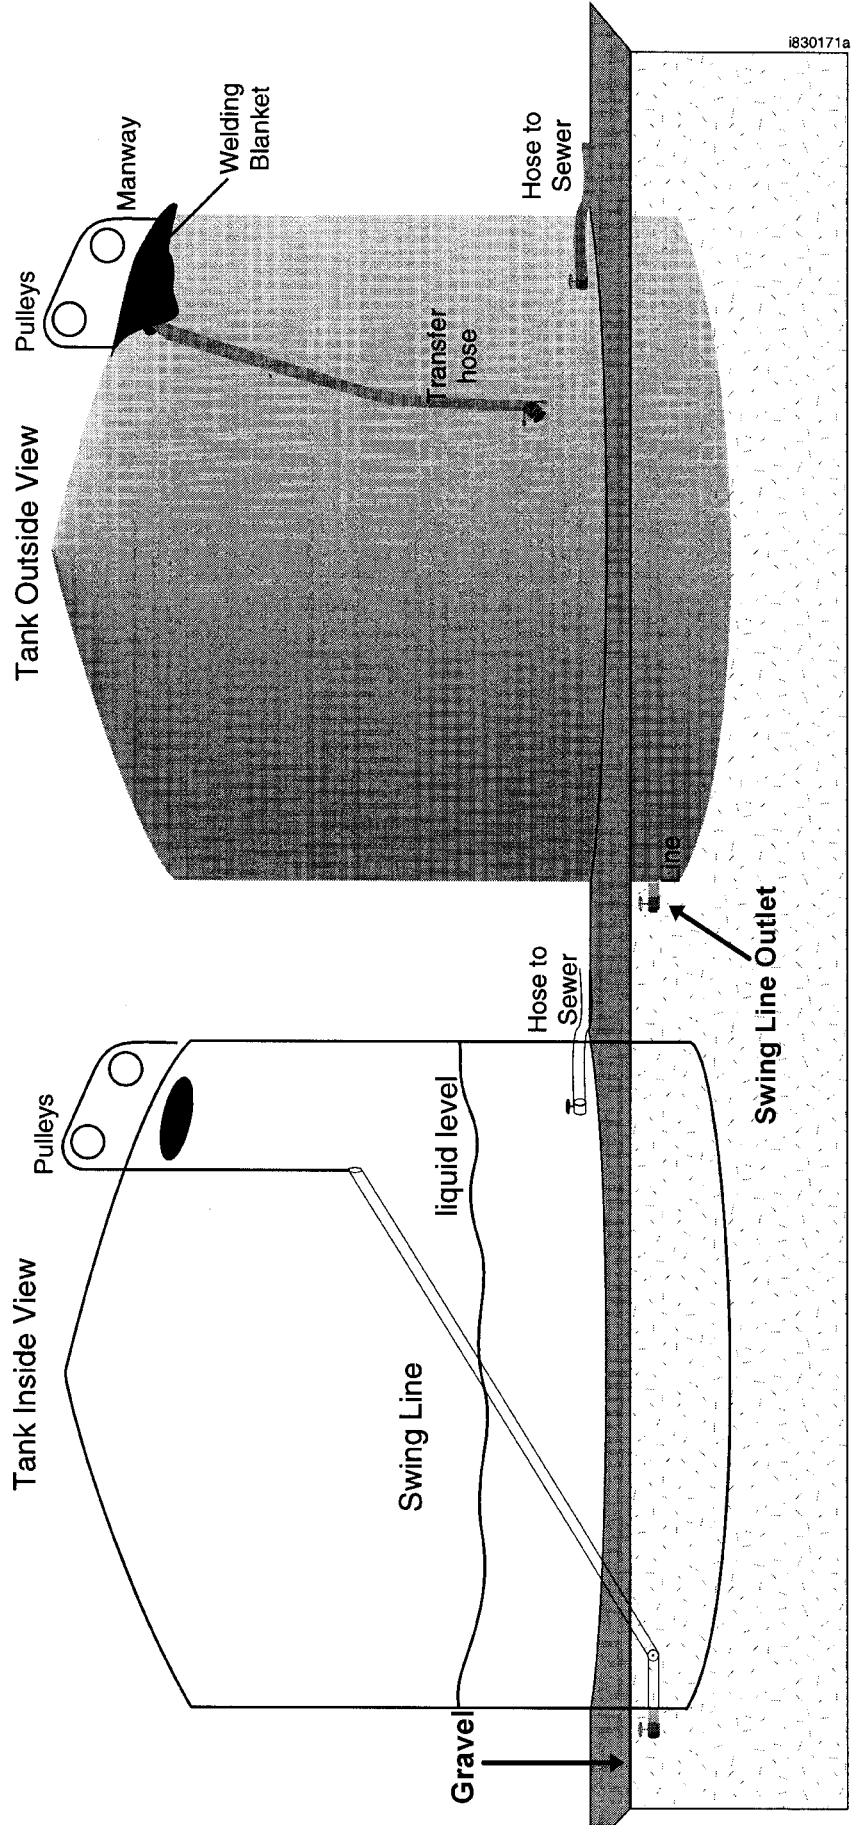
Exhibit 4
Inside and Outside Views of Tank 487

Tanks 487 and 488, which were similar in size and design, were 30 feet in diameter with 25-foot high sidewalls and five-foot high domes. The tanks, built in 1937, were constructed of steel plates riveted together. The riveted "umbrella" domes were replaced in 1950. The tanks were about four feet apart and shared a common set of stairs leading to the top for employee activities such as gauging the volume of liquid in the tank or inspections. These tanks were not individually diked; i.e., they did not have a secondary containment wall around them. However, they were located in a general tank farm area that had walls and berms to prevent any spilled materials from reaching the Oil Creek.

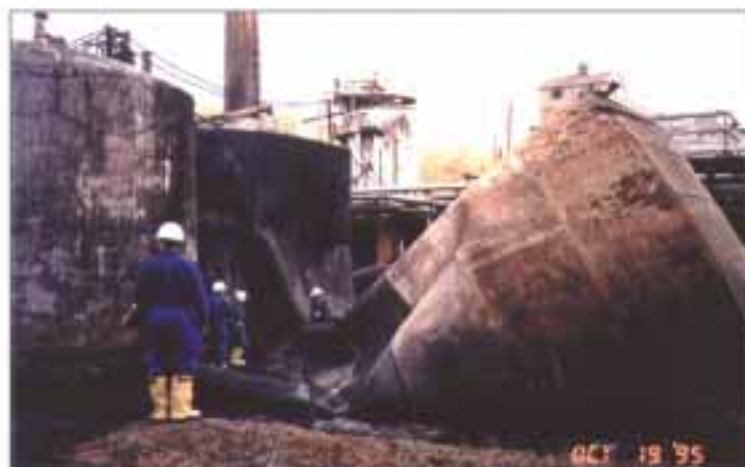
As a result of the explosions, each tank failed catastrophically at the bottom seam where the vertical sidewall of the tank was connected to the bottom horizontal floor plate, lifting the tanks up in opposite directions. Tank 487 lifted off its base and landed about 20 feet to the west. Tank 488 landed about 50 feet to the east after clearing a storage tank and a pipe rack. The burning contents of the tanks, released when the tanks failed, created a wave of burning hydrocarbon that engulfed the entire area.

C. Tank 488, after explosion.
