EPA/OSHA JOINT CHEMICAL ACCIDENT INVESTIGATION REPORT

**Surpass Chemical Co., Inc.
Albany, NY**

Accident Investigation Report
Surpass Chemical Company, Inc., Albany, New York, April 8, 1997

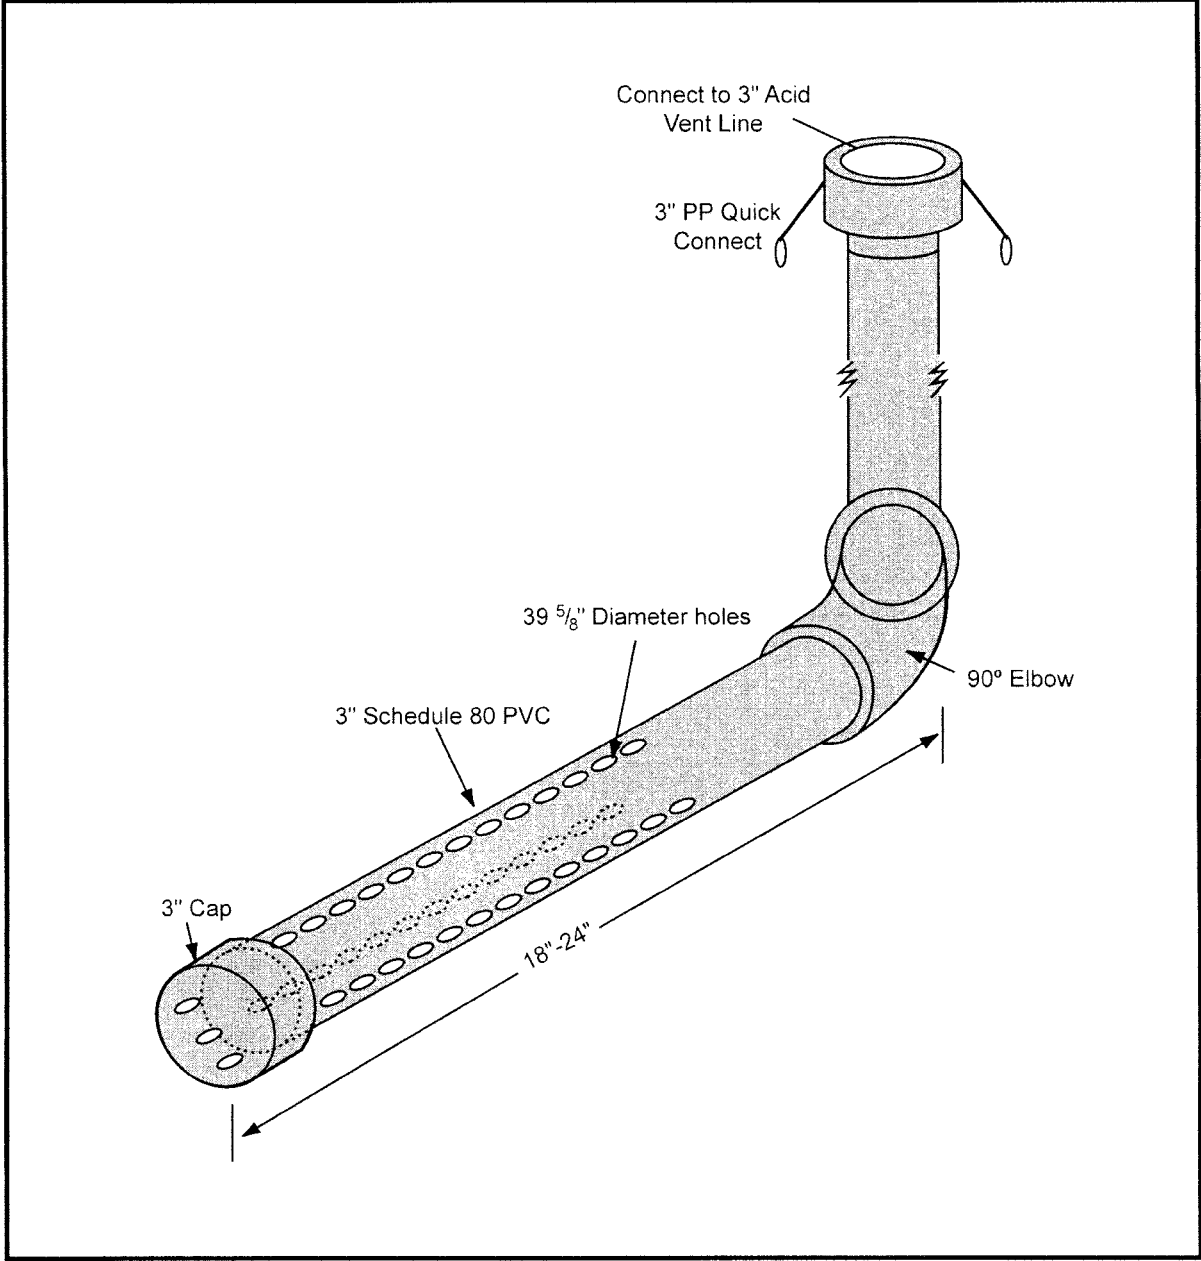
Figure 3: Diffuser Section of Vent System
(not to scale)

Inadequate maintenance permitted the diffuser section to become clogged with solids, further reducing the scrubber's capacity to vent the pressure buildup in the HCl tank. Surpass had no written procedure for maintaining or inspecting the scrubber system. Maintenance procedures would have been improved by developing detailed procedures for testing and adjusting the scrubber solution-- including the frequency of tests, the parameters (pH, specific gravity, etc.) to be measured, and the acceptable range of those parameters. Maintenance results should be documented in order to provide a historical basis for revising the procedures.

Surpass and other facilities should maintain environmental control systems to ensure continuous reliability and effective operation. Based on the system design, the known failure history, and engineering judgement, Surpass and similar facilities should evaluate how long the scrubber solution can be used before it needs to be replaced; develop detailed procedures for inspecting, testing, and adjusting the scrubber solution-- including the frequency of tests, the parameters (pH, specific gravity, etc.) to be measured, and the acceptable range of those parameters; and establish control mechanisms to ensure that preventive maintenance is performed correctly. Maintenance procedures should be written. Maintenance results should be documented in order to provide a historical basis for revising the procedures.

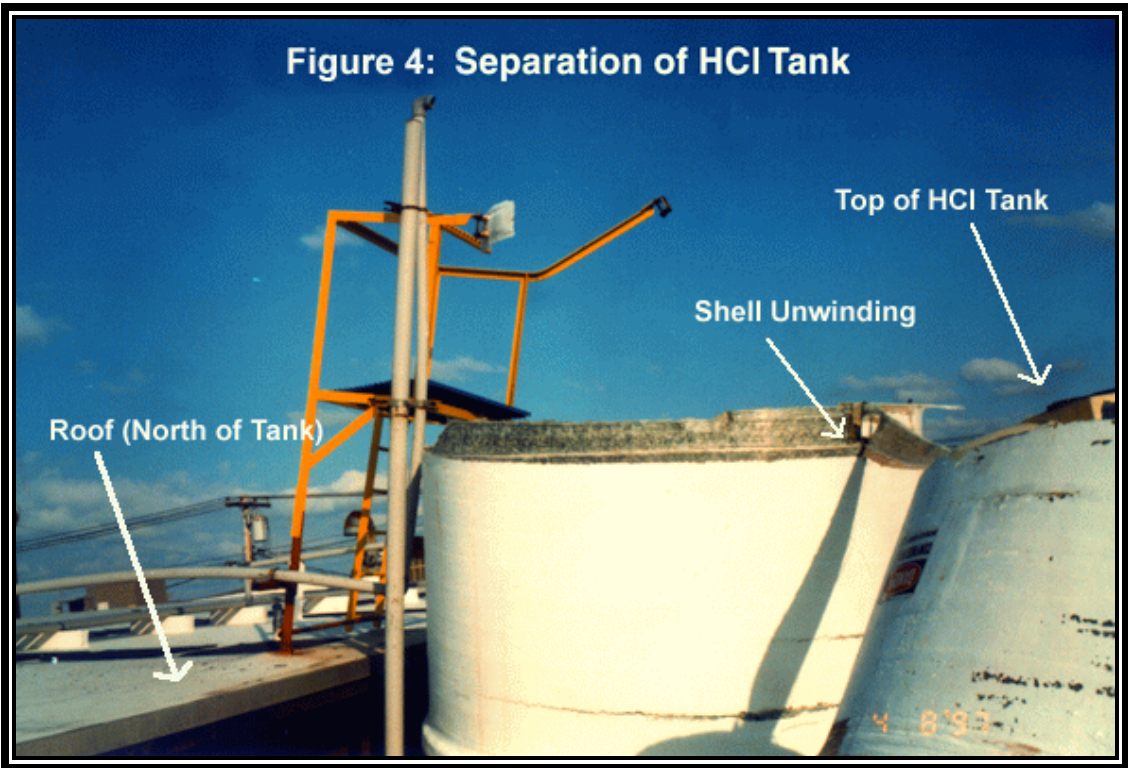
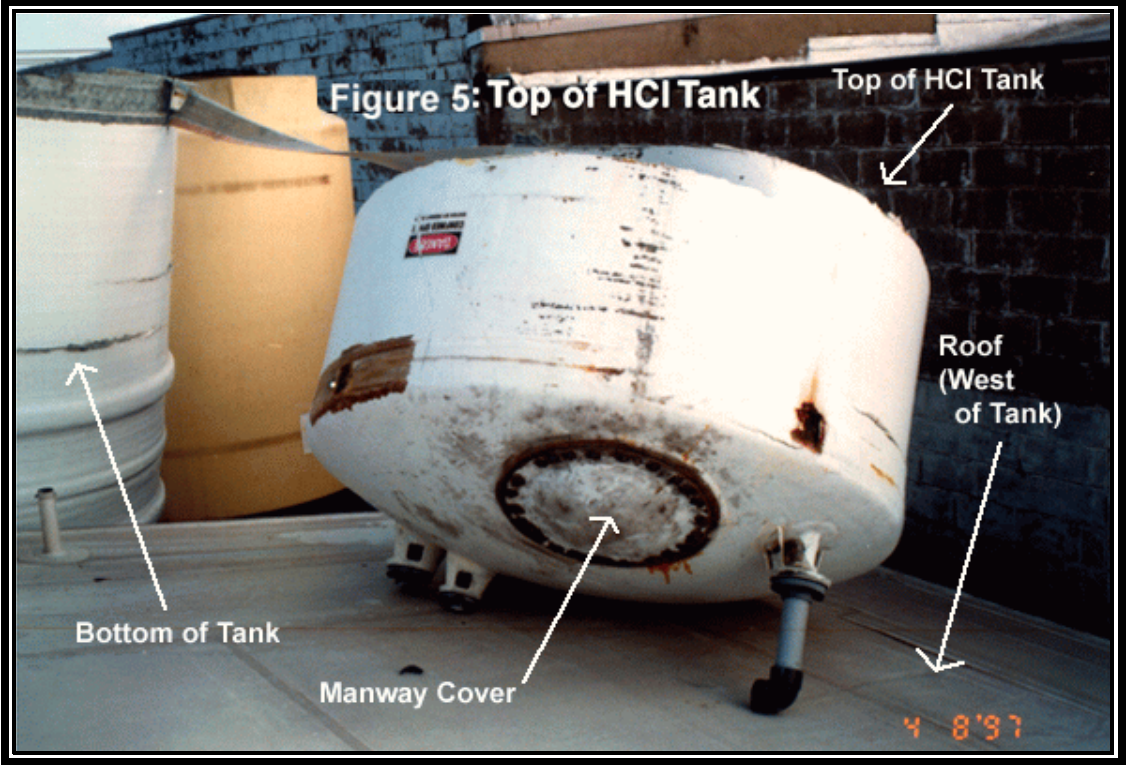
The HCl tank head separated at a point about 5 feet from the top of the tank and flew about 15 feet west to the roof of an adjacent building. **Figure 4** shows the separated tank after the incident, and **Figure 5** shows the top of the tank. The bottom of tank failed in the knuckle area where the cylindrical part of the HCl tank meets the flat bottom, as shown in **Figure 6**. The tank bottom remained on the platform. The cylindrical part of the fiberglass shell began to unwind itself at the top edge (see **Figures 4 and 5**). The shell also remained on the platform but collapsed, leaning toward the west building wall (see **Figure 6**). The scrubber tank was not affected by the tank failure; it was found intact in its original position after the incident, as shown in **Figure 7**.

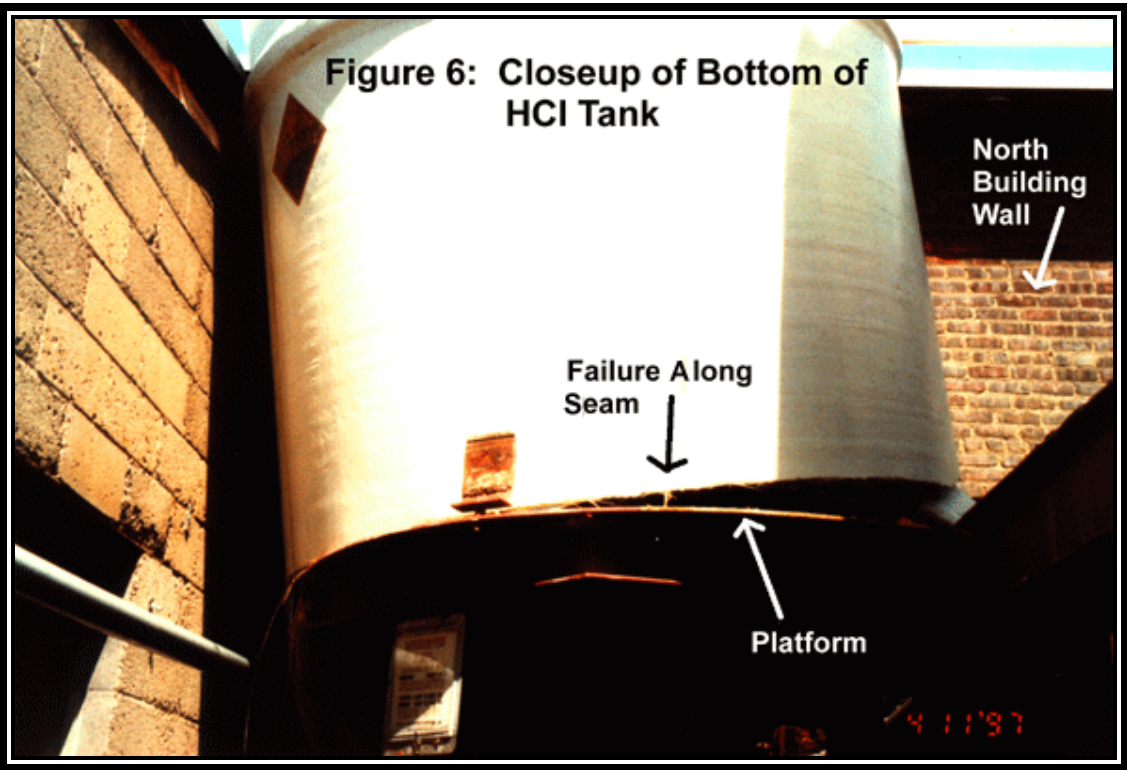
- The HCl tank ruptured into three pieces, as described in Section 3.2.
- The manway on the tank top was sealed shut, and the only way for vapor to escape from the tank was through the vent line. (See **Figure 7**.)

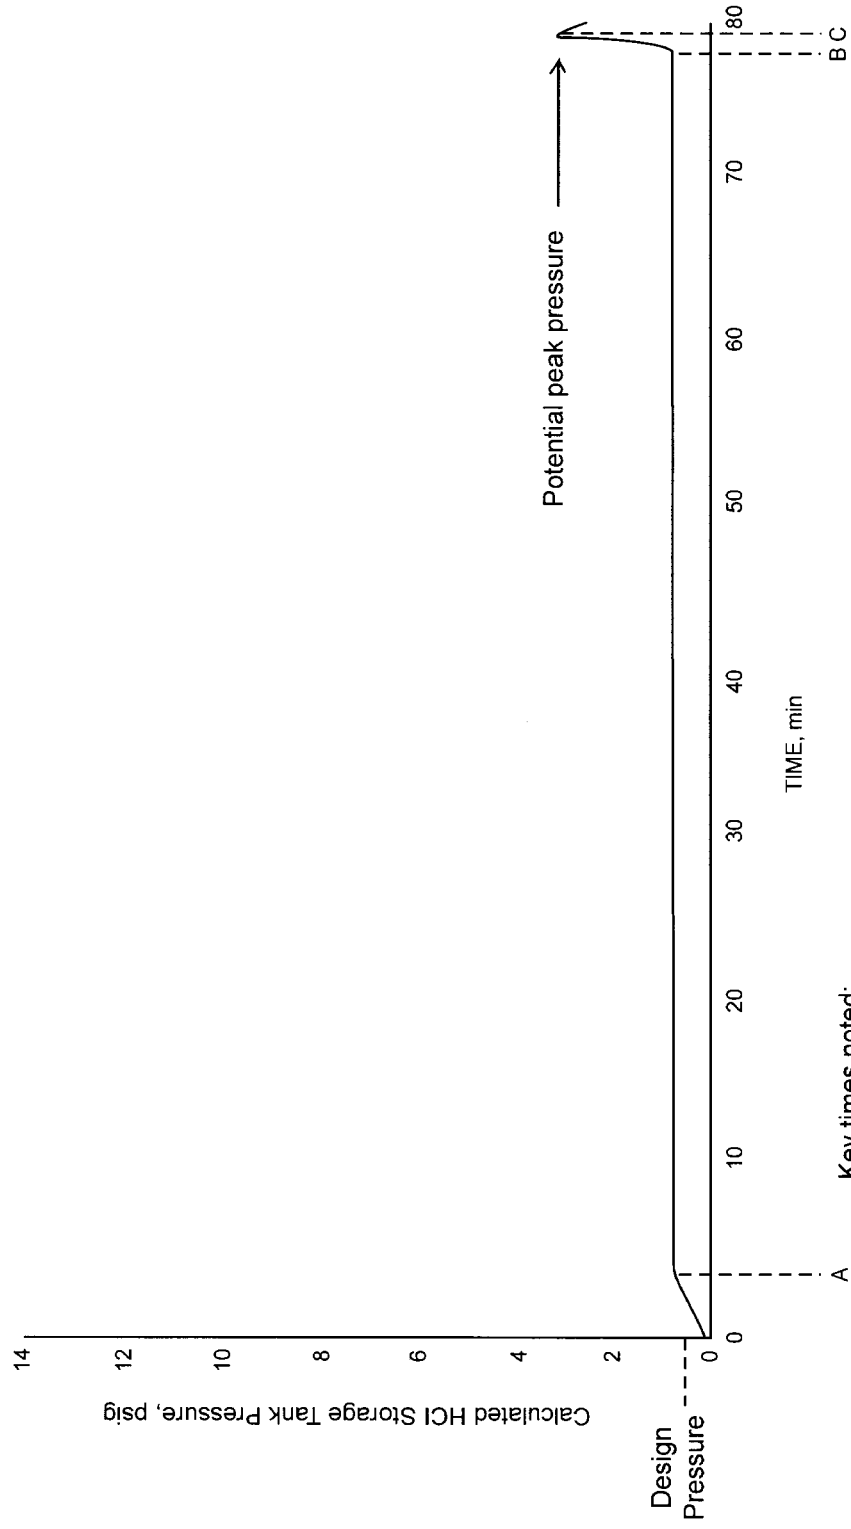
Figure 10
 Modeled HCl Storage Tank Pressure
 Scenario: No Fouling of Diffuser Openings

The exact pressure that caused the tank failure was not estimated. Because FRP composite structures are not homogenous; the design and manufacture of tanks varies with the manufacturer; and the original design calculations were not available, the exact pressure at which the tank would have failed cannot be readily predicted from the known facts. The modeling of the pressure profile in the HCl tank predicted a peak pressure of 3.4 psig during the off-loading, under normal operation of the scrubber. Although this predicted value is significantly above the design specifications of the HCl tank, the prior use of the tank in this service indicates that it did not exceed the yield point for the tank. Additionally, the diffuser was found to be plugged, potentially raising the pressure to 12 psig, well beyond the normal operation peak.

Key times noted:
 A - HCl storage tank pressure exceeds hydrostatic pressure of solution in scrubber tank.
 B - Pressurized air from truck's cargo tank flows into HCl tank.
 C - Potential peak pressure as modeled for scenario.

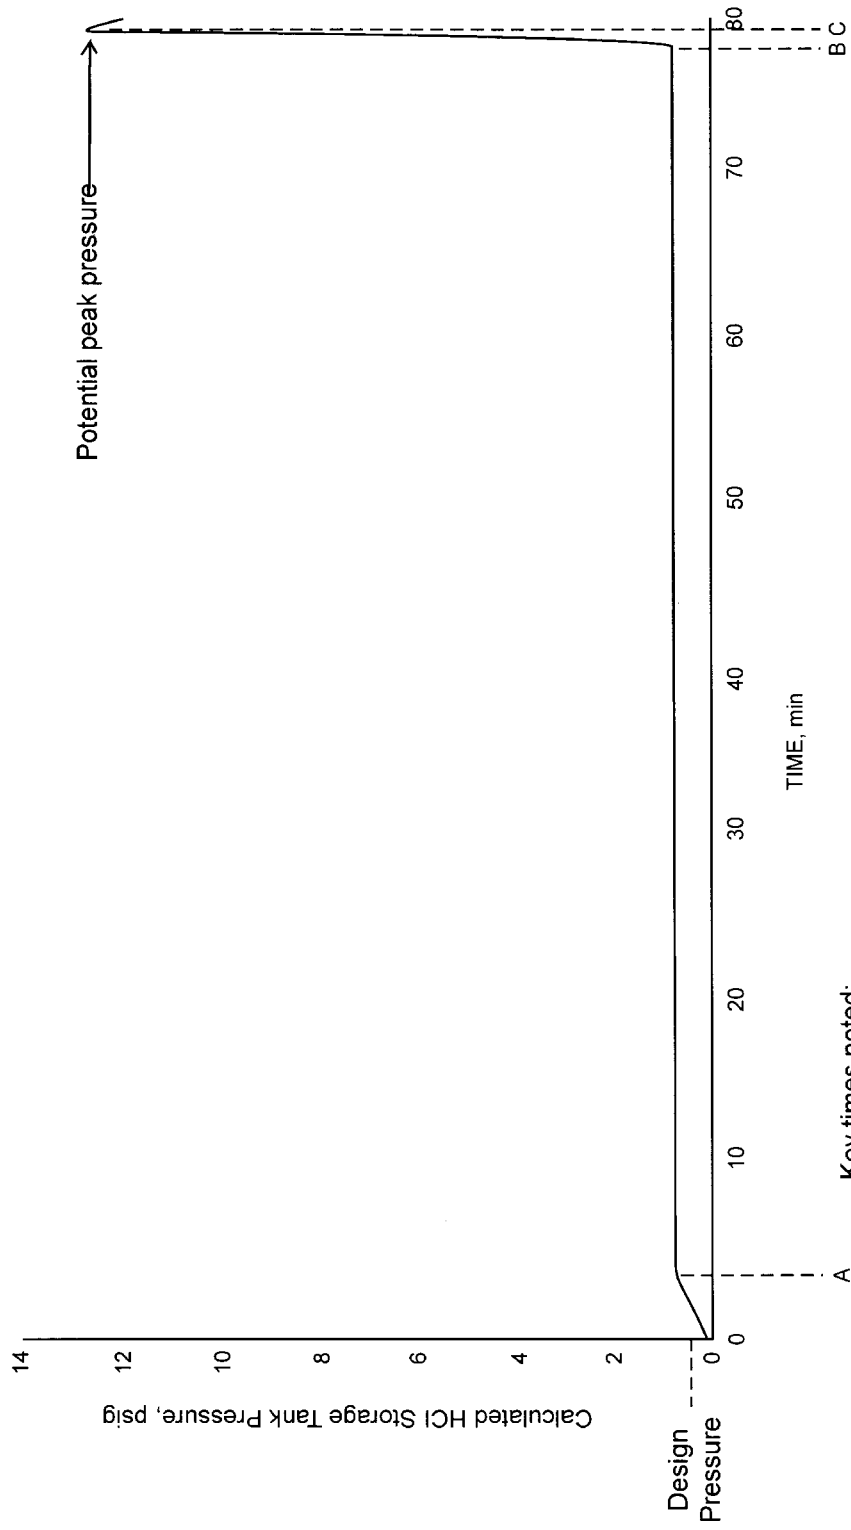
Figure 11
 Modeled HCl Storage Tank Pressure
 Scenario: 84% Fouling of Diffuser Openings

Key times noted:
 A - HCl storage tank pressure exceeds hydrostatic pressure of solution in scrubber tank.
 B - Pressurized air from truck's cargo tank flows into HCl tank.
 C - Potential peak pressure as modeled for scenario.
