MECHANICAL DAMAGE: HOW BIG IS THE PROBLEM ? A EUROPEAN PERSPECTIVE

Mechanical Damage Workshop: February 29th, March 1st, 2006

Dr. Murès ZAREA, Gas Facilities Development Manager

Gaz de France R&D Division

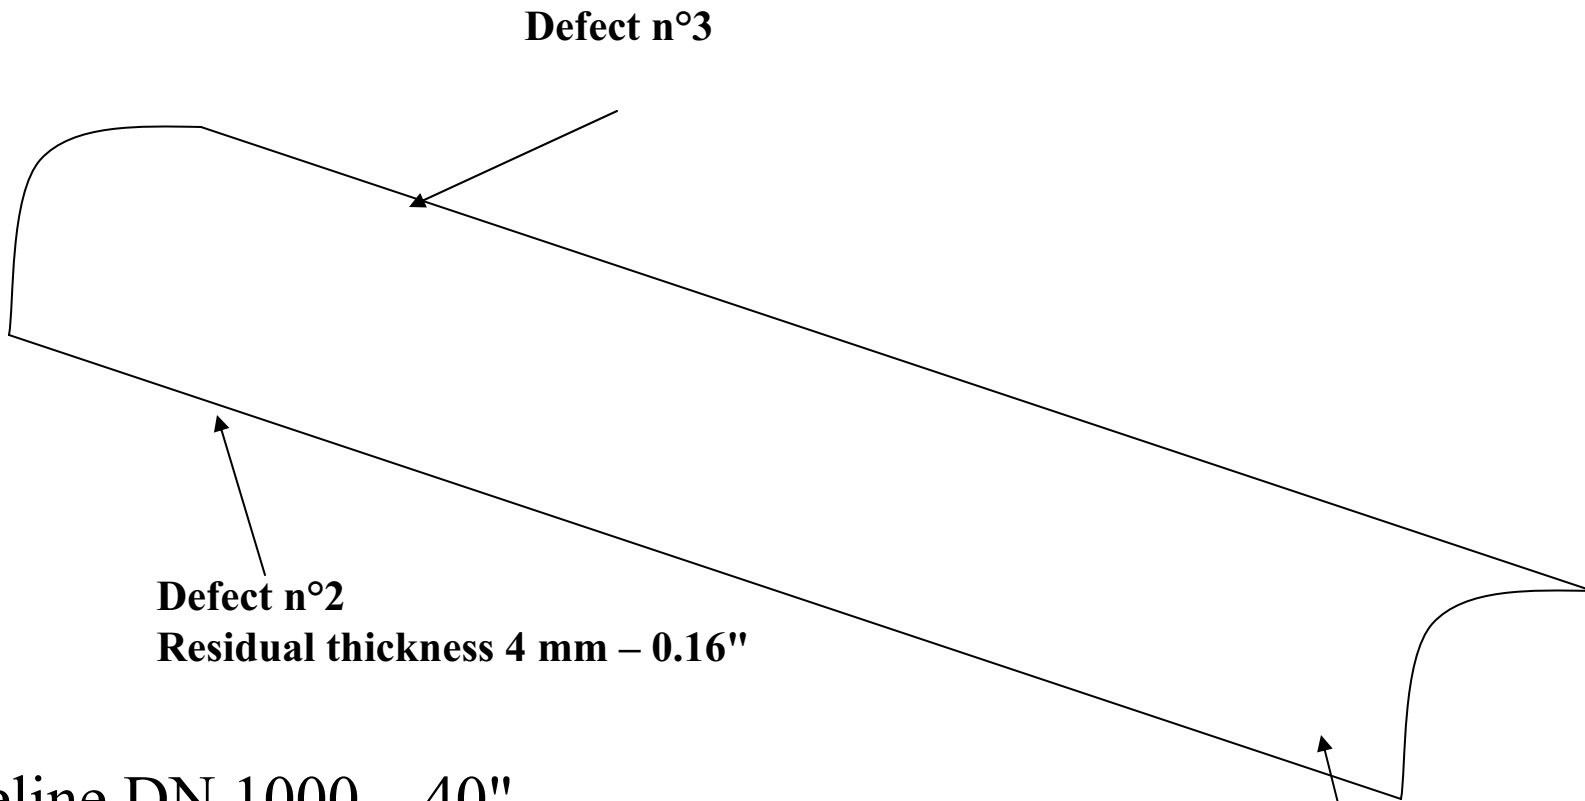
Defects on piece of broken pipe

Defect n°2
Residual thickness 4 mm – 0.16"

Pipeline DN 1000 – 40"
Wall Thickness 12.7 mm – 0.5"
Piece 11 m – 36 ft long
Weighs about 6 tons

Defect n°1

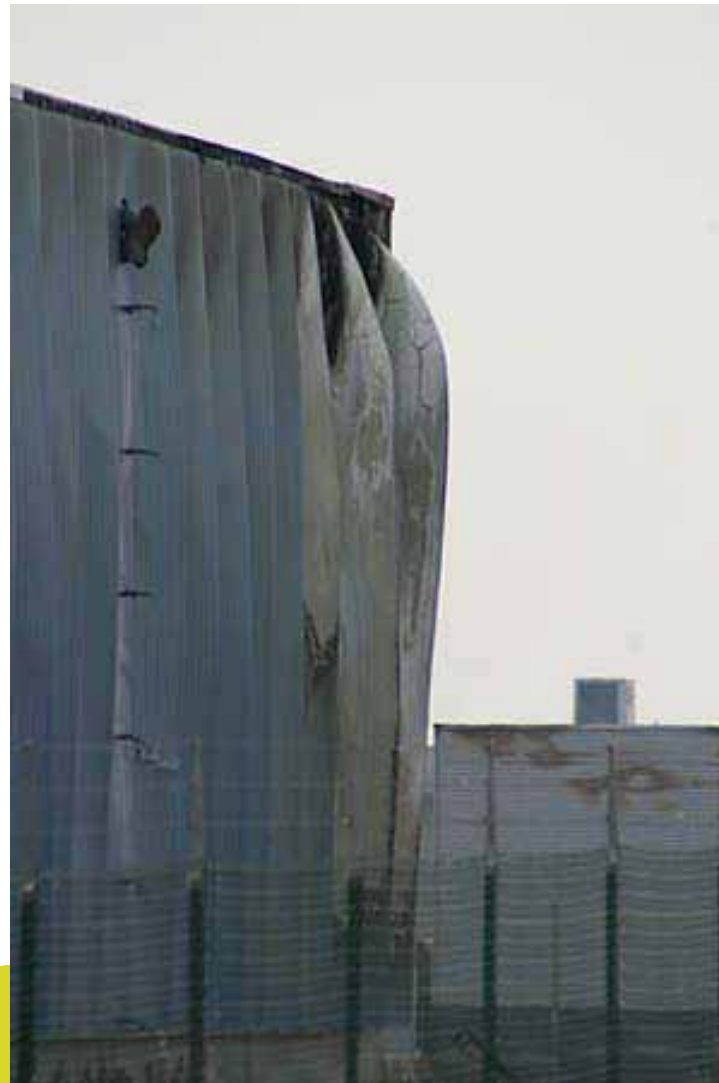
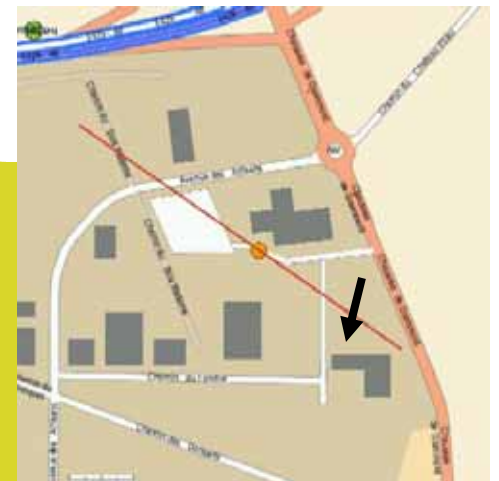
Deformation of building structure @ 150 m to south east of crater

- Two factories burnt
- Metallic structure deformed on nearby building
- Several cars burnt within 150 m – 492 ft
- Vehicle plastics meltdown within 400 m – 1312 ft

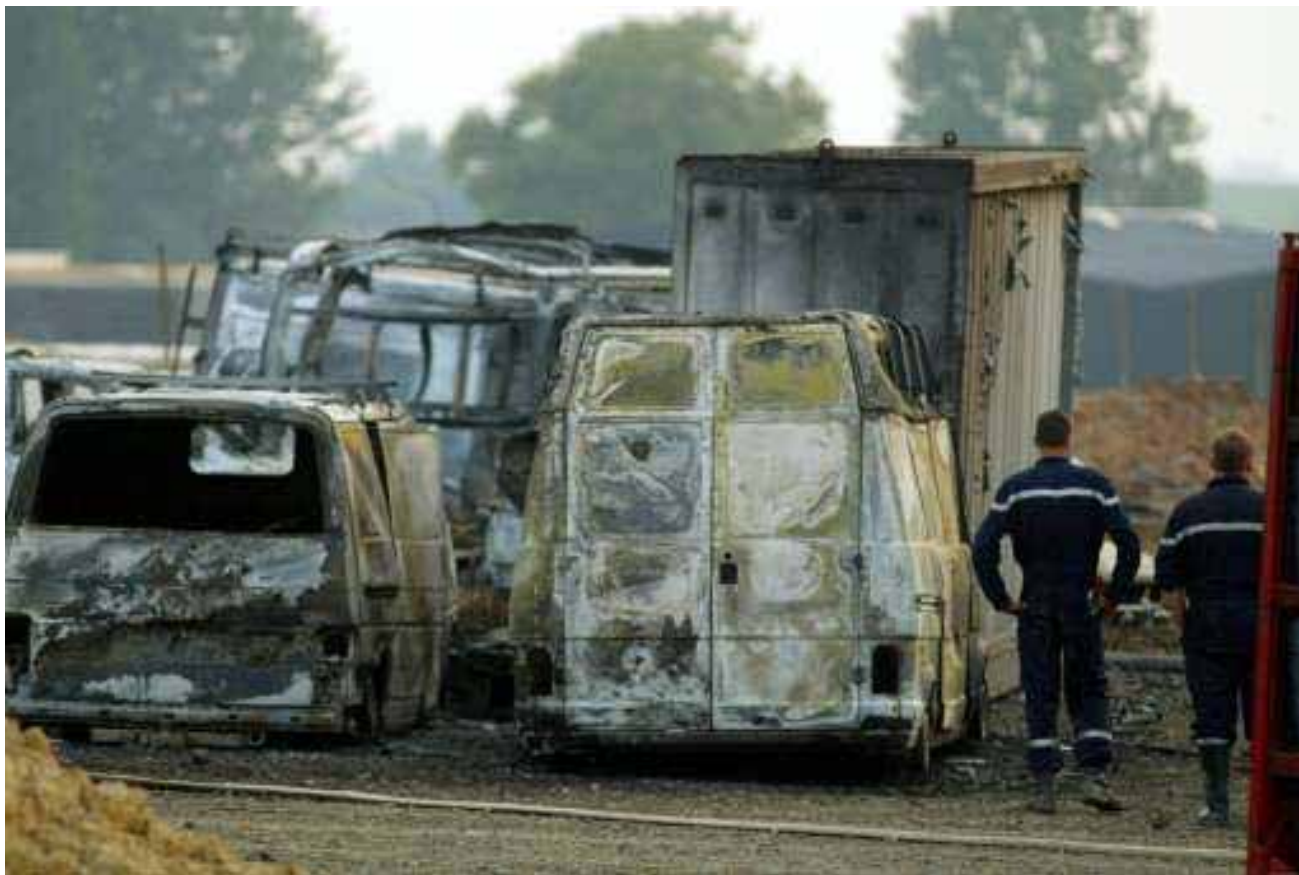
Burnt down vehicles (not localized)

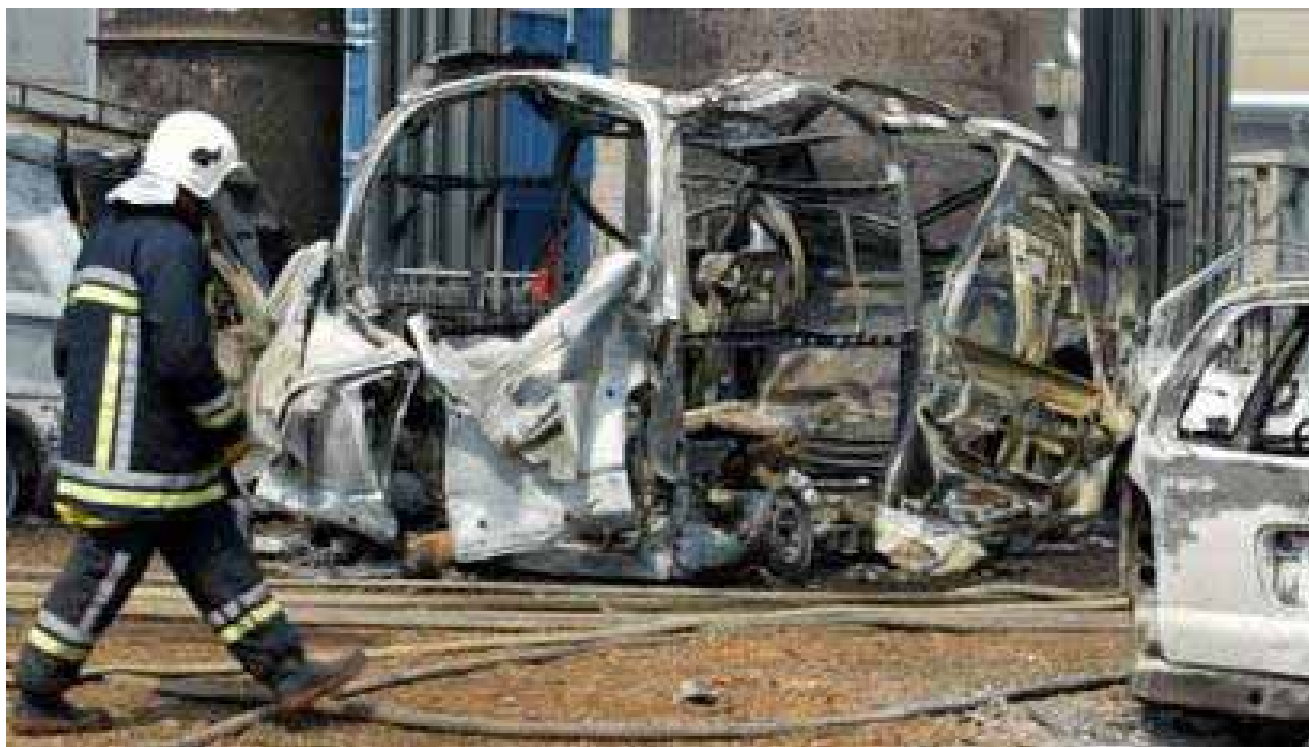
Burnt down vehicles (not localized)

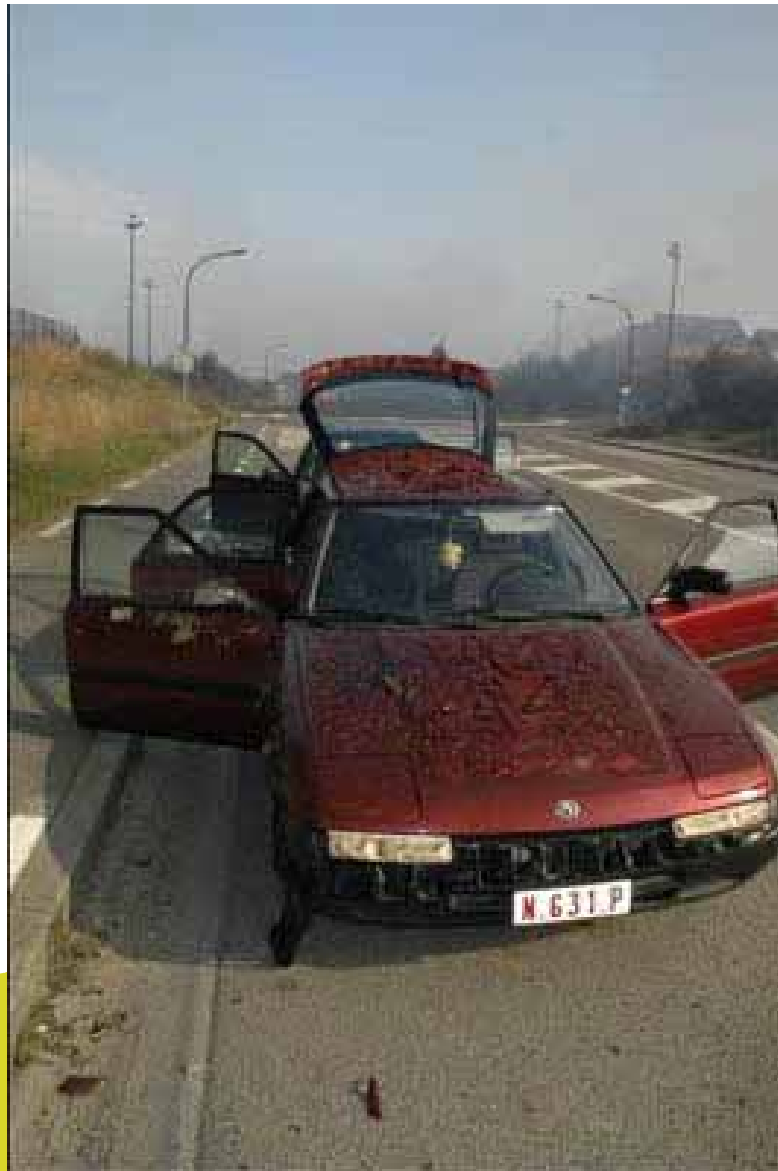
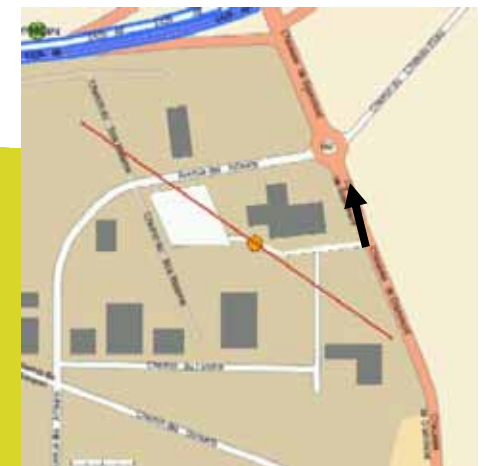
Damaged vehicle : molten plastics and blistered paint (@ 160 m – 524 ft towards north east)

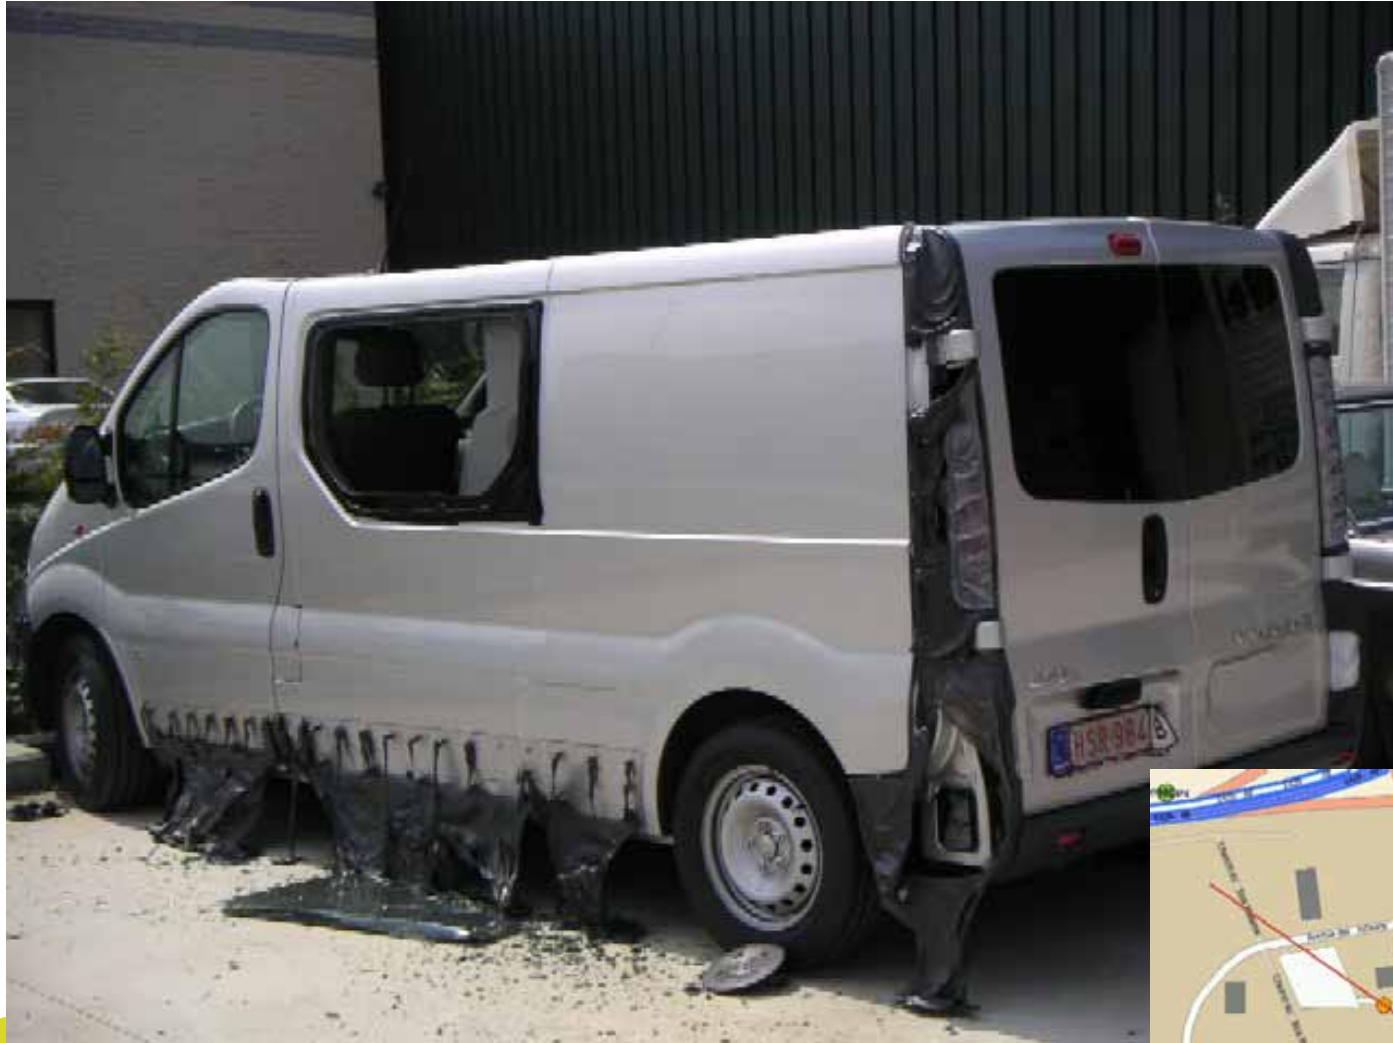
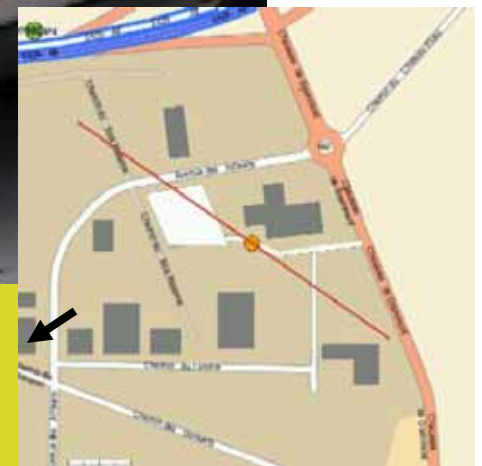
Damaged vehicle : molten plastics (@ 400 m – 1312 ft towards west)

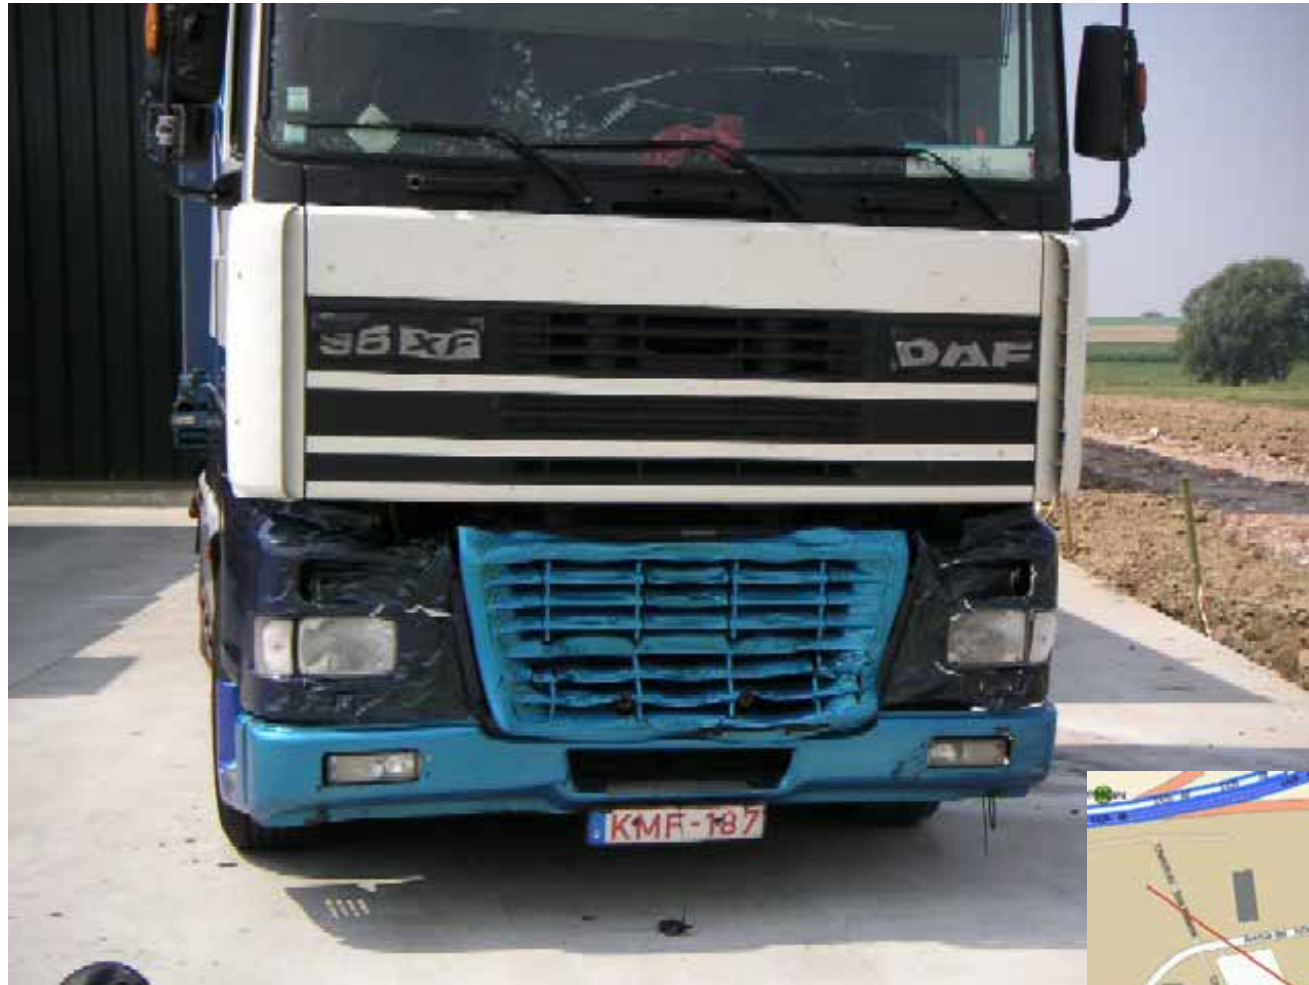
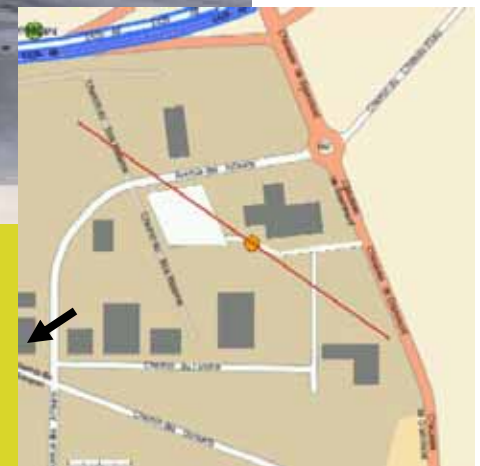
Damaged vehicle : molten plastics (@ 400 m – 1312 ft towards west)

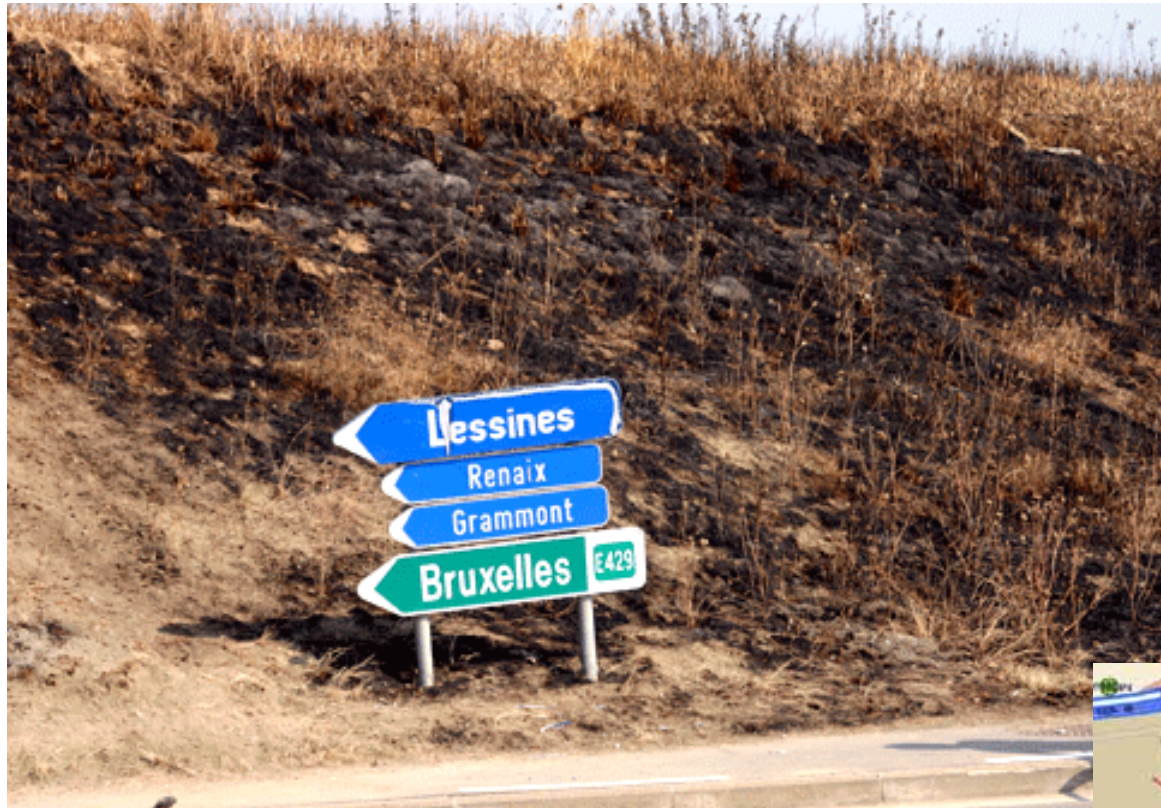
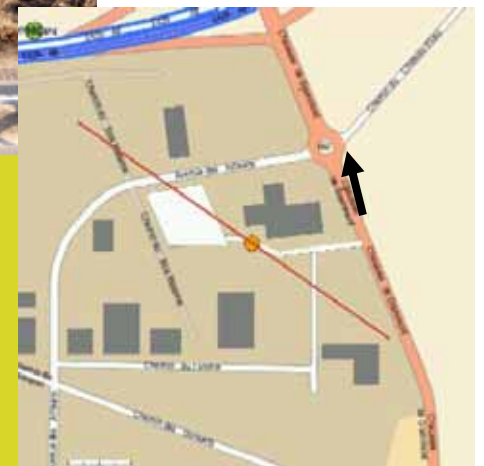
Burnt vegetation

➤ **Burnt vegetation within 250m – 820 ft**
