**HETA 98-0027-2709**  
**Stericycle, Inc.**  
**Morton, Washington**

**Health Hazard Evaluation Report 98-0027-2709**  
**Stericycle, Inc.**  
**Morton, Washington**  
**October 1998**

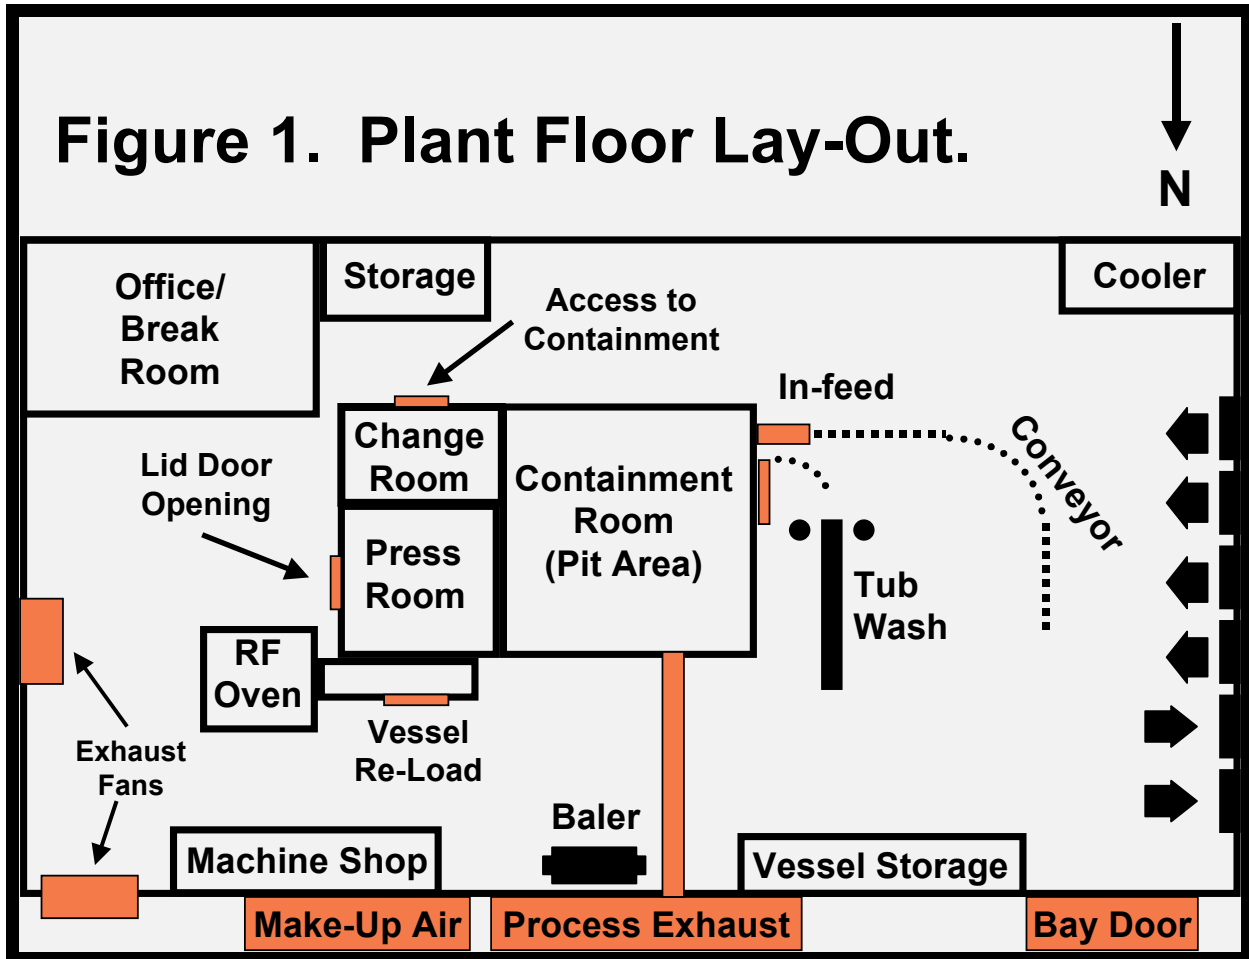
# Figure 1. Plant Floor Lay-Out.

From May through September 1997, three cases of active TB were reported to the Lewis County Health Department. All cases were current or recent former employees of the Morton Stericycle facility. Drug susceptibility testing for the three cases indicated that each case had a different susceptibility pattern, including one case of multidrug resistant TB. The different susceptibility patterns indicated that person-to-person transmission of TB among the three cases was not possible. A contact investigation was performed and failed to identify any person-to-person sources of infection for these three cases. Further laboratory testing confirmed that one of the cases had a strain of TB which was the same as that from a person treated at a facility that sends waste to Stericycle.<sup>2</sup> The three employees with active TB had worked at the following locations: tub wash station, in-feed station, and press room (refer to Figure 1).
