# Historic Mills and Mill Tailings as Potential Sources of Contamination in and near the Humboldt River Basin, Northern Nevada

**USGS Bulletin 2210-D**

**Geoenvironmental Investigations of the Humboldt River Basin, Northern Nevada**

U.S. Geological Survey Bulletin 2210-D

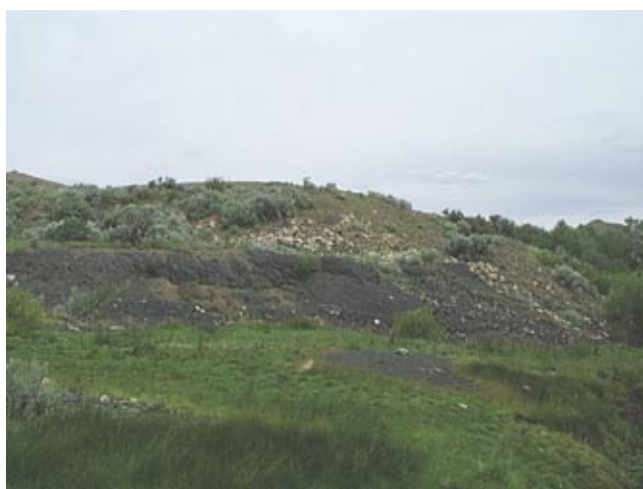
**Photograph 1.** These piles of black smelter slag are all that remain of the smelter at Bullion in the Railroad district. The smelter was located at a spring, about a mile east of the mines.

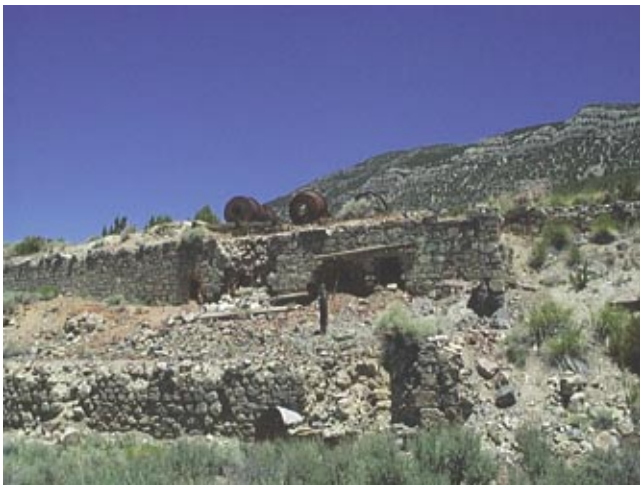
**Photograph 2.** This mill at Cortez is typical of older mills with its stone foundation and three levels. Newer mills in the 20th century were made with concrete foundations, and many had four to six levels.

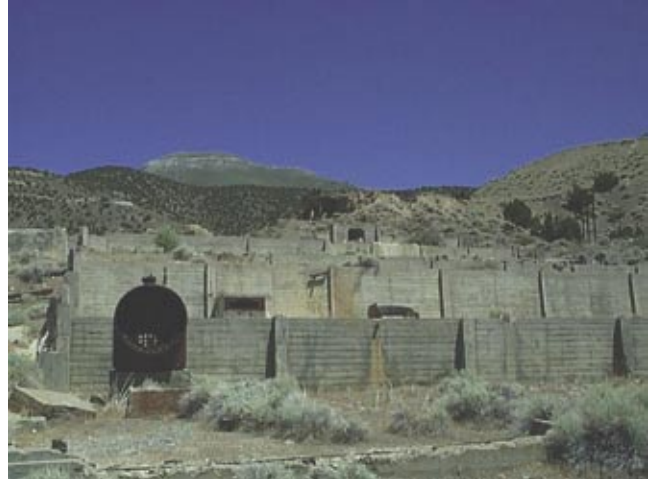
**Photograph 3.** This mill at Lower Rochester operated from 1913 to 1929 at about 150–300 tons/day. This relatively large mill utilized the best cyanide technology of the time. Concrete was used in foundations after about 1900.

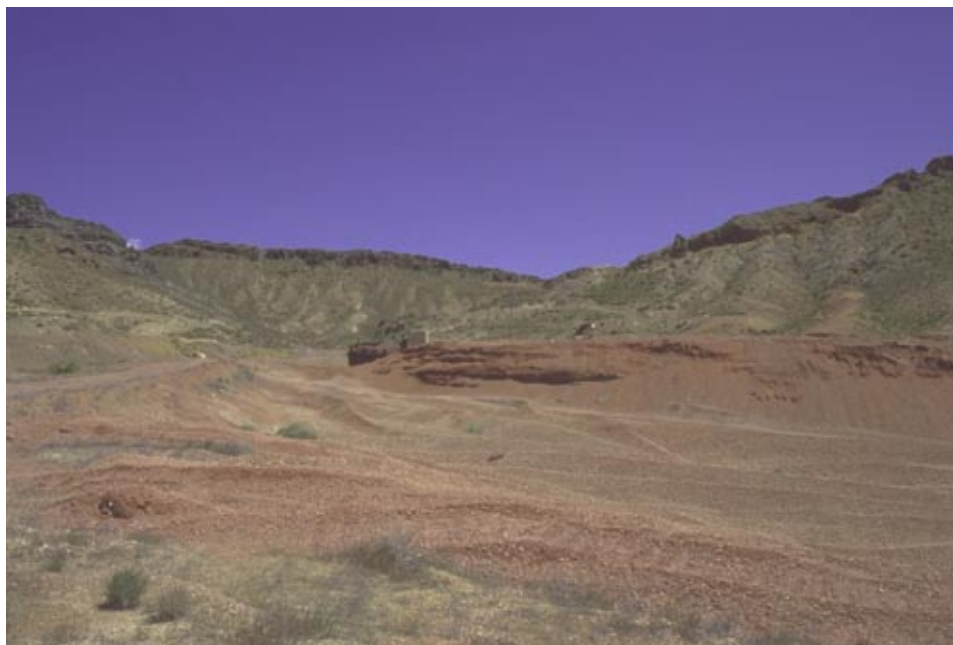
**Photograph 4.** Large piles of red calcine were created at the Pershing mercury mine, Antelope Springs district. Calcine can release significant amounts of Hg, As, and Sb.

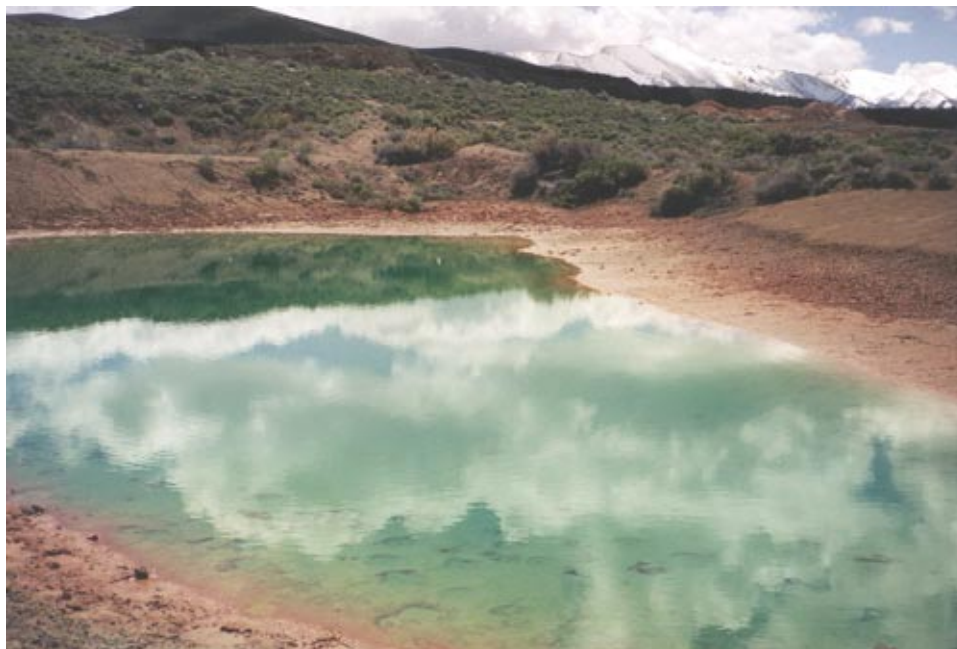
**Photograph 5.** A tailings pond at the Big Mike mine complex, dating to the 1930s, collects runoff for short periods of time. The combination of reactive tailings and evaporation creates acidic waters with extremely high metal concentrations.

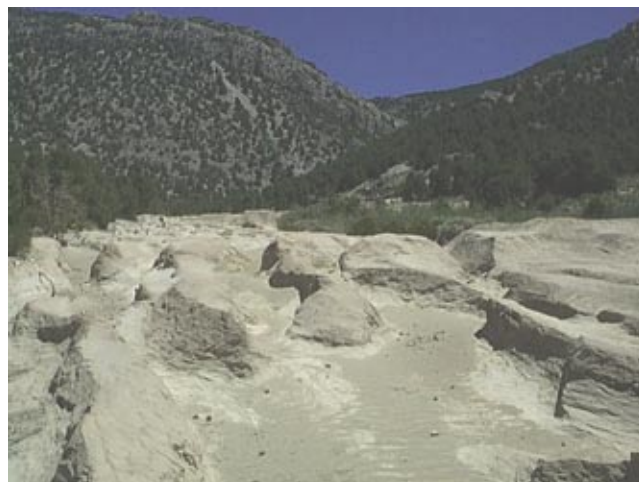
The Cortez tailings provide good lessons on what happens to tailings in Nevada. These tailings are highly eroded, with gullies 2 to 4 m deep (photograph 6), and the tailings now extend for 3 km down the wash (Nash, 2002a). There is evidence of two impoundments below the mill in which the operators piled wet tailings to a depth of 3 to 5 m. The operators used flumes with spigots to direct the slimes and sands to appropriate places; the dams were made from tailings sands with some boards. The dams have been breached on one or more occasions. The 1980s haul road has acted as a dam about 3 m high, and it too has been eroded by stormwaters, as shown by repairs made in recent years. The downslope tailings surround mature pine trees, and have killed some; the large trees must have been growing before the tailings were deposited. The materials to the west are stratified, as in the ponds closer to the mill, indicating deposition from water; the extreme length of the tailings deposit suggests that they were not intentionally placed where they are now. I interpret this geometry as the result of erosion and downstream redistribution of tailings in extreme storm events. The bedding sequence in the fluvial tailings, with lower brown (coarse grained) middle gray (fine grained) and upper pink (fine) tailings is the same as in the impoundments, which can be explained only by a series of erosional events or dam failures.

**Photograph 6.** Tailings from the new (1920s) mill at Cortez were placed in a wash and now are deeply eroded. Fluvial tailings from one or more major storm events have been carried 4 km to the west.

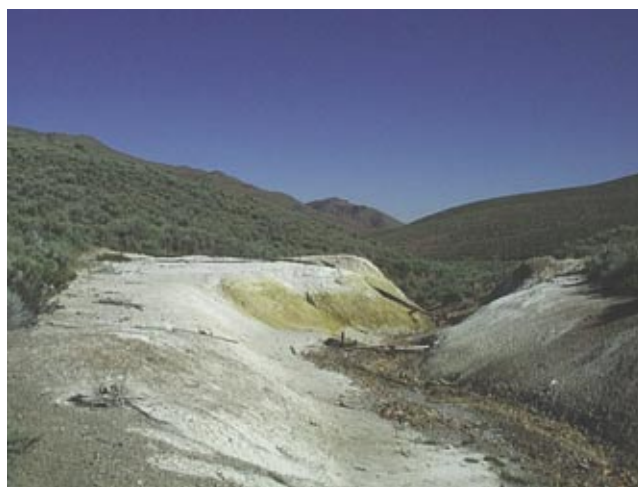
**Photograph 7.** Tailings from the Hilltop mill were placed in the canyon across from the mill with no regard for the small creek, which has eroded through the dam. This was standard practice through 1935, when the first regulations were established for tailings disposal.

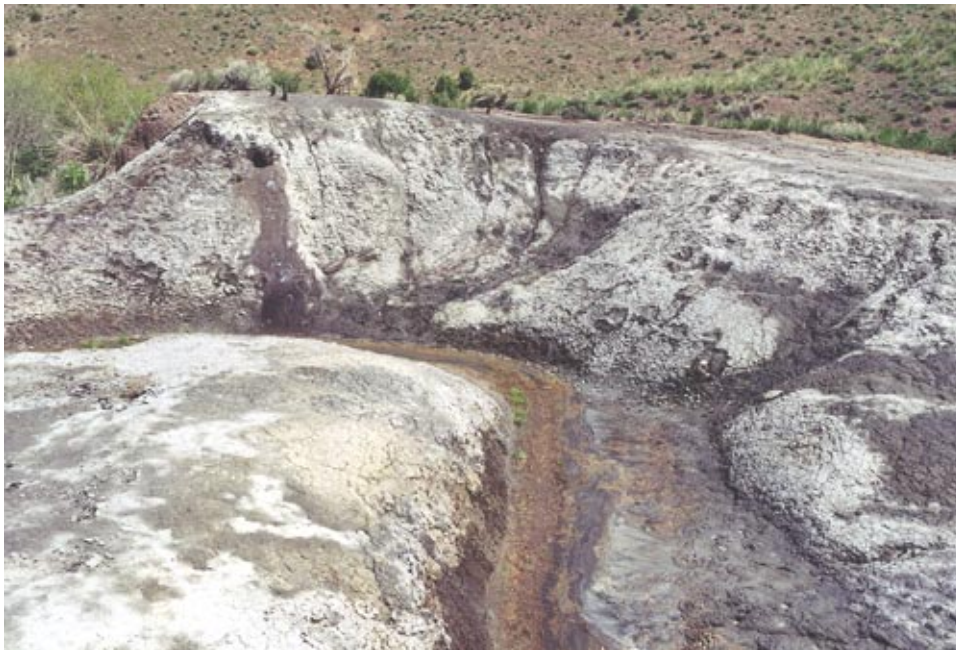
**Photograph 8.** Tailings from the Rip Van Winkle mill were placed in Coon Creek, which has small flow for part of the year. This view shows the white sulfate mineral crusts that form on the dried surface of these sulfidic tailings and a thin band of red coloration at the edge of the water. The red colors from iron are produced when acidic, metal-rich pore waters seep from the tailings and mix with the circum-neutral-pH waters of the creek.

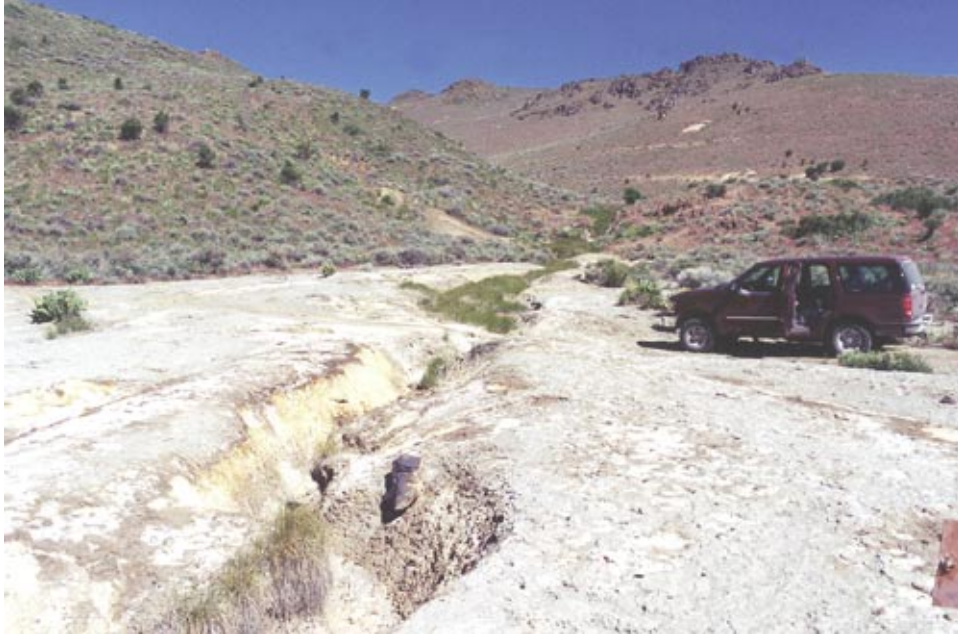
**Photograph 9.** Tailings from the Leadville mine were placed in the canyon east of the mill in the 1920s and have been eroded by numerous storm events. The white color is from sulfate mineral crusts on the surface of gray and ochre sulfidic tailings.

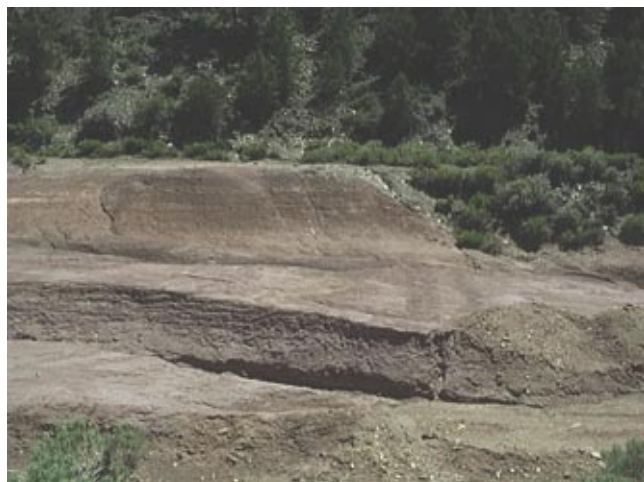
**Photograph 10.** This was one of the smaller tailings ponds below the White Caps mill at Manhattan. The dam, about 3 m high, was breached and most of the tailings eroded in one or more storm events.

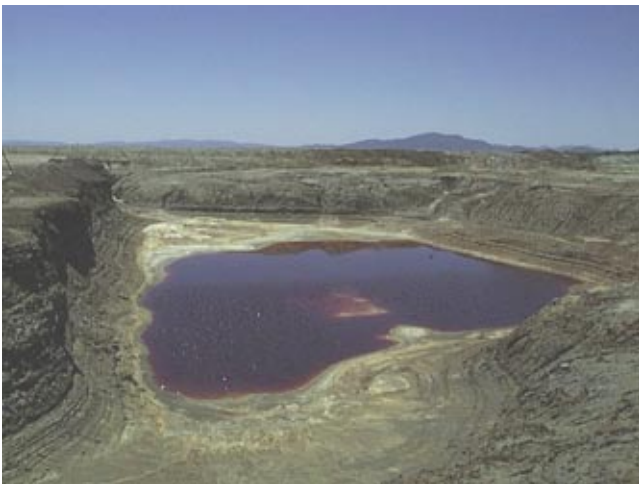
The Caselton tailings appear to be a prime example of bad tailings-disposal practices into sites that are subject to reaction and erosion in storm events. Here, however, the situation is ameliorated by hardpan that appears to minimize permeability and erosion in stormwaters. The extent of chemical reactions in stormwaters is more variable here than in most districts. In some places, the low apparent permeability caused by clays and hardpan appears to negate the potential for acid generation and release of metals suggested by leach tests and chemical compositions. Some ponds do not develop the Fe-Mn hardpan, possibly due to a difference in composition, and these seem to generate more acid. The highly acidic waters in trenches on one pond may develop from a distinct ore composition that was rich in both sulfide minerals and clays. Extensive studies are needed on the chemical reactivity of various tailings piles in storm events, the physical stability of the piles, and the flowpaths of contaminated waters, before planning reclamation that will be effective.

**Photograph 11.** A trench in the large tailings impoundment at Caselton collects and retains surface runoff. The sulfidic tailings create acidic, metal-rich waters that are further enriched by cycles of evaporation. Native sulfur crusts on the surface are a reactive source of sulfuric acid.

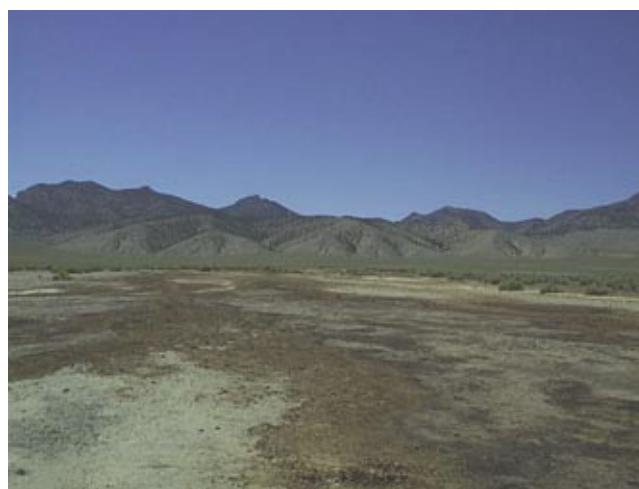
**Photograph 12.** This swath of ocher materials that will not support vegetation is fluvial tailings, carried down Tybo Creek about 8 km from the tailings impoundment at the mouth of the canyon. The site shown here is near the terminus of the flood deposits where there is very low slope on the alluvial fan and virtually no channel for the ephemeral stream.
