U.S. Department
of Transportation
**Federal Highway
Administration**

February 1995

Maintenance of Pavement Underdrain System

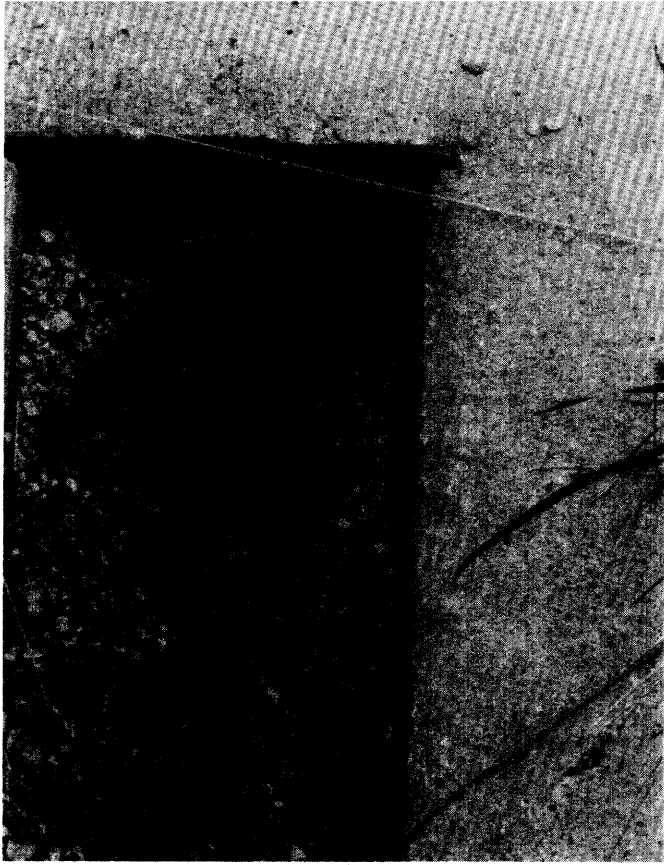
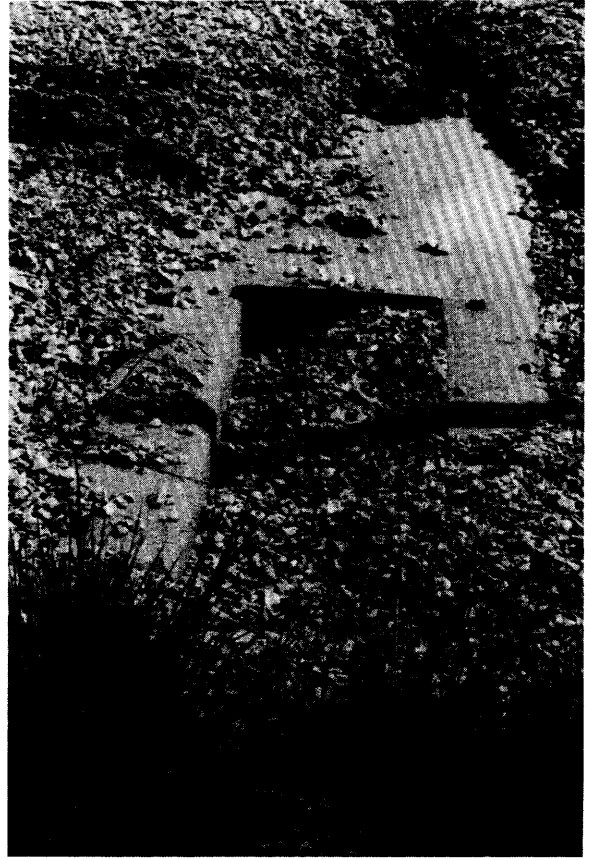
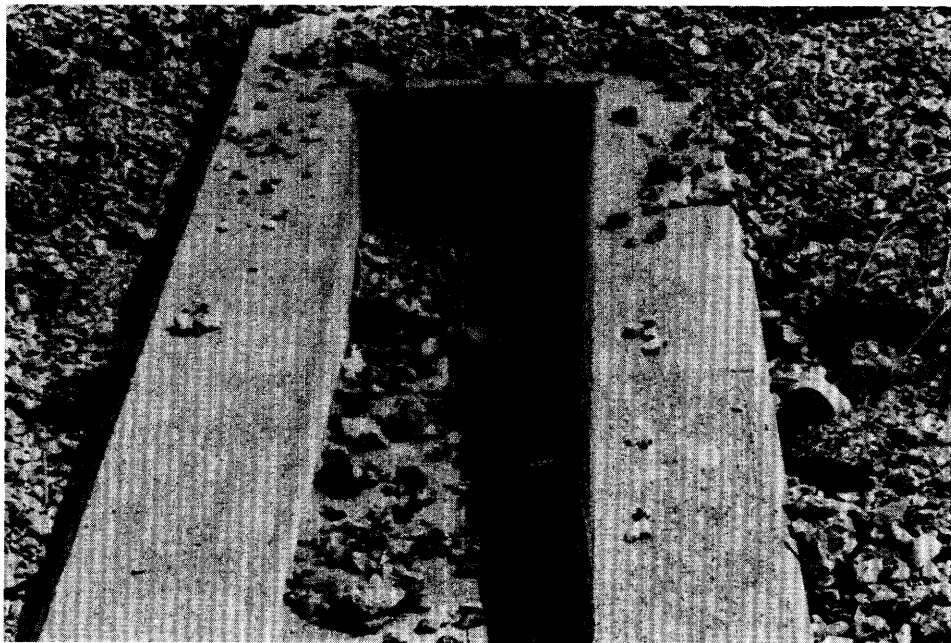
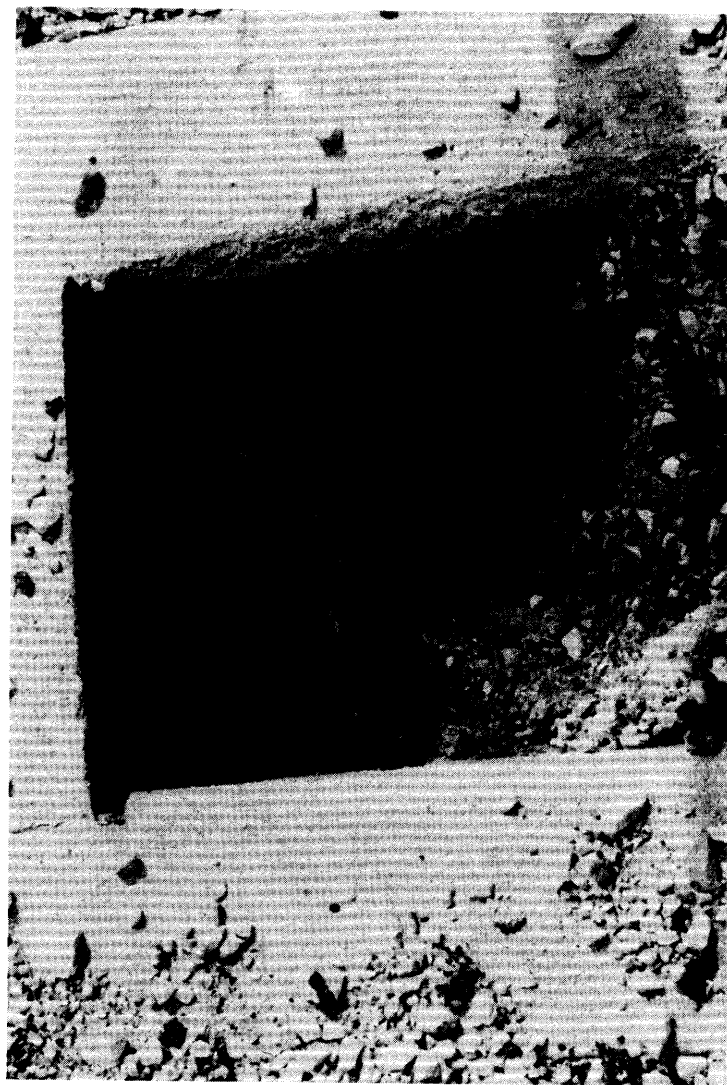
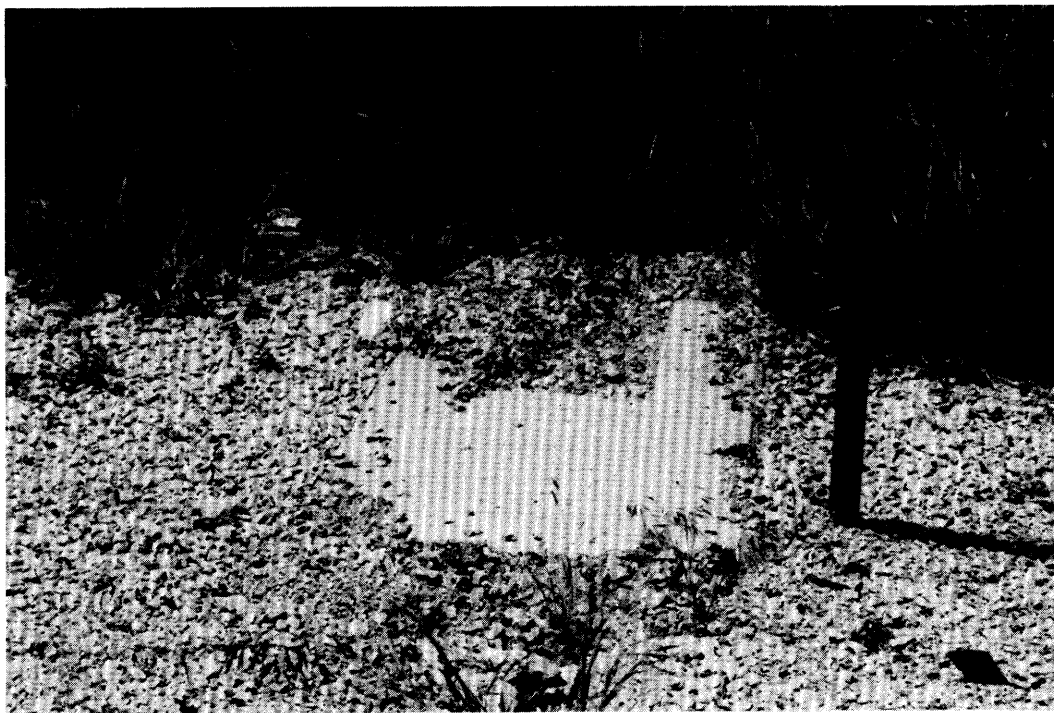
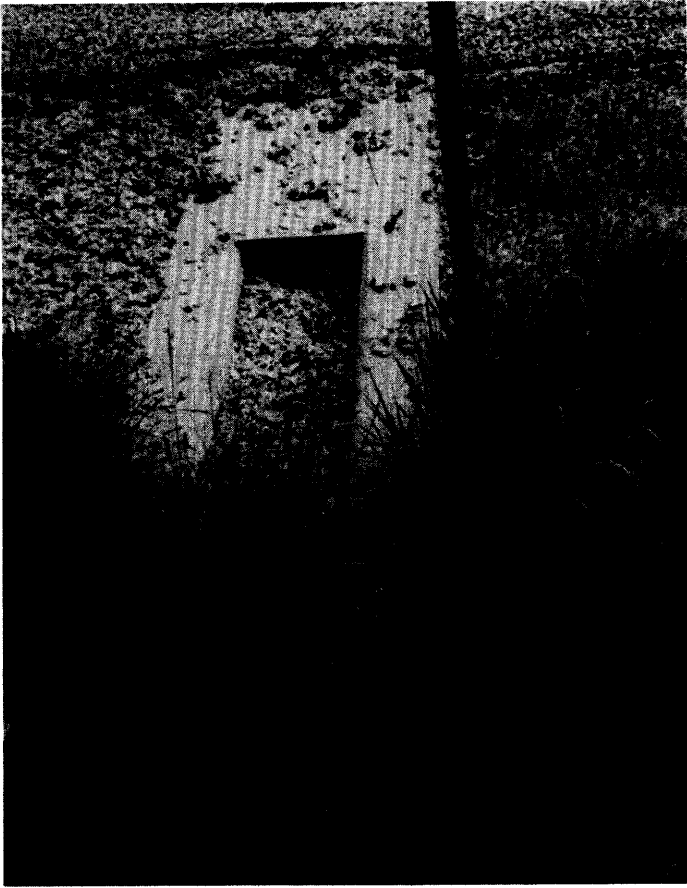
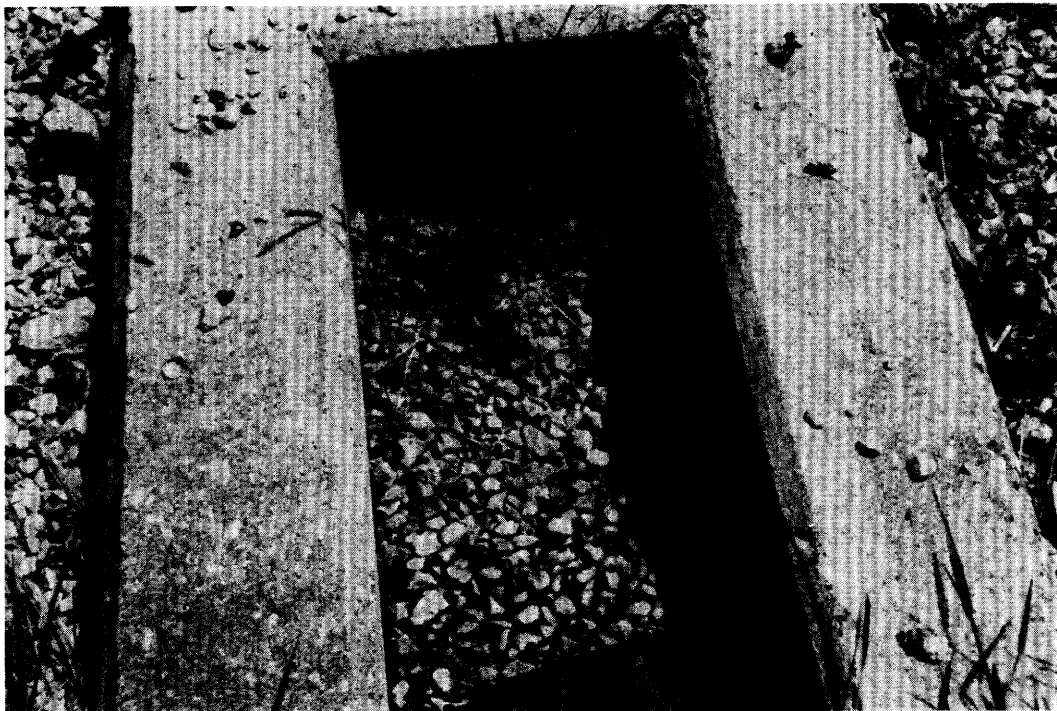
ROCK BLOCKING OUTLET

- **Rock Blocking Outlet, Attachment A**
Crushed stone from the shoulders was found to be the most consistent and probable cause of the blockage. Occasional maintenance checks should have greatly eliminated this problem.

- Dense graded aggregate and/or chip seal aggregate from the shoulder had filled numerous troughs resulting in the pipes becoming totally clogged.

It is recommended that a list of locations of headwall troughs prone to blockage be kept so frequent checks are assured.

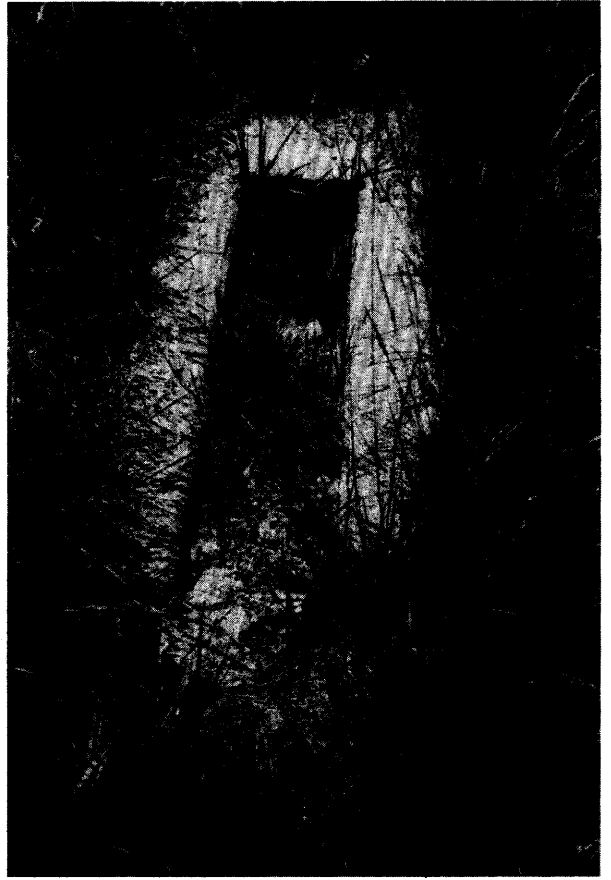
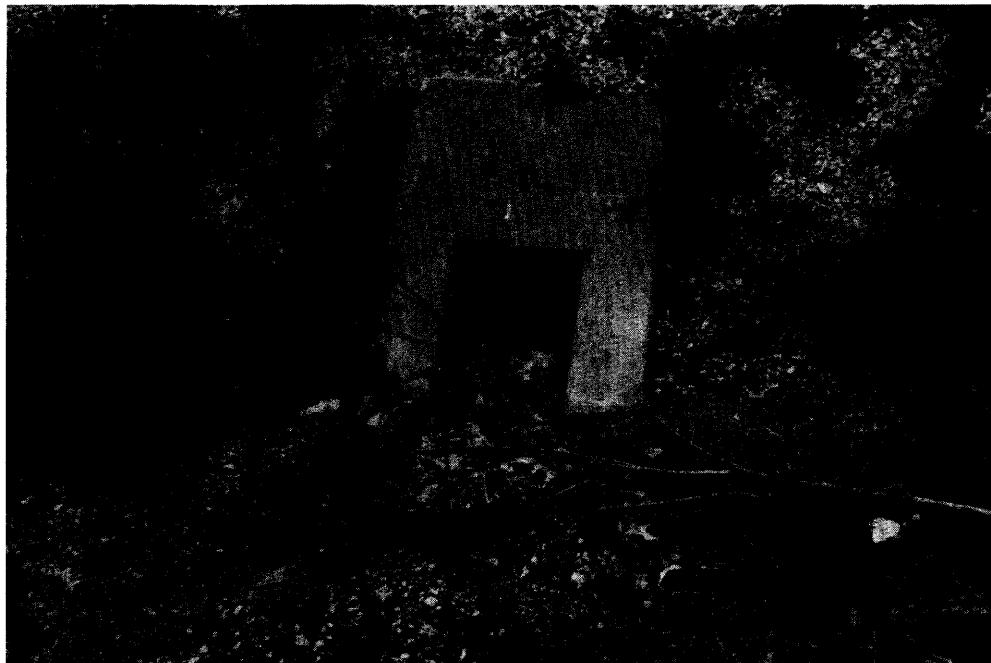
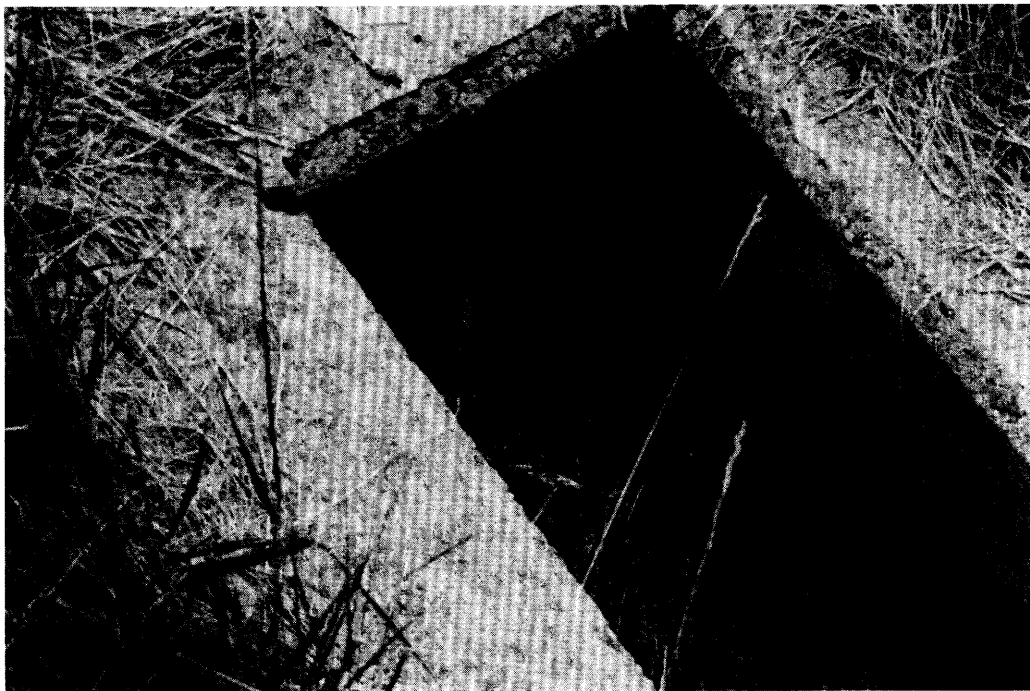
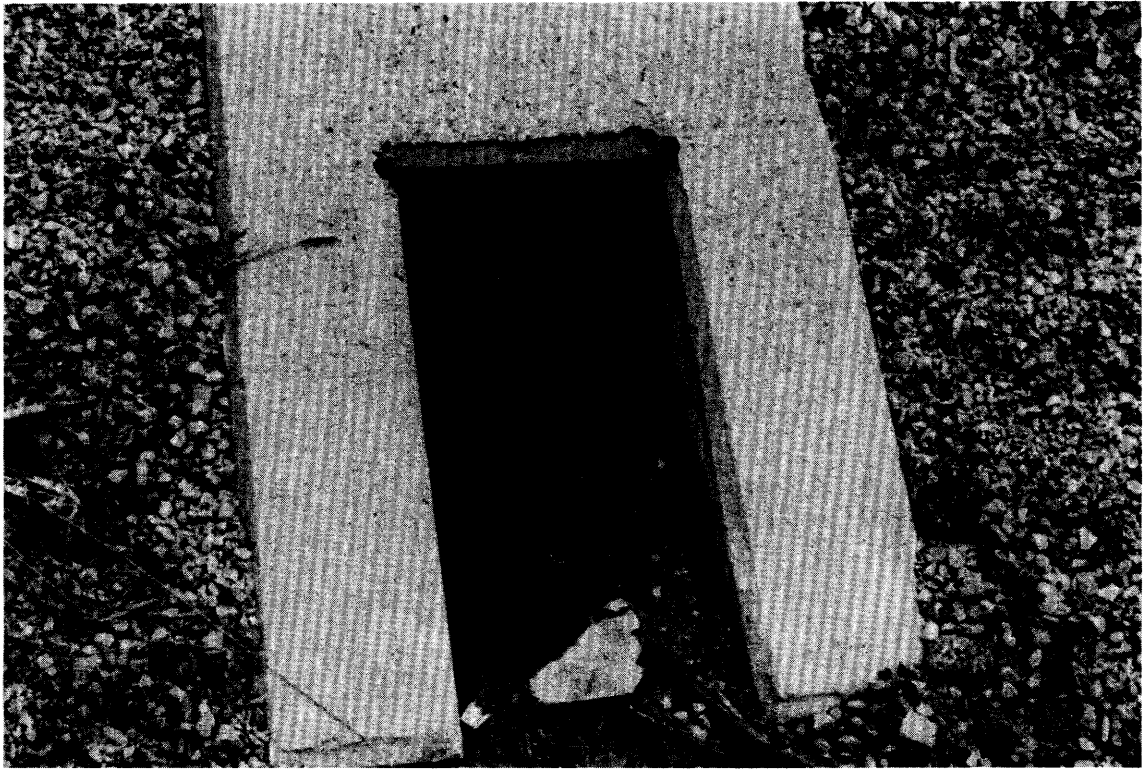
SILTED HEADWALL TROUGHS

- **Silted Headwall Troughs, Attachment B**
Partially blocked headwall troughs allowed silt to build-up in the troughs preventing silt from being washed through the trough. Some large cut sections have ditches filled with material possibly completely covering the headwalls.

- There were numerous headwall troughs completely full and many more partially filled from sediment.

It is recommended that the design for underdrain pipe headwalls be revised to have the pipe outlet above the headwall apron to allow for some sediment, if routine maintenance is expected to be haphazard and infrequent.

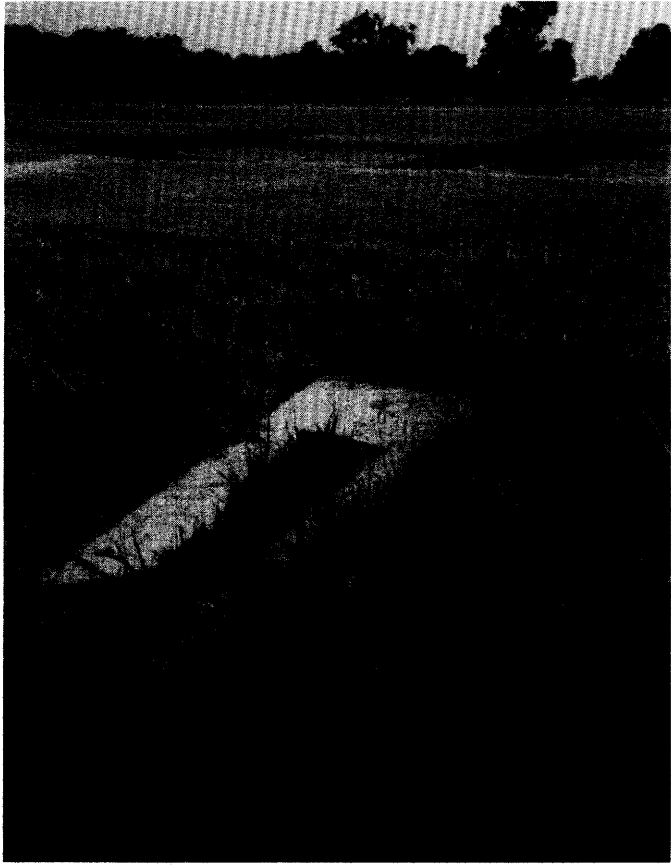
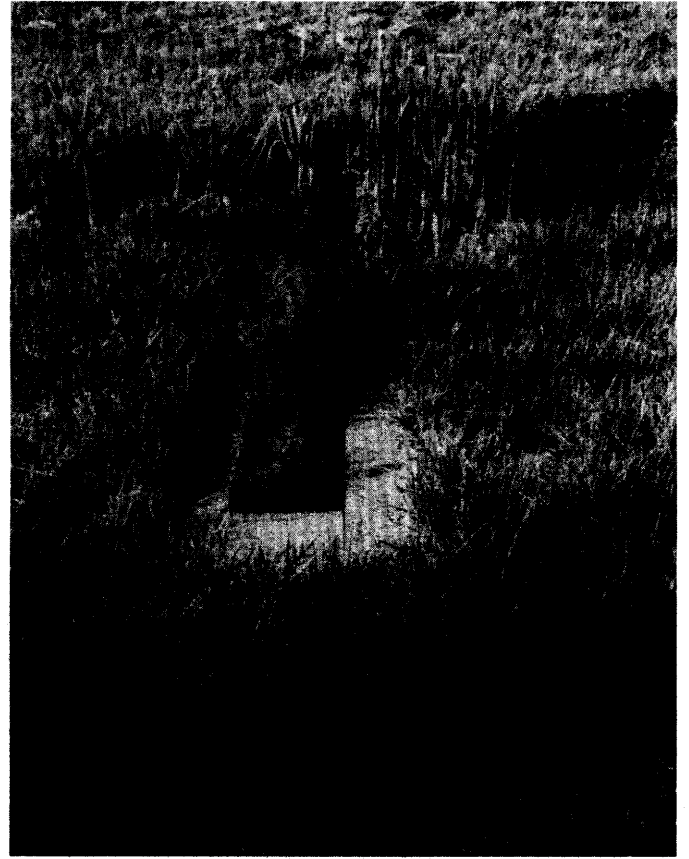
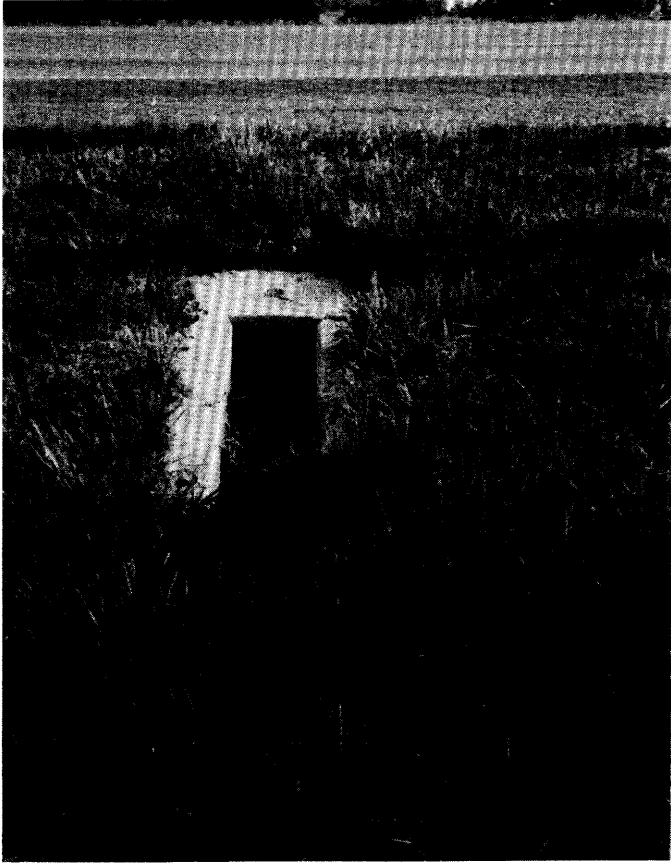
VEGETATION BLOCKING OUTLET

- **Vegetation Blocking Outlet, Attachment C**
Vegetation retains the silt causing gradual build-up to where many outlets were largely blocked. Trimmings from mowing operations were found to be the cause of some blockages.

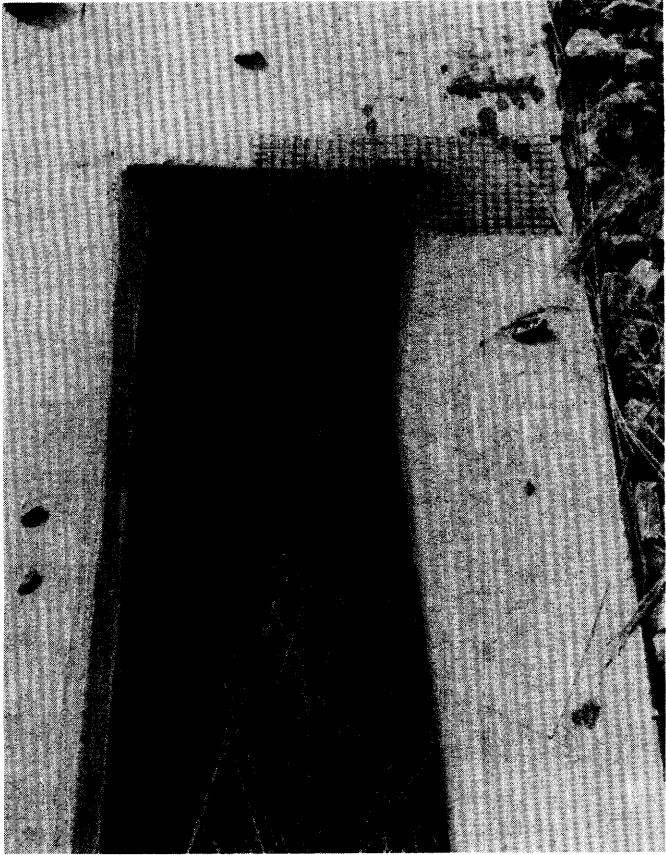
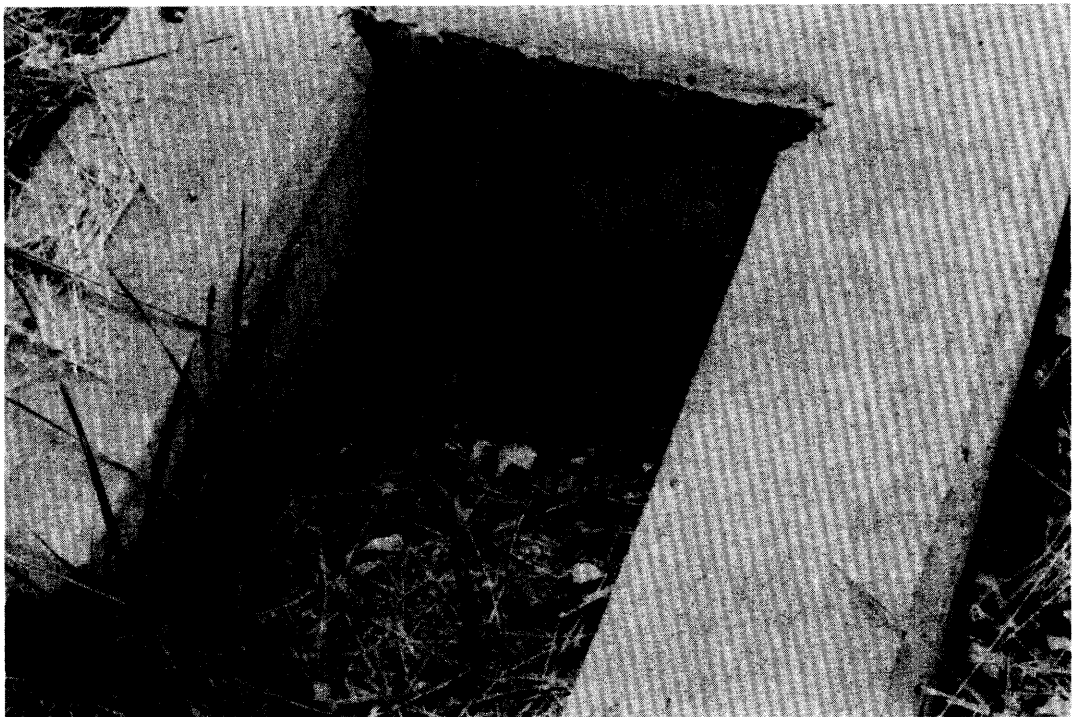
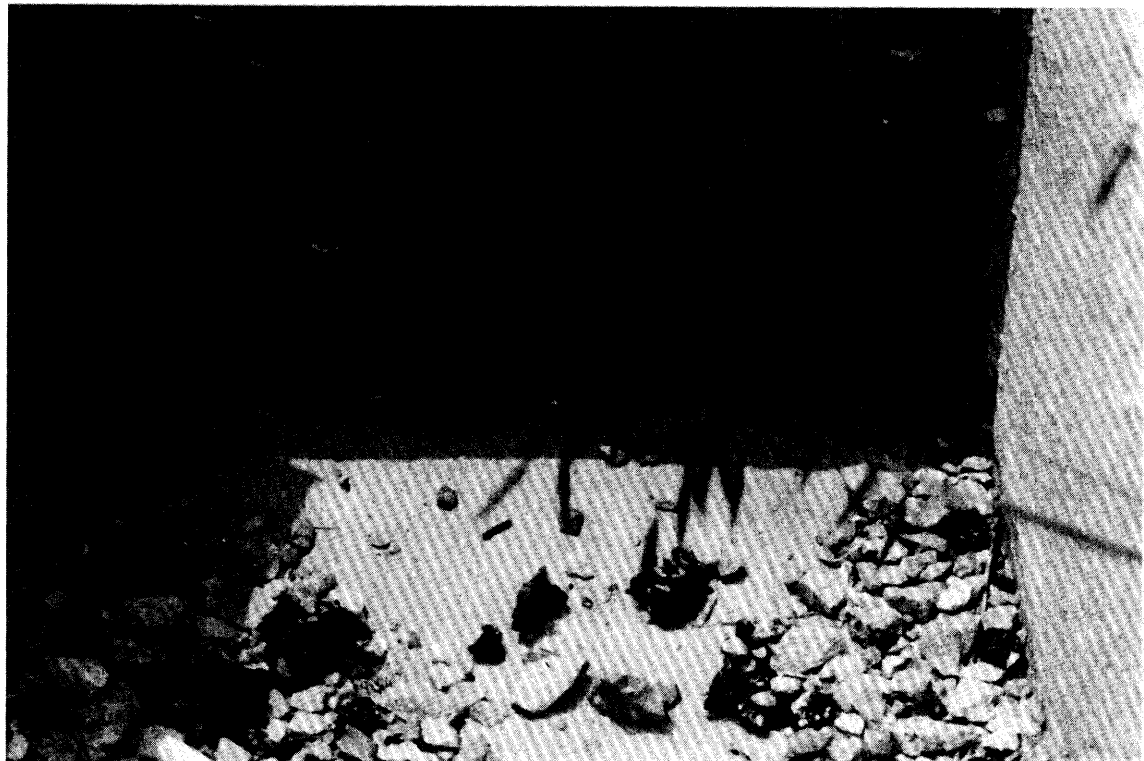
CLOGGED OUTLET PIPE

- **Clogged Outlet Pipe, Attachment E**
Clogged outlet pipes were found at many locations. Some were recent installations. Some had the old heavy type screens. Some pipes were clogged even though the troughs were clear, perhaps cleared after the blockage.

- There were several old-heavy type screens that may have caused the pipes to become silted back of the screens.

It is recommended that consideration be given to removing these screens in areas that silt has built up.

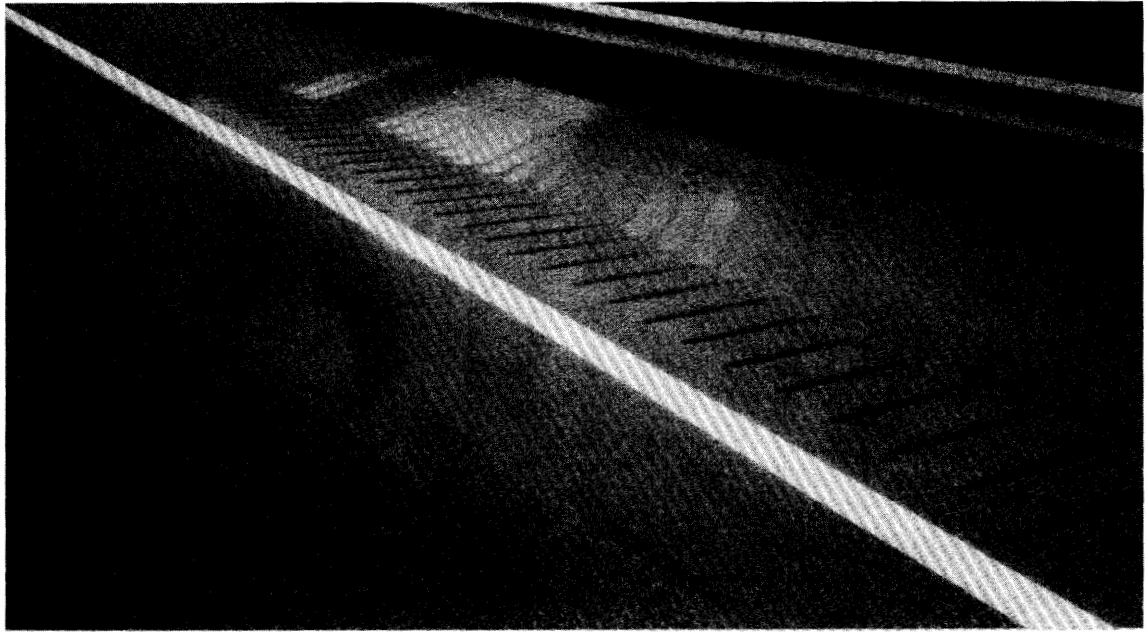
WATER PAVEMENT DAMAGE

The last page of photographs is of typical pavement damage that results from water in the pavement. (Attachment F)
