Highway Concrete Pavement Technology Development and Testing: Volume II— Field Evaluation of Strategic Highway Research Program (SHRP) C-203 Test Sites (Freeze-Thaw Resistance)

PUBLICATION NO. FHWA-RD-02-083

AUGUST 2006

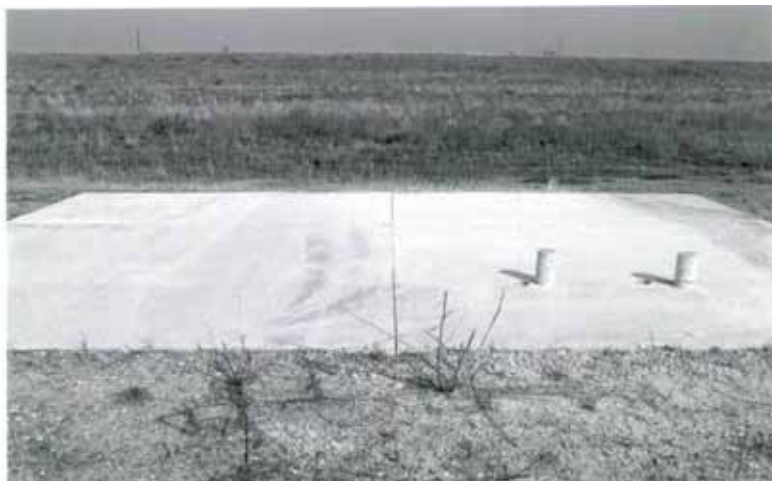
Figure 1. Test panels for mixture MN7 showing cores taken in 1994.

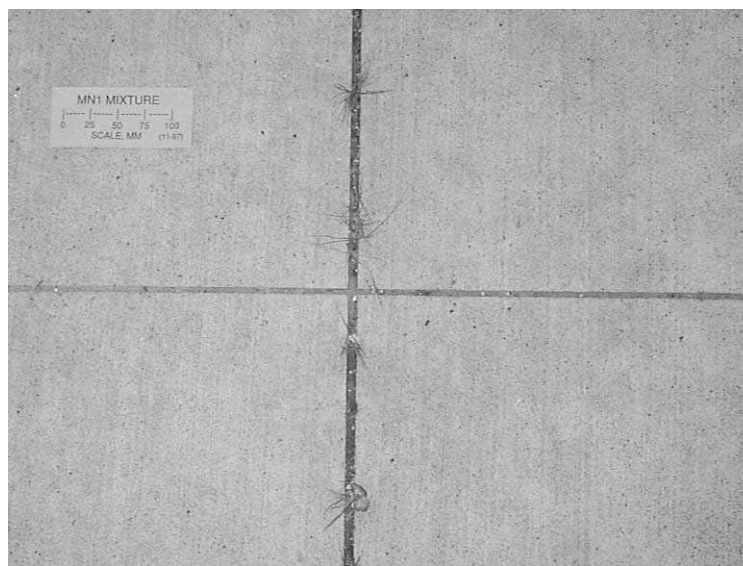
Section 1—15 percent fly ash, 3.9 percent air content—Very light surface scaling (visible sand particles are about 0.2 mm diameter) over the whole surface. See figure 2 for 1998 photograph of section 1.

Figure 2. Photograph of Minnesota test section 1 (1998). Most of the surface texture (brooming) is still visible. Sand particles up to 2 mm are visible in a very lightly scaled surface.

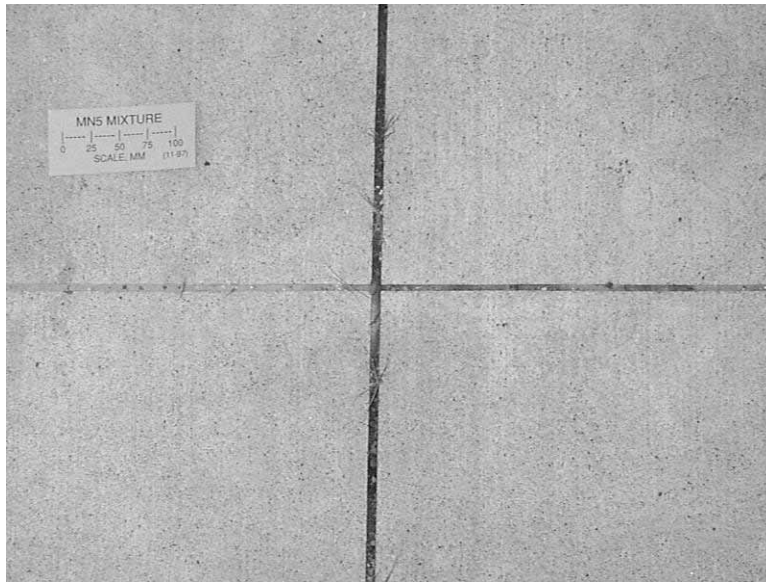
Section 5—No fly ash, 1.5 percent air content—Light scaling, with enough scaling in a few places to obscure the brooming marks. See figure 3 for photograph of section 5 in 1998.

Figure 3. Photograph of Minnesota test section 5 (1998). Scaling is slightly heavier than figure 2, and in some areas the surface texture (brooming) is obscured.

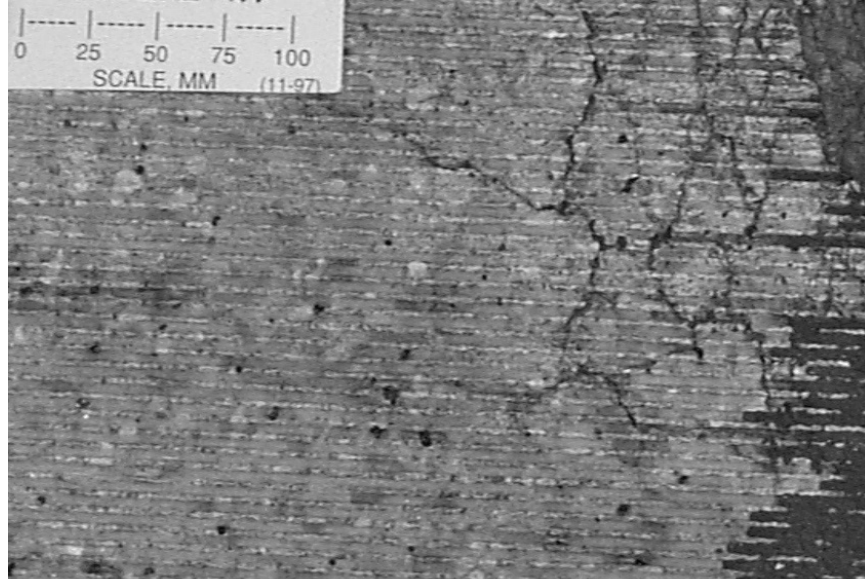
The patches were examined annually from 1994 through 1998. No additional surface defects were noted in any of the patches from 1994 through 1996. In 1997, surface map-pattern cracking was noted in varying degrees (see figure 4). The cracking was generally worse in the wheelpath near the transverse joints between the patches and the original pavement (figure 5). By 1998, the severity of the cracking had increased; some patches had been repaired with asphalt concrete where the deterioration had produced potholes.

Samples were taken from portions of the patches, and microscopic examination of the samples indicated that both cracks and air voids in the concrete were filled with ettringite.

**Figure 4. Surface cracking in patch, mixture I3
(parallel lines on surface are the result of
surface diamond grinding soon after construction).**

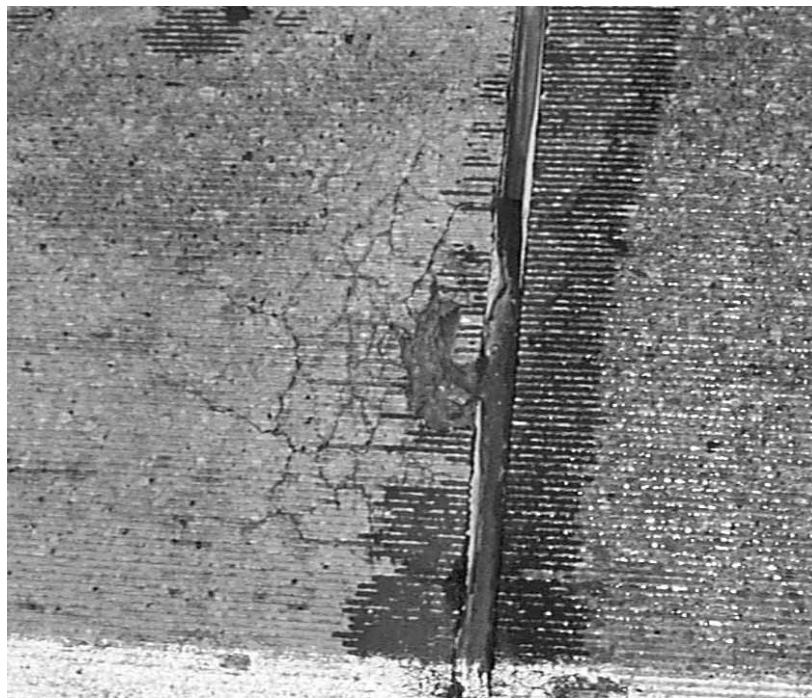
**Figure 5. Deterioration in patch (left) in wheelpath, mixture
I4 (surface has been diamond ground, and note longitudinal
paint strip along pavement edge at bottom of photo).**

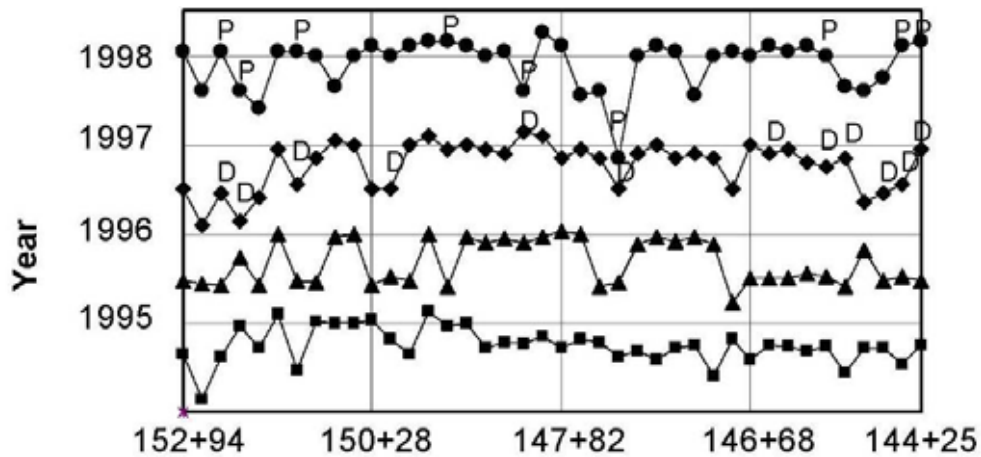
Figure 6. Field NDT velocity measurements.

However, an examination of the concrete velocity measurements indicates that many sections have some degree of deterioration. Direct comparisons of the velocity values from year to year cannot be made, probably because temperature effects could not be taken into account (pavement temperature measurements at either the surface or at depth were not part of the scope of work). By normalizing the data to the approximate maximum value recorded each year (assuming the maximum values represent non-deteriorated concrete), the values can be compared. Figure 6 shows the concrete velocities for each test joint for all 4 years of testing. Visual examination during 1997 and 1998 indicated cracking near the transverse joints, which appeared to be D-cracking. These joints are marked with a "D" in figure 6. Also, in 1998 tests could not be conducted at some of the transverse joint locations because the concrete near the joints was missing right adjacent to the joint or had been patched. These are marked with a "P" in figure 6. Tests were conducted (and test values are plotted in figure 6) for these locations, but the actual testing location was a few inches (depending upon the extent of the patching or damaged concrete) further back from the original joint location. Since D-cracking severity decreases with increasing distance from the joint, these test results labeled "P" can be expected to be higher than they would have been if the test could have been conducted right at the joint.

D-cracking has reappeared adjacent to some of the patches and can be identified both visually and with the NDT velocities (Vokes et al., 1997). Areas with visual D-cracking are identified with a “D” in figure 6. D-cracking has reappeared in all of the sections made with aggregate having a 25-mm top size, except for three of the sections listed as being on ATB, which may reduce the moisture availability from the subbase. This suggests that none of the edge treatments was successful in significantly delaying the return of D-cracking. D-cracking has returned to some of the sections made with 19-mm aggregate, and the 19-mm sections with no evidence of D-cracking include both treated sections and control sections with no treatment. A few of the 12-mm sections also have D-cracking but, as expected, the smaller aggregate size has reduced the D-cracking potential.

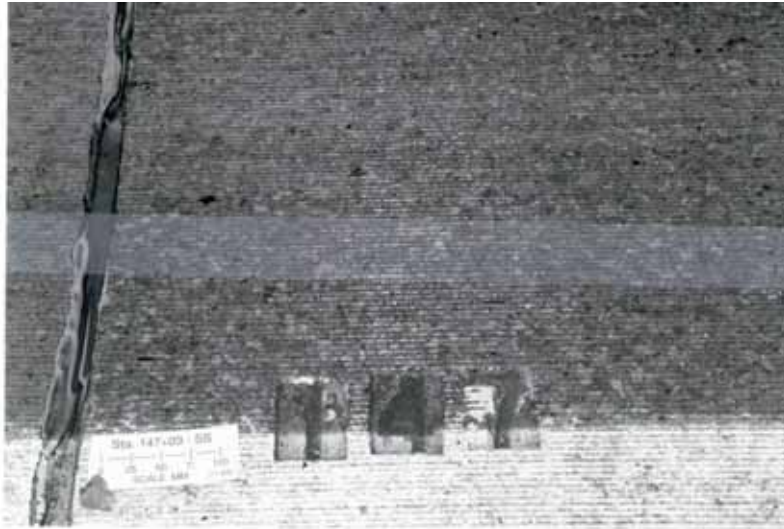
Figure B1. Typical surface textures after diamond grinding, Ohio test sections.

The test sections in Ohio were diamond ground between construction and the first monitoring visit (figure B1), so no evidence of surface scaling was visible. However, the diamond-ground surface did not experience any deterioration.
