October 21, 2008

**Re: Floodplain GE-Pittsfield/Housatonic River Site
Floodplain Residential and Non-Residential Properties Adjacent to 1½ Mile Reach of
Housatonic River (GECD710 and GECD720)
Summary of August/September 2008 Inspection Activities for the Group 4C Floodplain
Properties**

**AREAS SUBJECT TO INSPECTION
- PHASE 4, GROUP 4C**

RESTORATION PLANTING PLAN FOR PHASE 4 - GROUP 4C

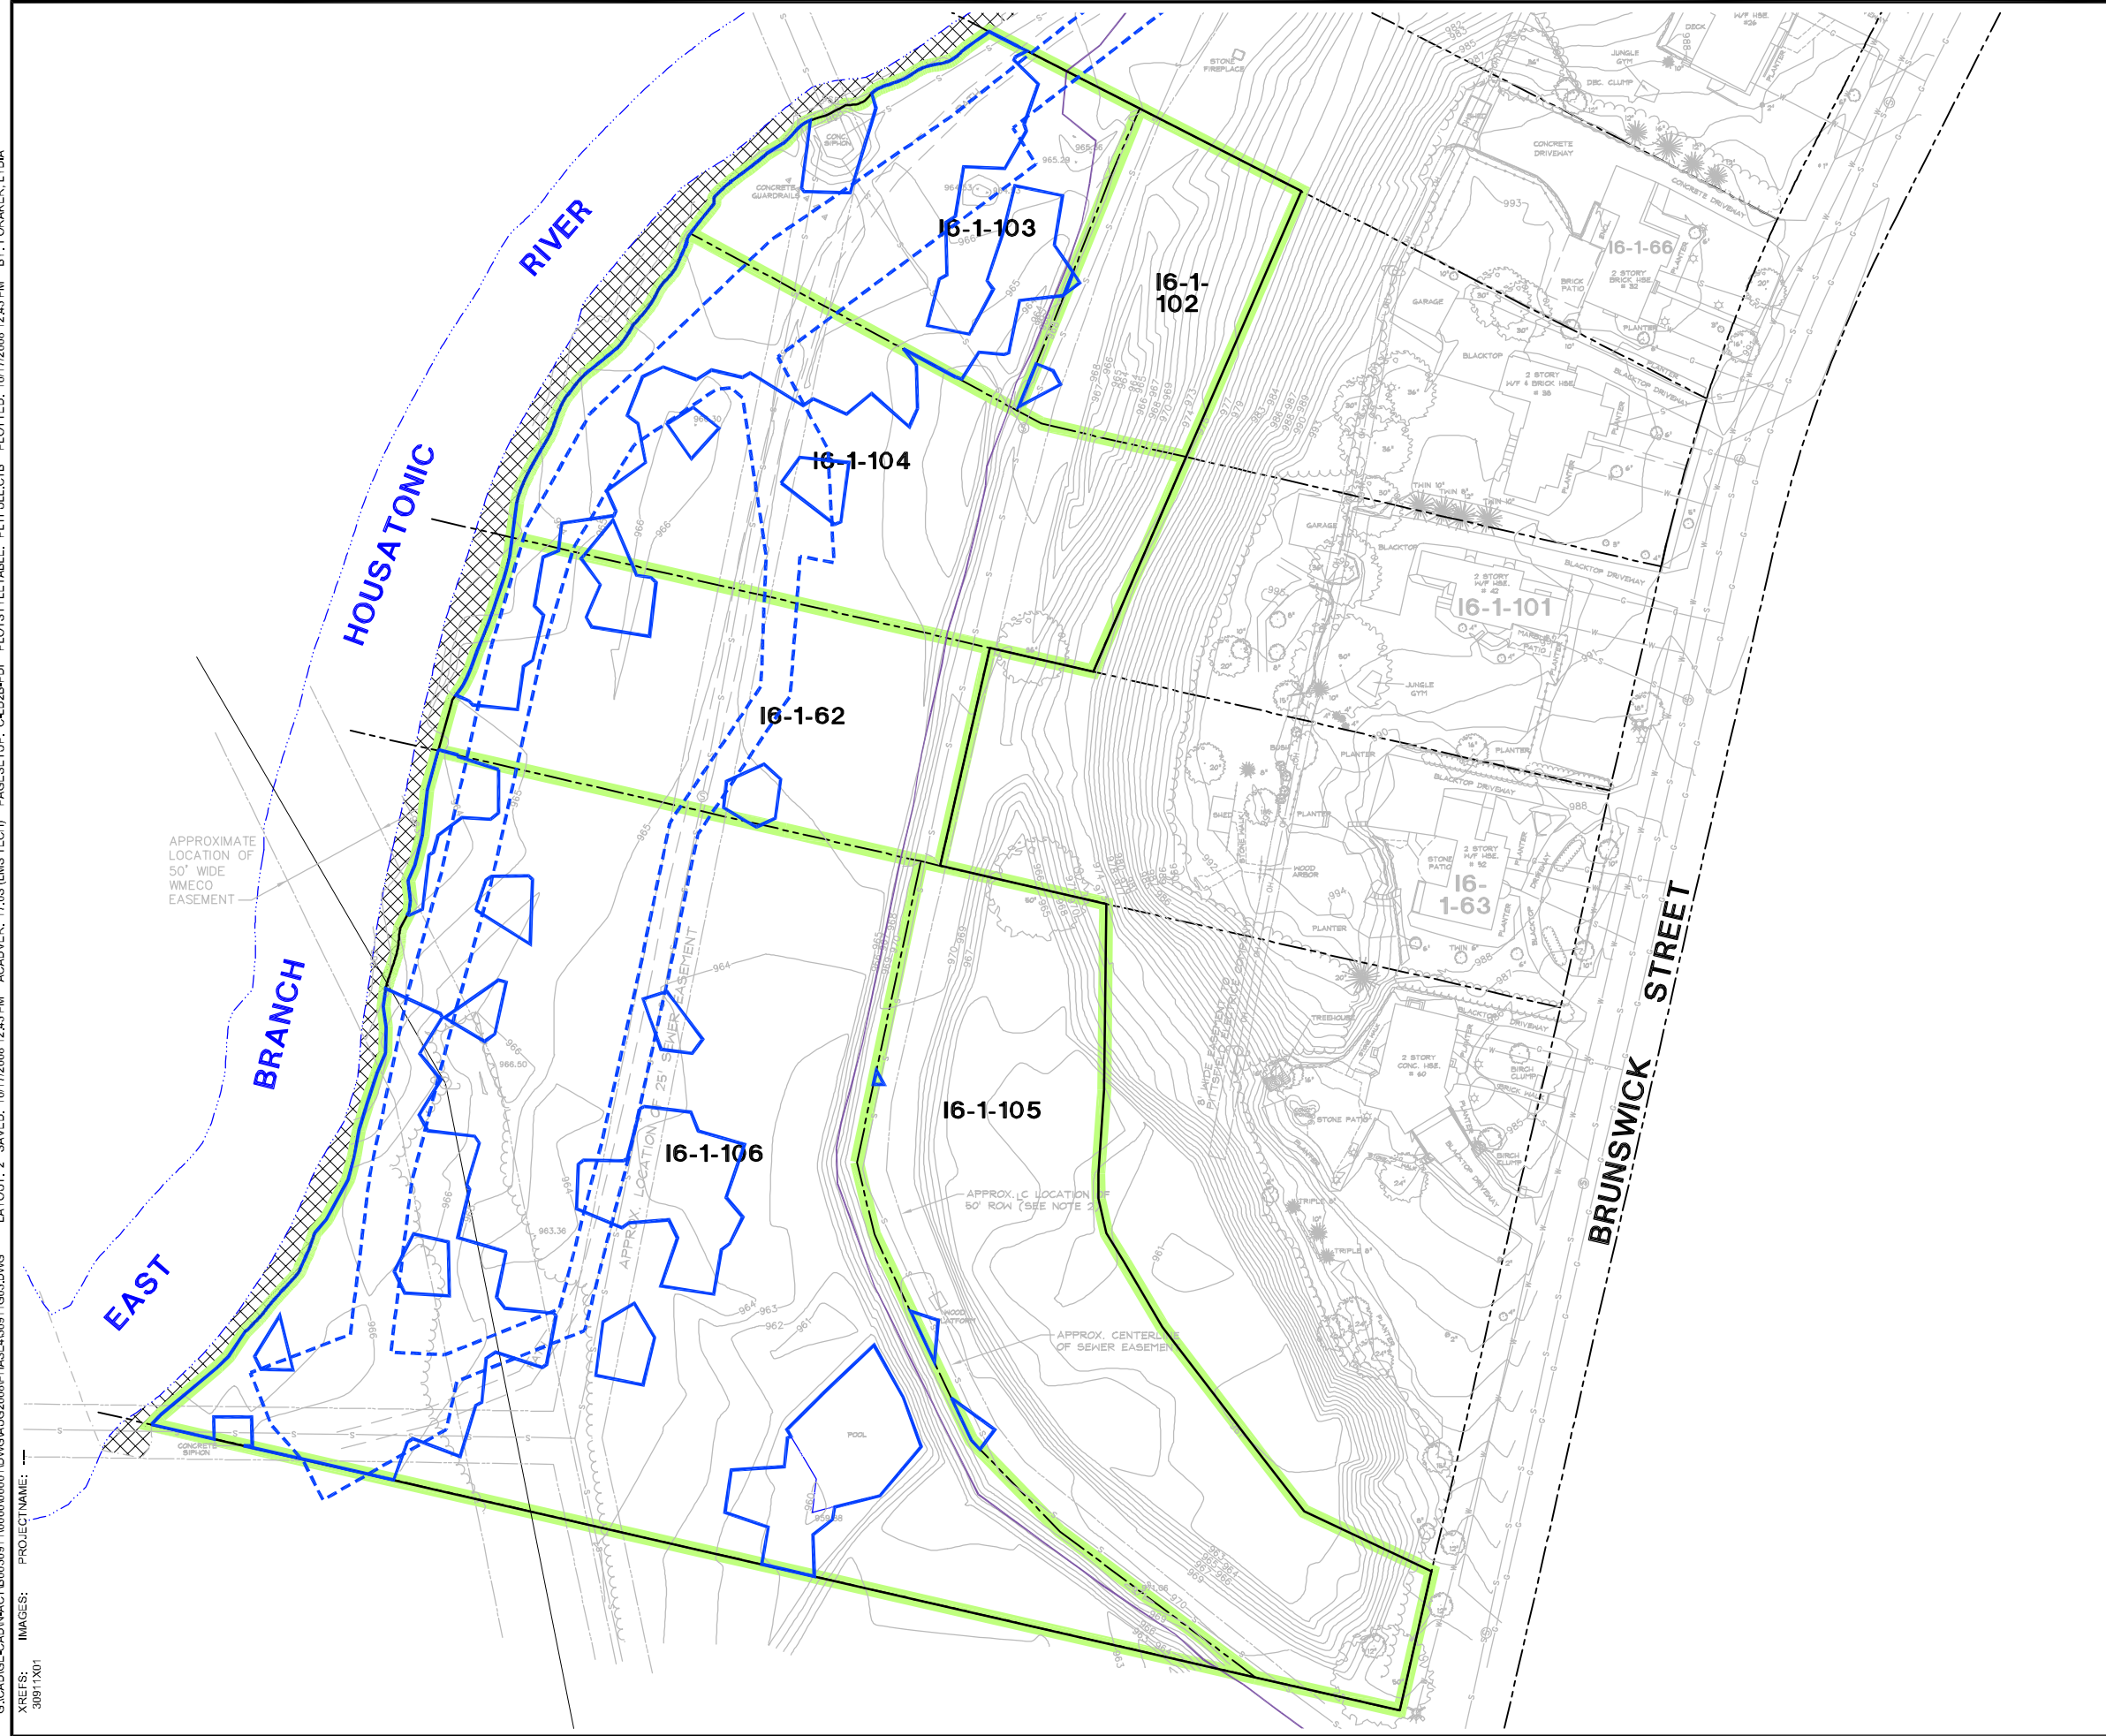
FIGURE
2

The areas inspected during the August/September 2008 inspection are shown on Figure 2. The four Group 4C non-residential properties (Parcels I6-1-62, I6-1-103, I6-1-104, and I6-1-106) were inspected and evaluated jointly. As shown on Figure 2, the areas inspected at these properties included not only the remediated areas, but also the approximate areas where access roads and staging areas were used and areas that were otherwise disturbed during the remediation.

The August/September 2008 inspection included observations of the backfilled/restored areas, as well as the other disturbed areas shown on Figure 2. These observations focused on the following: (a) the effectiveness of erosion controls in areas where vegetation is not yet established; (b) any areas where excessive settlement has occurred relative to the surrounding areas; (c) any drainage or growth problems; (d) any areas of erosion; and (e) other conditions that could affect the outcome of the completed remediation actions (for example, burrows, vehicle ruts, unauthorized uses of areas, etc.). The inspection also evaluated whether the herbaceous vegetation that has been planted or seeded is growing as anticipated and providing the desired degree of erosion control.

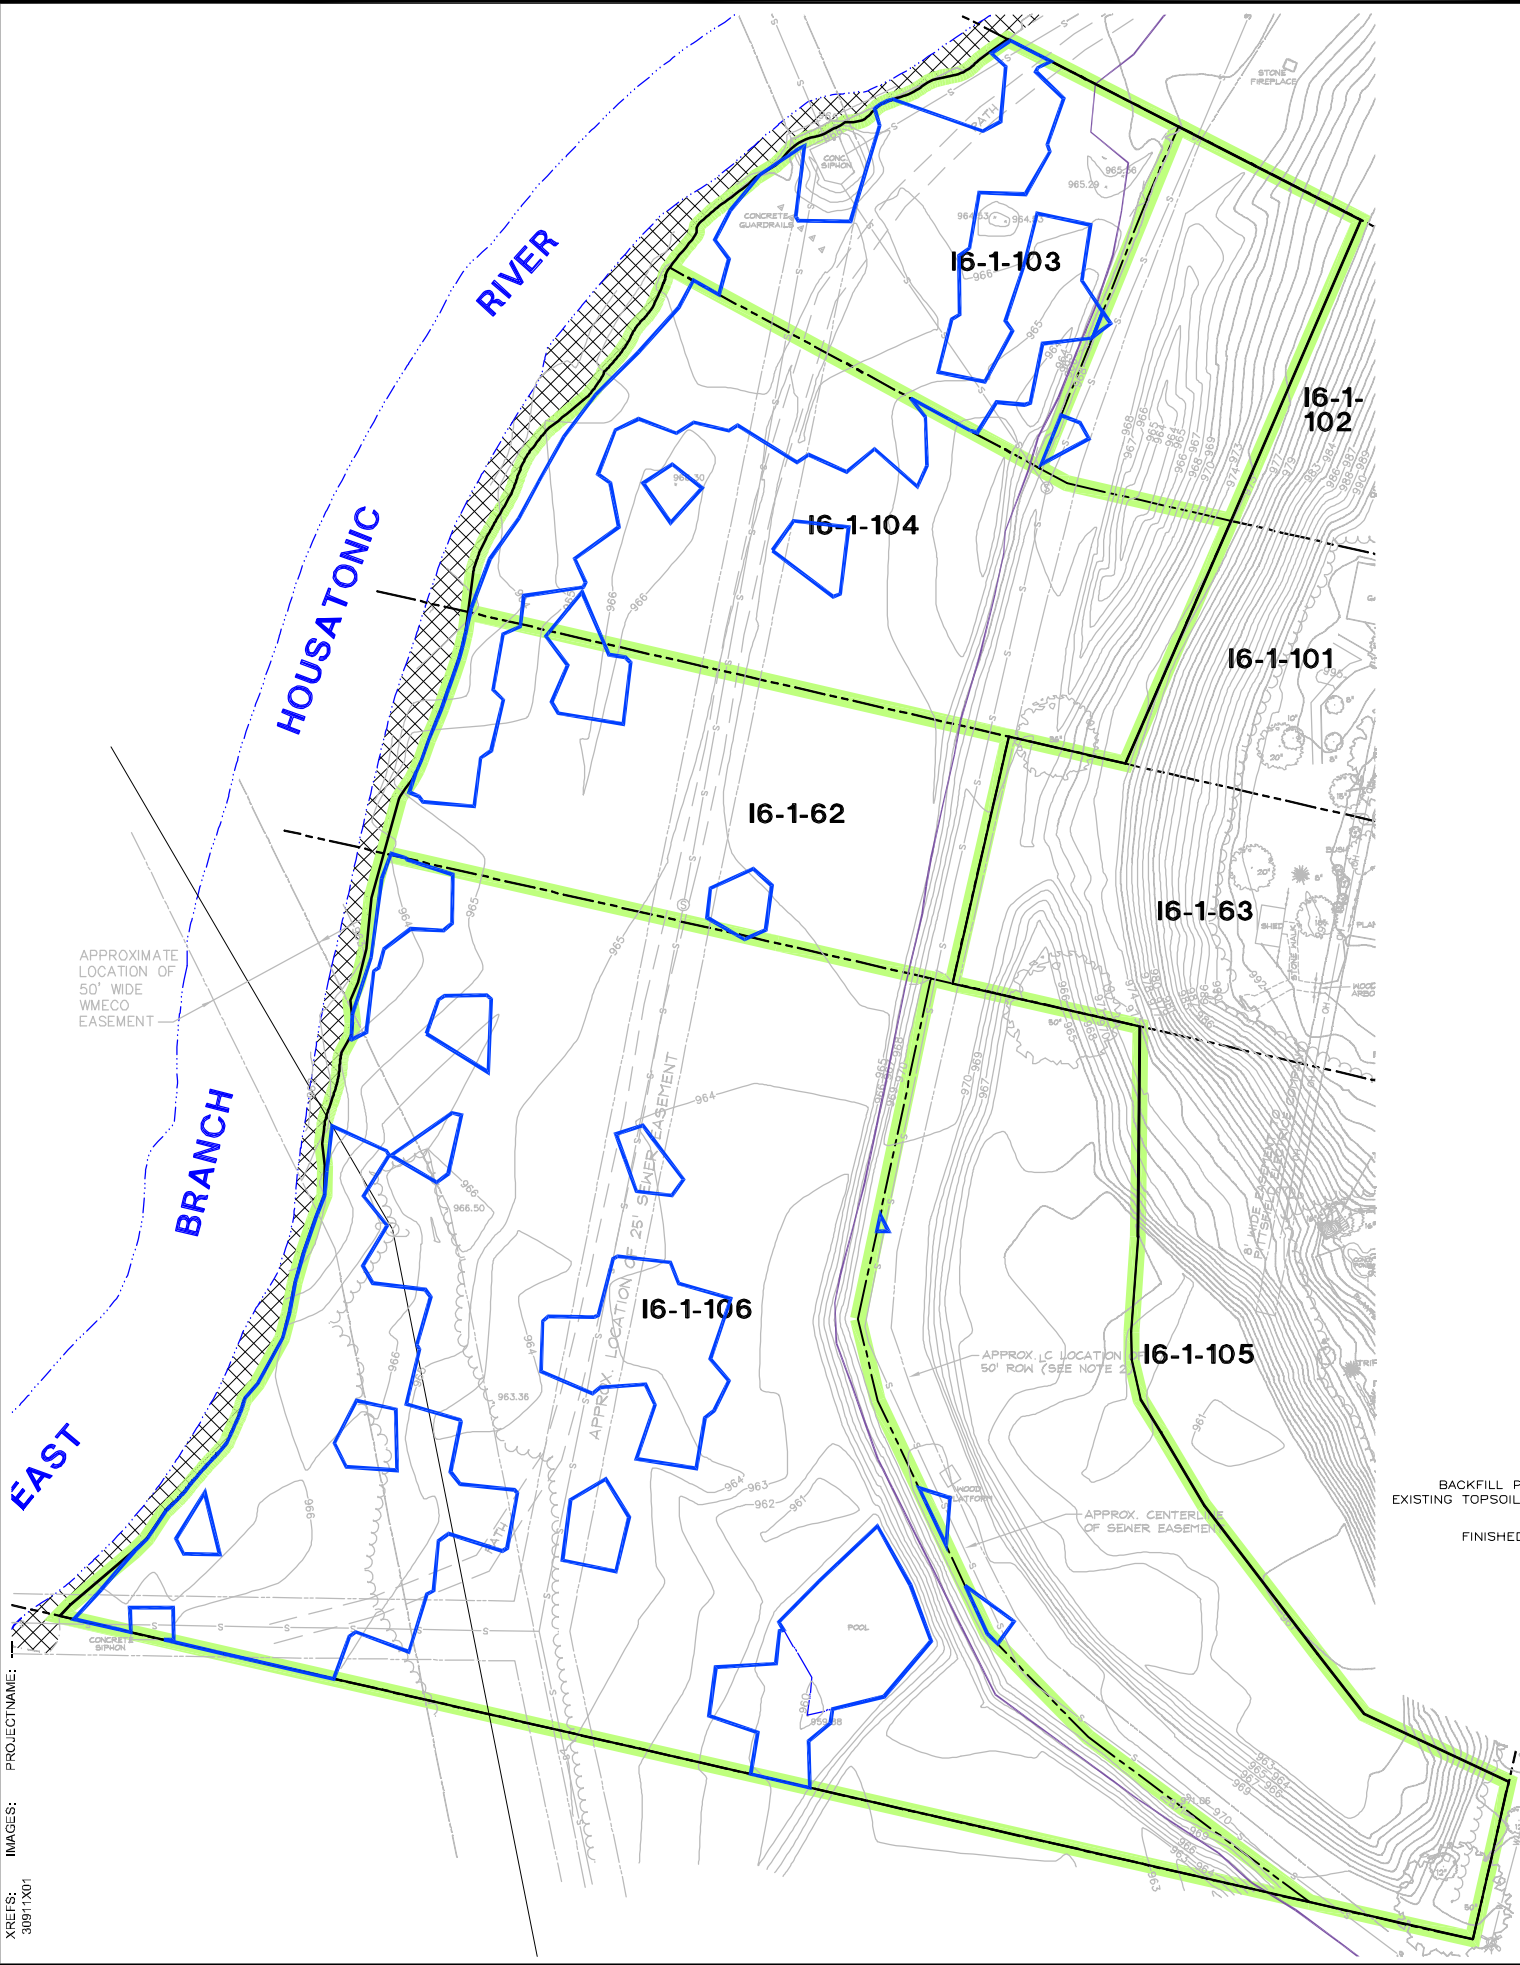
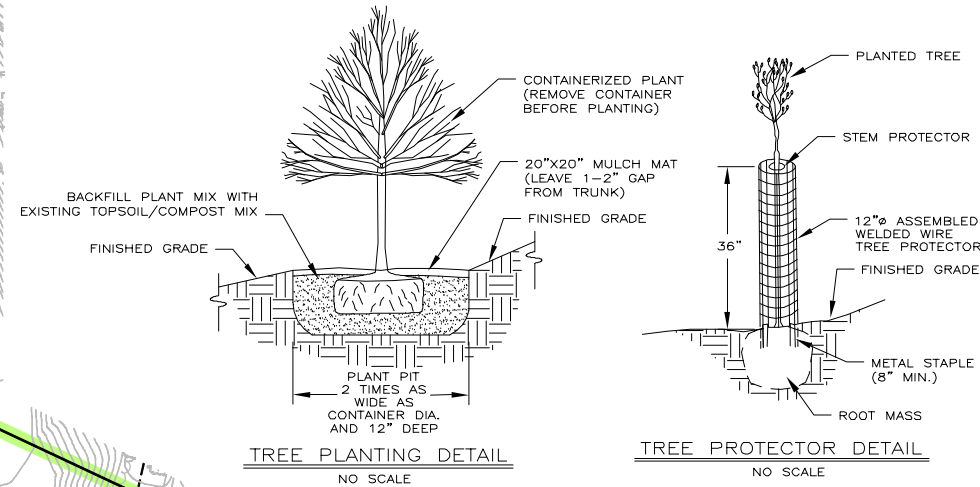
In addition, these activities included the inspection of trees and shrubs planted as part of restoration activities to ensure that they are growing as anticipated. Figure 3 contains the current restoration planting plan for the Group 4C properties. Observations at these properties included a stem count of planted trees/shrubs (quantity per species) in good health and a stem count of trees/shrubs that were dead or dying or showing evidence of stress or other potential problems within the Group 4C properties. Additionally, each tree/shrub observed was measured to determine the approximate average height and range of heights of each species of tree/shrub within the Group 4C properties. In conjunction with the tree and shrub observations, GE inspected tree cages, tree guards, and tree stakes (where present).

1. The quantity of each species listed in this column corresponds to the planted quantity identified on Figure 3 of this letter, which was based on prior planting plans updated by observations during the May 2008 inspection and discussions with EPA.
2. This column lists the number of dead trees/shrubs observed (if any) and then the number of trees/shrubs that were not dead but were considered “stressed.”
3. This column shows the percentage of trees/shrubs that were in good condition relative to the quantity specified on Figure 3.
4. This column shows the percentage of trees/shrubs that were alive (including plants with identified problems) relative to the quantity specified on Figure 3.
5. Three of the maples planted within the Group 4C properties are on residential Parcel I6-1-102. The remaining maples were planted on non-residential parcels.

For the three species that were found to have a percent survival less than 80% (northern arrowwood, dogwood, and choke cherry), GE will perform replanting activities to meet the planting plan quantities indicated on the restoration planting plan. This will include planting 6 northern arrowwoods, 3 dogwoods, and 1 choke cherry. These replanting activities will be completed this fall. GE will equip replanted trees with a tag identifying the species of tree, the installation date, and the size at the time of installation. These replanting activities will be documented in the next inspection summary letter. In addition, GE will revise Figure 3 to include an inventory of the original plantings as well as the species, installation date, and size of the replanted shrubs at the time of the replanting. The revised Figure 3 will serve as the basis for the next inspection and will be submitted to EPA.
