December 26, 2006  
Project No. J1447-01-02

Prepared for:  
Pittsfield Economic Development Authority  
81 Kellogg Street  
Pittsfield, MA 01201

**Semi-Annual Inspection  
Building Demolition Barrier Areas**

**20s and 30s Complexes  
William Stanley Business Park  
Pittsfield, Massachusetts**

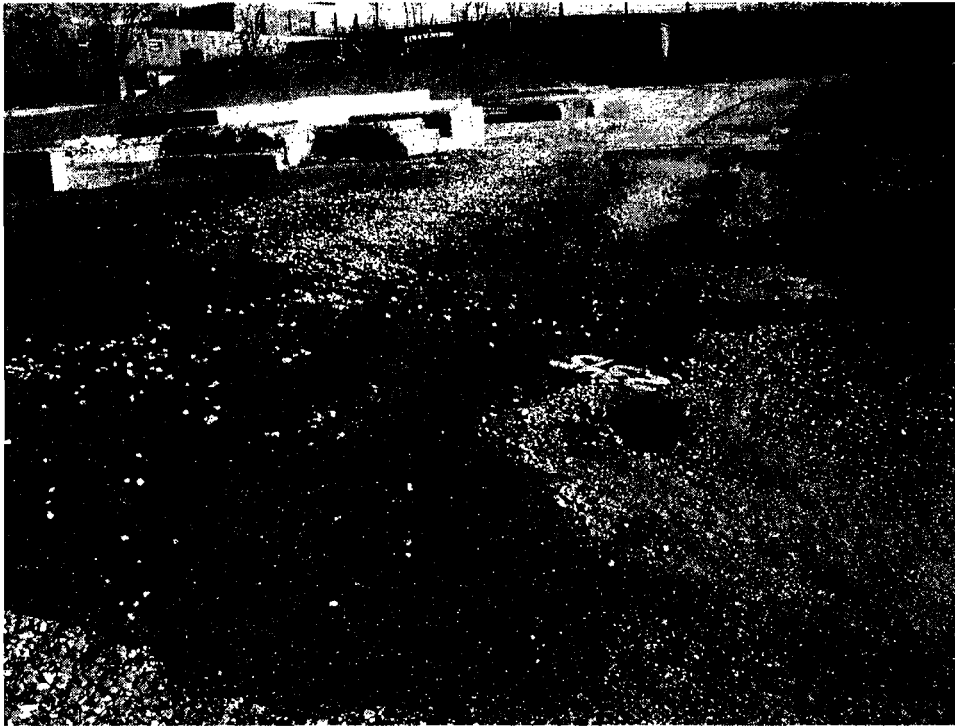
- Description of any conditions or problems noted during the inspection which are or may be affecting the performance of the engineered barrier:  
Two small potholes were observed along the southern border of the asphalt pavement. The potholes were filled with soil and measured approximately 6" long by 6" wide by 2.5" deep and 12" long by 6" wide by 2.5" deep.

Evidence of vehicular use was observed along the southern border of the asphalt pavement (see photos). Vehicle tracks indicated a vehicle the size of a car, truck, or off-road vehicle had driven over the southernmost border of the pavement.

~6" x 6" x 2.5"  
~12" x 6" x 2.5"

30s Complex Building Demolition Barrier Area.  
Evidence of vehicular traffic and small, soil-filled  
potholes.
