December 13, 2007
Project No. J1447-01-02

**Semi-Annual Inspection
Building Demolition Barrier Areas
December 2007
20s and 30s Complexes
William Stanley Business Park
Pittsfield, Massachusetts**

Building Demolition Barrier Areas
20s and 30s Complexes
William Stanley Business Park
Pittsfield, Massachusetts

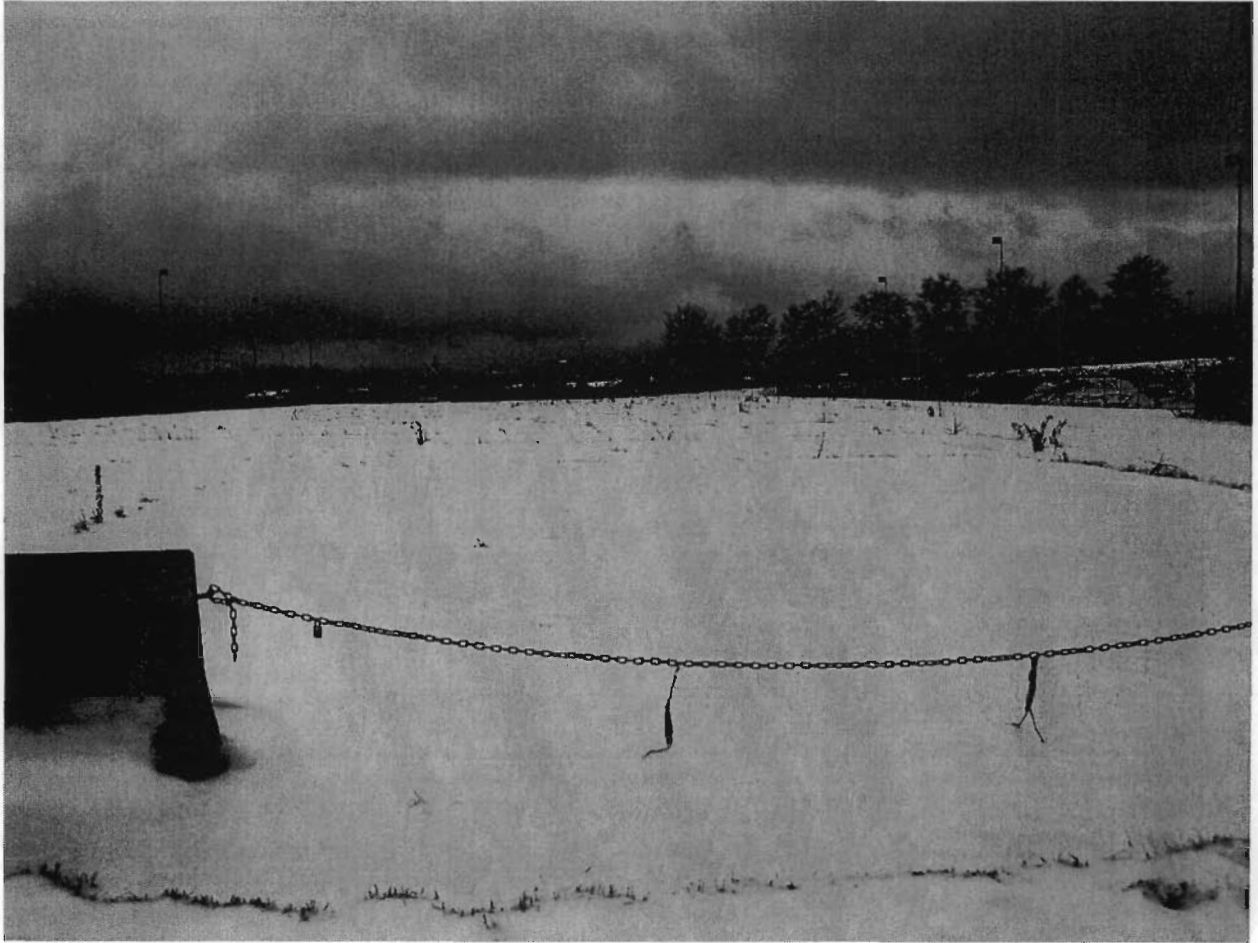
20s Barrier Area #1

View Looking West
December 10, 2007

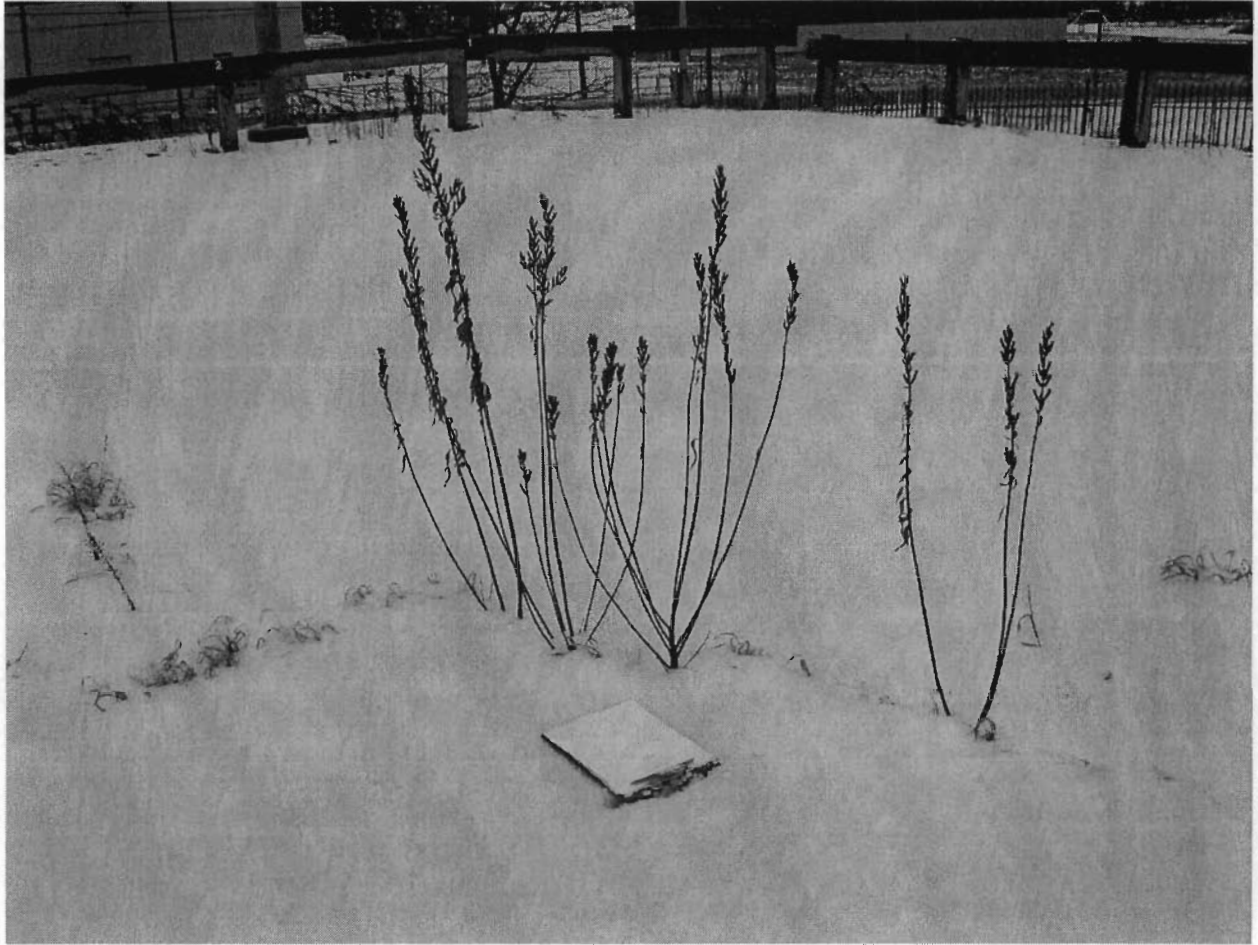
20s Barrier Area #1

- Description of any conditions or problems noted during the inspection which are or may be affecting the performance of the engineered barrier:
No conditions were observed which are or may be affecting the performance of the engineered barrier. Minor vegetative growth was observed (see photos). The frequency and density of vegetative growth in small cracks seems to be increasing.

Typical Vegetation Growth
December 10, 2007

- Description of any measures that may need to be performed to correct any conditions affecting the performance of the barriers:
Continued monitoring of minor cracking and minor vegetative growth. Repair of cracking and control of vegetation may be necessary if conditions deteriorate.

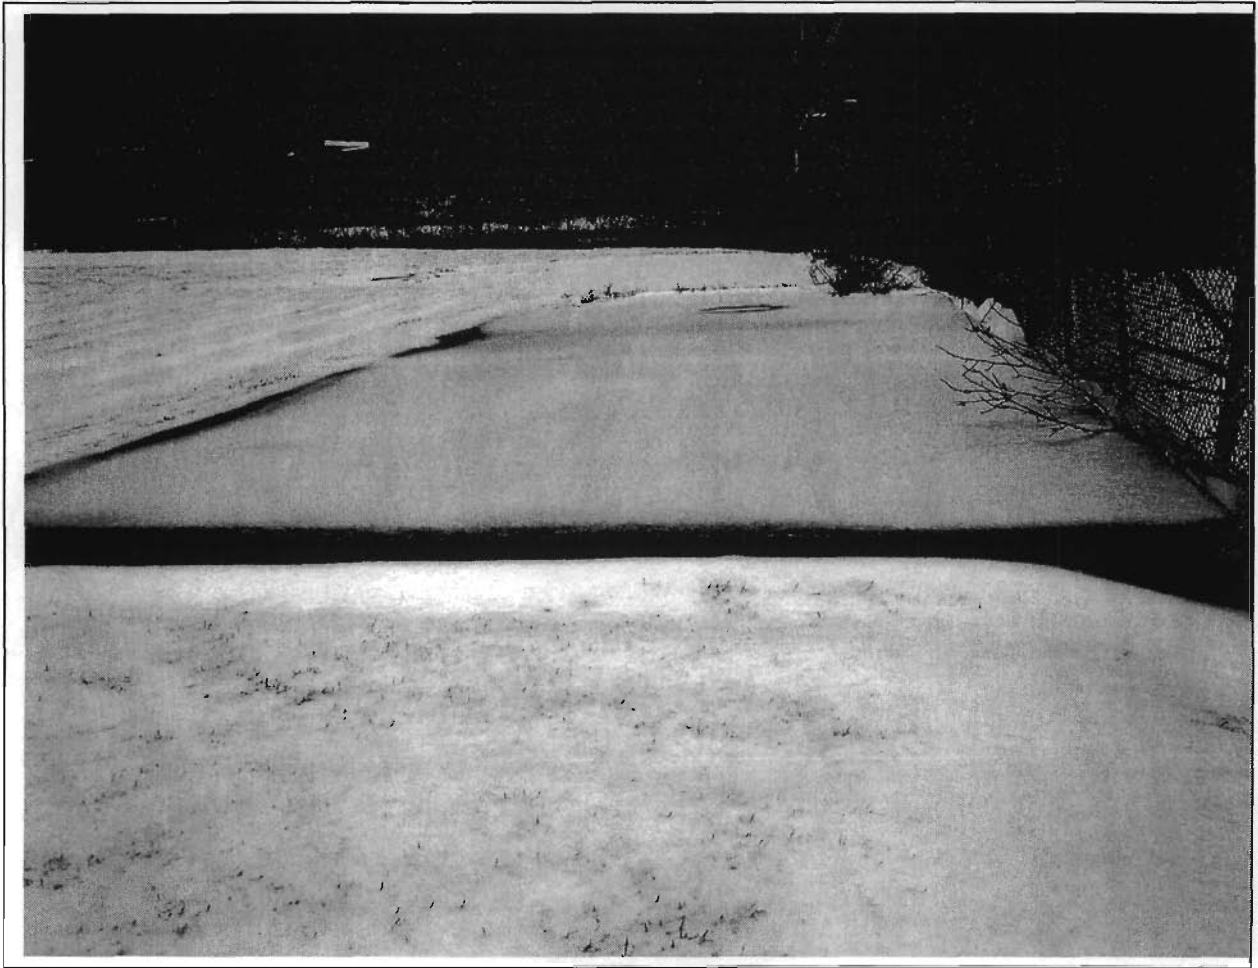
20s Barrier Area #2

View Looking North
December 10, 2007

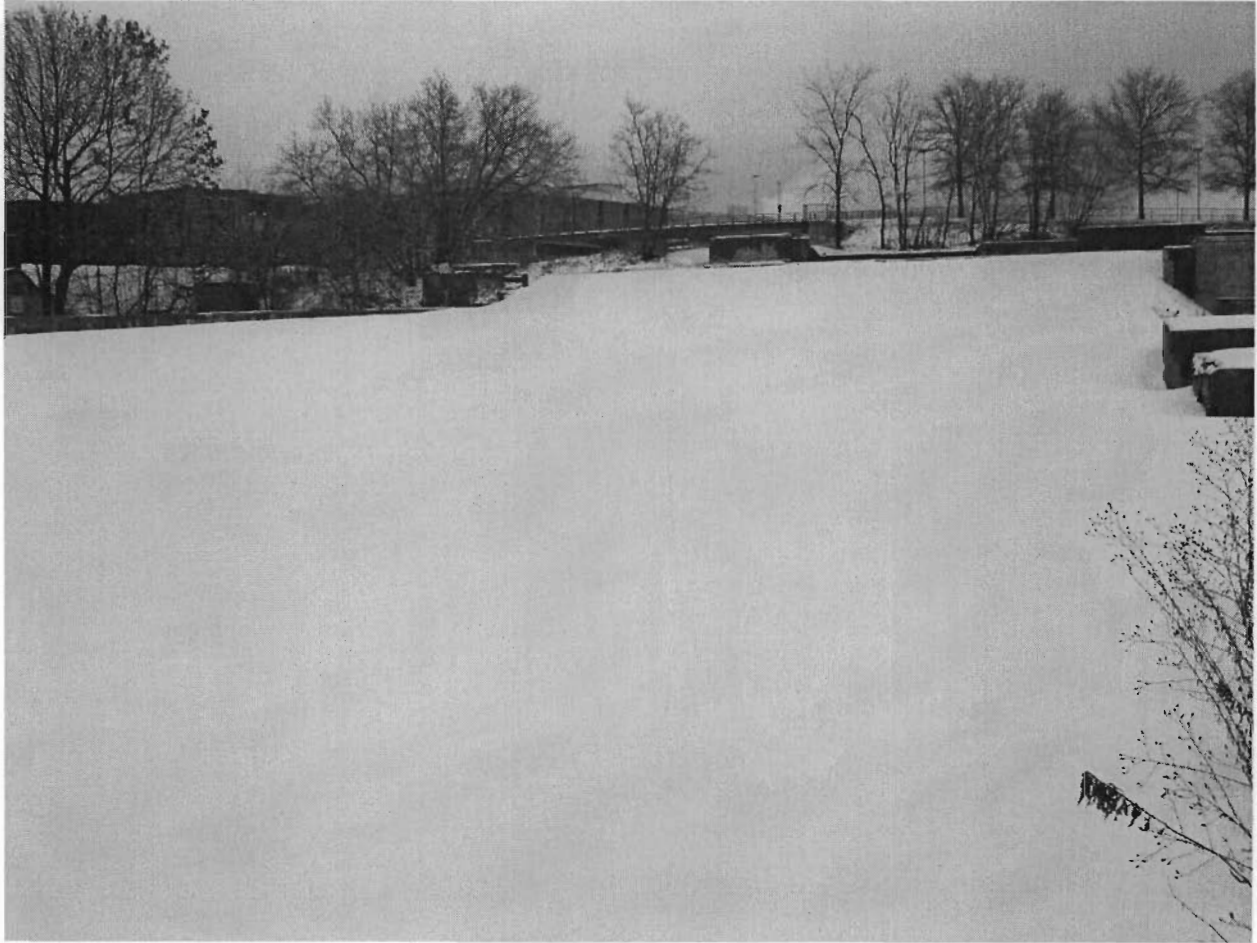
30s Barrier Area

View Looking East
December 10, 2007

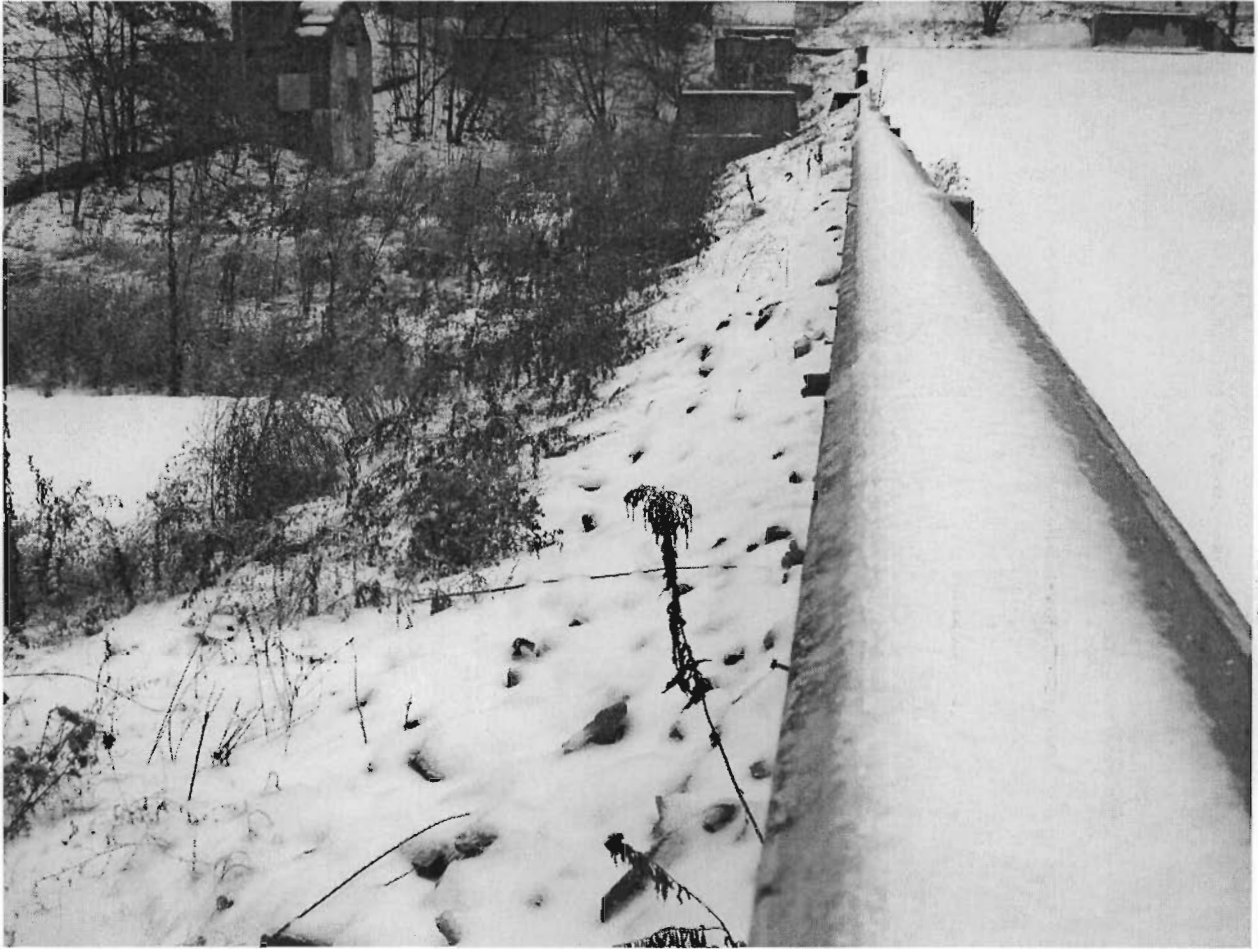
30s Barrier Area

View Along North Side
December 10, 2007
