July 11, 2008

Project No. J1447-01-02

**Semi-Annual Inspection
Building Demolition Barrier Areas
Summer 2008**

**20s and 30s Complexes
William Stanley Business Park
Pittsfield, Massachusetts**

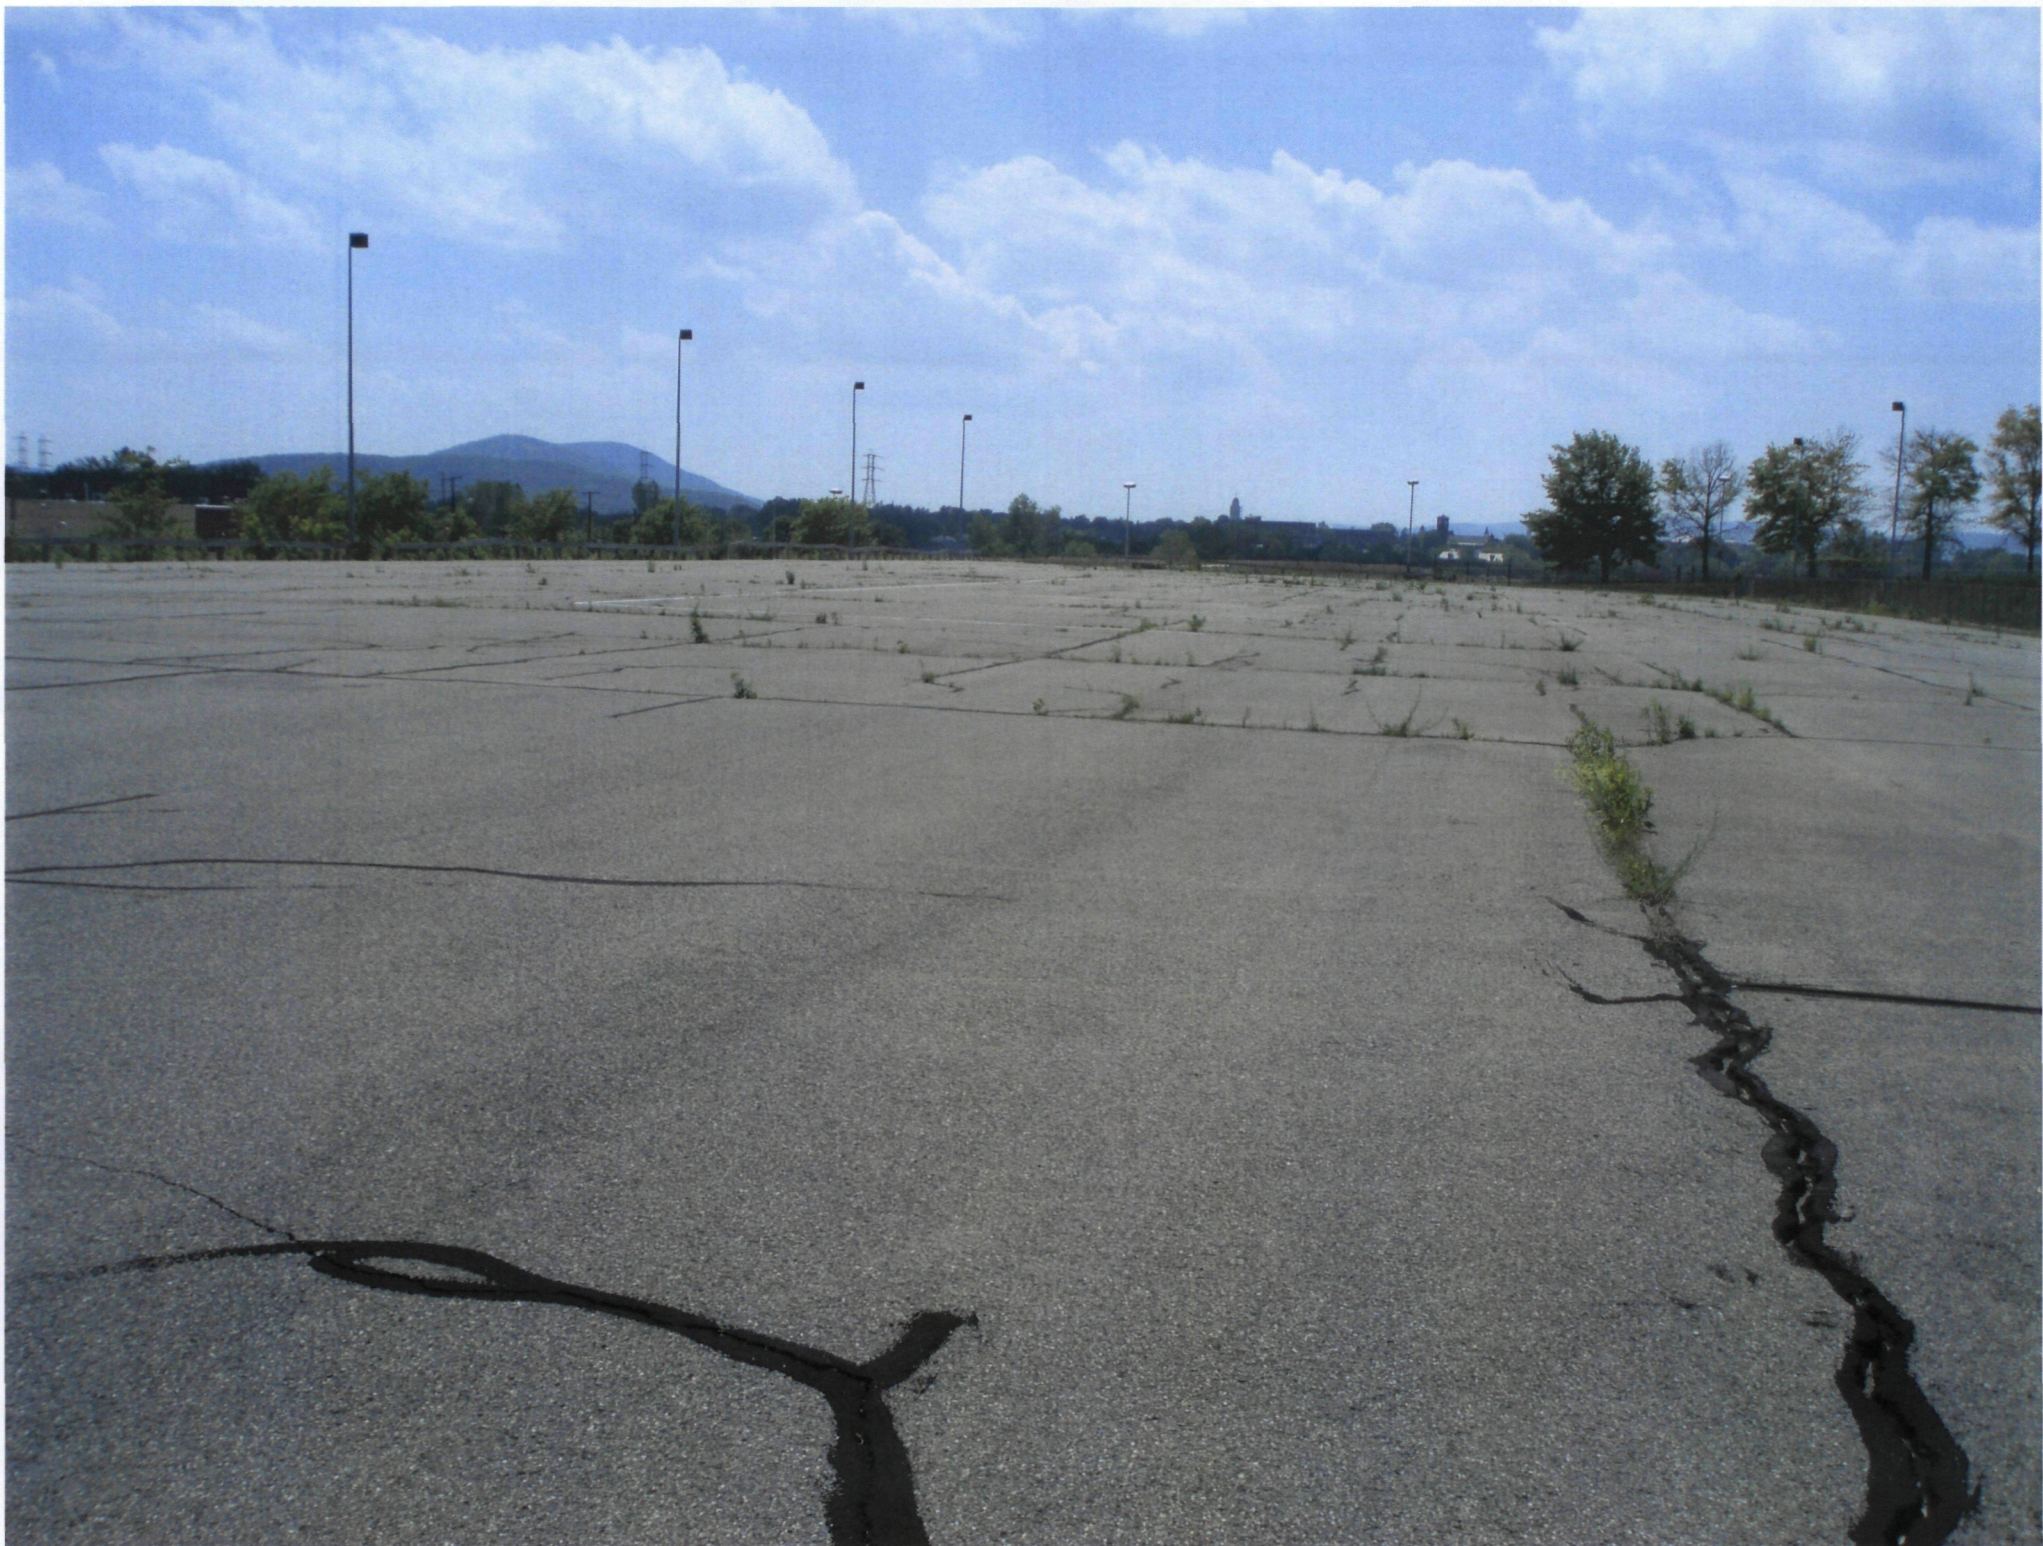
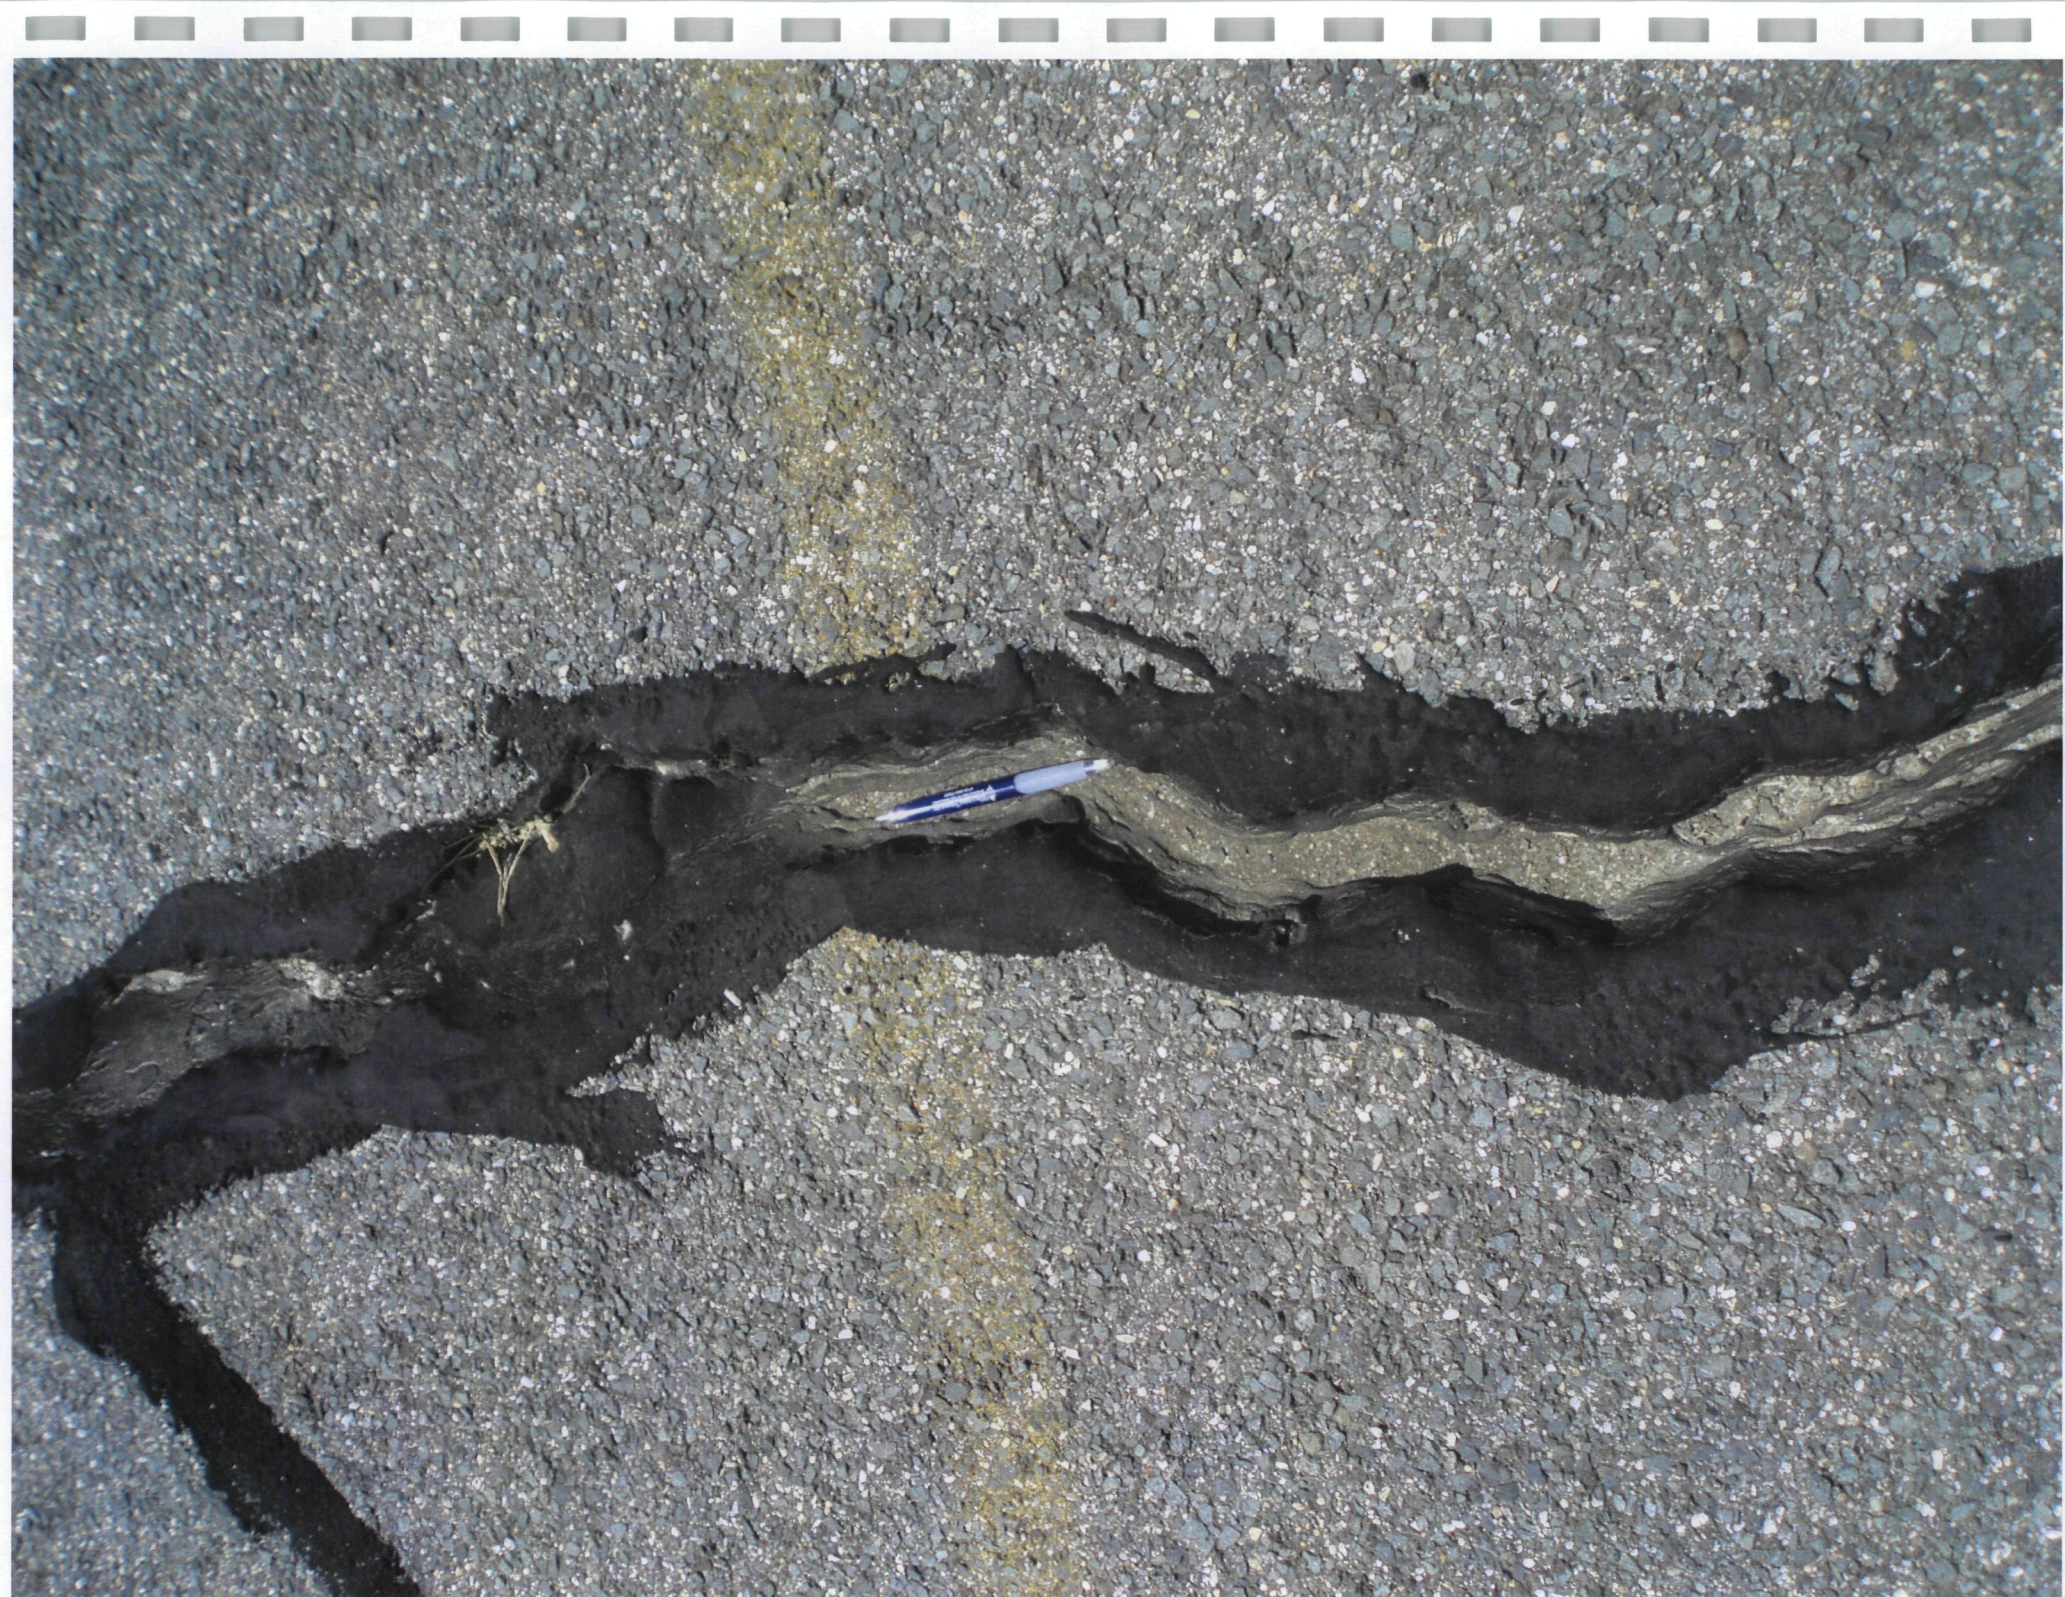
20s Complex
Barrier Area 1

- **Description of any conditions or problems noted during the inspection which are or may be affecting the performance of the engineered barrier:**
No conditions were observed which are or may be affecting the performance of the engineered barrier. Minor vegetative growth was observed (see photos). The frequency and density of vegetative growth in small cracks seems to be increasing.

Date	6/9/05
Inspector	Chris Streeter
Weather Conditions	Sunny 90-92
Evidence Of Change In Use	Bus Driver tracking area
Physical Changes And Conditions Adjacent To Barrier Area	None observed
Soil Erosion	None observed
Excessive Vegetative Growth	Moderate in Cracks
Excessive Cracking	Moderate observed 1/2" → 3"
Fissures	None observed
Spalling	None observed
Potholes	None observed
Heaving or Uneven Settling	None observed
Vehicular Use	None observed
Depressions	None observed
Water Ponding	None observed
Excessive Rutting	None observed
Exposed Subbase	None observed,

- **Description of any measures that may need to be performed to correct any conditions affecting the performance of the barriers:**
Continued monitoring of minor cracking and minor vegetative growth. Repair of cracking and control of vegetation may be necessary if conditions deteriorate.

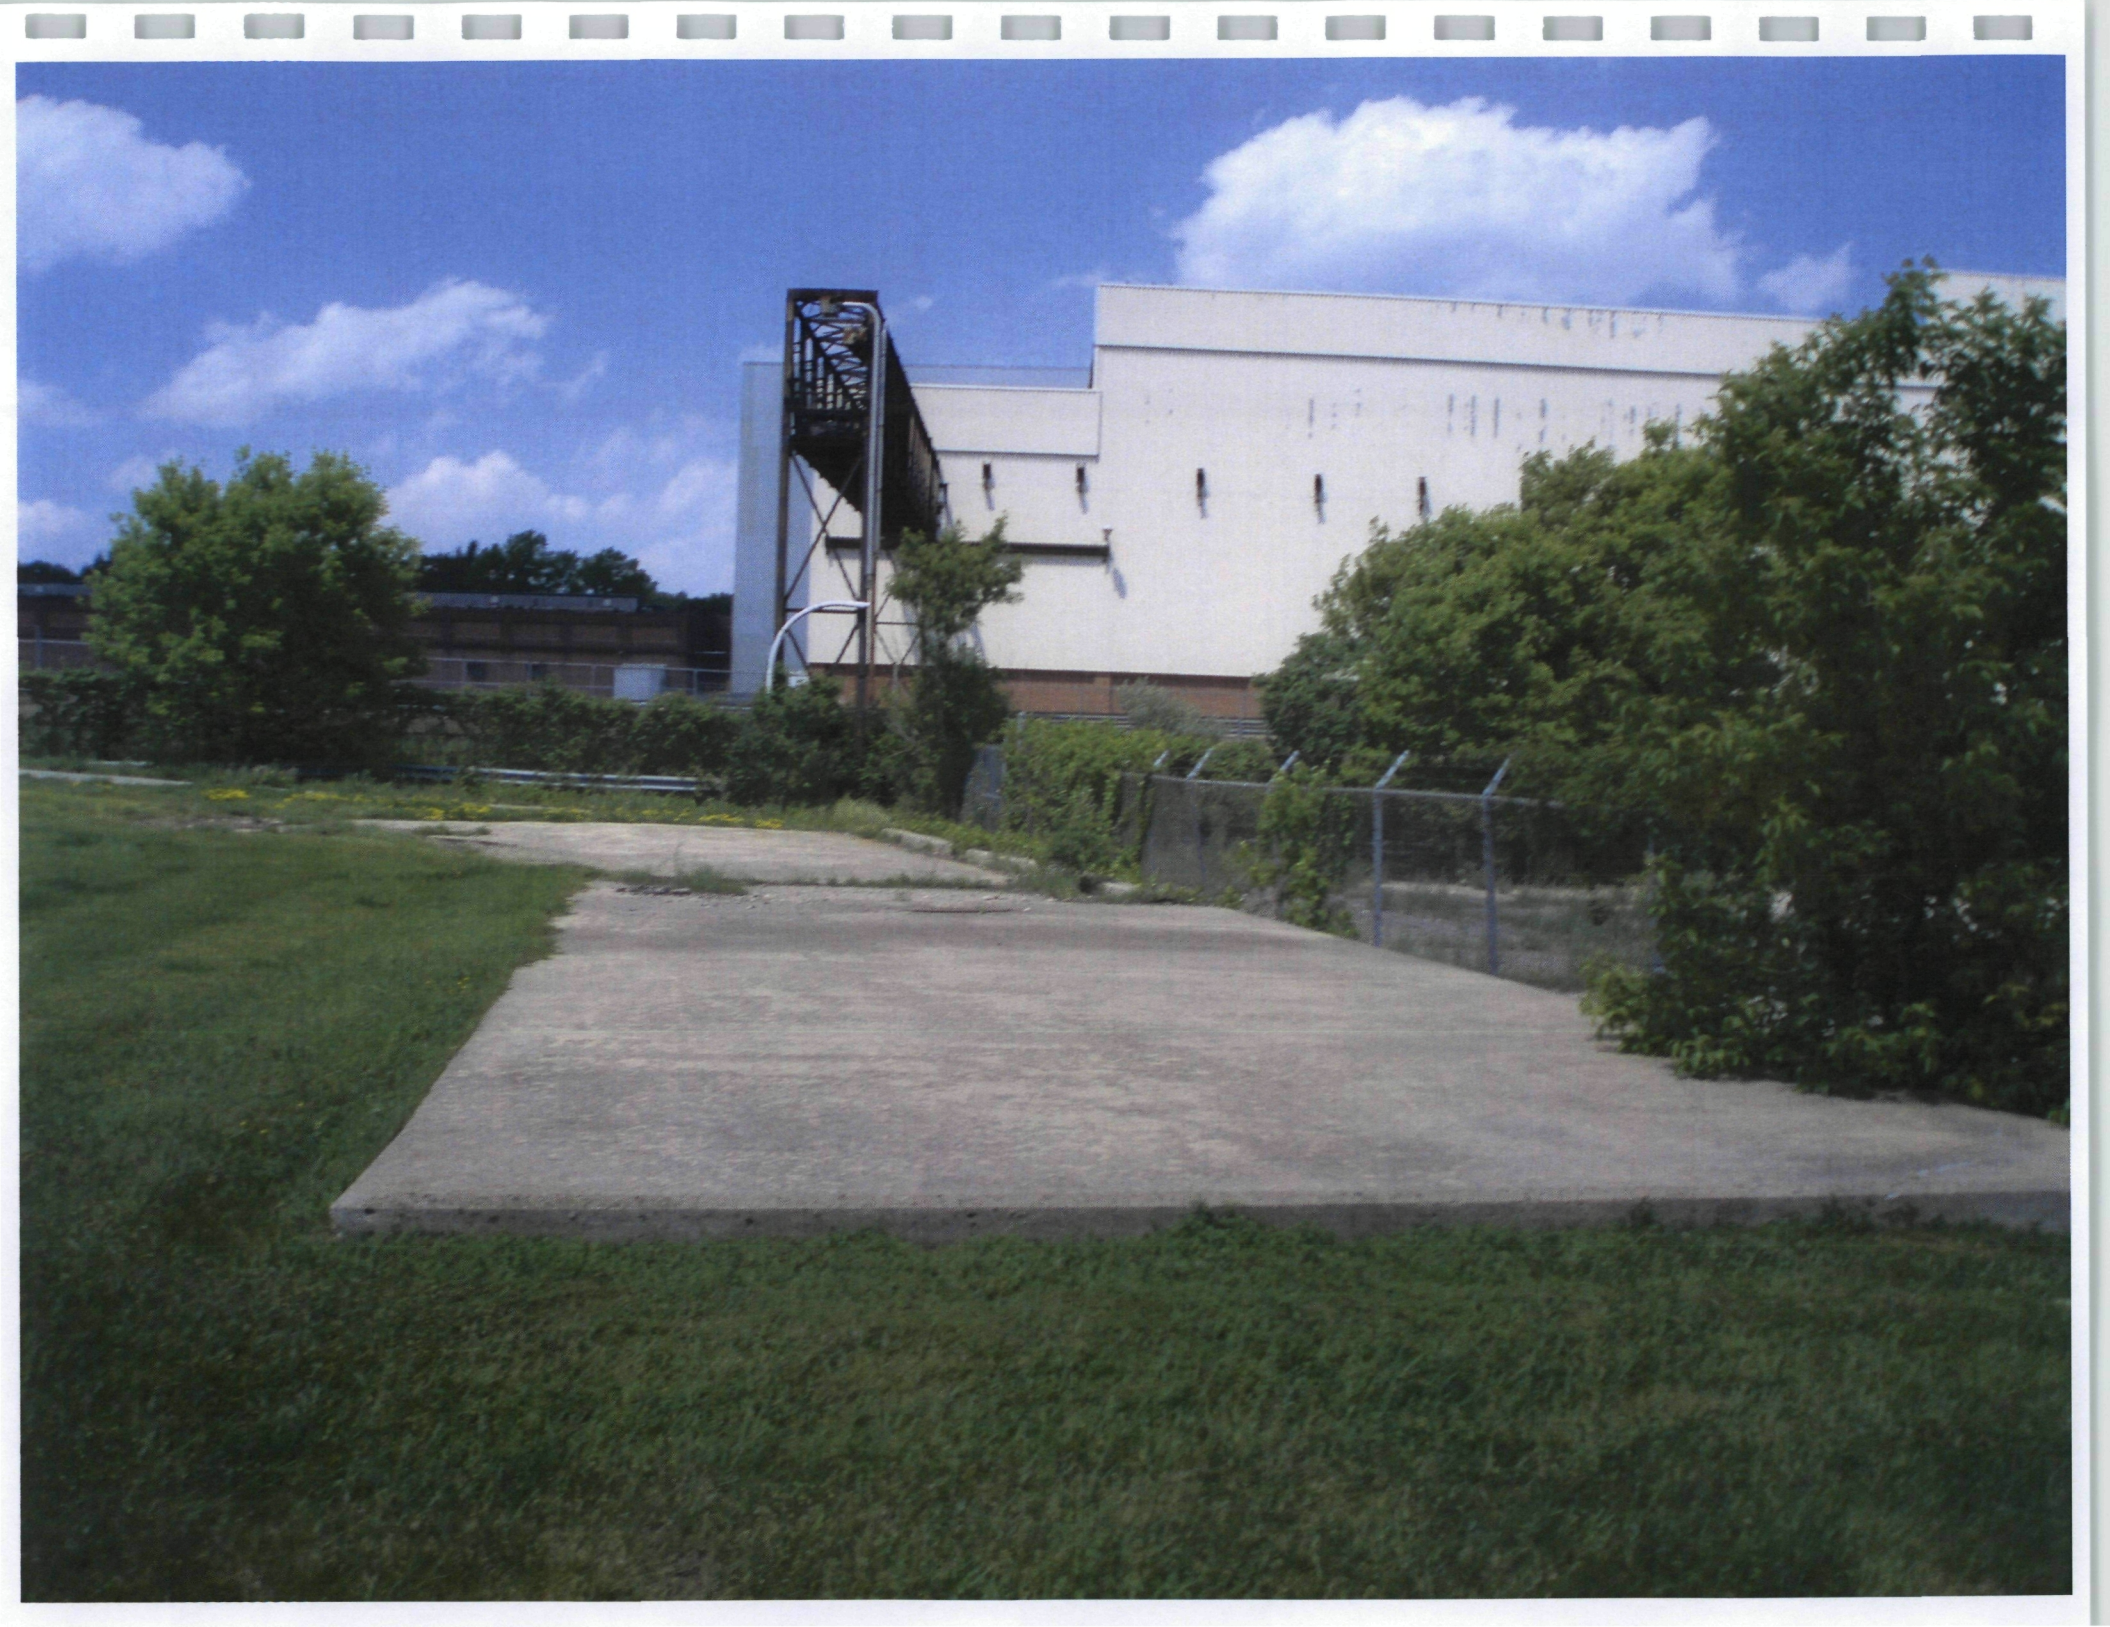
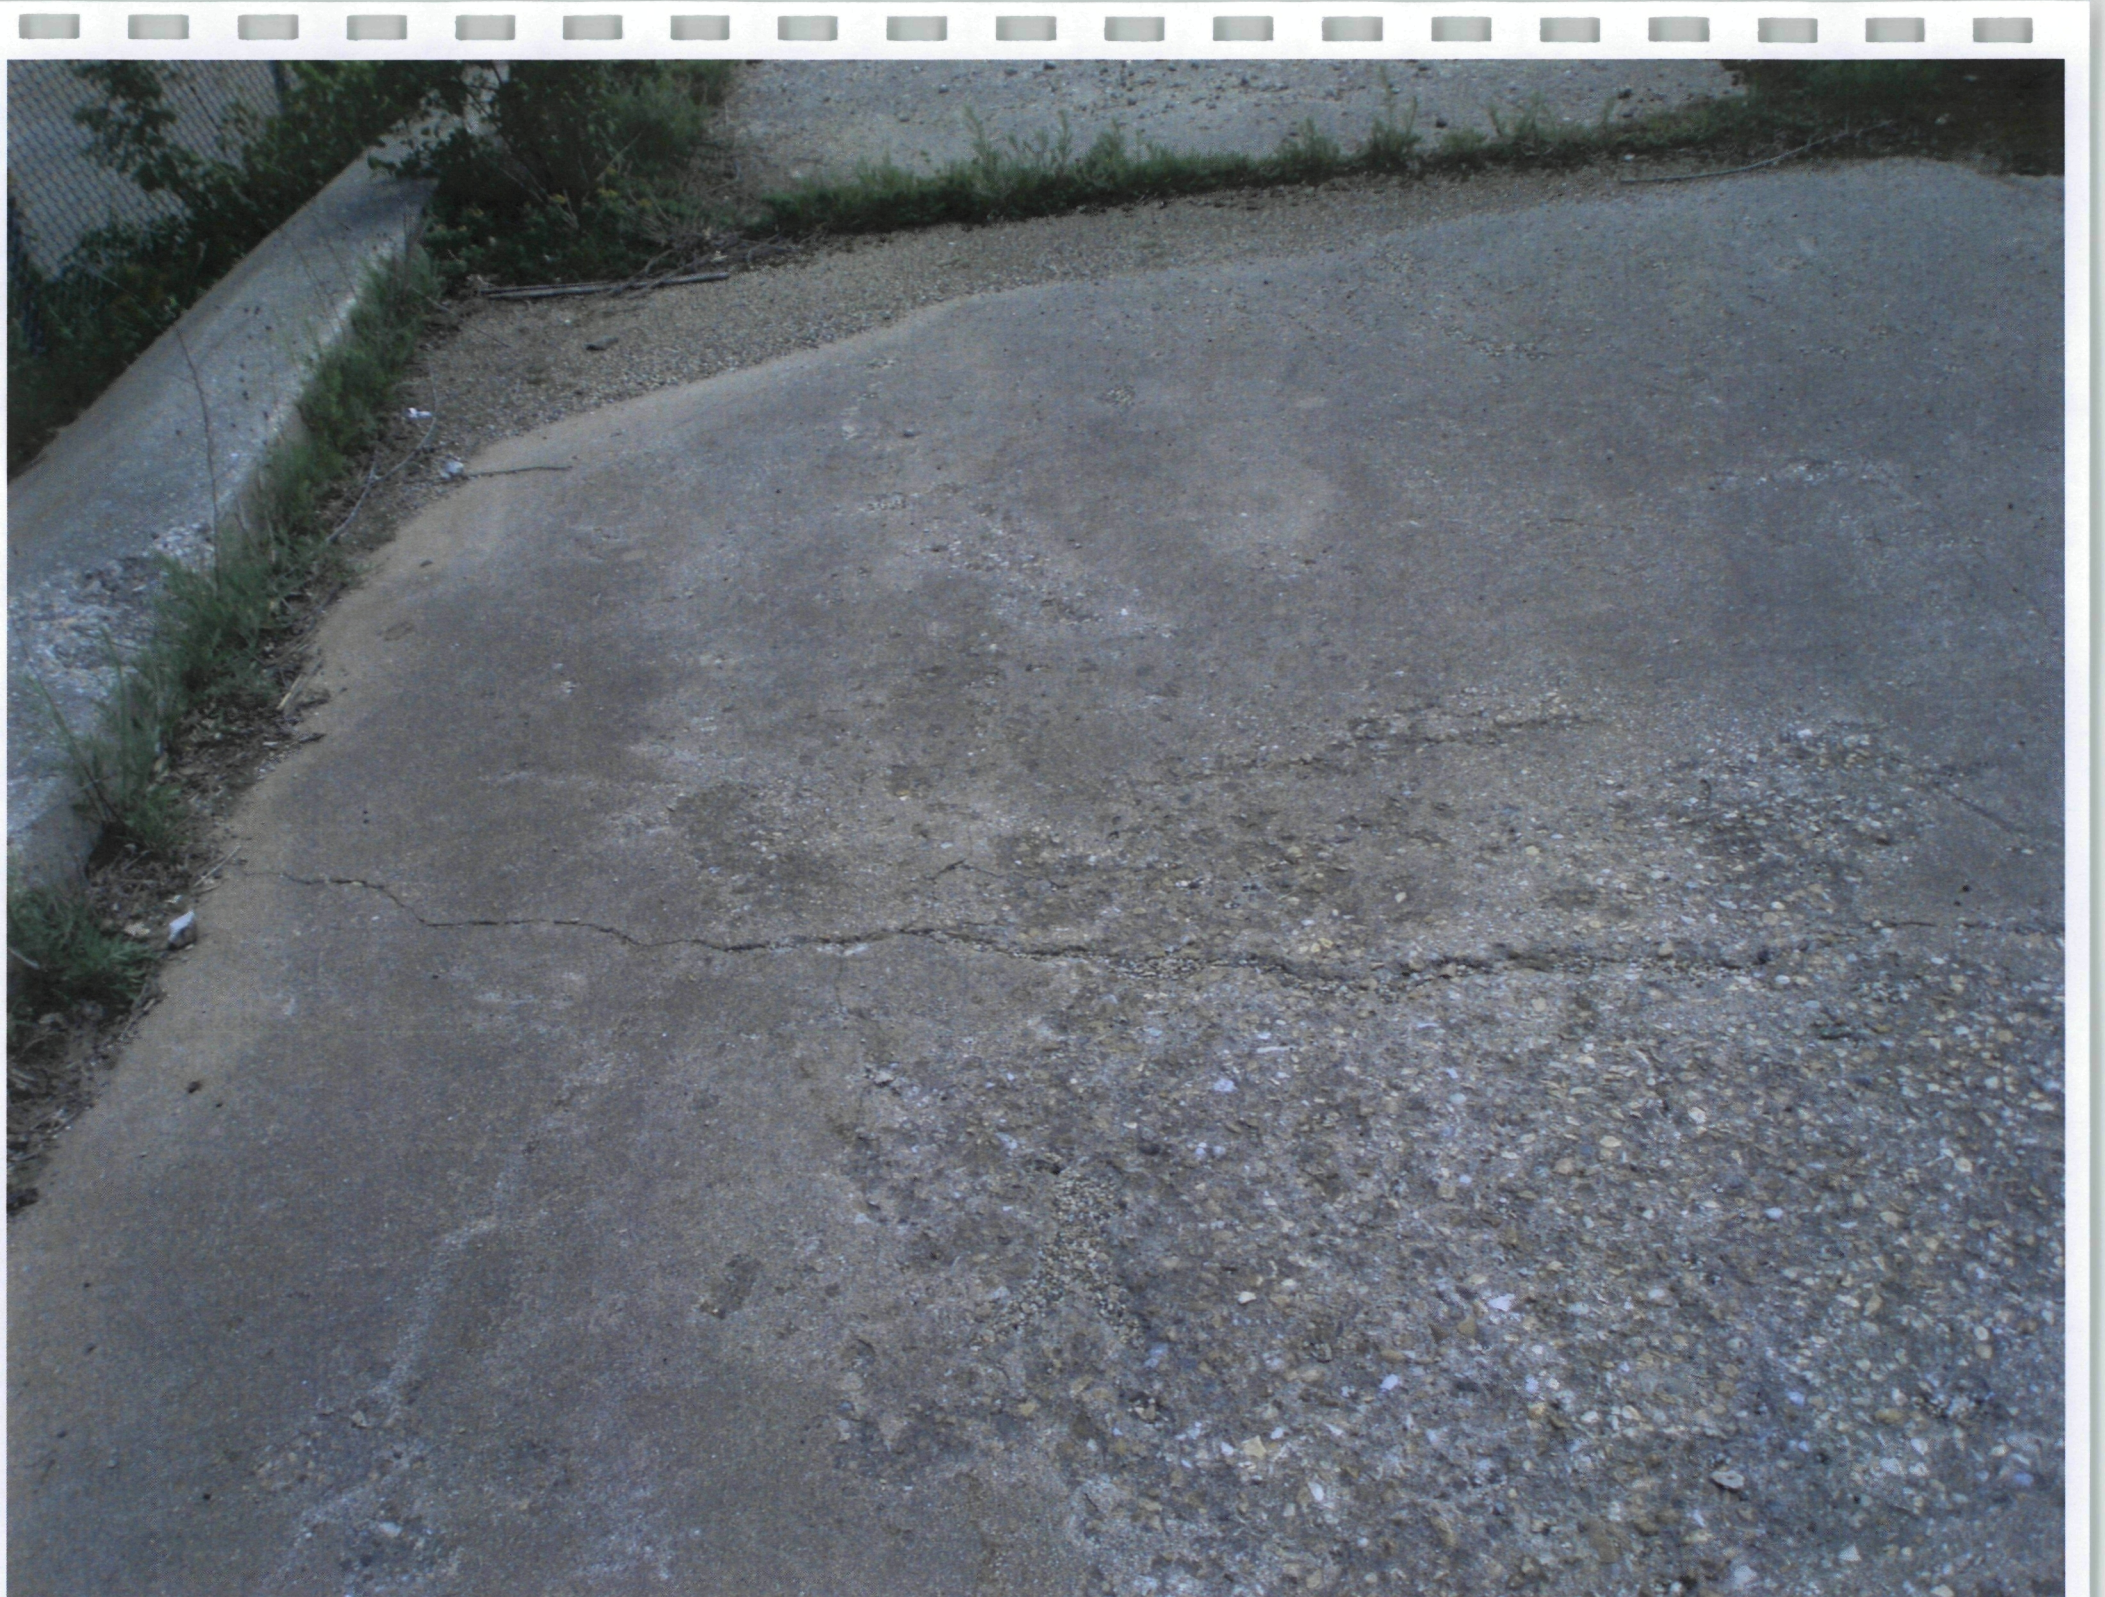
20s Complex
Barrier Area 2

- **Description of any conditions or problems noted during the inspection which are or may be affecting the performance of the engineered barrier:**
No conditions were observed which are or may be affecting the performance of the engineered barrier.

Date	6/9/09
Inspector	Chris Streeter
Weather Conditions	Sunny 90-89°
Evidence Of Change In Use	None observed
Physical Changes And Conditions Adjacent To Barrier Area	None observed
Soil Erosion	None observed
Excessive Vegetative Growth	Minor - Border + Surface
Excessive Cracking	Minor cracks - surface
Fissures	None observed
Spalling	None observed
Potholes	None observed
Heaving or Uneven Settling	None observed
Vehicular Use	None observed
Depressions	None observed
Water Ponding	None observed
Excessive Rutting	None observed
Exposed Subbase	None observed

- **Description of any measures that may need to be performed to correct any conditions affecting the performance of the barriers:**
No corrective actions required at this time.

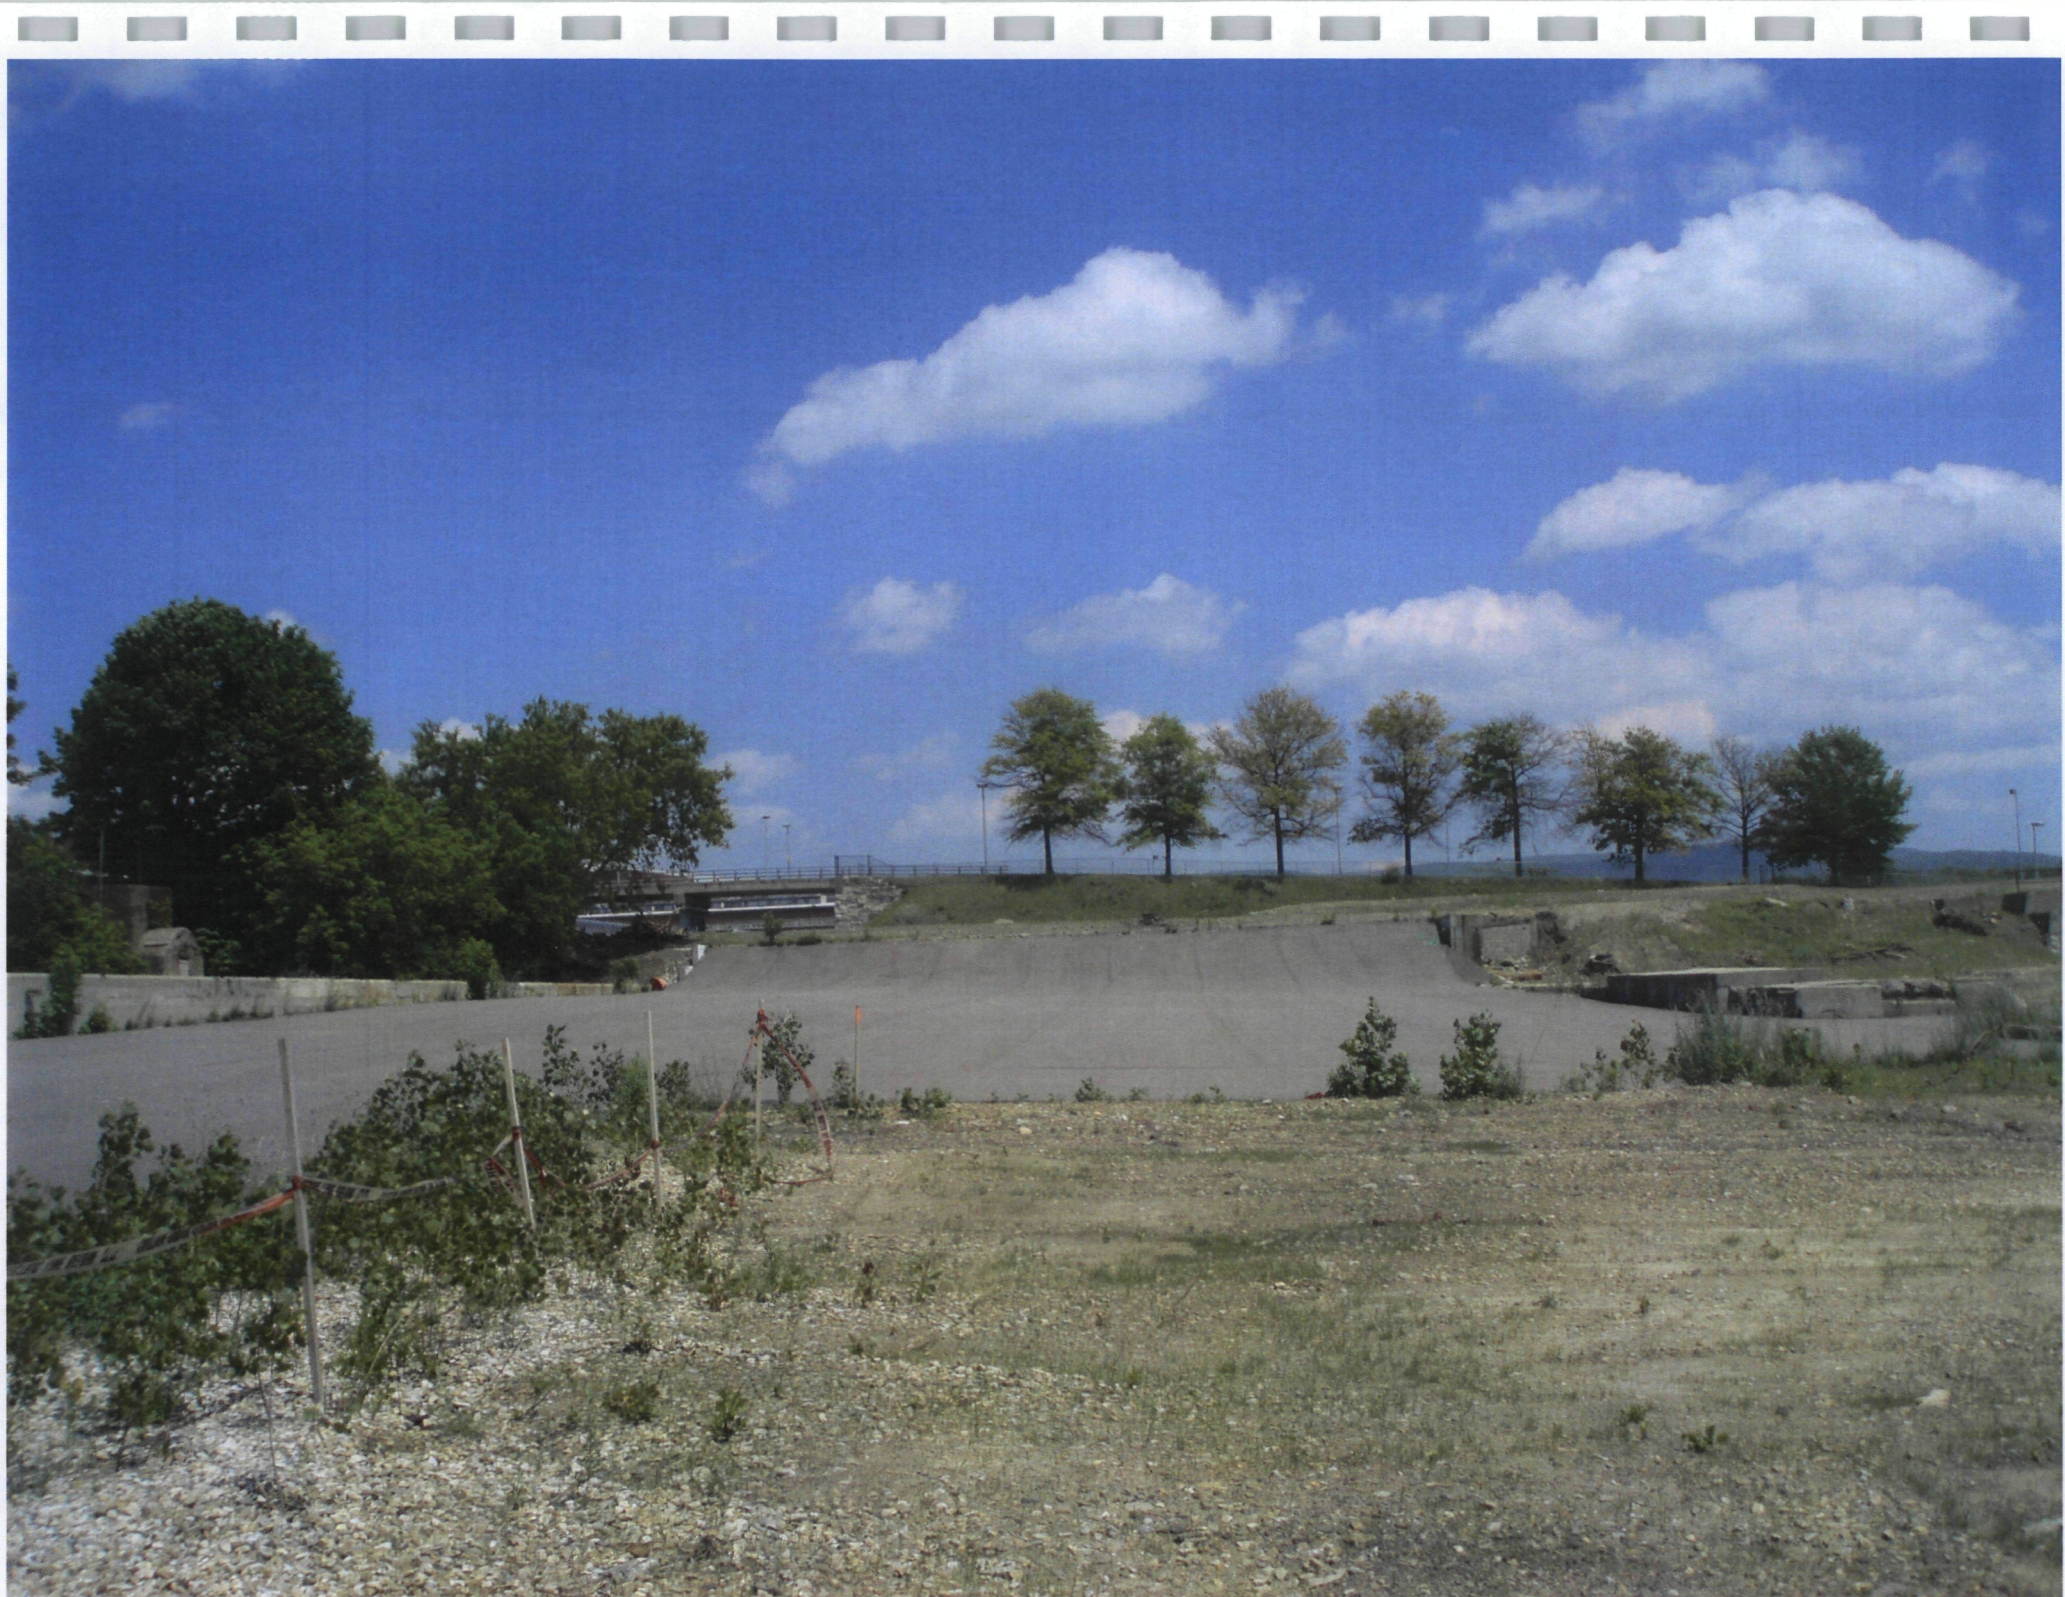
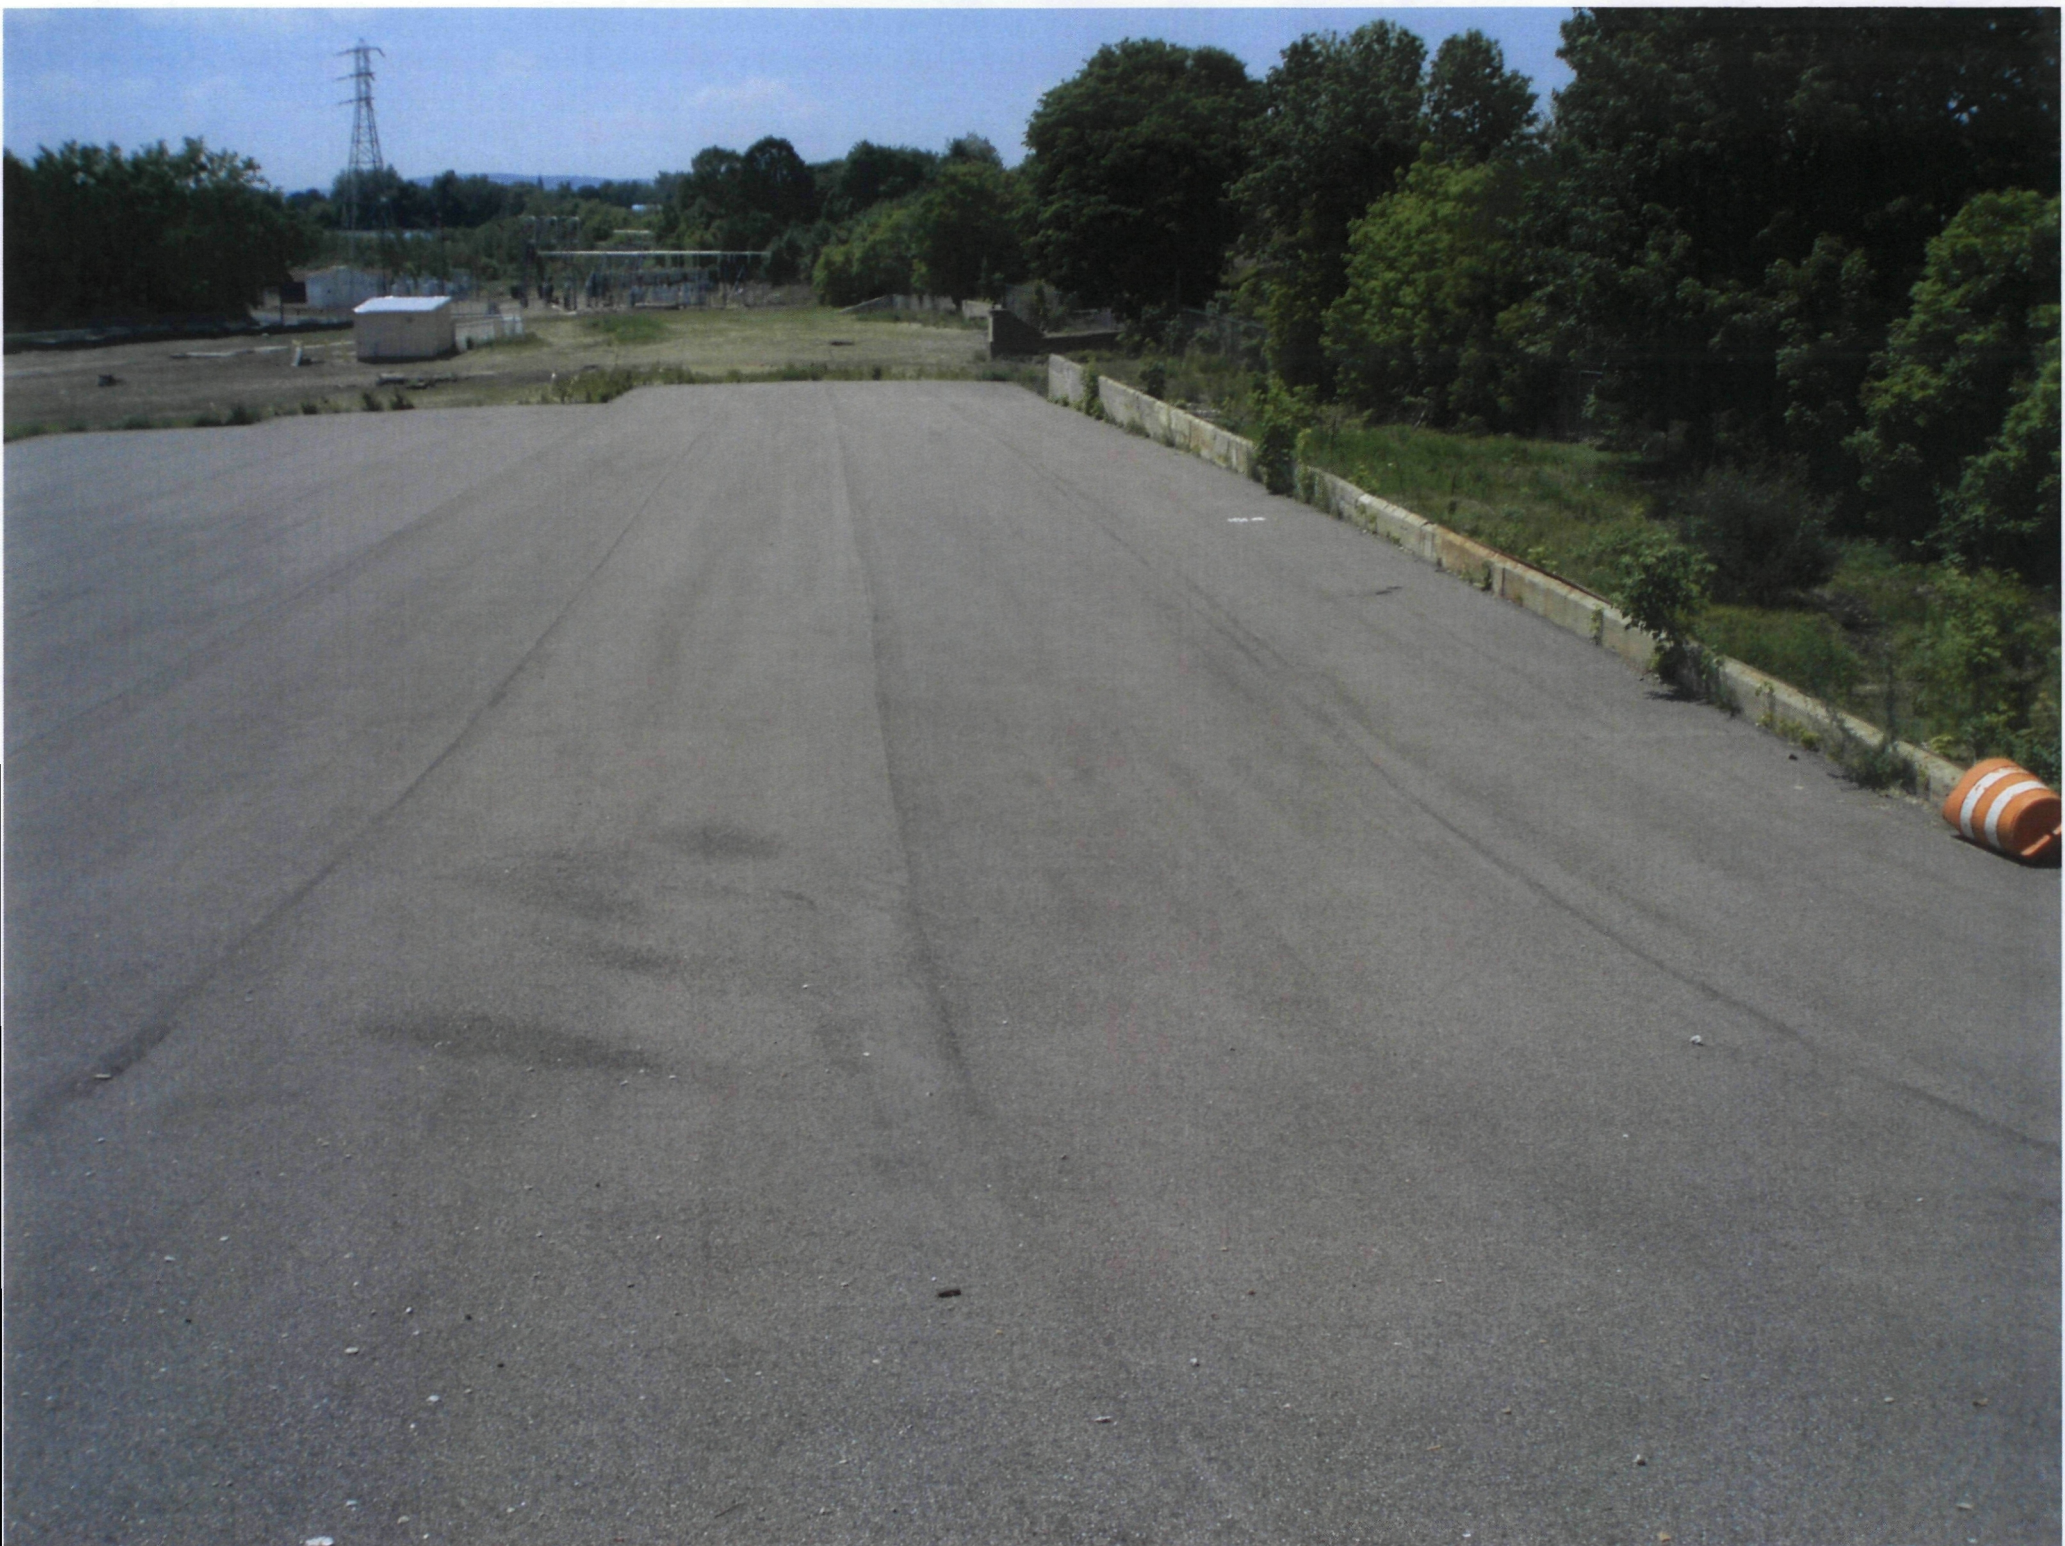
**30s Complex
Barrier Area**

- Description of any conditions or problems noted during the inspection which are or may be affecting the performance of the engineered barrier:
No problems that are or may affect the performance of the engineered barrier were observed.

Date	6/9/03
Inspector	Chris Streeter
Weather Conditions	Sunny 90-93°
Evidence Of Change In Use	None
Physical Changes And Conditions Adjacent To Barrier Area	Site preparation for development grading, clearing, Hydroseed
Soil Erosion	None observed
Excessive Vegetative Growth	minor border vegetation
Excessive Cracking	None observed
Fissures	None observed
Spalling	None observed
Potholes	2 repaired, no holes observed
Heaving or Uneven Settling	None observed
Vehicular Use	None observed
Depressions	None observed
Water Ponding	None observed
Excessive Rutting	None observed
Exposed Subbase	None observed

- Description of any measures that may need to be performed to correct any conditions affecting the performance of the barriers:
No conditions which require correction were observed.
