**Re: GE-Pittsfield/Housatonic River Site
East Street Area 2-South (GECD150)
Summary of November 2005 Inspection Activities – City Recreational Area**

**INSPECTION SUMMARY AND CHECKLIST
CITY RECREATIONAL AREA**

GENERAL ELECTRIC COMPANY
PITTSFIELD, MASSACHUSETTS
SUMMARY OF NOVEMBER 2005 INSPECTION
ACTIVITIES - CITY RECREATIONAL AREA

**BALLFIELD AREA AND
ACCESS ROAD AREA**

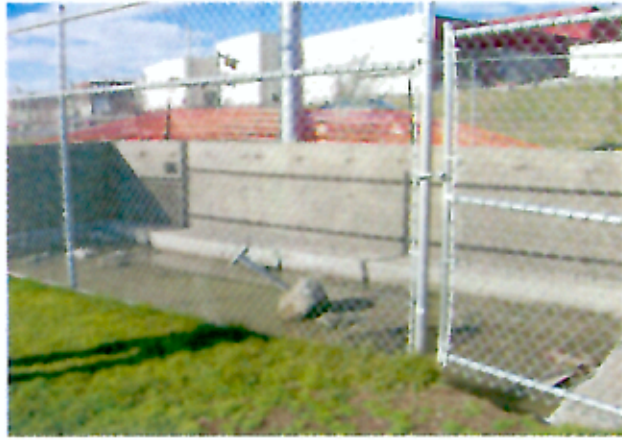
Photo #1: 3rd Base Dugout. Partial Concrete Slab/Wall Installation (11/18/05)

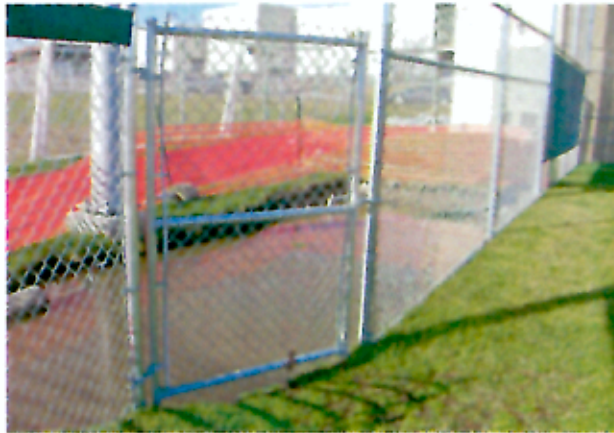
- Erosional gully noted along southern fenceline of Ballfield Area (see Part III below).
- Ongoing construction of new dugout structures, noted; Dugout on 1st base side currently excavated with standing water; depth of excavation may extent to native pre-cover soils.
- New playground structure noted in northeast corner of Ballfield Area
- All other areas in good condition

Photo #2: 1st Base Dugout. Excavation in Advance of Dugout Construction. Note approximate excavation depth (12 inches) and standing water (11/18/05)

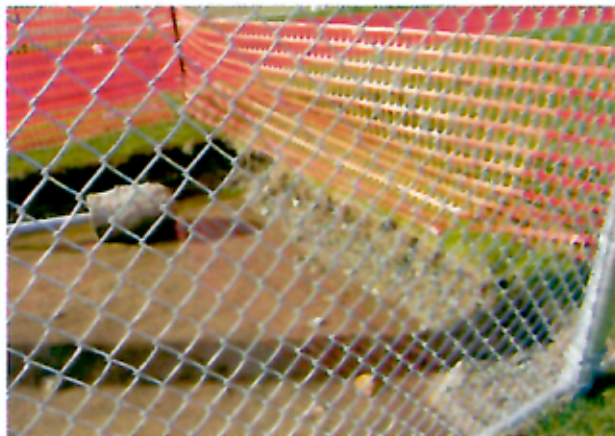
Photo #3: 1st Base Dugout. Excavation in Advance of Dugout Construction. Note approximate excavation depth (12 inches) and standing water (11/18/05)

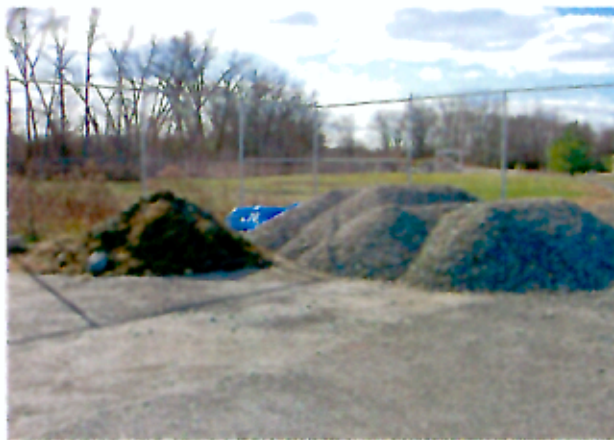
- Portions of Access Road Area contain soil, stone, debris stockpiles.
- See attached photographs for further information.

Photo #5: City Material Stockpile in Southwest Corner of Access Road Area (11/18/05)

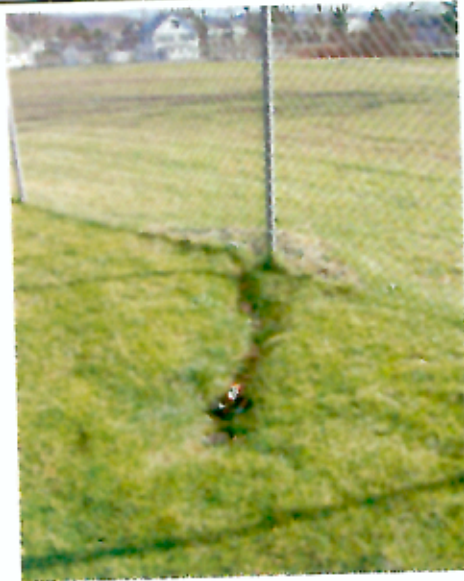
Photo #6: Erosion Gully with Soil Cover Area Along Southern Fenceline of Ballfield Area
Note Soil Deposit on Far Side of Fenceline (11/18/05)

Erosional gully noted along southern fenceline of Ballfield Area was repaired and re-seeded by GE on December 2, 2005.

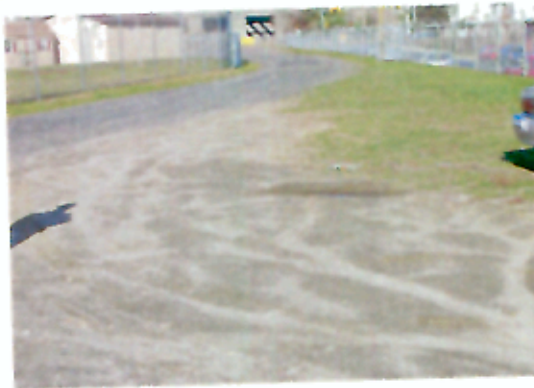
- Gravel surfaces all in good condition; no signs of settlement, erosion, etc.
- Some areas adjacent to gravel surfaces void of vegetation (may be due to vehicle traffic/parking); need to discuss future use of this area with City.

Photo #7: Absence of Vegetative Cover East of Gravel Access Road. Note Access Road is Adjacent to Fenceline in Upper Right Corner of Photo (11/18/05)

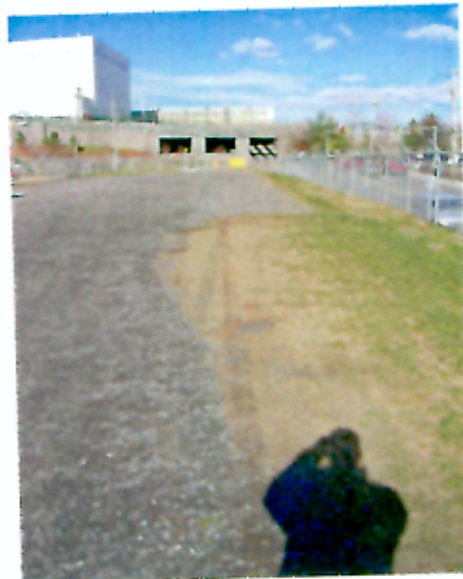
Photo #8: Absence of Vegetative Cover East of Gravel Parking Area (11/18/05)
