**Re: GE-Pittsfield/Housatonic River Site  
East Street Area 2-South (GEC150)  
Summary of October 2007 Inspection Activities – City Recreational Area**

**SUMMARY OF OCTOBER 2007 INSPECTION  
 ACTIVITIES - CITY RECREATIONAL AREA**

**BALLFIELD AREA AND ACCESS  
 ROAD AREA**

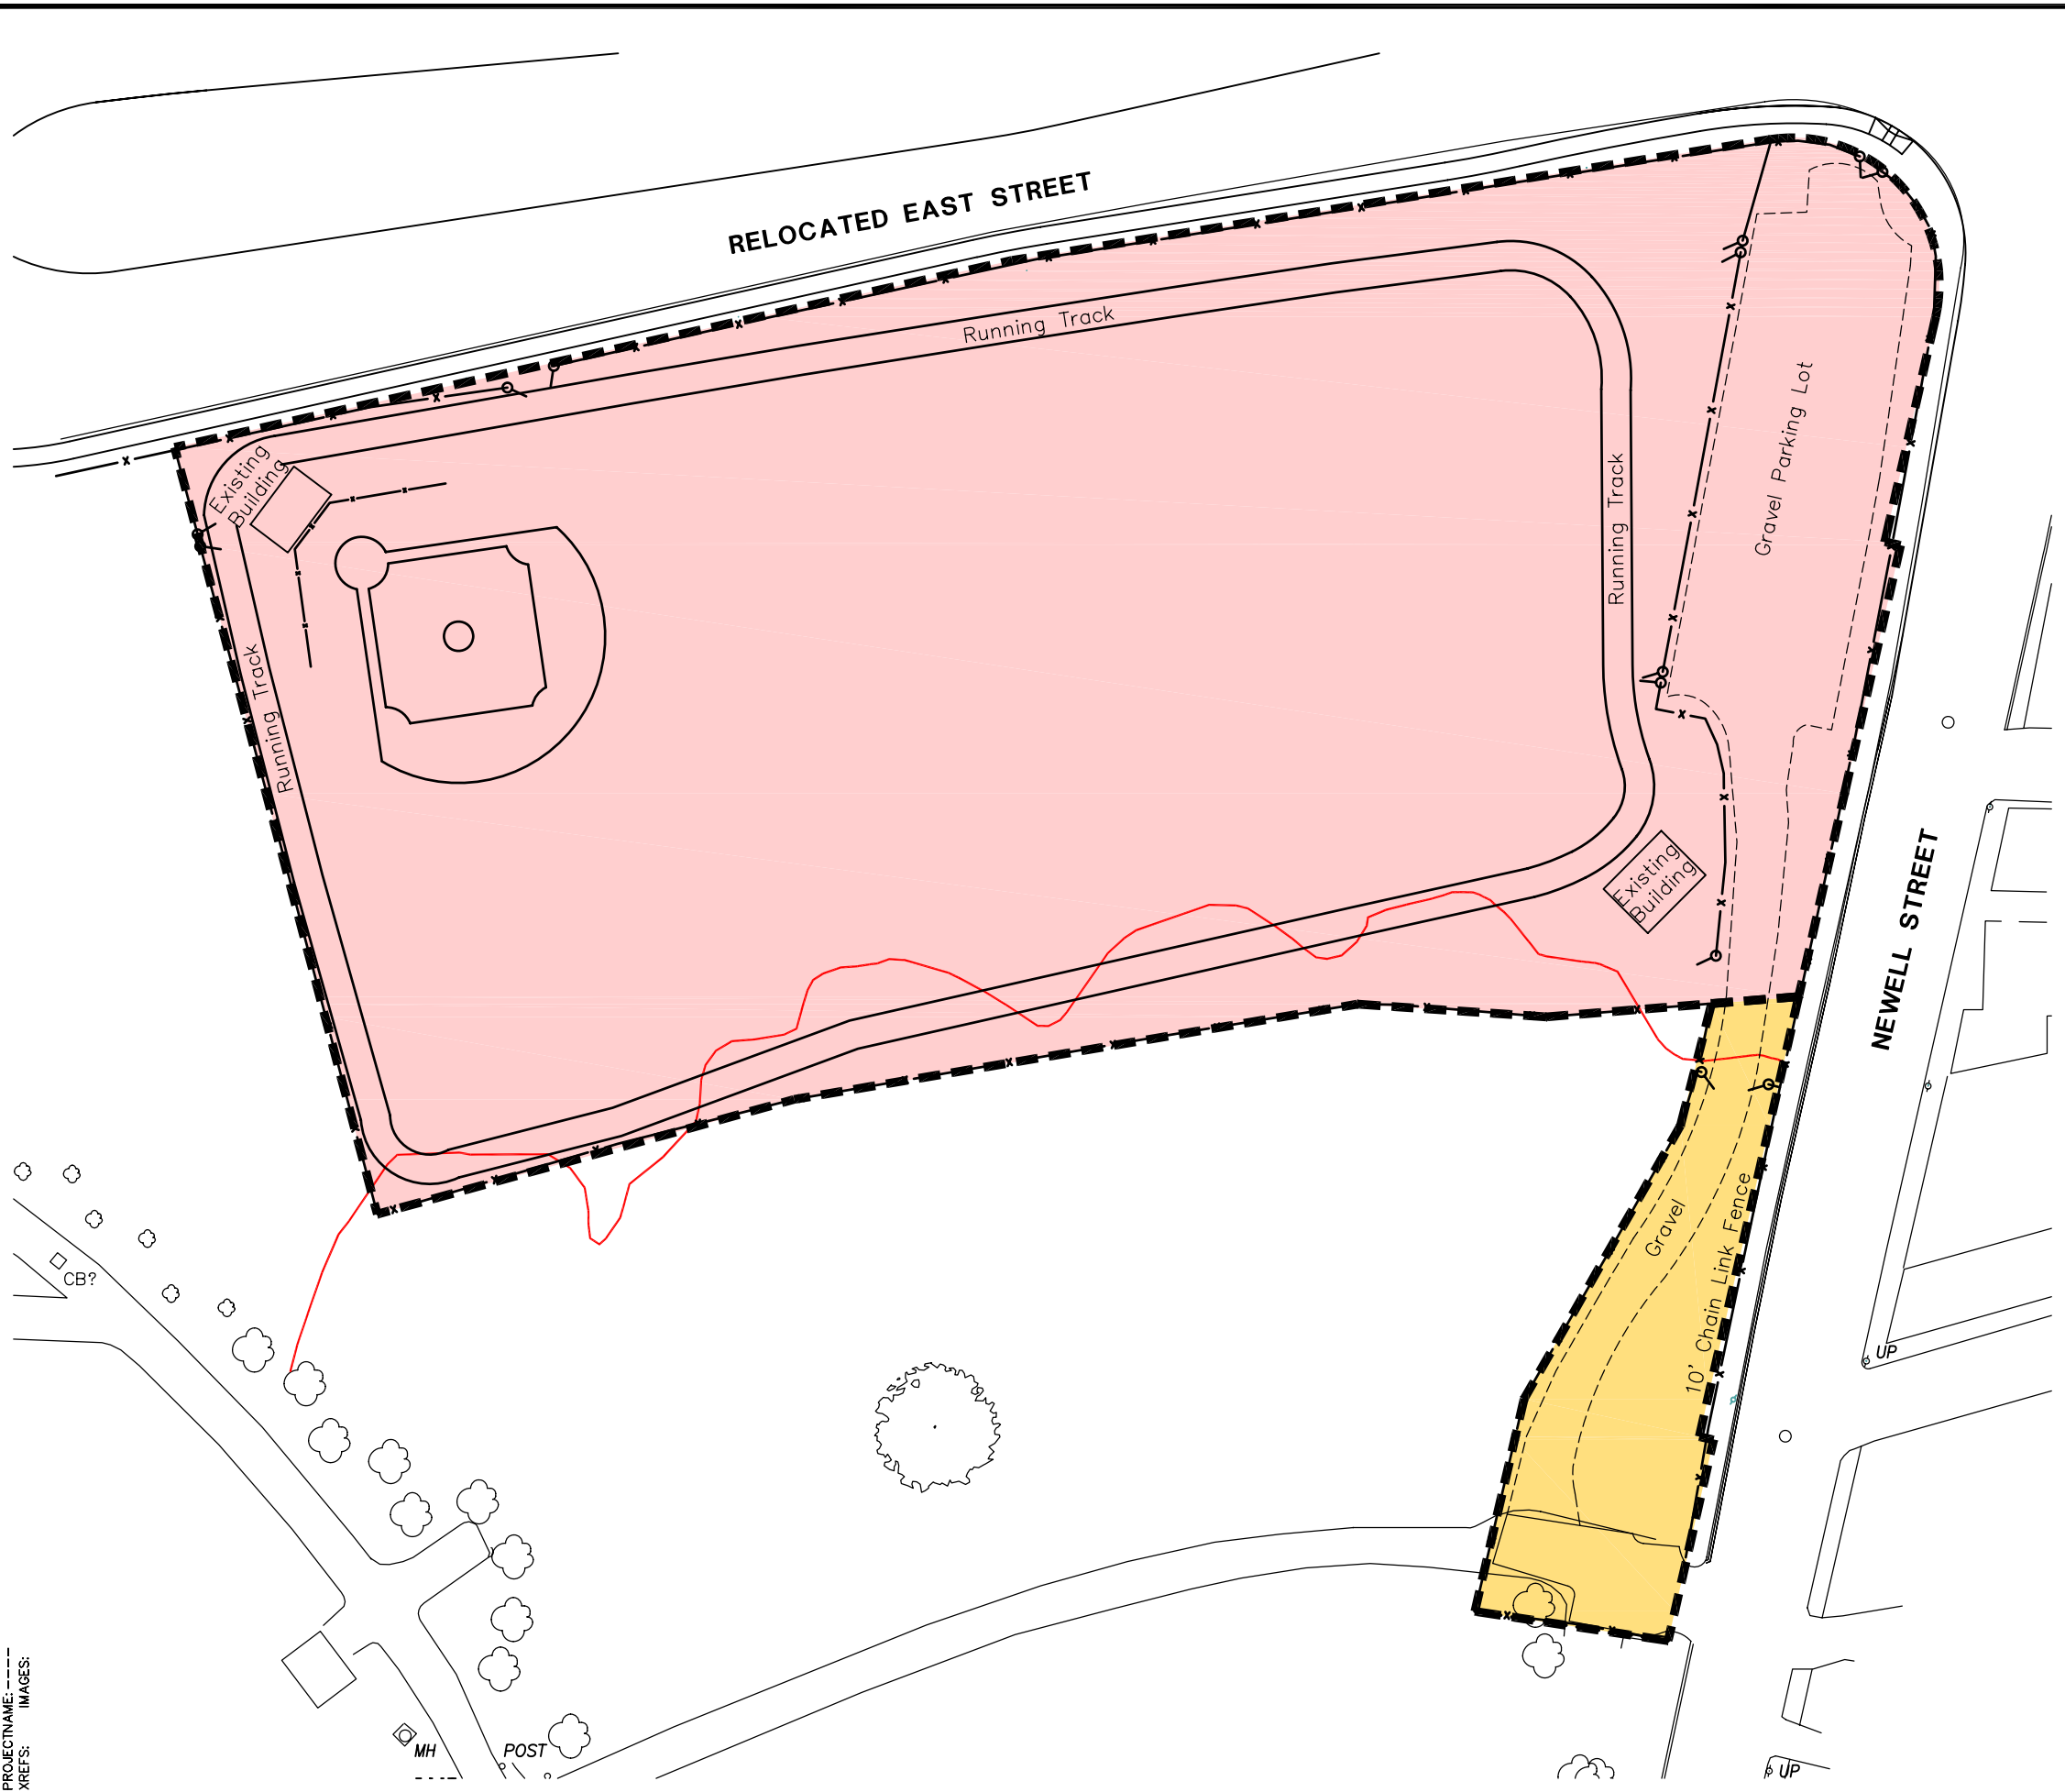
FIGURE  
**1**

- A large section of stone curbing is staged along the southern fence line. GE will discuss the necessary action to be taken with the City.
- Certain areas adjacent to the access road remain devoid of vegetation due to vehicle traffic/parking. GE will discuss this issue with the City again.
