**Re: GE-Pittsfield/Housatonic River Site
East Street Area 2-South (GECD150)
Summary of September 2008 Inspection Activities – City Recreational Area**

**INSPECTION SUMMARY AND CHECKLIST
CITY RECREATIONAL AREA**

**AREAS/ITEMS SUBJECT TO
 INSPECTION**

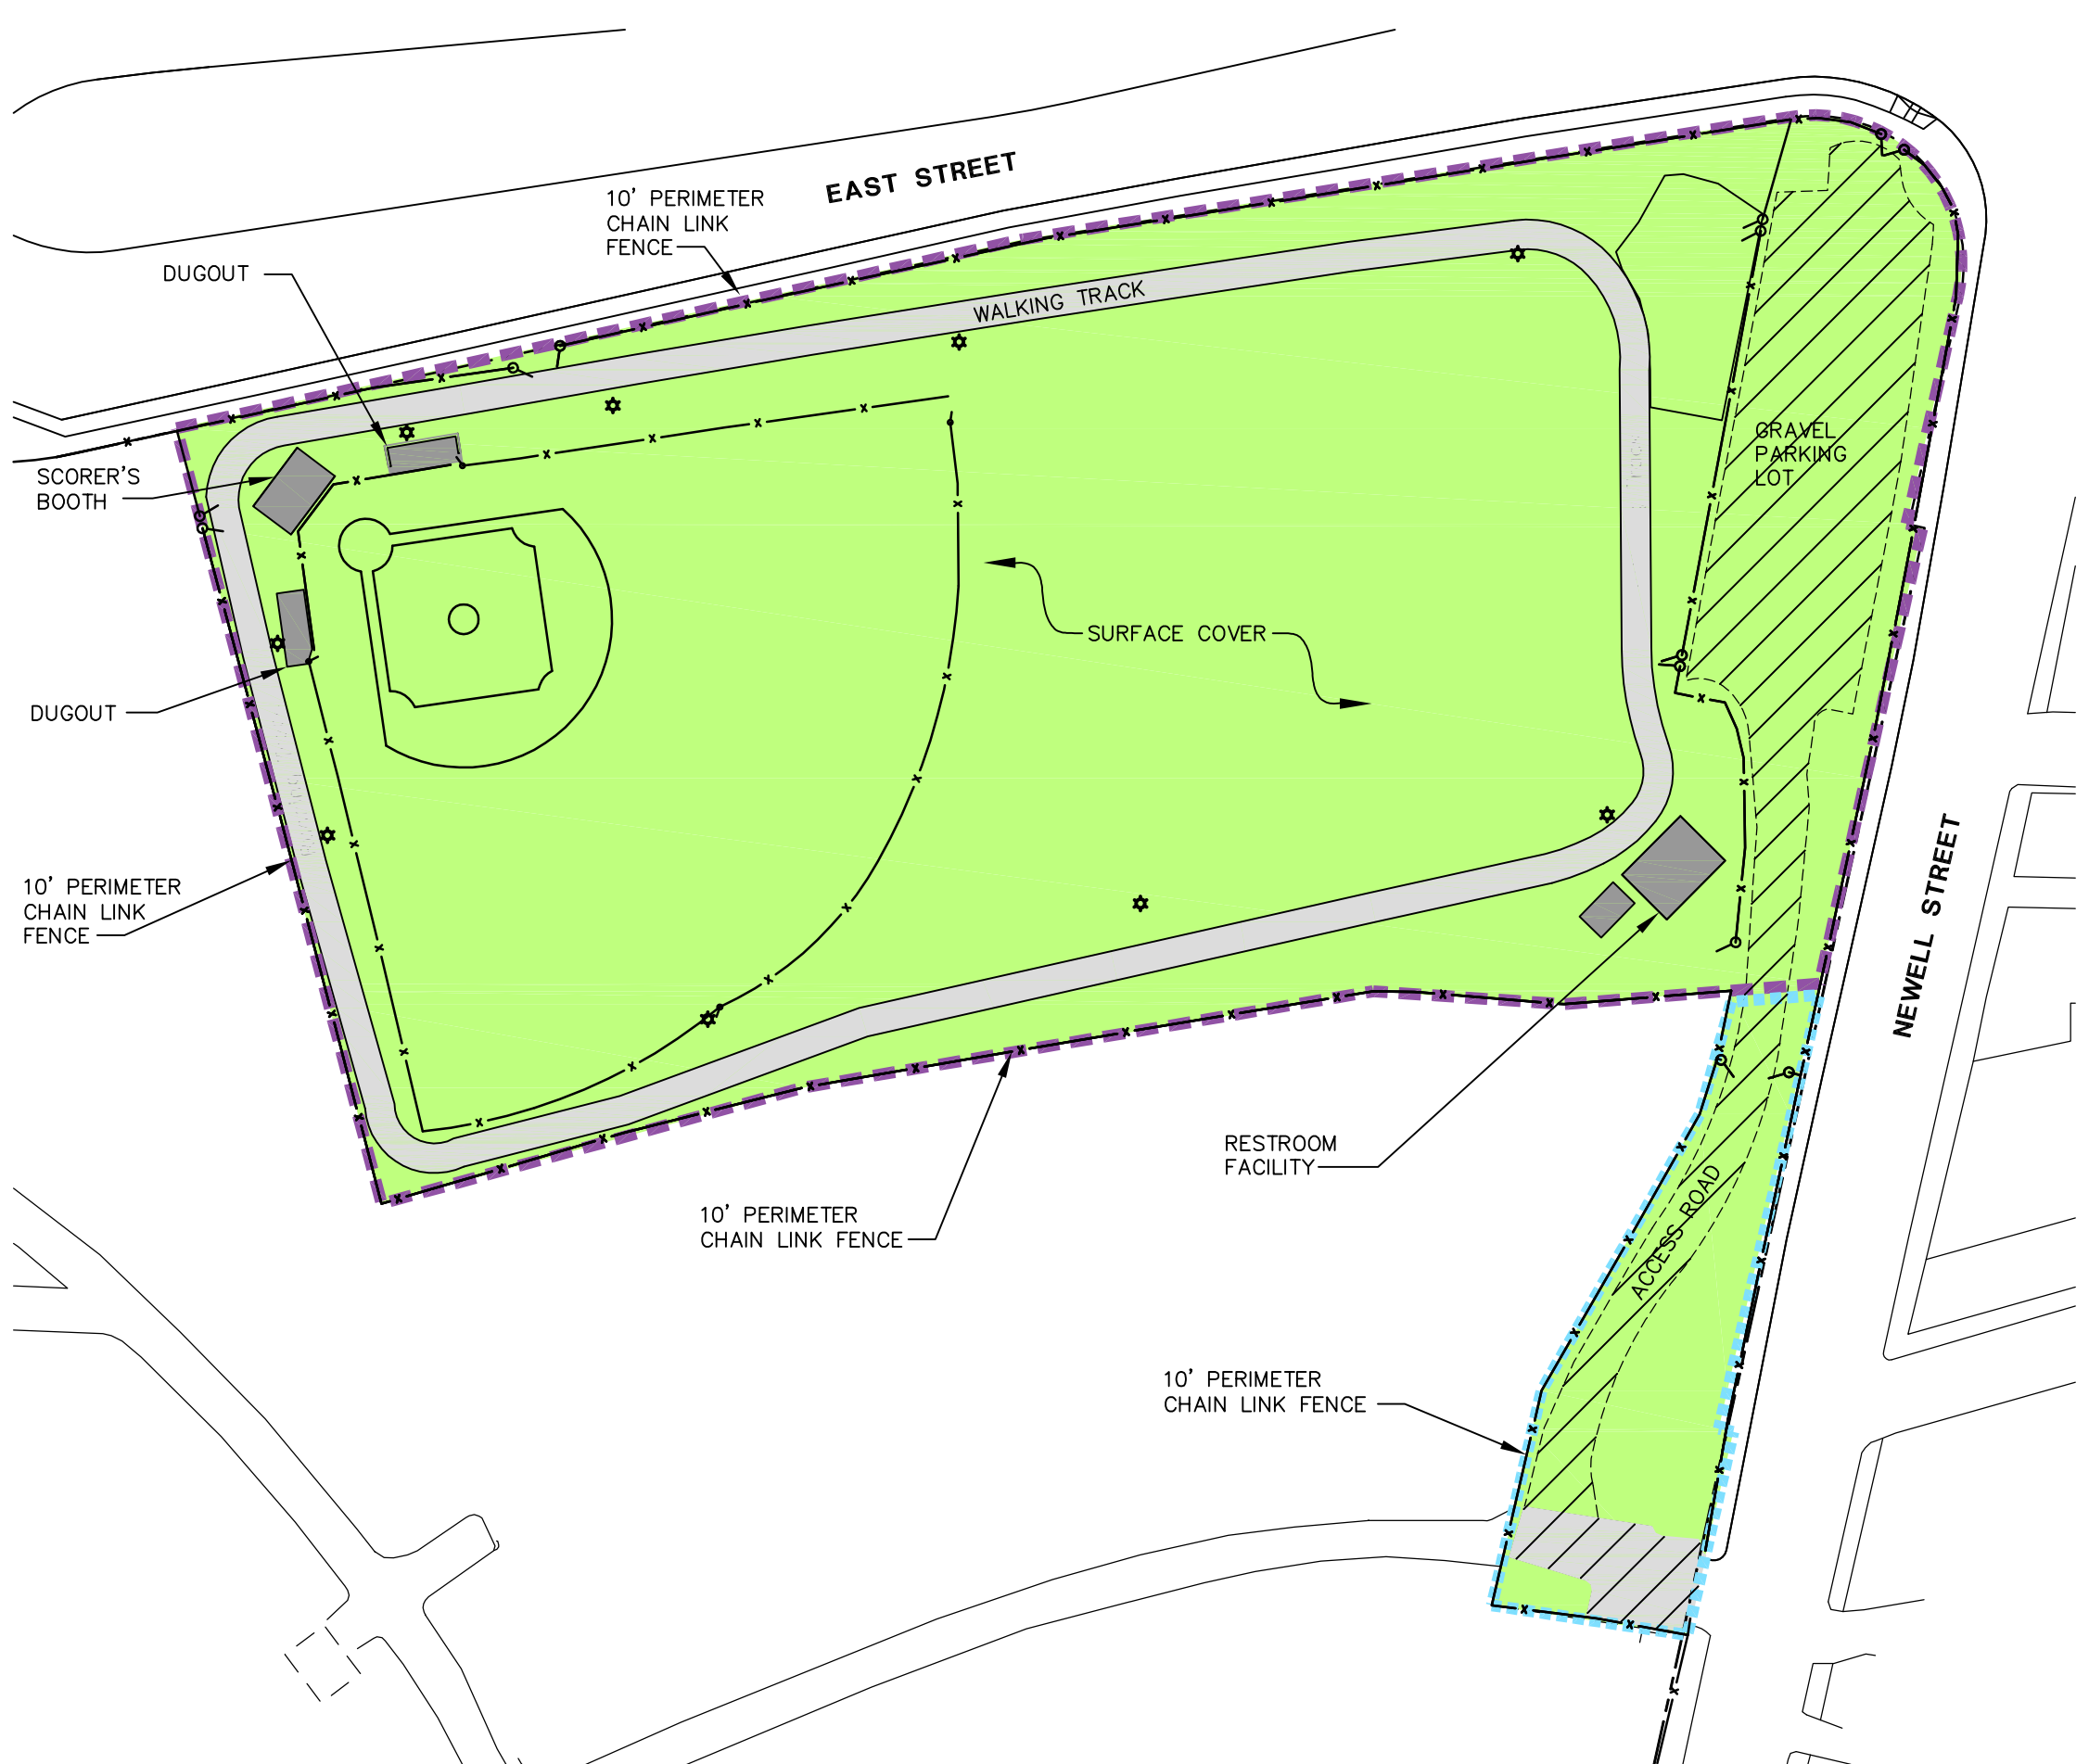
FIGURE
3

The September 2008 inspection was performed in accordance with the Post-Removal Site Control requirements specified in the *Final Completion Report for the City Recreational Area* (Final Completion Report), which was submitted to EPA on July 31, 2008 and approved by EPA on August 27, 2008. This inspection included observations of the soil cover and the perimeter fencing, as shown on Figure 3 of the Final Completion Report, a copy of which is attached hereto.
