**Re: GE-Pittsfield/Housatonic River Site
East Street Area 1-North (GECD130)
Summary of 2007 Conditional Solution Inspection Activities**

CONDITIONAL SOLUTION ANNUAL INSPECTION CHECK LIST FOR EAST STREET AREA 1-NORTH

GENERAL ELECTRIC COMPANY
 PITTSFIELD, MASSACHUSETTS
**FALL 2007 CONDITIONAL SOLUTION INSPECTION
 FOR EAST STREET AREA 1 - NORTH**

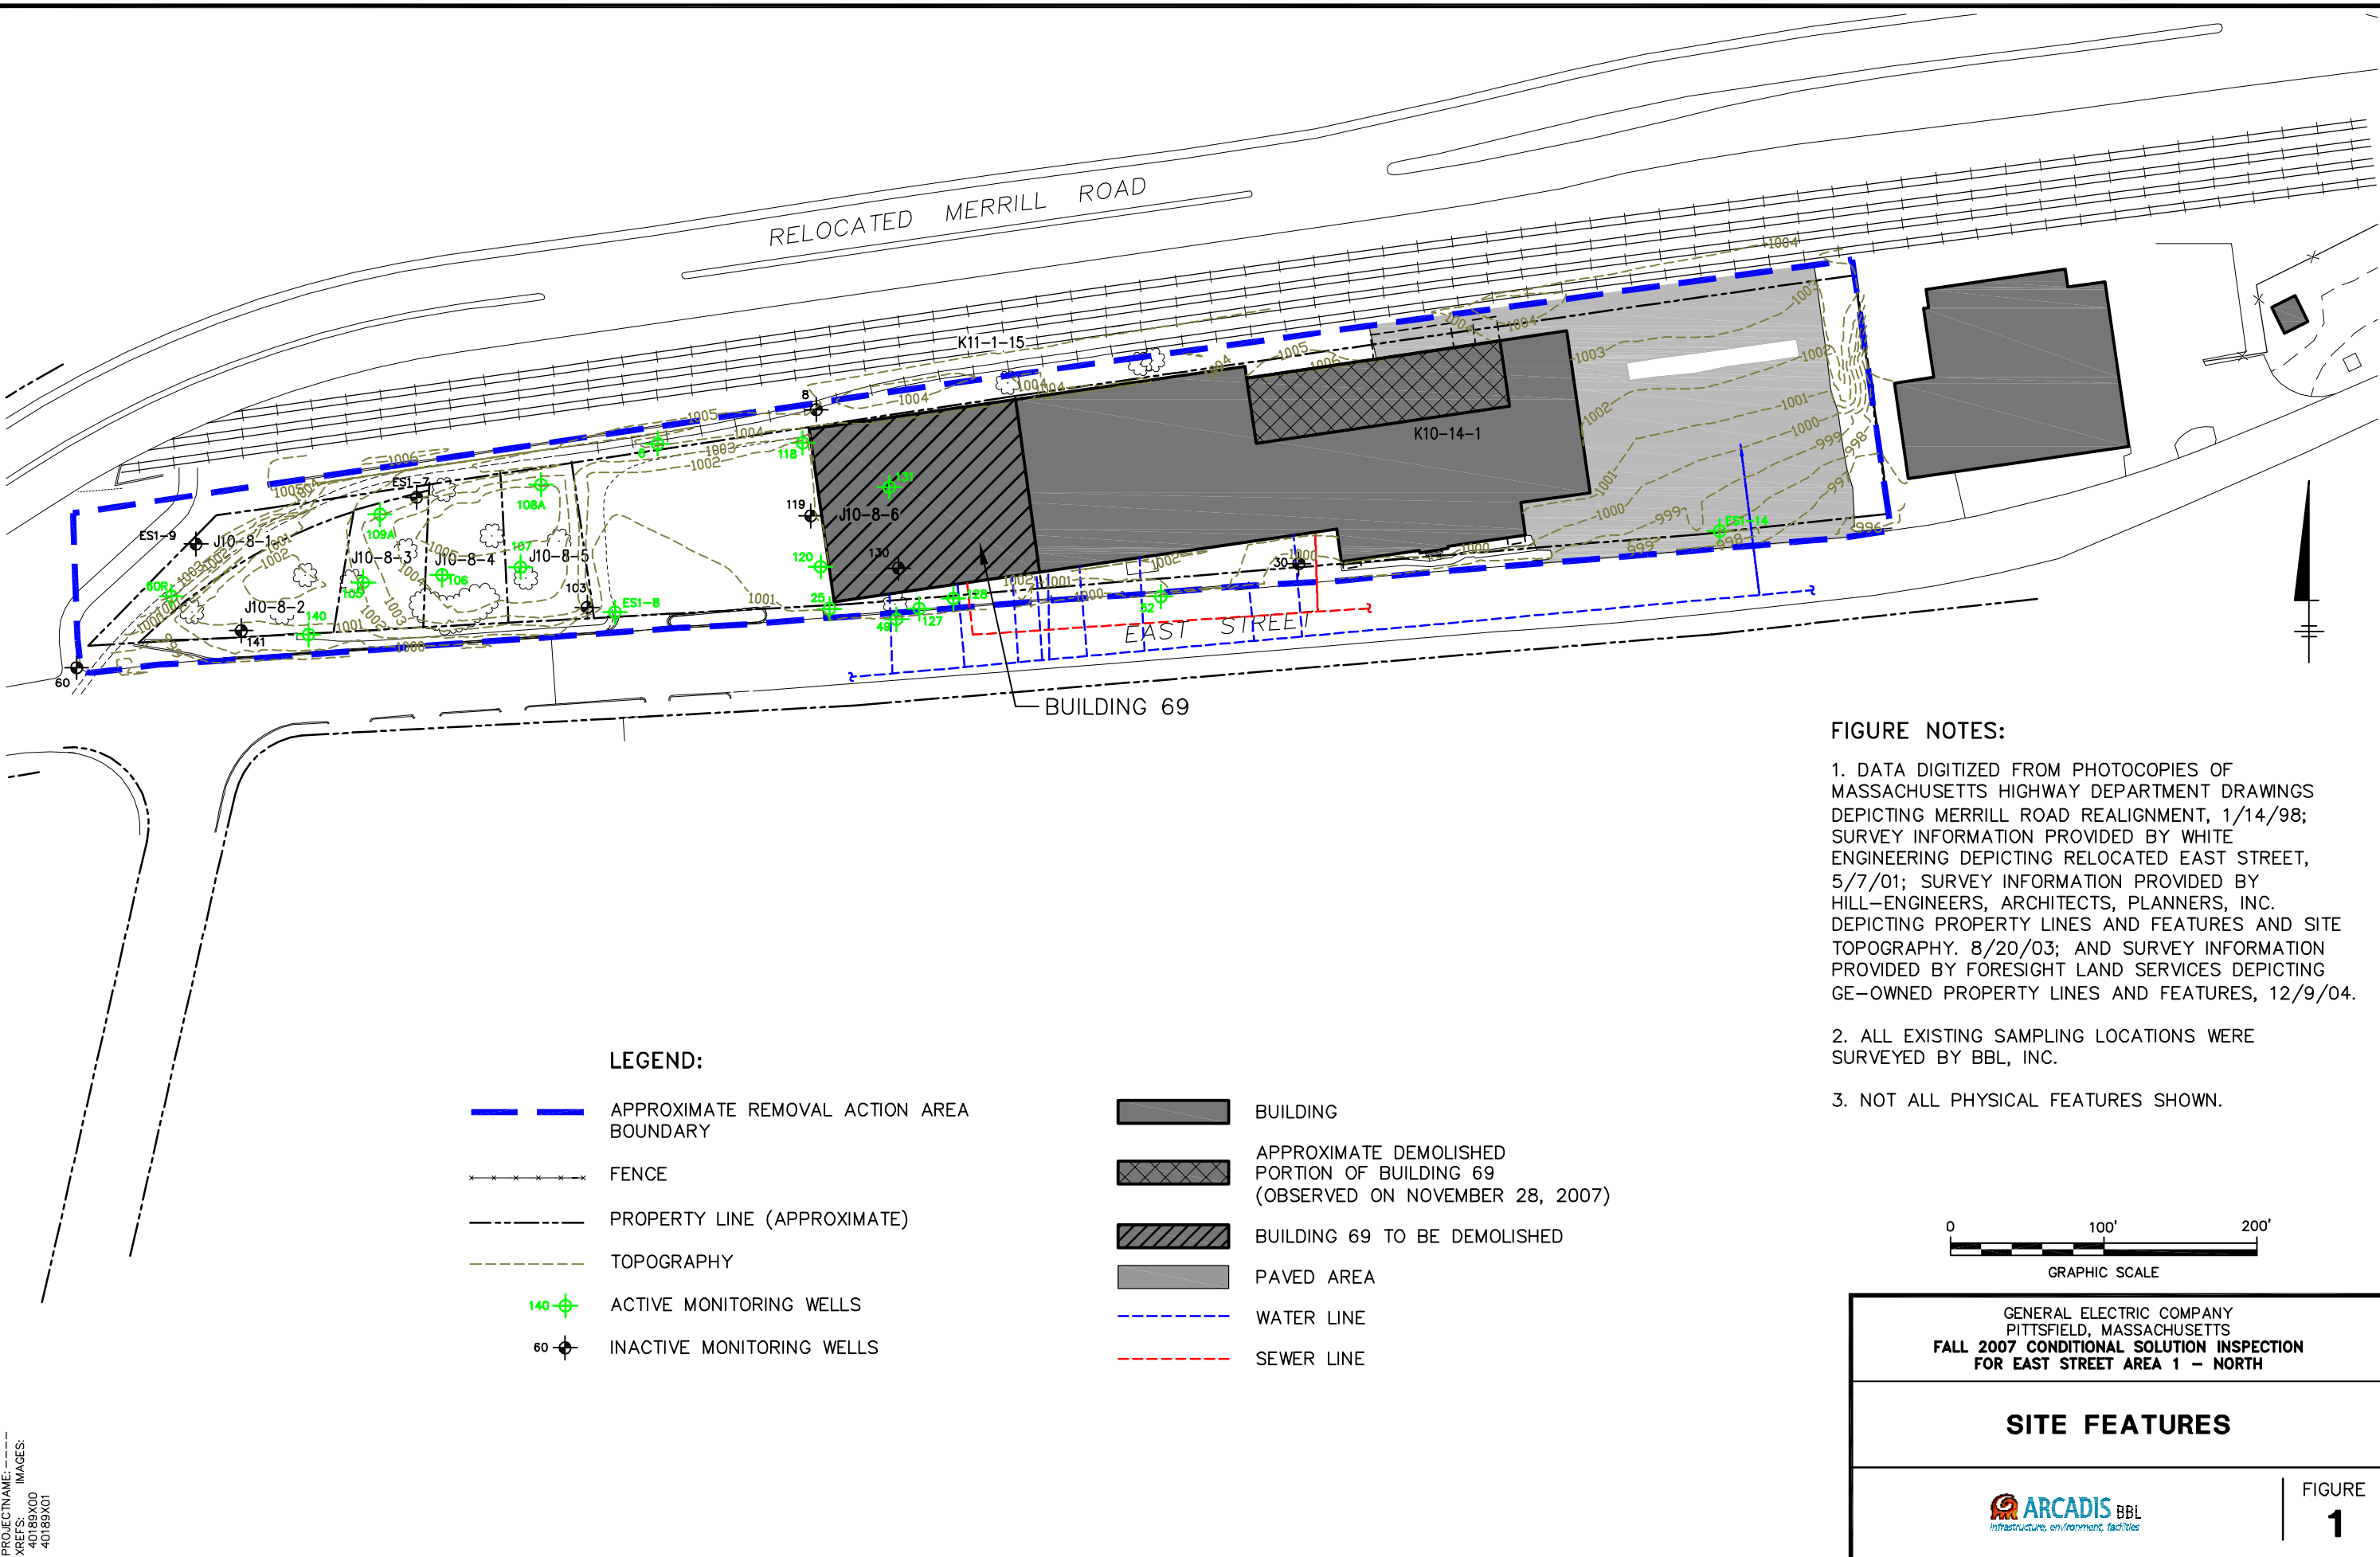
FIGURE
1

An area of Building 69 was demolished which caused the ground in and around this area to be disturbed. The approximate area that was demolished is shown on the attached figure.
