GE  
159 Plastics Avenue  
Pittsfield, MA 01201  
USA

June 27, 2008

**Re: GE-Pittsfield/Housatonic River Site  
Former Oxbow Areas A and C (GECD410)  
Summary of May 2008 Vegetation Inspection Activities**

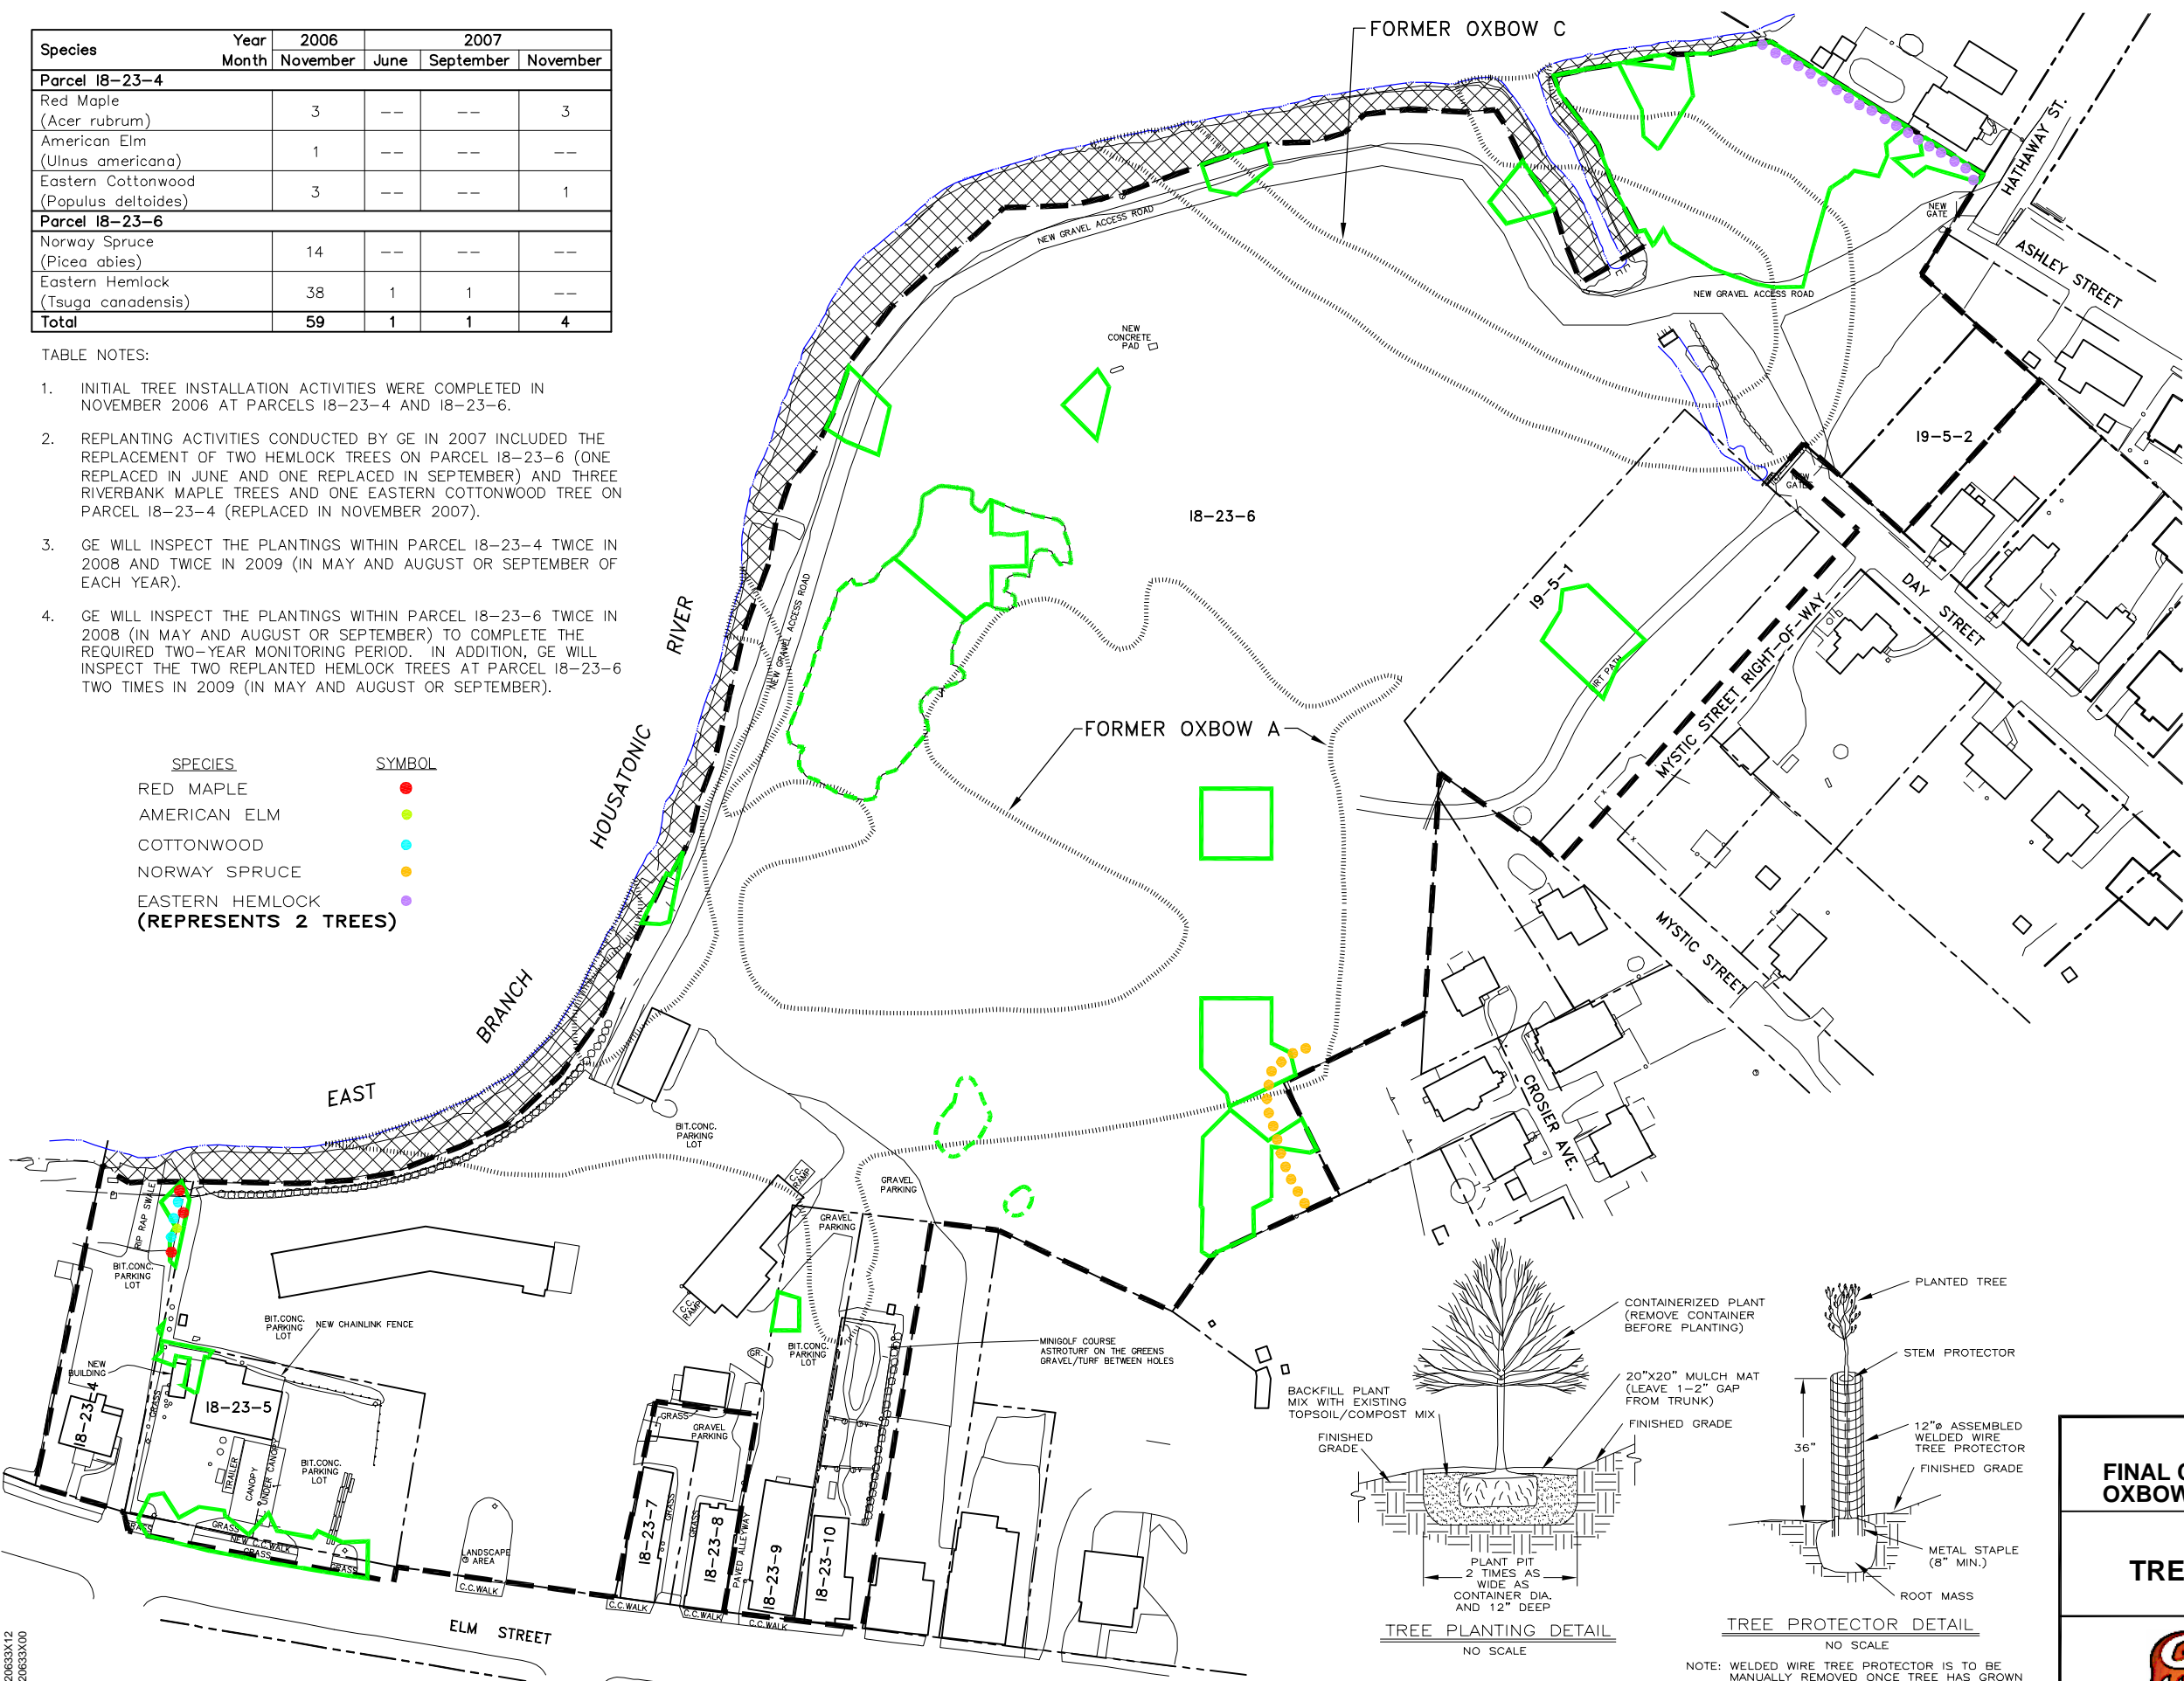
FIGURE 4

planted on Parcels I8-23-4 and I8-23-6 as part of restoration activities to ensure that they are in good general health. Figure 4 from the Final Completion Report (copy attached) contains the restoration planting plan for the trees that were planted as part of restoration activities. Observations at these properties included a stem count of planted and newly established trees (quantity per species per parcel) in good health and a stem count of trees that were dead or dying or showing evidence of stress, if any, within each property. The results of these observations were used to evaluate if trees are surviving at a frequency of 100% of the planted quantity specified on Figure 4. Additionally, each tree observed was measured to determine the average height and range of heights of each species of tree within each property. In conjunction with the tree observations, GE inspected tree cages, tree guards, and tree stakes (where present) to ensure that these items were functioning to protect the trees from damage.

Note that, in the above table, the quantity of eastern hemlocks at Parcel I8-23-6 is higher than the quantity specified in the planting plan and shown on Figure 4. That is because, in accordance with discussions with EPA and the adjacent property owner, eight additional eastern hemlocks (beyond those specified in the planting plan) were planted to further provide privacy for that property. In this case, the percentage of trees in good health and the percentage surviving are greater than 100% relative to the quantity specified on Figure 4.

The results of the tree observations indicated that the trees planted were in good health with the exception of three trees at Parcel I8-23-6: one dead eastern hemlock, one Norway spruce which was observed to be leaning, and one other stressed Norway spruce. In addition, as shown on the tables in Attachment B, the observations of the tree guards, cages, and stakes (where present) indicated that the tree guards/cages for the red maples on Parcel I8-23-4 were in good condition, but that the tree cages for the eastern cottonwoods and American elm tree on Parcel I8-23-4 need repair. (The trees on Parcel I8-23-6 do not have such guards, cages, or stakes.)

- Repair tree cages on three eastern cottonwood trees and one American elm tree on Parcel I8-23-4;
- Replace the dead eastern hemlock on Parcel I8-23-6 (although not required since the percent of eastern hemlocks surviving is greater than 100% of the quantity specified on the planting plan);
- Straighten the leaning Norway spruce on Parcel I8-23-6 and replant the roots;
- Monitor the other stressed Norway spruce on Parcel I8-23-6; and
- Repair the erosion/sinkholes observed along the top of the riverbank on Parcel I8-23-6.

GE planted the eastern hemlock and straightened the Norway spruce during the first part of June 2008. Repair of the erosion/sinkholes and tree cages will be completed prior to the next inspection in August/September 2008.
