GE  
159 Plastics Avenue  
Pittsfield, MA 01201  
USA

**Re: GE-Pittsfield/Housatonic River Site  
Former Oxbow Areas J and K (GECD420)  
Summary of May 2008 Vegetation Inspection Activities**

GENERAL ELECTRIC COMPANY  
 PITTSFIELD, MASSACHUSETTS  
**MAY 2008 INSPECTION**

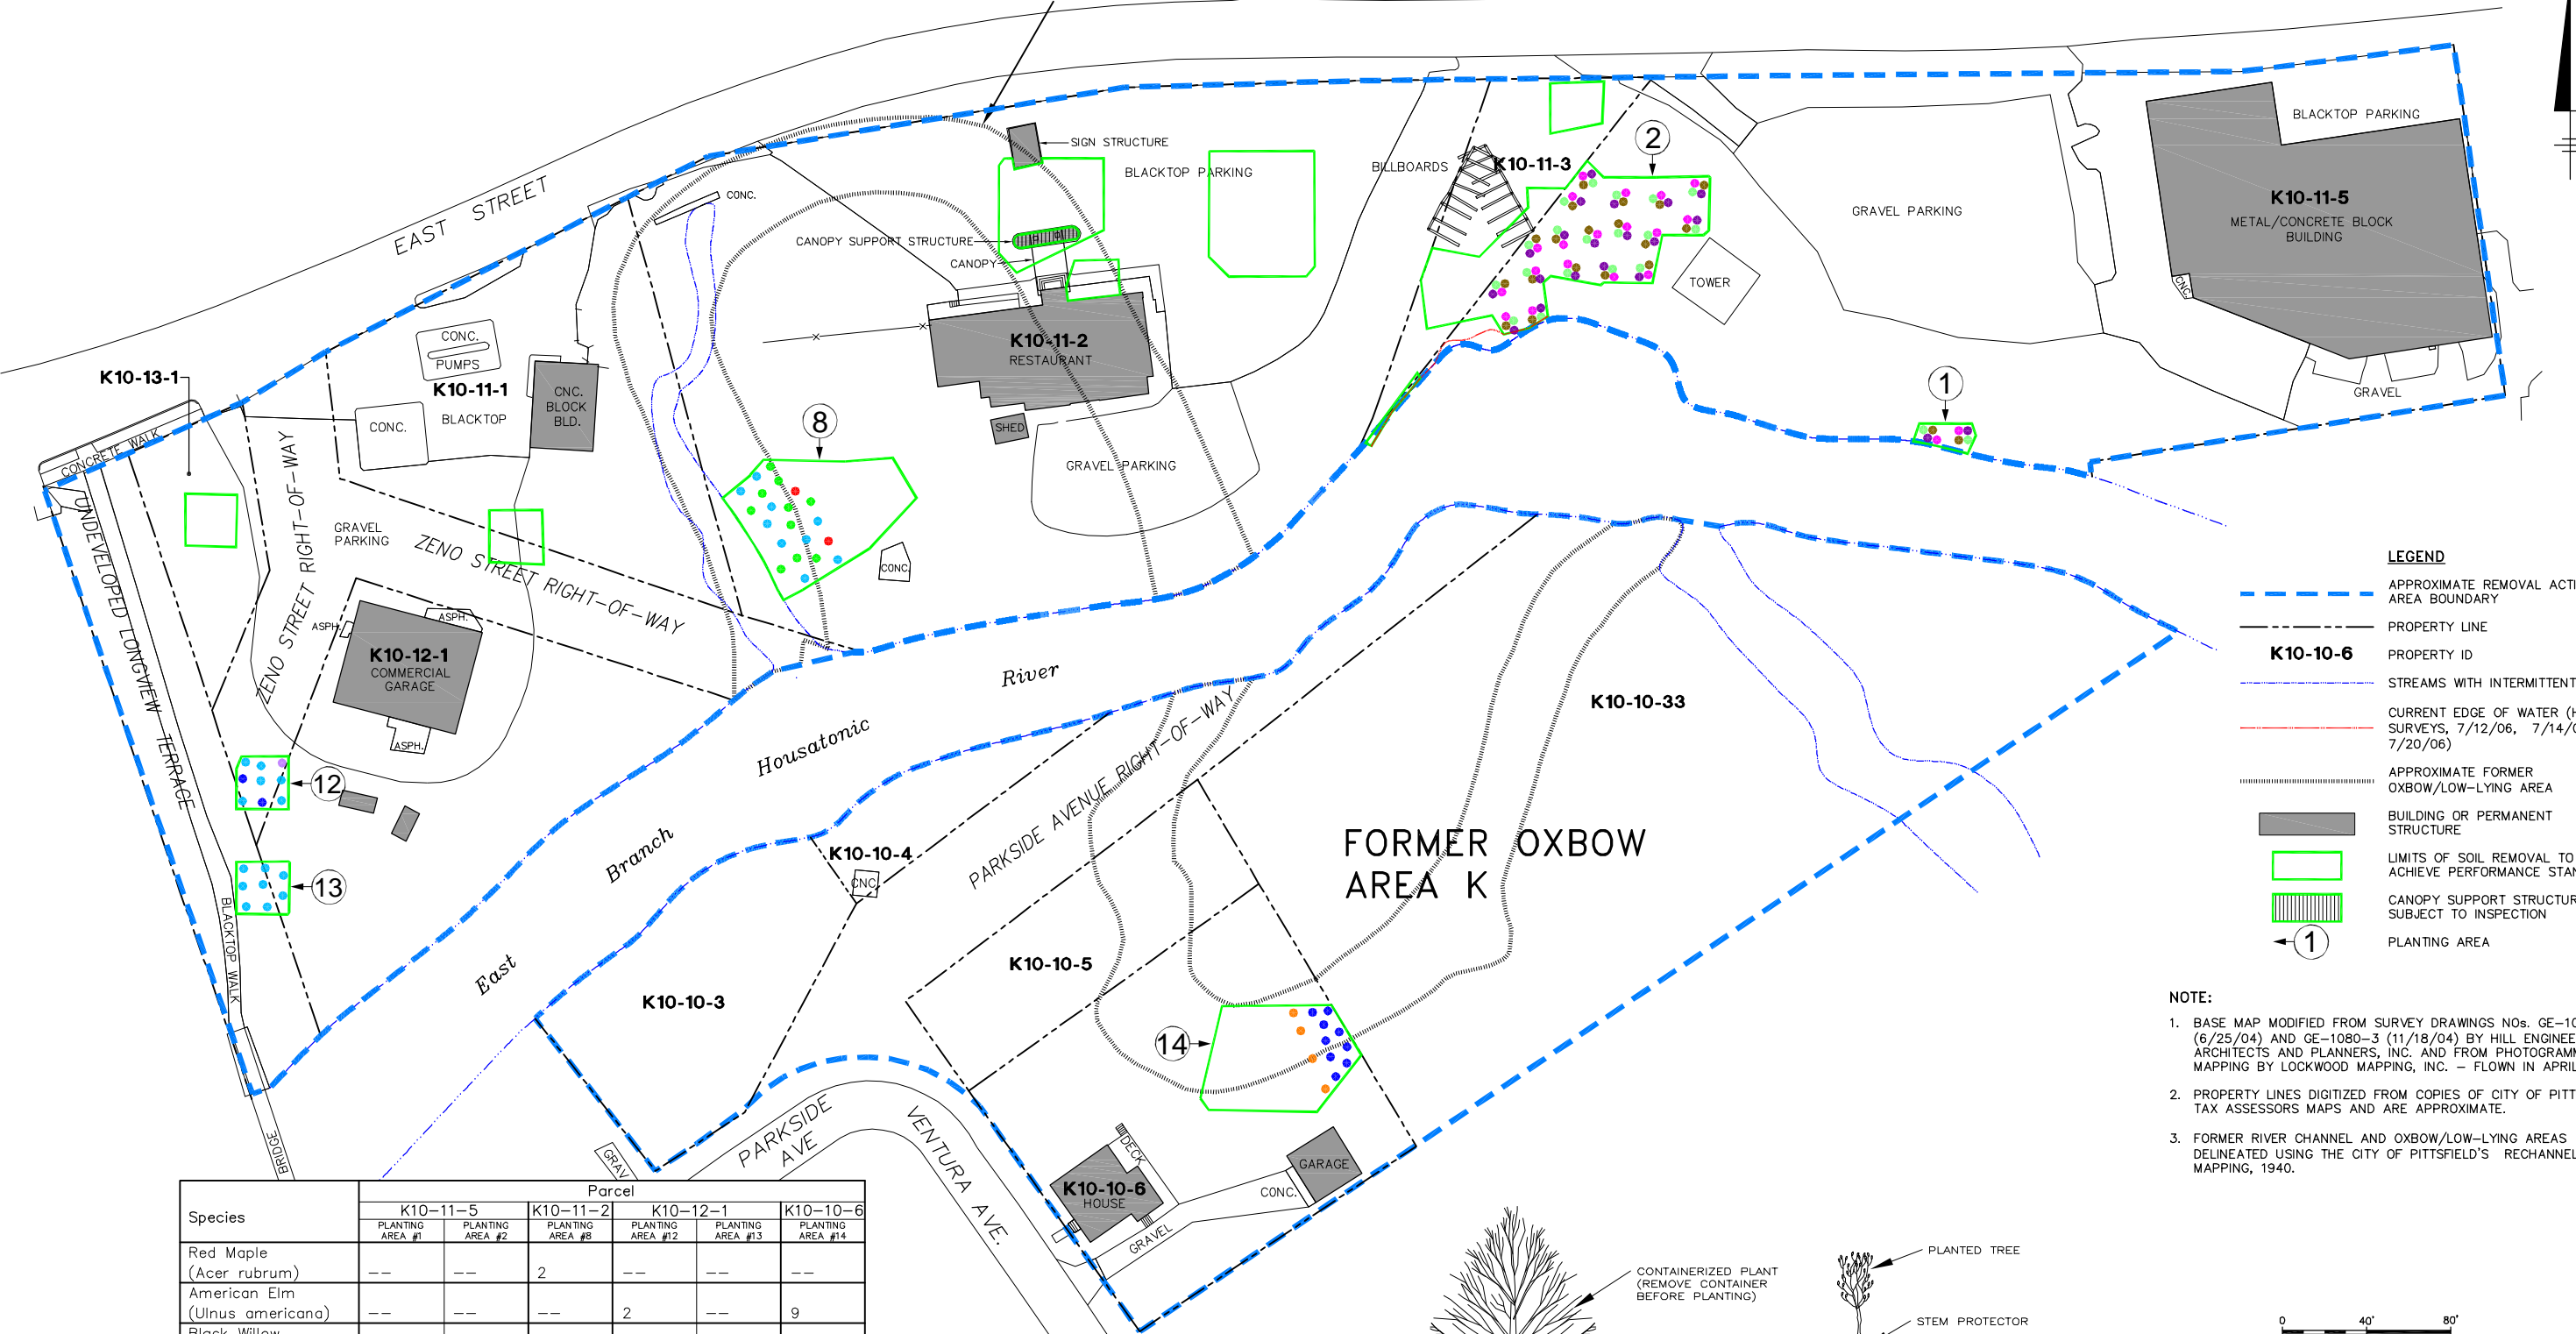
**FIGURE  
 4**

- One dead eastern cottonwood, one dead red maple, and one stressed red maple at Parcel K10-11-2; and
- Two dead northern arrowwoods and one stressed northern arrowwood, three dead silky dogwoods, and one dead winterberry at Parcel K10-11-5.

In addition, as shown on the attached forms, the inspection revealed that the tree guards, cages, and stakes (where present) for live trees were in good condition, with the exception of the tree guard at the white ash tree on Parcel K10-12-1, which needs replacement.

- Install one eastern cottonwood and one red maple on Parcel K10-11-2 and two northern arrowwoods, three silky dogwoods, and one winterberry on Parcel K10-11-5;
- Monitor one stressed red maple on Parcel K10-11-2 and one northern arrowwood on Parcel K10-11-5; and
- Replace tree guard around white ash tree on Parcel K10-12-1.
