**Re: GE-Pittsfield/Housatonic River Site
Lyman Street Area (GECD430)
Summary of November 2006 Inspection Activities**

GENERAL ELECTRIC COMPANY
 PITTSFIELD, MASSACHUSETTS
NOVEMBER 2006 INSPECTION

SITE PLAN

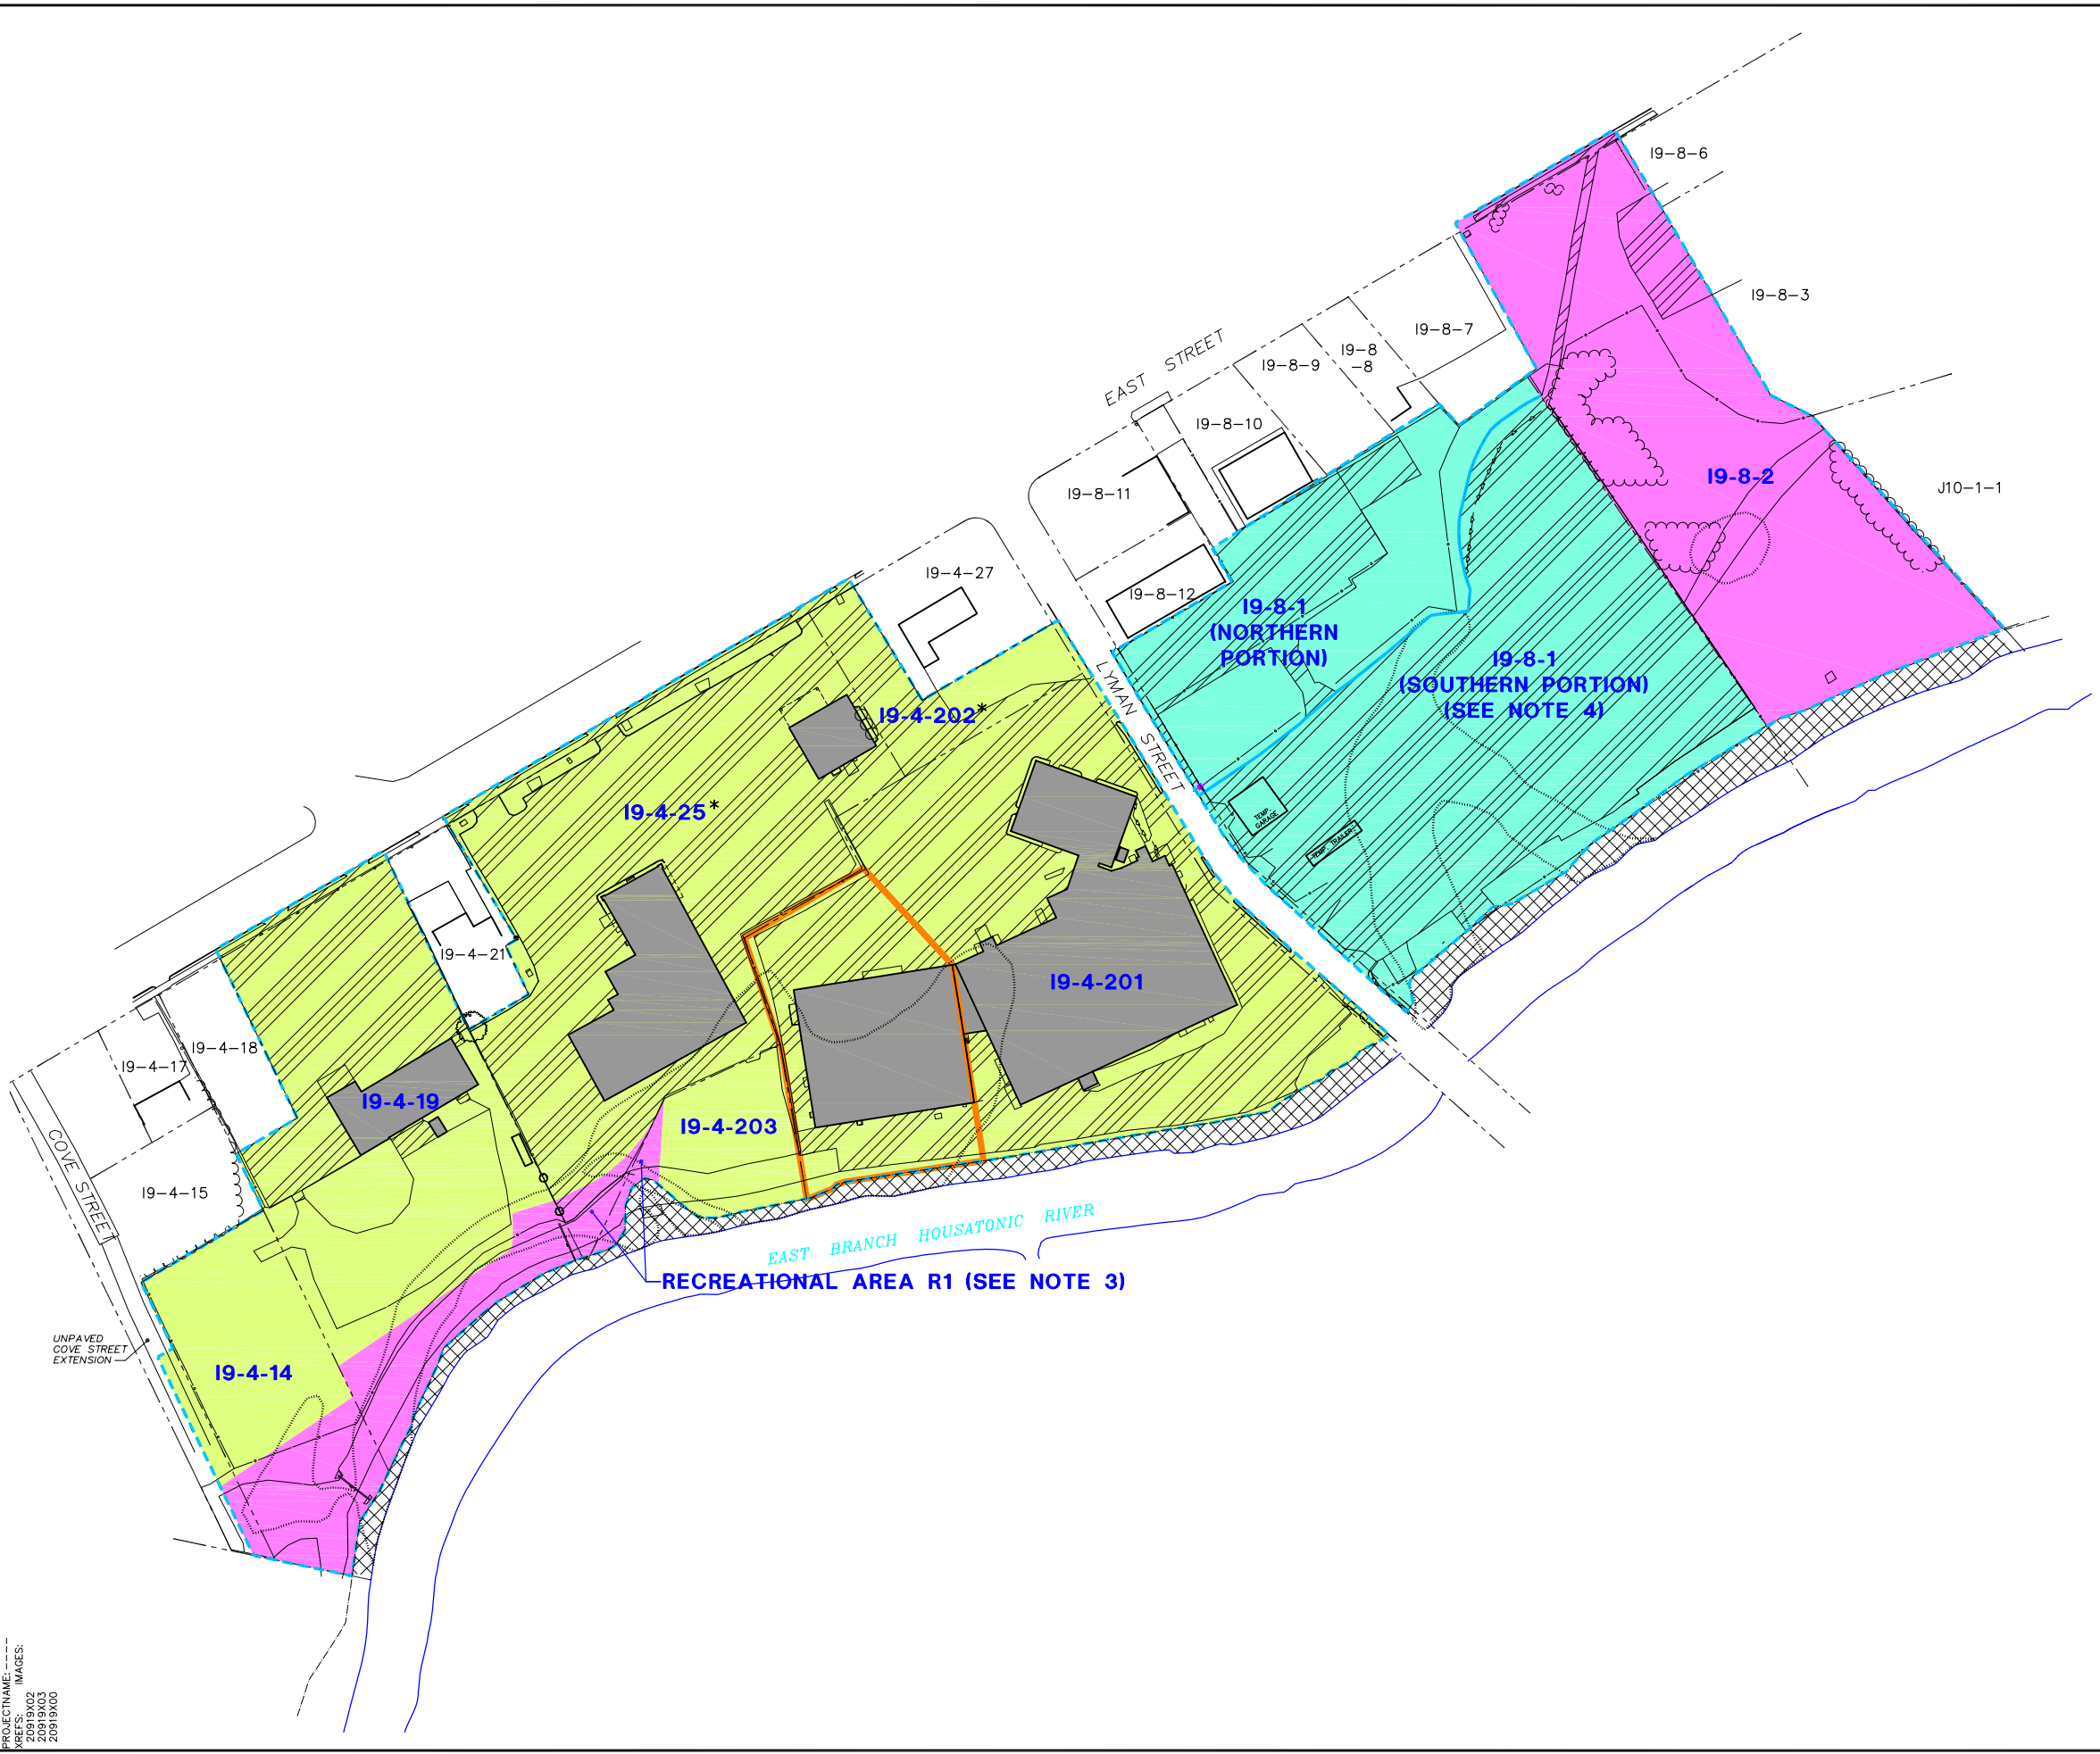
FIGURE
1

On November 29, 2006, the General Electric Company (GE) performed its first post-remediation inspection of the properties located within the Lyman Street Area, west of Lyman Street, at which remediation activities have been performed. As shown on Figure 1, the Lyman Street Area includes six commercial parcels (four of which, Parcels I9-4-14, -19, -25, and -203, have recreational portions) and two recreational parcels. In accordance with GE's *Final Removal Design/Removal Action Work Plan for Lyman Street Area* (Final RD/RA Work Plan), which was submitted to EPA in September 2005 and conditionally approved by EPA on March 6, 2006, GE conducted remediation actions at the six properties west of Lyman Street in 2006, completing those actions in September 2006. (Remediation activities for the properties east of Lyman Street are anticipated to be performed in summer 2007.) In addition, vegetation restoration activities were conducted at two of these parcels (Parcels I9-4-14 and I9-4-19), as described in the revised Vegetation Restoration Plan for Lyman Street Area (west of Lyman Street) provided in Attachment 3 to GE's October 5, 2006 Addendum to Supplemental Information Package.
