GE  
159 Plastics Avenue  
Pittsfield, MA 01201  
USA

**Re: GE-Pittsfield/Housatonic River Site  
Lyman Street Area (GECD430)  
Summary of May 2008 Inspection Activities**

GENERAL ELECTRIC COMPANY  
 PITTSFIELD, MASSACHUSETTS  
 MAY 2008 INSPECTION

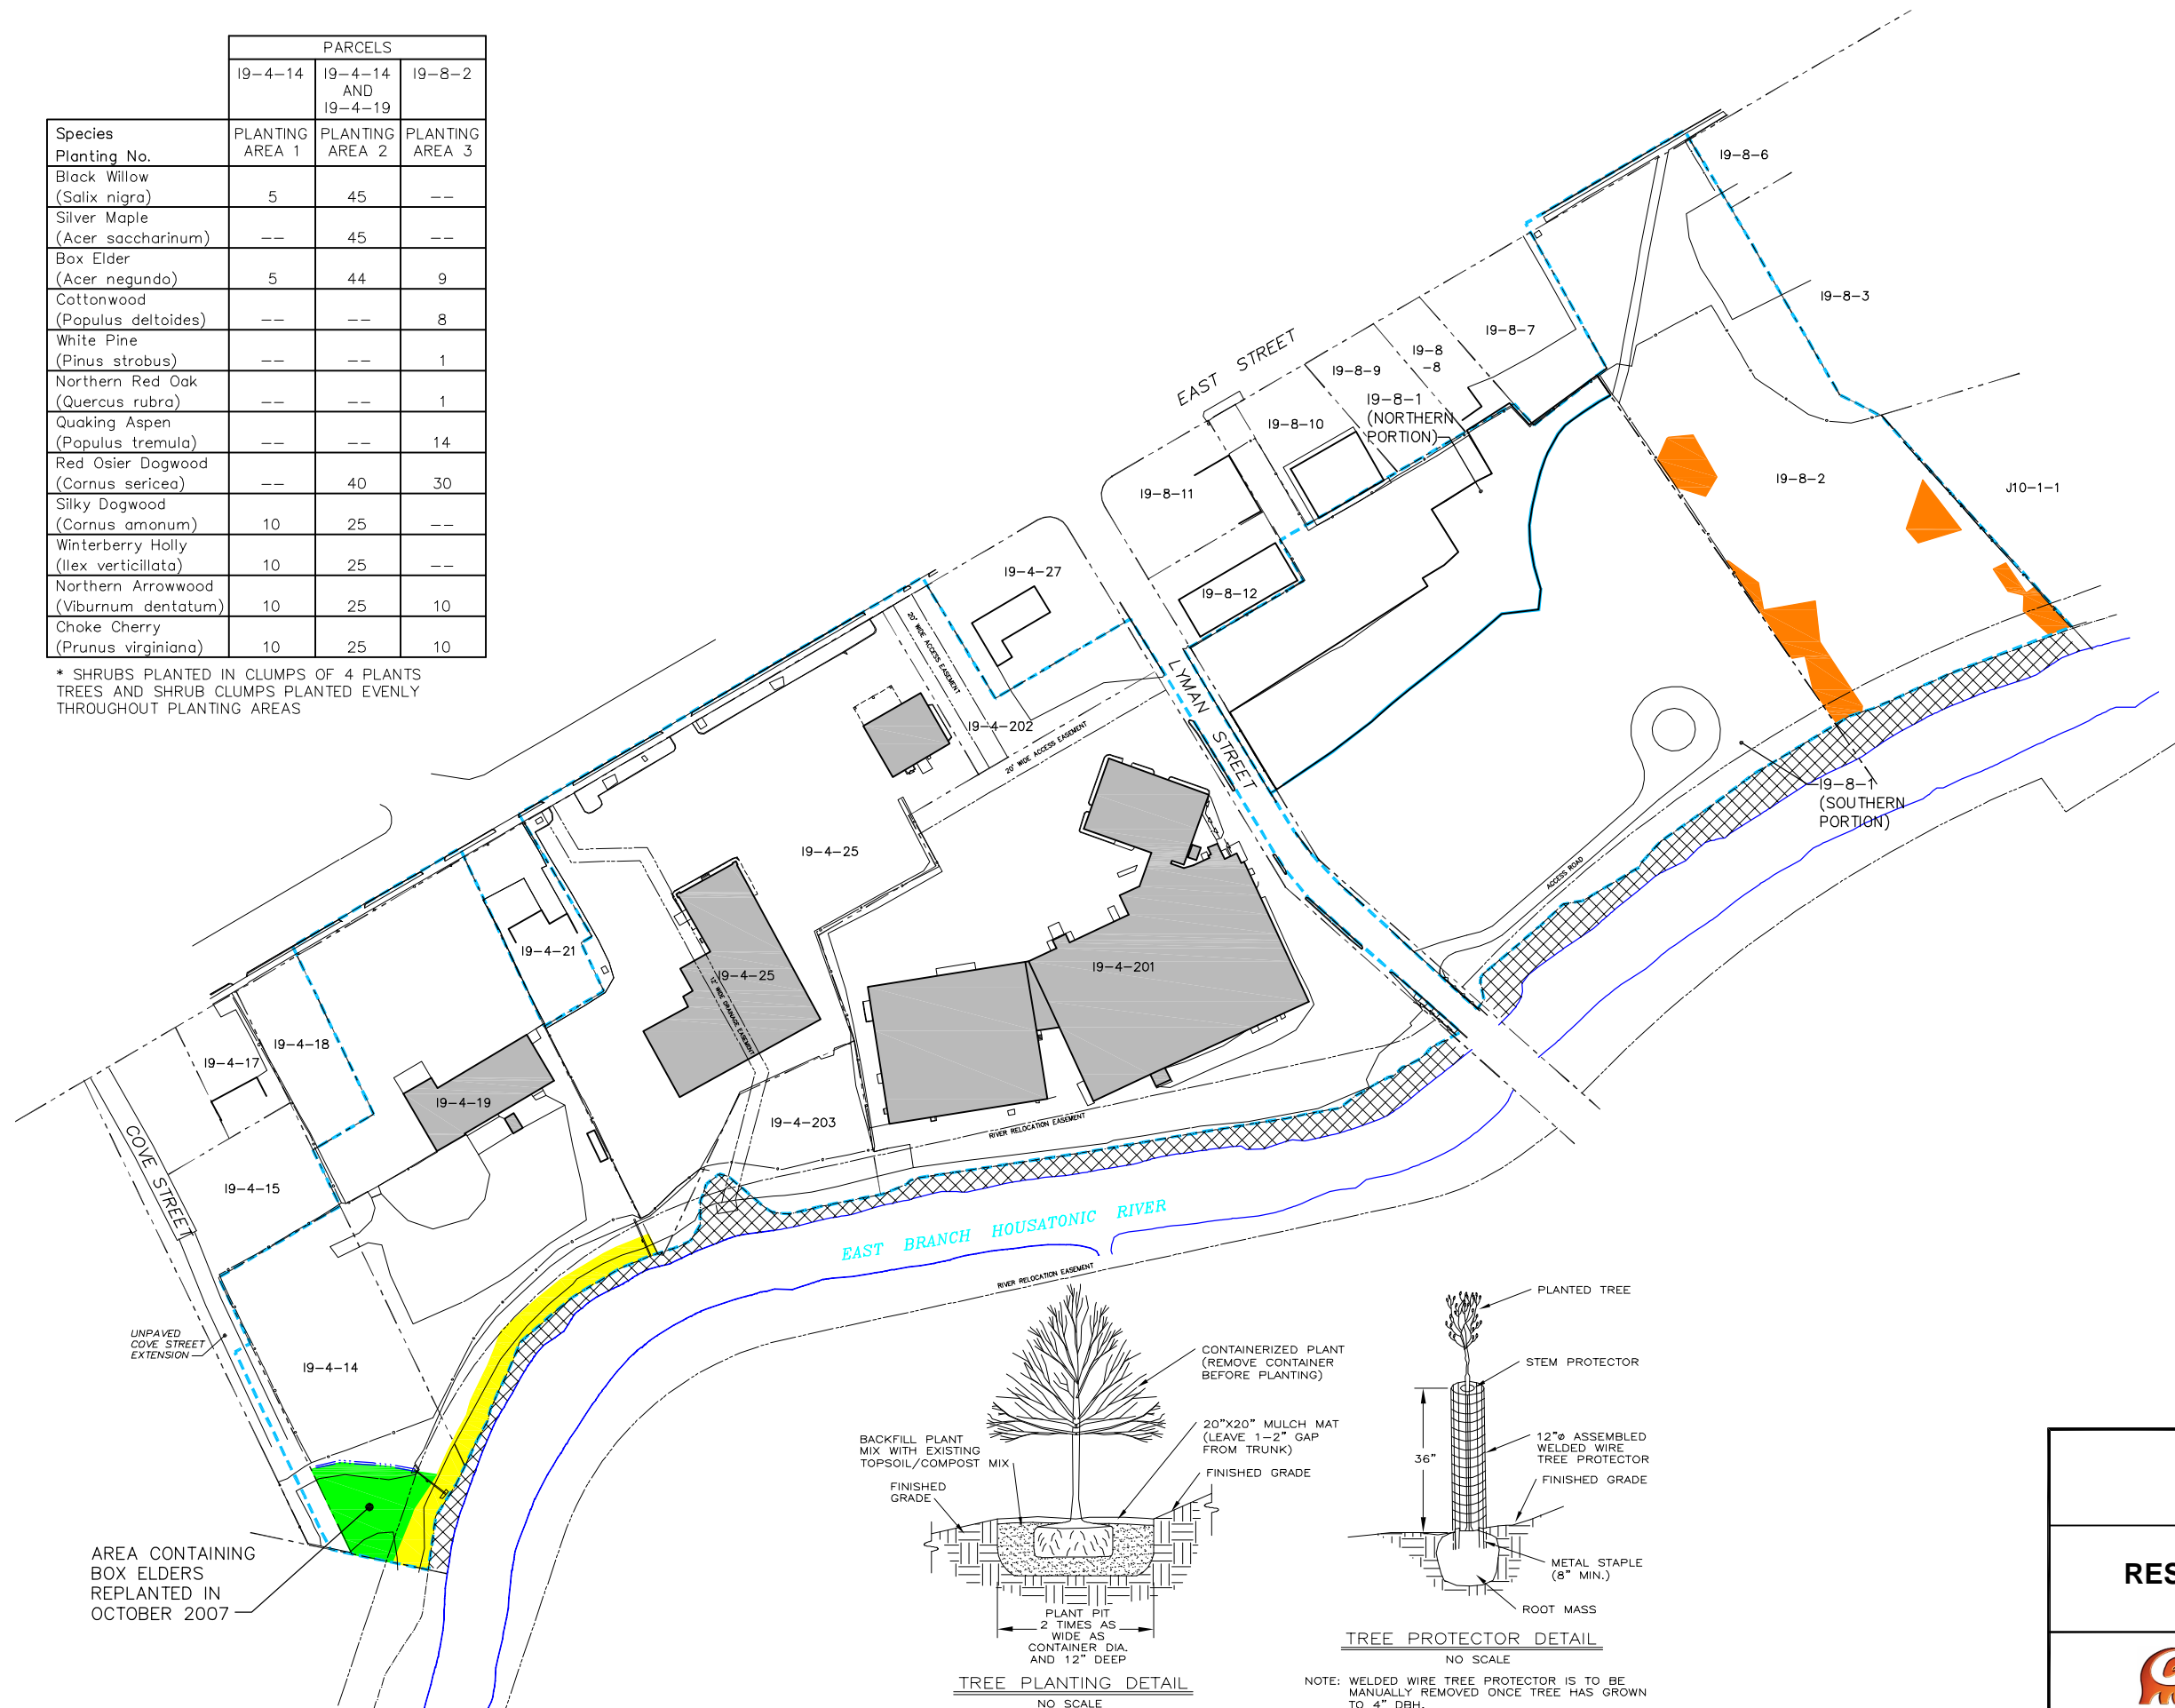
**FIGURE 2**

- Erosion observed in Planting Area 3 (see Figure 2).

- Disturbed areas are in need of seeding.  
 - Tree/shrub observations are shown in Tables B-7 through B-14 in Attachment B; all trees and shrubs, as well as tree guards, cages, and stakes (where present), are in good condition except as follows:  
 \* One dead choke cherry observed.  
 \* One dead white pine observed.  
 \* Two dead cottonwoods observed.  
 \* Two dead quaking aspens observed.  
 \* One red osier dogwood not located.  
 \* Tree guard on one box elder needs repair.

- Repair erosion in Planting Area 3.  
 - Re-seed disturbed areas.  
 - Replant one choke cherry, one white pine, two cottonwoods, two quaking aspens, and one red osier dogwood.  
 - Repair damaged tree guard on one box elder.
