GE
159 Plastics Avenue
Pittsfield, MA 01201
USA

**Re: GE-Pittsfield/Housatonic River Site
Newell Street Area II (GEC450)
Summary of November 2006 Inspection Activities**

GENERAL ELECTRIC COMPANY PITTSFIELD, MASSACHUSETTS NOVEMBER 2006 INSPECTION	
SITE PLAN	
	FIGURE 1

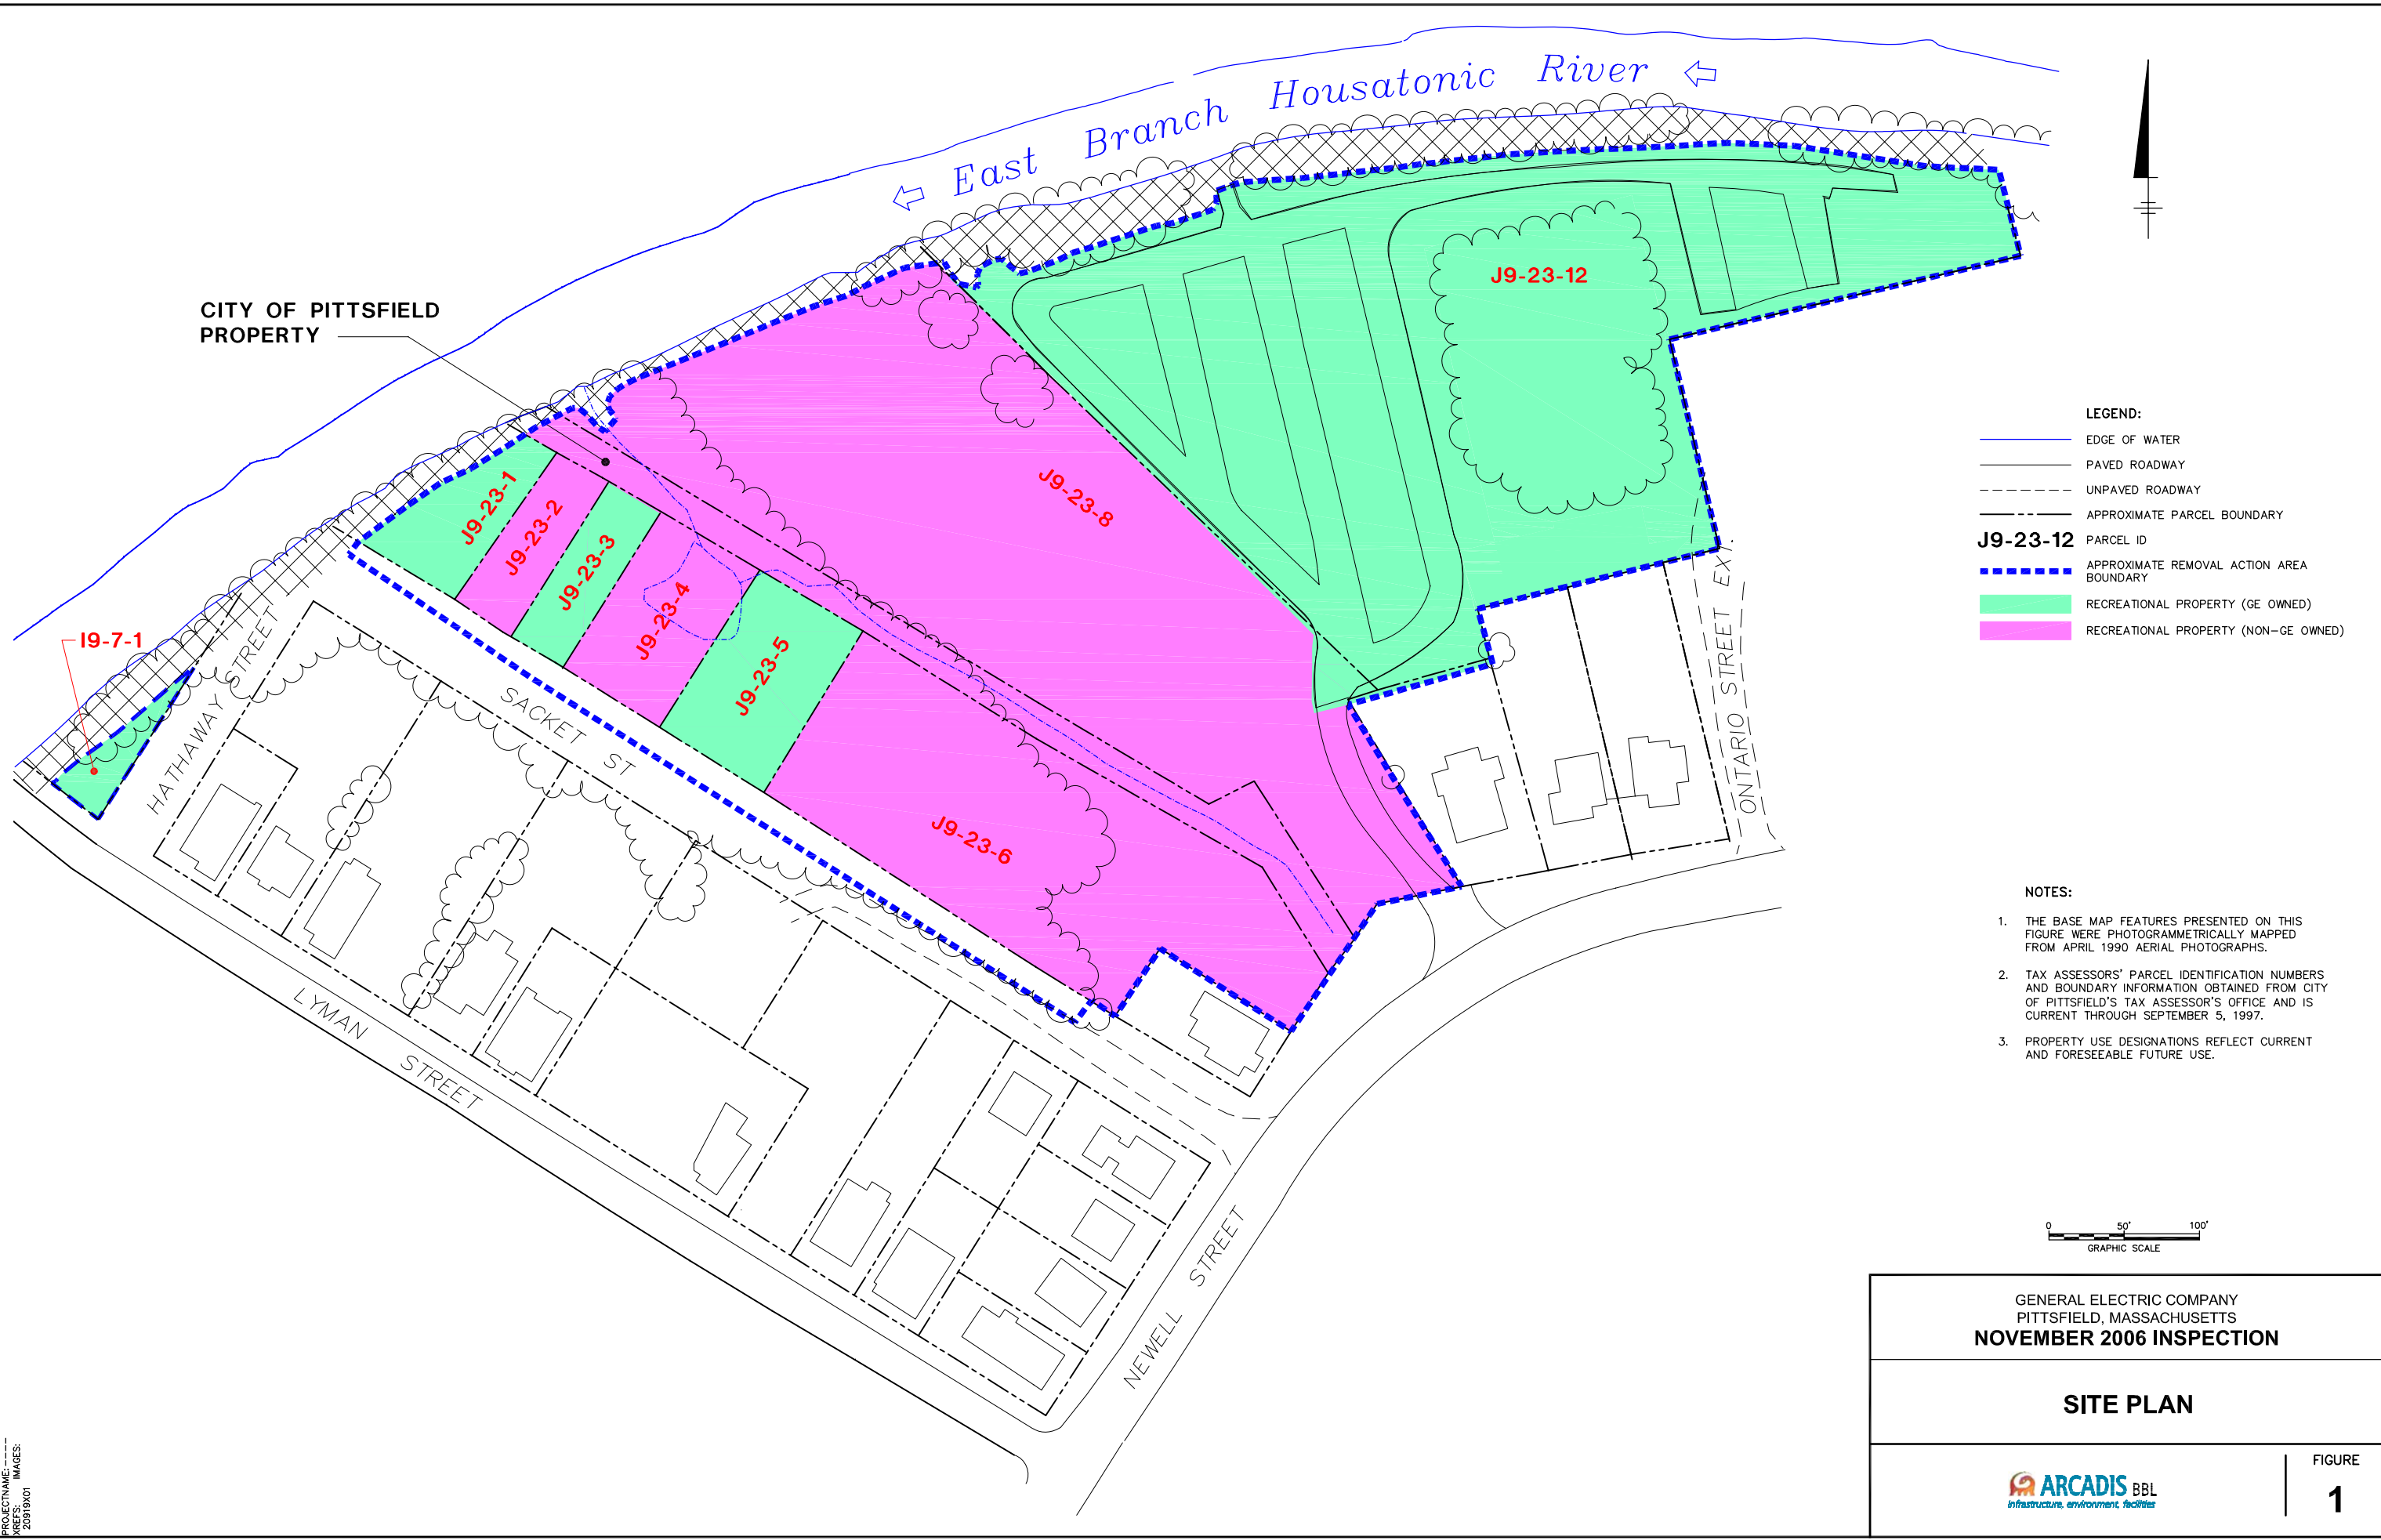
On November 1 and 22, 2006, the General Electric Company (GE) performed its first post-remediation inspection of the properties within Newell Street Area II at which remediation activities have been completed. As shown on Figure 1, Newell Street Area II includes nine recreational parcels (five of which, Parcels I9-7-1, J9-23-1, -3, -5 and -12 are GE-owned). GE conducted remediation activities at all nine of these parcels in accordance with GE's *Final Removal Design/Removal Action Work Plan for Newell Street Area II* (Final RD/RA Work Plan, March 2005), as conditionally approved by EPA on May 12, 2005, revised in a May 25, 2005 Addendum to Final RD/RA Work Plan, and subsequently modified with EPA approval. These remediation activities were completed in July 2006. In addition, GE conducted restoration actions at these properties, including natural resource restoration/enhancement activities at the GE-owned Newell Street parking lot area (Parcel J9-23-12).
