**Re: GE Pittsfield/Housatonic River Site
Upper ½-Mile Reach Removal Action (GEC800)
2001 Annual Monitoring Report Addendum**

*2001 Annual Monitoring Report
Addendum – Upper ½ Mile Reach of
the Housatonic River*

**General Electric Company
Pittsfield, Massachusetts**

March 2002

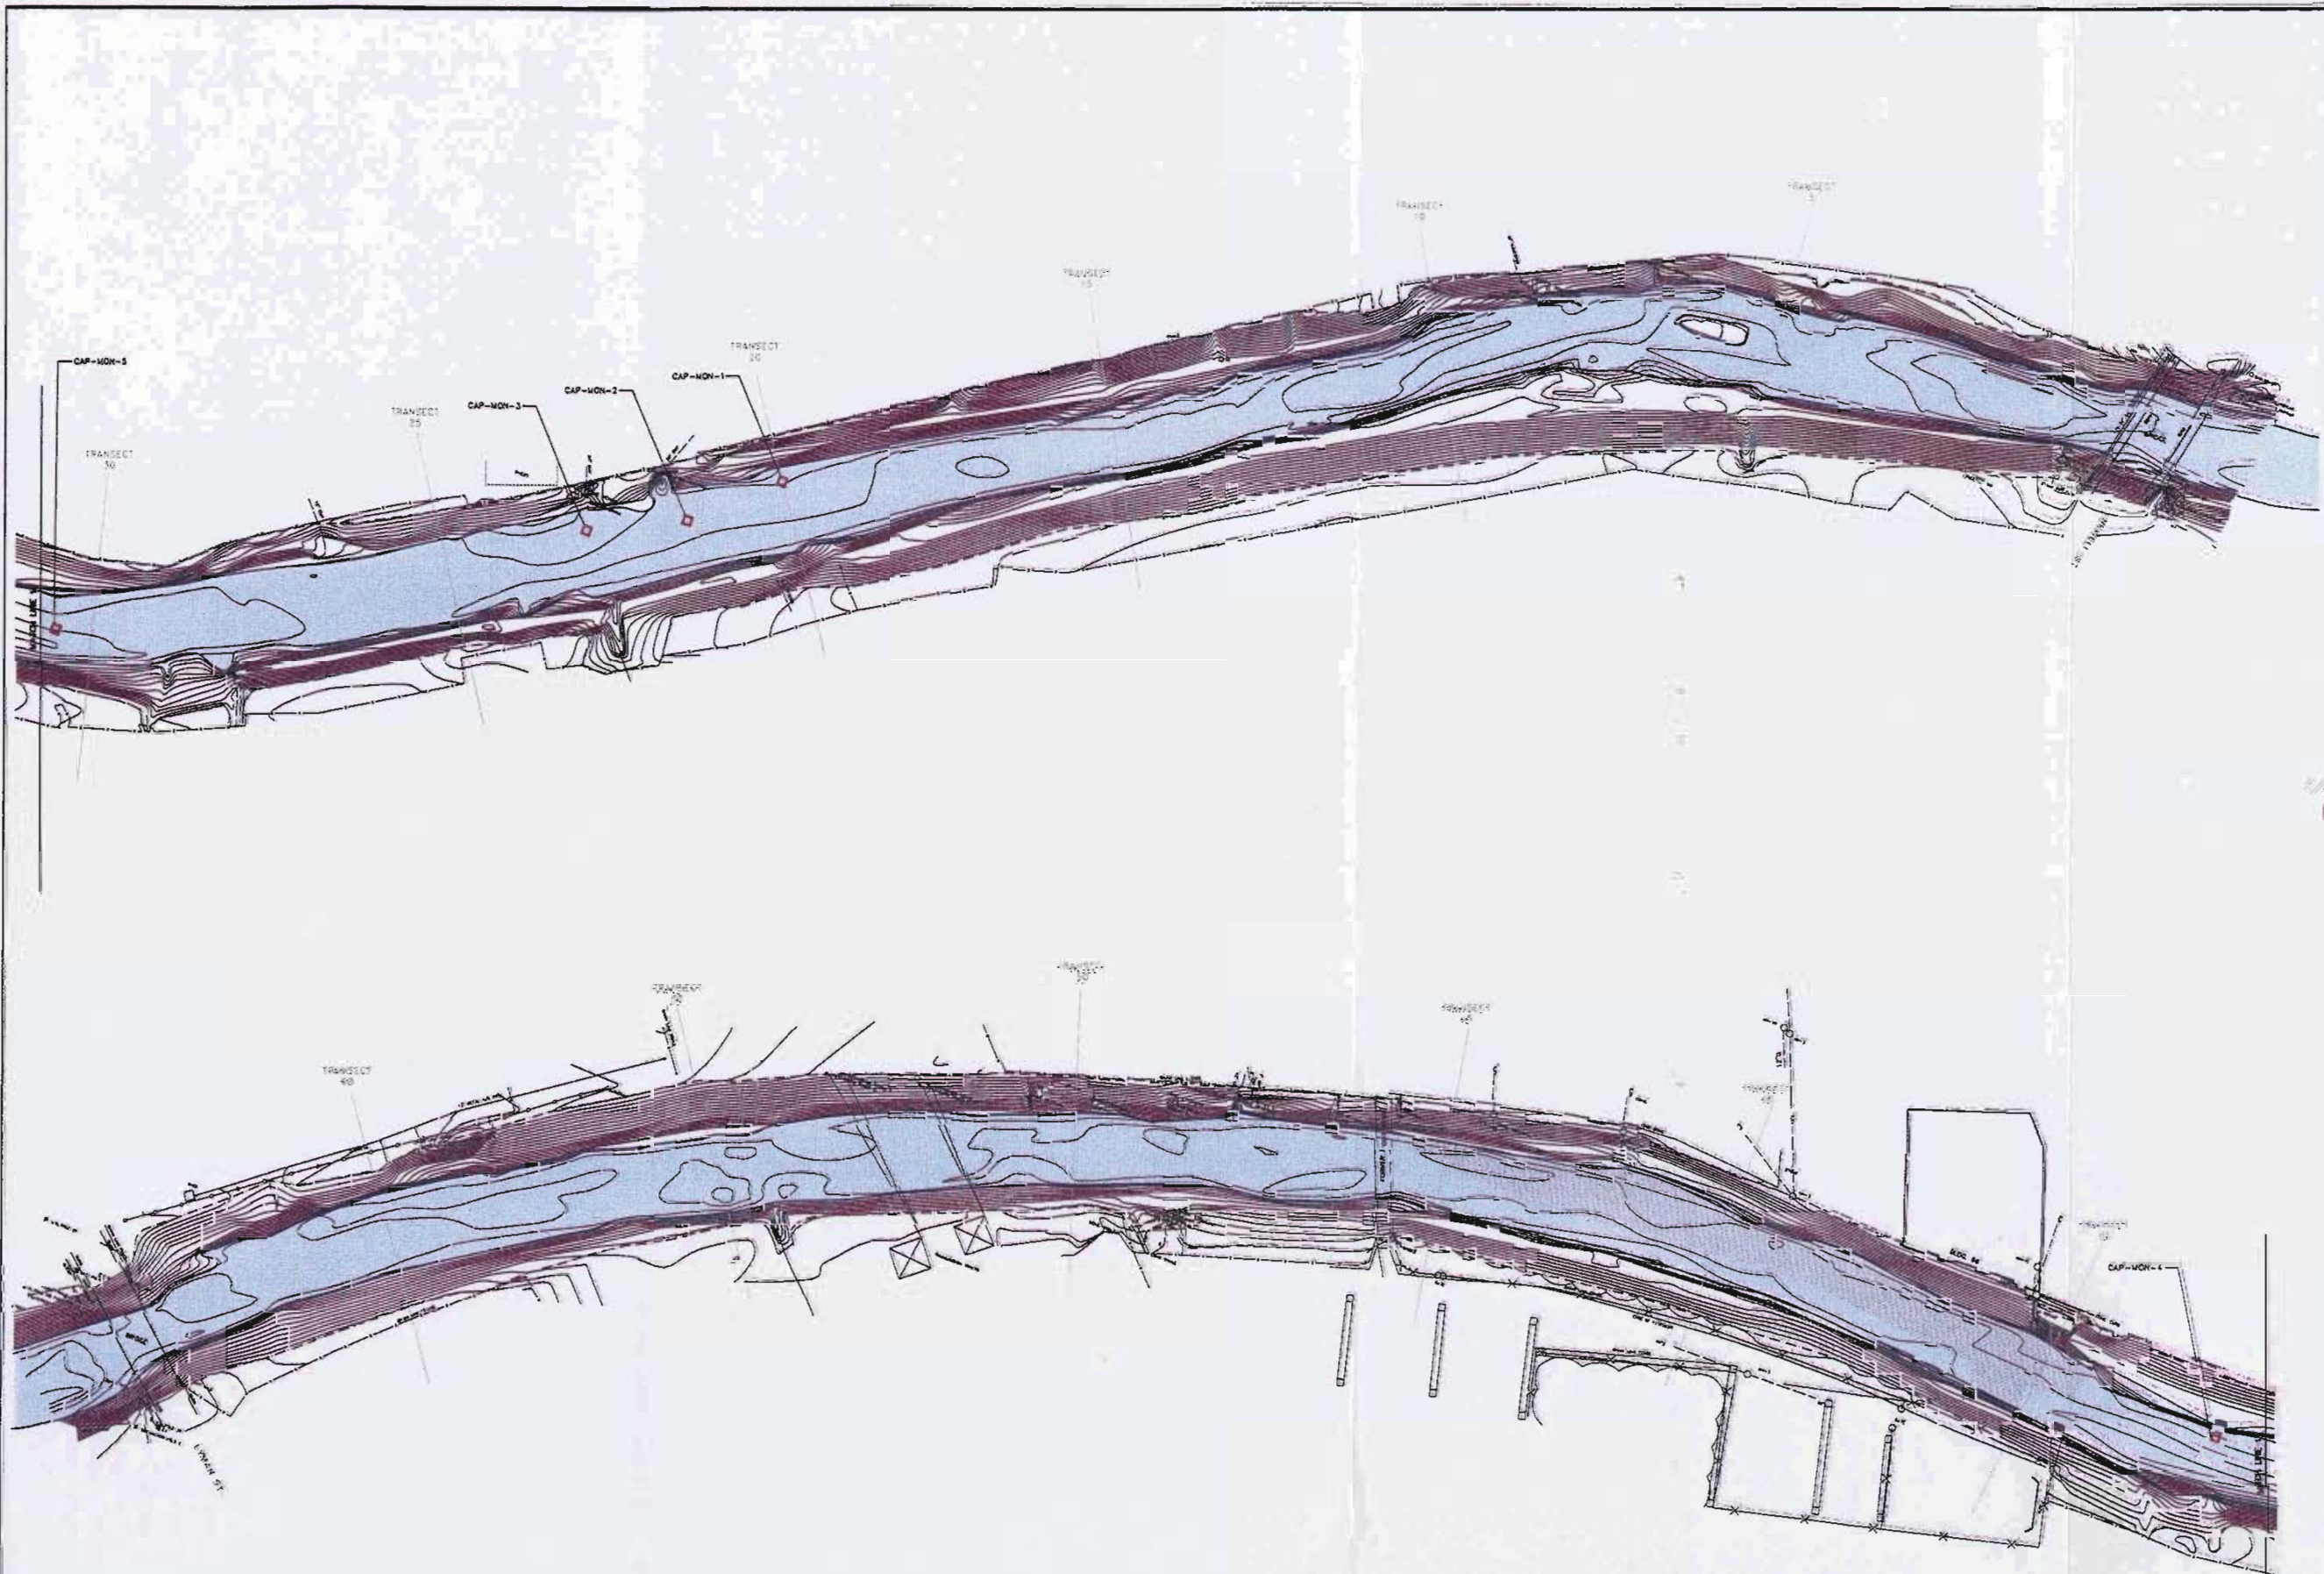
GENERAL ELECTRIC COMPANY
 PITTSFIELD, MASSACHUSETTS
 2001 ANNUAL MONITORING REPORT ADDENDUM
 UPPER 1/2-MILE REACH OF HOUSATONIC RIVER
**SEDIMENT CAP ISOLATION
 LAYER MONITORING LOCATIONS**

During 2001, the post-excavation and baseline sampling events were conducted at two locations (locations 4 and 5), and the 1-year monitoring event was conducted at three locations (locations 1, 2, and 3) at which the post-excavation and baseline sampling had been conducted in 2000. At each of the baseline and 1-year sampling events conducted in 2001, the overlying armor stone and newly deposited sediment in the armor stone were first removed by hand to the extent practicable and the geogrid and geotextile were temporarily cut back to allow access to the underlying isolation layer. Following this step, an undisturbed core of the sediment isolation layer was collected at each sampling location. At the time of sample collection, each core was sectioned into 2-inch increments. Consistent with the requirements of the Upper ½-Mile Reach Work Plan, the core segment intervals that measured 2 to 4, 4 to 6, and 6 to 8 inches above the bottom geotextile layer were analyzed for PCBs and total organic carbon (TOC).

The 1-year isolation layer monitoring sampling that was performed at three locations showed the following results for the isolation layer material:

- PCBs were not detected in any samples except two, which were reported at levels less than 0.1 ppm (slightly above the detection limit); and
- TOC ranged from 0.07 to 0.15 percent.

It should also be noted, however, that at these three locations, considerable newly deposited natural sand material had accumulated within the armor stone layer. Sampling of the surficial sediments upstream of the Upper ½ Mile Reach, primarily by EPA, indicated the TOC levels in these sediments were approximately 2.8%. Including this natural material (with a TOC concentration of 2.8%) in the modeling calculations regarding PCB “breakthrough” times, which were originally presented in the Upper ½ Mile Reach Removal Action Work Plan, would result in a predicted “breakthrough” time of approximately 500 years, which is approximately four times higher than the “breakthrough” time predicted in the Work Plan.

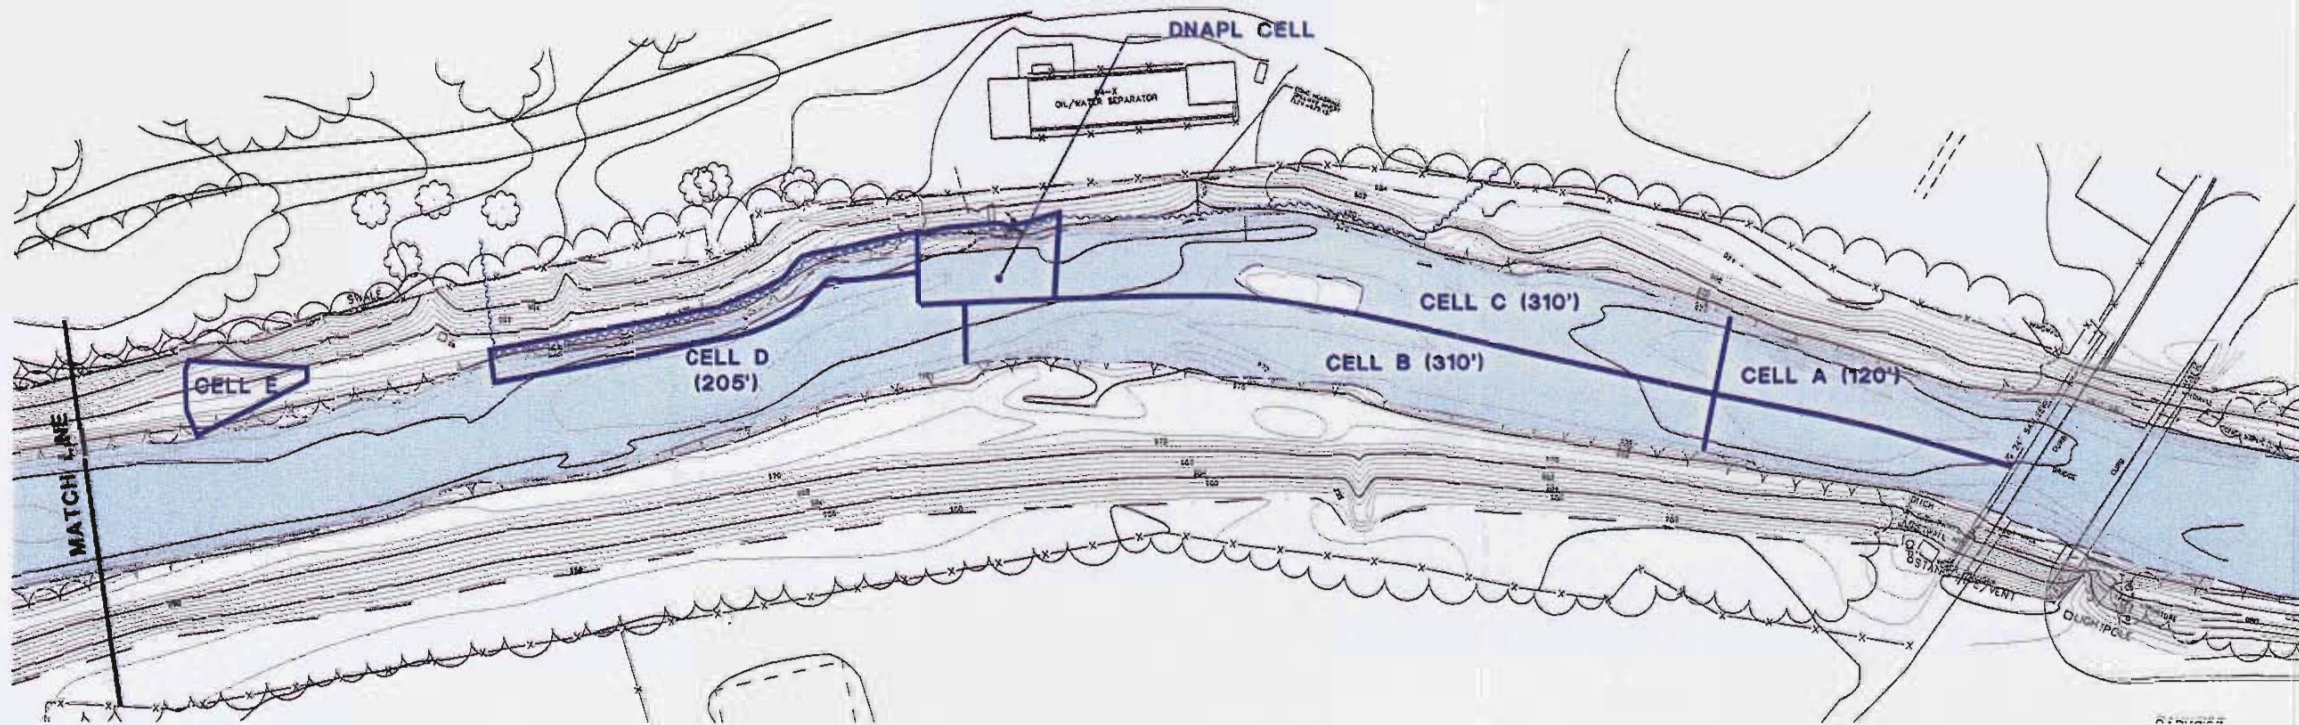
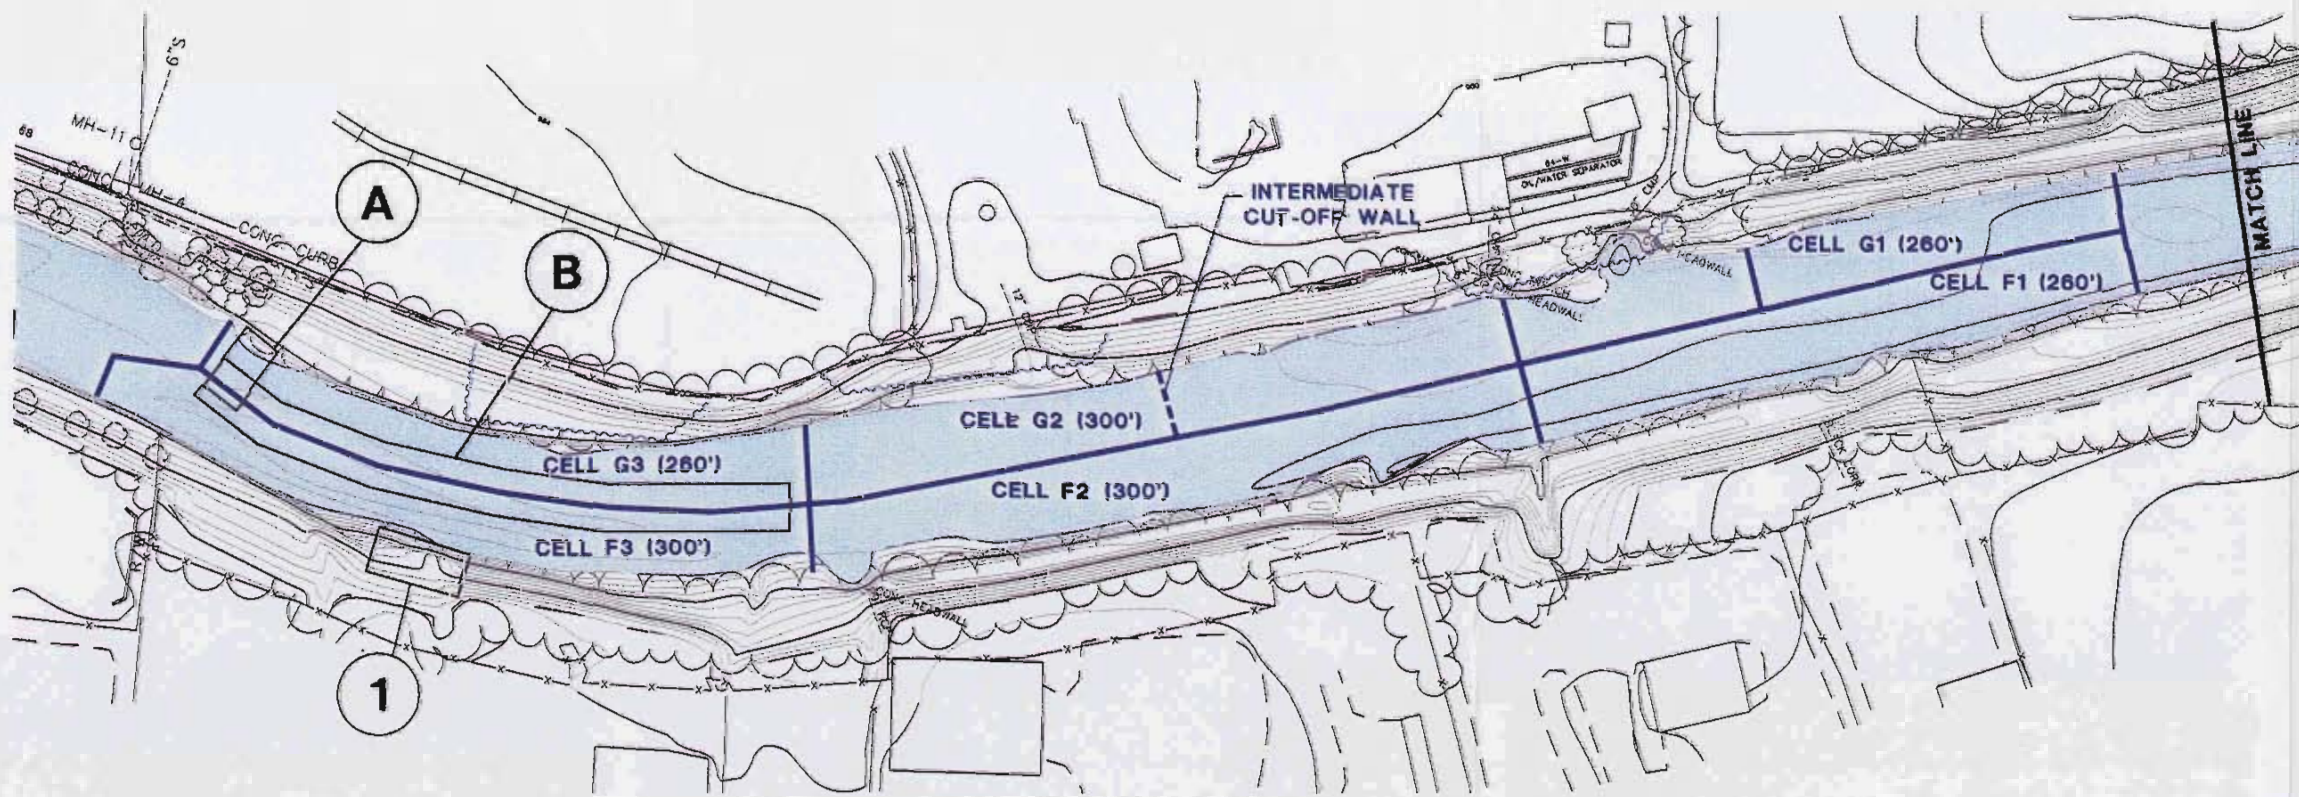
FIGURE
3-1

During 2001, a bank inspection was performed on May 2, 2001, following the first ice-out and high-water condition. In addition, observations were made at various times throughout the year while implementing the Removal Action. Results of the spring monitoring and maintenance activities were presented in a letter report entitled *Erosion Inspection Monitoring and Maintenance Report* (BBL, 2001). The letter report is provided as Attachment A. Results of additional monitoring and maintenance activities performed as a result of observations made during the Removal Action were presented in various monthly reports on activities at the GE-Pittsfield/Housatonic River Site. These additional monitoring and maintenance activities are summarized below, and the locations where such activities were performed are identified on Figures 3-1 and 3-2.

Area 1 (Adjacent to Cell F3)

During November 2001, a small area (approximately 10'x 10') was noted by EPA to have settled on the restored Cell F3 bank (south side). This bank area was previously restored in accordance with the Work Plan with rip-rap

Monitoring activities for the armor stone layer were performed in conjunction with monitoring events for restored bank areas of the Upper ½-Mile Reach during spring 2001, as well as through other observations during the course of the Removal Action, including during low-flow conditions. During the spring 2001 monitoring event, one area at the downstream end of restored Cell G3 was observed to have significant movement of armor stone or reduced thickness of the armor stone layer. In addition, during performance of the Removal Action, an additional area between Cells F3 and G3 was identified that required further response action. A description of each of these areas along with the corresponding response actions is presented below and the locations are shown on Figure 3-1.

Area A

During the spring 2001 monitoring event, an area where the rip-rap had moved and exposed the geotextile at the downstream end of Cell G3 was observed. The movement of the rip-rap was believed to be due to the temporary constriction of the river during a flood event by the sheetpile used for sediment removal and a pipe crossing. Additional rip-rap was added to this area to restore it to original conditions.

Area B

During sediment removal activities in Cell F3, EPA observed an apparent elevation differential along the centerline sheetpile wall between Cells F3 and G3. The elevations along the centerline sheetpile wall in both cells were measured with a survey rod and a small difference was found between the two cells (Cell G3 was slightly lower than Cell F3). To address the area of settlement in Cell G3, rip-rap was added to the armor stone cap along the centerline sheetpile wall to match the restored armor stone cap elevations in Cell F3.

for slope stabilization due to a 1:1 slope. There were no apparent signs of significant erosion at this area and no observation of soil deposition into the river. To address the settlement in this area, rip-rap was placed over the settled area and blended to grade with the existing rip-rap cover.

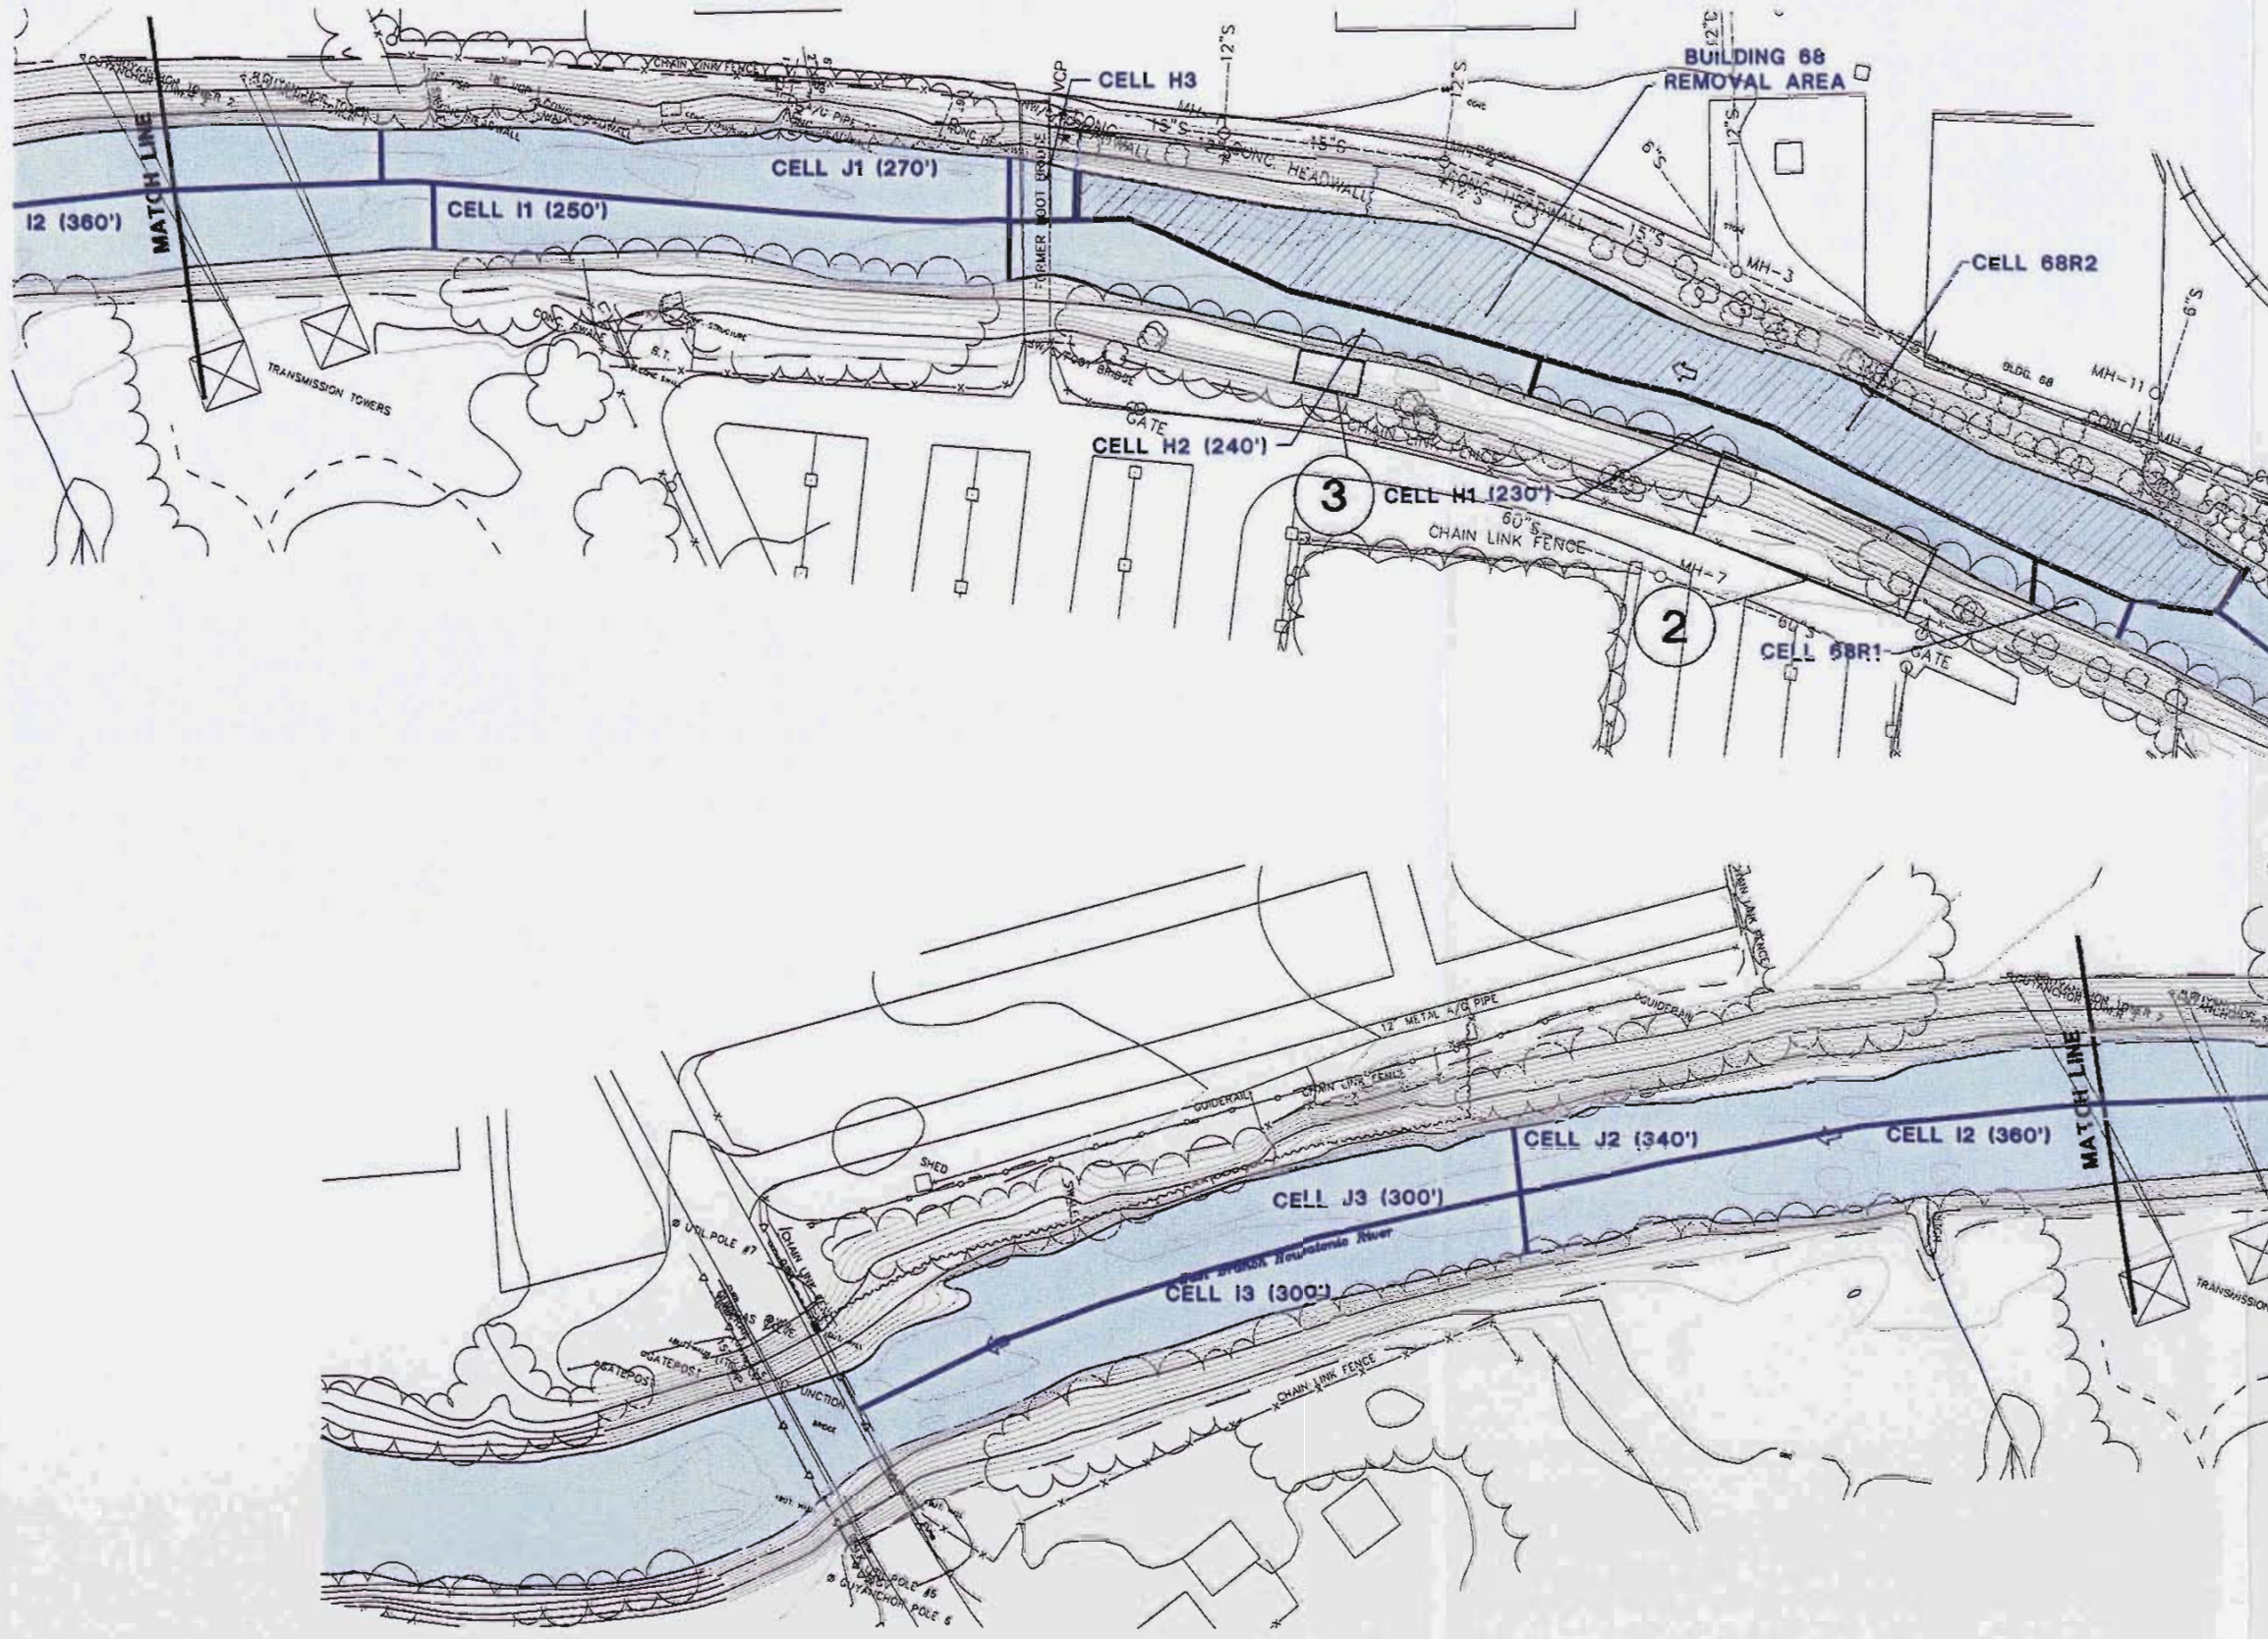
FIGURE
3-2

Area 2 (Adjacent to Cell H1)

During removal activities in Cell H1, EPA identified 3 swales that required response actions. These swales were not previously identified in the Upper ½-Mile Reach Work Plan. The swales were restored in a similar manner to the existing Upper ½-Mile Reach swales by placing geofabric over the bottoms of the swales, and installing rip-rap over the geotextile. Areas of settlement/erosion were observed at two swales in this area following completion of restoration activities. To address this observation, additional rip-rap was placed at the swales to minimize possible future erosion in these areas.

Area 3 (Adjacent to Cell H2)

During November 2001, a small area of bare ground was noted by EPA to have possibly settled on the restored Cell H2 bank (south side). There were no apparent signs of significant erosion at this area, and no soil was observed deposited in the river. Based on the observation that this area appeared to be at a similar elevation as the surrounding area, a supplemental survey was performed to record existing bank elevations. The data from the supplemental survey were compared to the data from the Cell H2 final restoration survey. No significant differences were found between the final survey data and the supplemental survey data, and therefore no response activities were performed in this area.

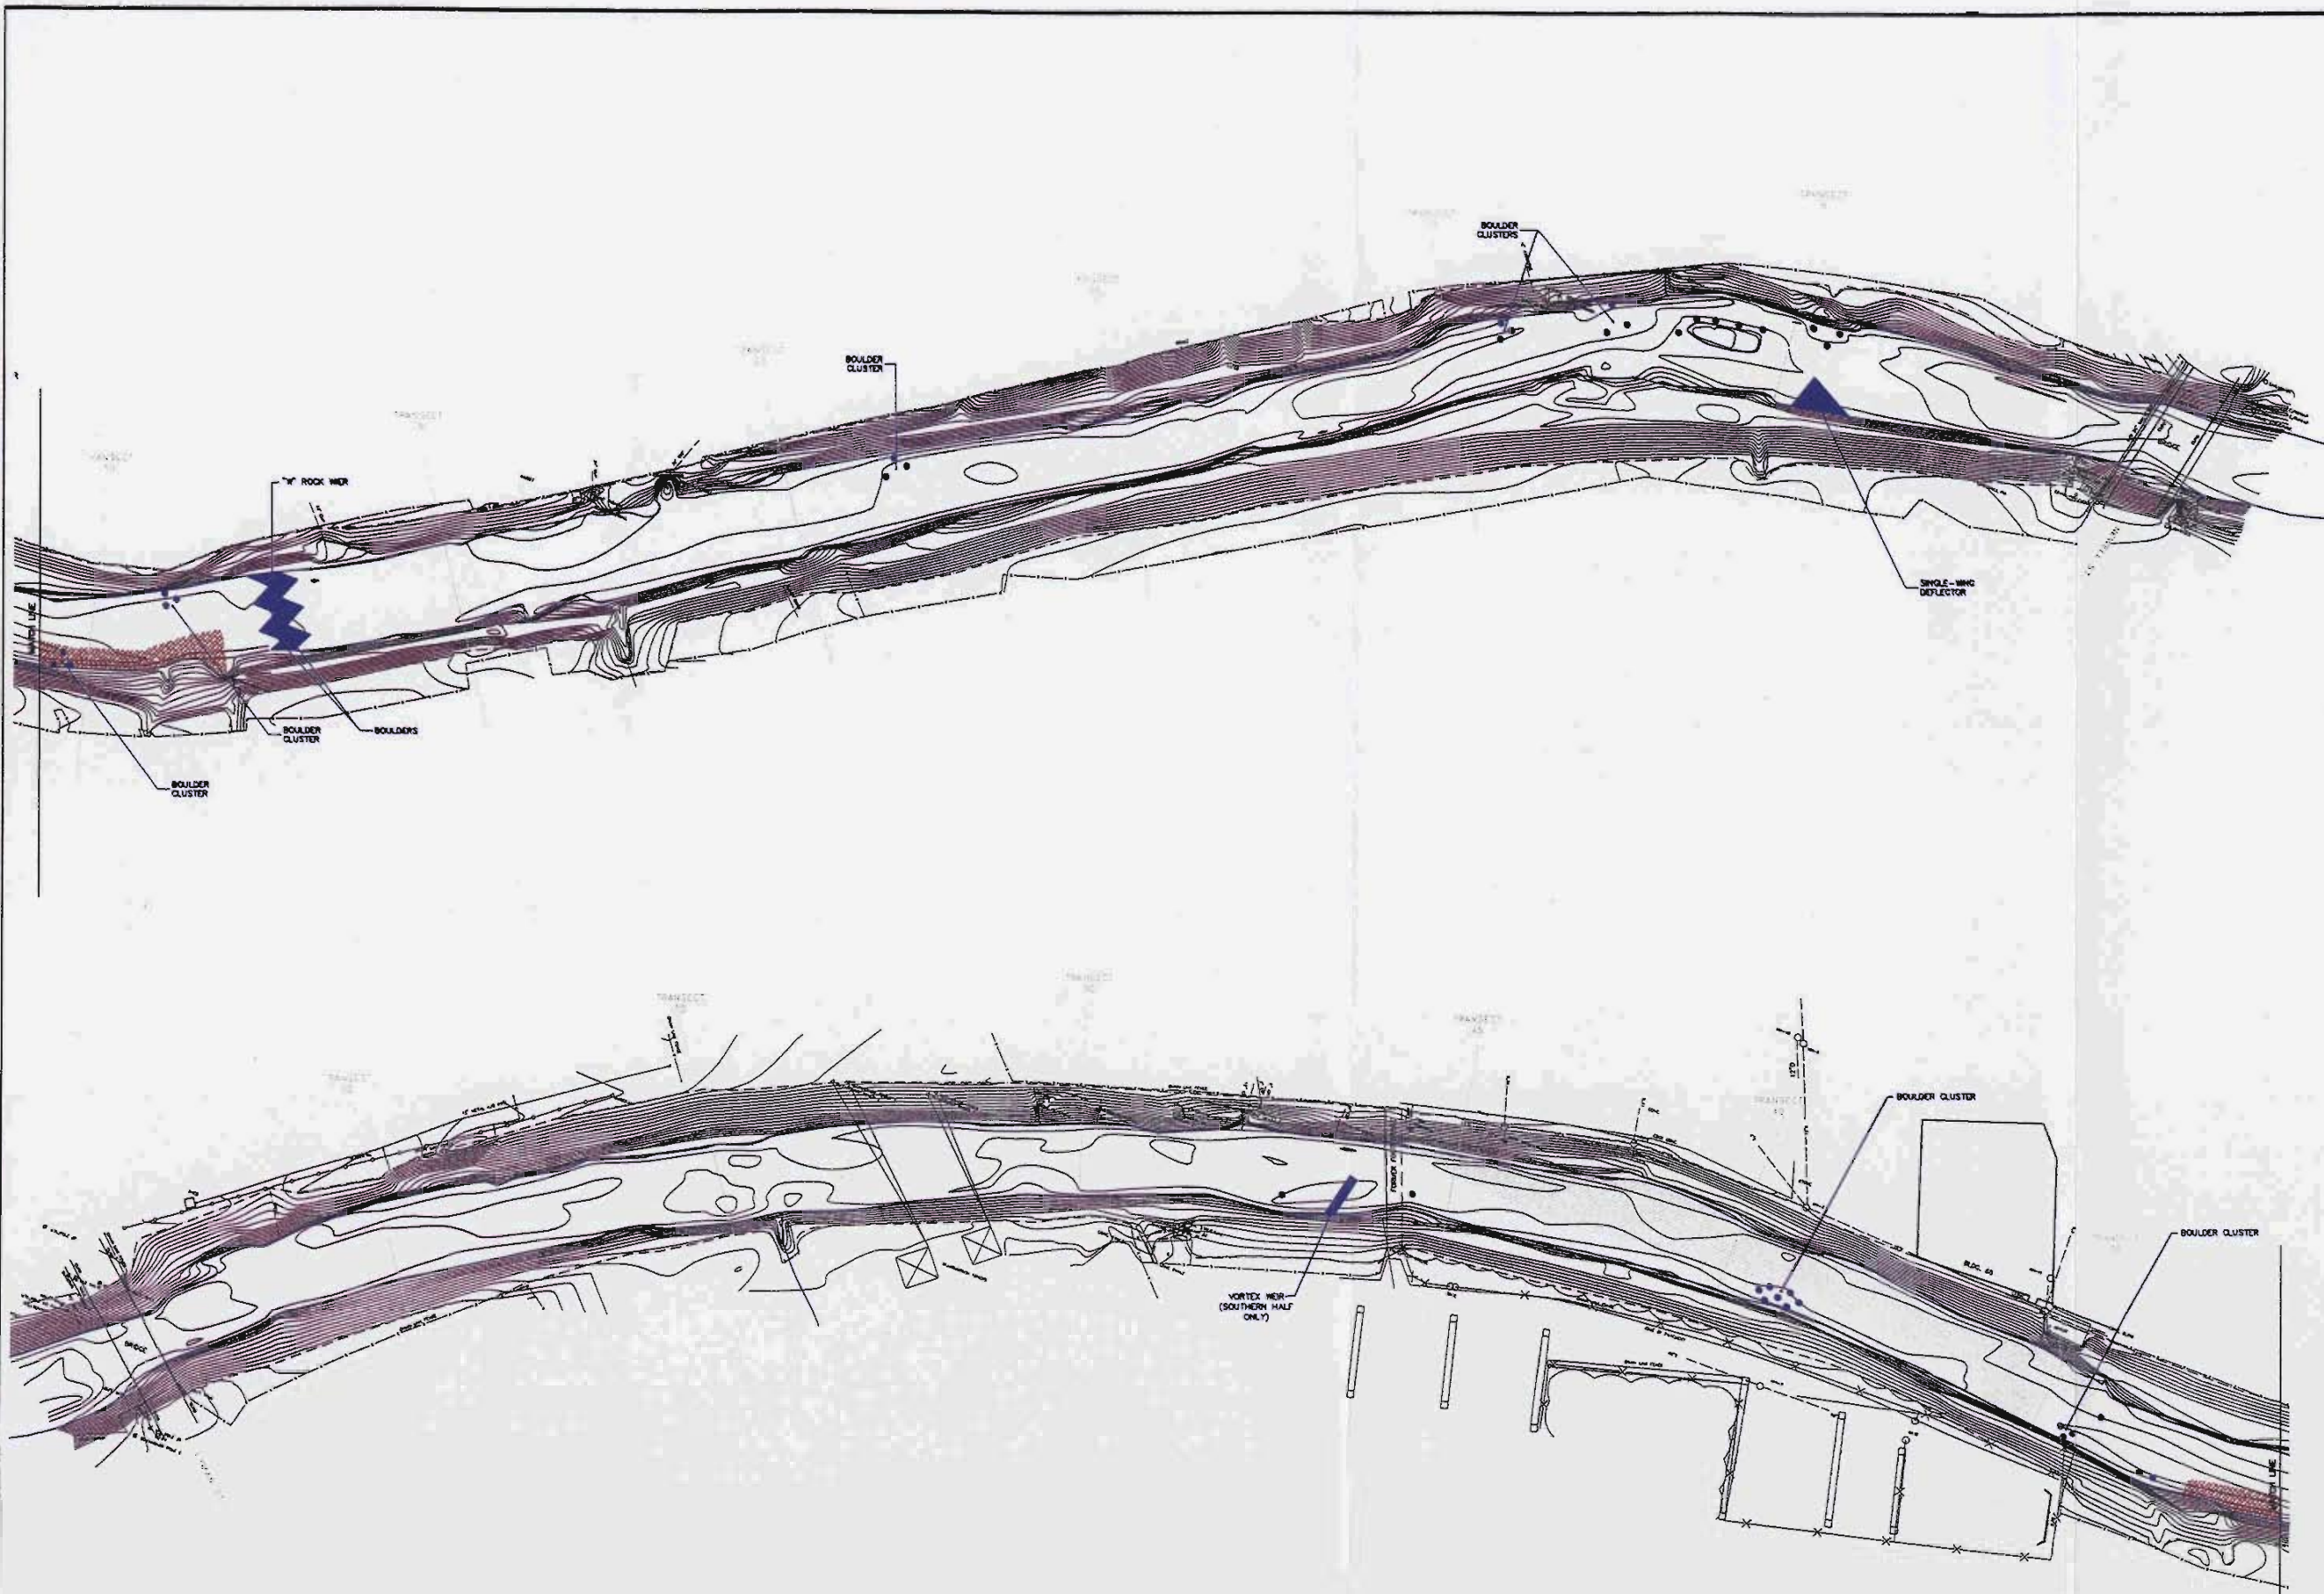
**AQUATIC HABITAT
 ENHANCEMENT STRUCTURES**

The single-wing deflector is located on the south side of the river, downstream of the Newell Street Bridge, and was observed to be structurally stable with no apparent change in the location of the boulders. The wing deflector perimeter is composed of 1- to 2-foot-diameter cobbles, and the interior is filled with 6- to 9-inch-diameter stones to form a triangular shaped deflector with the base along the south bank and the apex directed toward the middle of the river. No bank erosion was noted along the bank adjacent to the deflector following high-flow events. In addition, the bank opposite (north side) the deflector, and the island located near midstream, did not exhibit signs of erosion. With respect to effects of this structure on aquatic habitat, the deflector appeared to be functioning as anticipated in the Work Plan.

A total of 38 habitat enhancement boulders had been placed in the Upper ½-Mile Reach through the end of 2001. At the request of the EPA and the Massachusetts Executive Office of Environmental Affairs (EOEA), several of the boulders were placed in different locations from those identified in the Work Plan. Figure 4-1 presents the “as-built” locations of the boulders.

During the spring 2001 inspection, as well as various other times during the year, the observations of these boulders provided no indication that the boulders were structurally unstable or had changed in location. In addition, no erosion was noted along the banks near any of the boulders. With respect to effects of these boulders on aquatic habitat, the boulders appeared to be functioning as anticipated in the Work Plan.

The rock w-weir was installed downstream from the location planned in the Work Plan (with EPA and EOEA approval). This w-weir was constructed with 2- to 3-foot-diameter boulders at the apexes (three apexes pointing upstream and two apexes pointing downstream) and 1-foot-diameter cobbles along the legs of the weir. During the various inspections, observations provided no indication that the w-weir was structurally unstable or had changed in location. In addition, no bank erosion was noted on the north and south banks adjacent to the w-weir following high-flow events. With respect to effects of this structure on aquatic habitat, the w-weir appeared to be functioning as anticipated in the Work Plan.

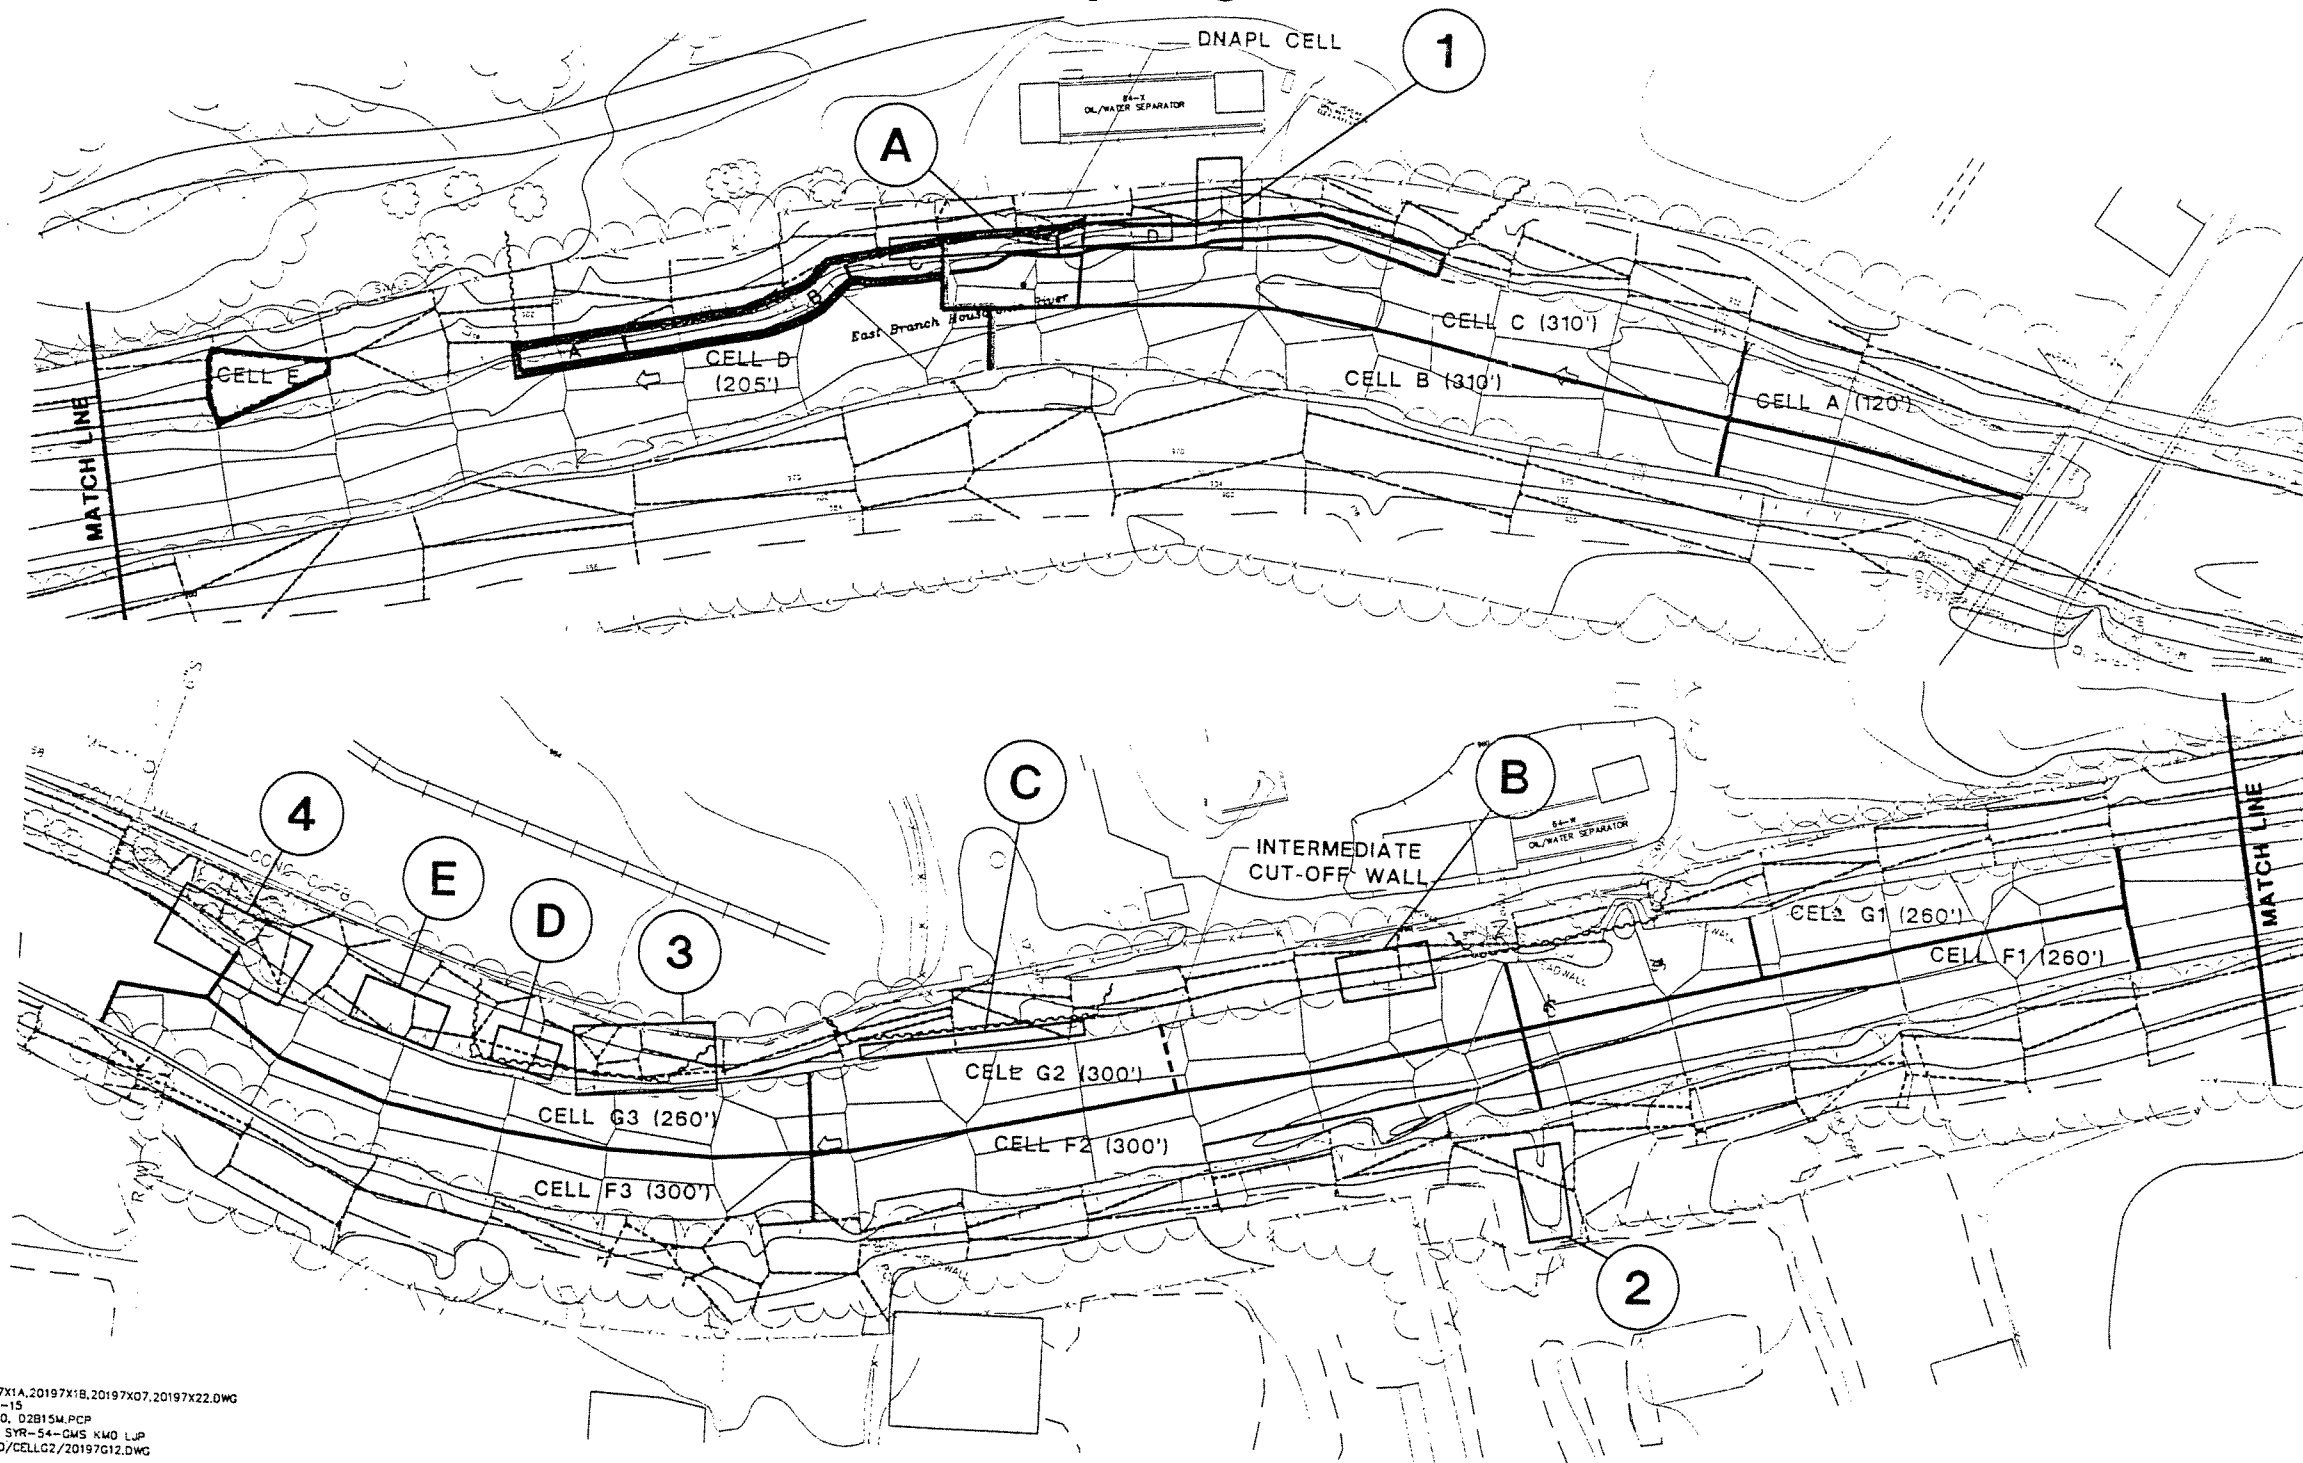
Exhibit A - Upper 1/2 Mile Reach Removal Action Sediment and Soil Removal Areas (Cells A-G) Bank Inspection - Spring 2001

During the May 2, 2001 bank inspection, a measurable loss of bank soil was noted at four areas, resulting from erosion caused by recent storm/high flow events. These areas are identified as Areas 1 through 4 on Exhibit A. A description of each area, along with the proposed action, is presented below and summarized in Table 1

Area 1 - Approximately 1.8 cubic yards (cy) of 1-inch stone eroded into the River from the area adjacent to the 64-X oil/water separator near Cell C/D (see Exhibit A). The source of eroded material was from the eastern drainage area outside the 64-X oil/water separator. The cause of erosion appears to be a stormwater catch basin (located in this area) that was covered and plugged with debris. To address eroded material in the River, GE proposes to remove the stone from the River and place the material back in the gravel drainage area outside the separator. In addition, to reduce future erosion in this area, the area around the stormwater catch basin and the drainage ditch leading to the catch basin will be cleared of debris, and the swale will be restored with 9 to 12-inch diameter rocks (rip-rap).

Area 2 - Approximately 2.5 cy of soil backfill eroded into the River near swale No. 15 on the south side of the River (see Exhibit A). The source of eroded soil appears to be from the restored bank area along the eastern fenceline at the top of swale No. 15. The erosion appears to have been caused by off-site stormwater accumulating at this point. No evidence of eroded soil was observed in the adjacent River and, therefore, no removal activities are planned at this location. To reduce possible future erosion in this area, rip-rap will be placed in the eroded area along the fenceline at the top of swale No. 15.

Area 3 - Approximately 59 cy of material (56 cy of soil backfill and 3 cy of material from below the previously excavated subgrade) eroded into the River from a restored bank area located at the upstream end of Cell G3 (see Exhibit A). The cause of erosion appears to be a combination of a major April flood event and the reduced cross-sectional area of river created by the sheetpiling used to isolate an adjacent cell (Cell F3). No evidence of eroded soil was observed in the adjacent River and, therefore, no removal activities are planned at this location. This area will be restored in accordance with the requirements of the Work Plan to previous conditions and grades; however, rip-rap will be placed over the 1:1 slope areas for additional stabilization. Once the river is returned to the original cross-section (i.e., the water diversion sheetpile is removed) and the additional rip-rap is placed, the potential for future erosion should be reduced.

Area 4 - The final area of observed erosion occurred near the downstream end of the restored bank in Cell G3 and extended into the Building 68 restored bank area (see Exhibit A). Approximately 28 cy of material (27 cy of soil backfill and 1 cy of material from below the previously excavated subgrade) eroded into the River from this area. In general, the apparent cause of erosion in this area is the same as presented above for Area 3 (April flood event and reduced river cross sectional area). The extent of erosion may have increased due to the temporary pipe bridge support in this area directing the floodwaters towards the bank. No evidence of eroded soil was observed in the adjacent River and, therefore, no removal activities are planned at this location. This area will be restored in accordance with the requirements of the Work Plan to previous conditions and grades. Once the river is returned to its normal cross-section and the temporary pipe bridge support is removed, the potential for future erosion should be reduced.

During the May 2, 2001 bank inspection, observations of the remaining restored bank areas indicated minimal evidence of erosion, and five areas were identified that required further action. These areas are identified as Areas A through E on Exhibit A. Primarily, these areas include locations where the source control sheetpiling was exposed and restored areas that had settled or where the seed and erosion mat had been displaced. These areas will be addressed by placing rip-rap and/or topsoil, seed, and erosion mats as required to restore the areas to final design conditions (see Table 1).
