**Re: GE Pittsfield/Housatonic River Site
Upper ½-Mile Reach Removal Action (GECD800)
2002 Annual Monitoring Report**

***2002 Annual Monitoring Report
Upper 1/2-Mile Reach of the
Housatonic River***

**General Electric Company
Pittsfield, Massachusetts**

December 2002

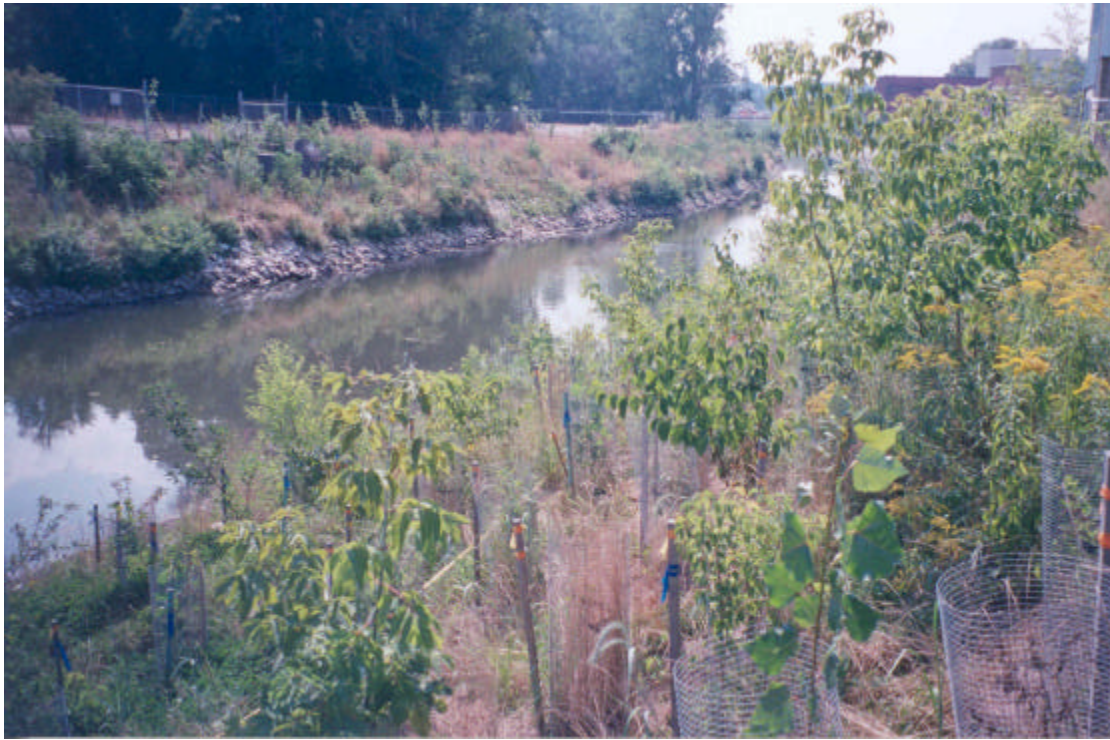
Photograph 9

August 12, 13, 14; Area 4 Plantings

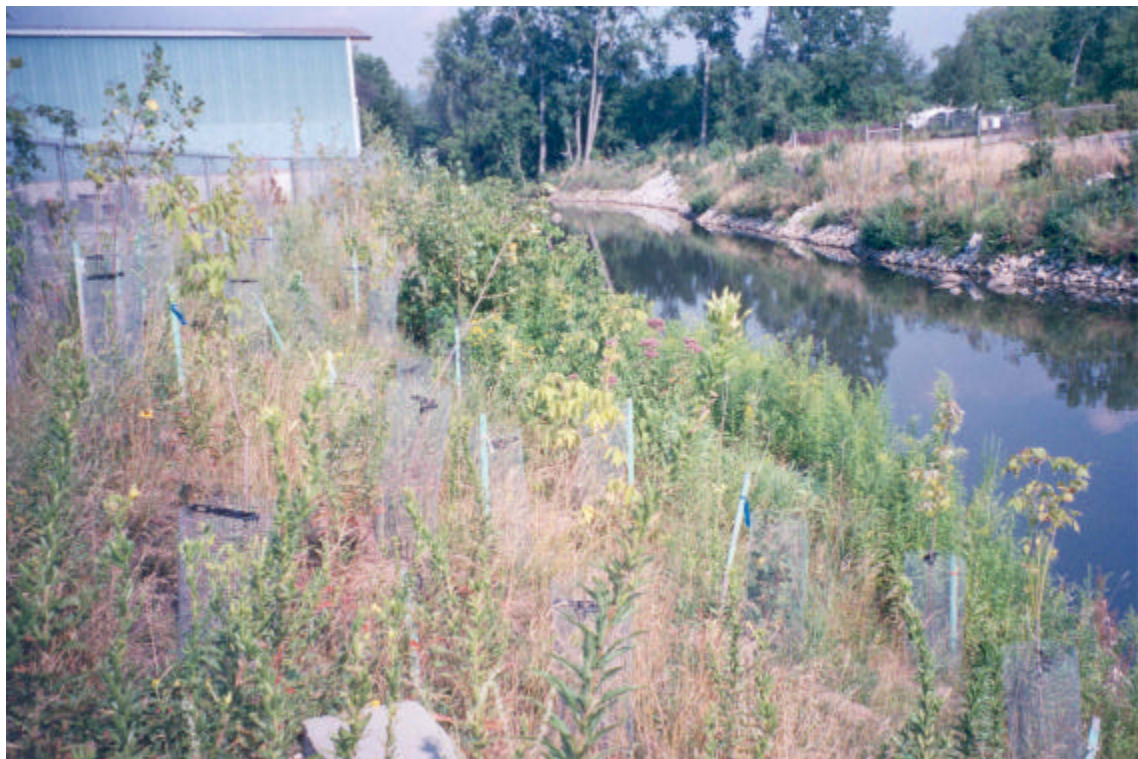
Photograph 10

August 12, 13, 14; Area 4 Plantings

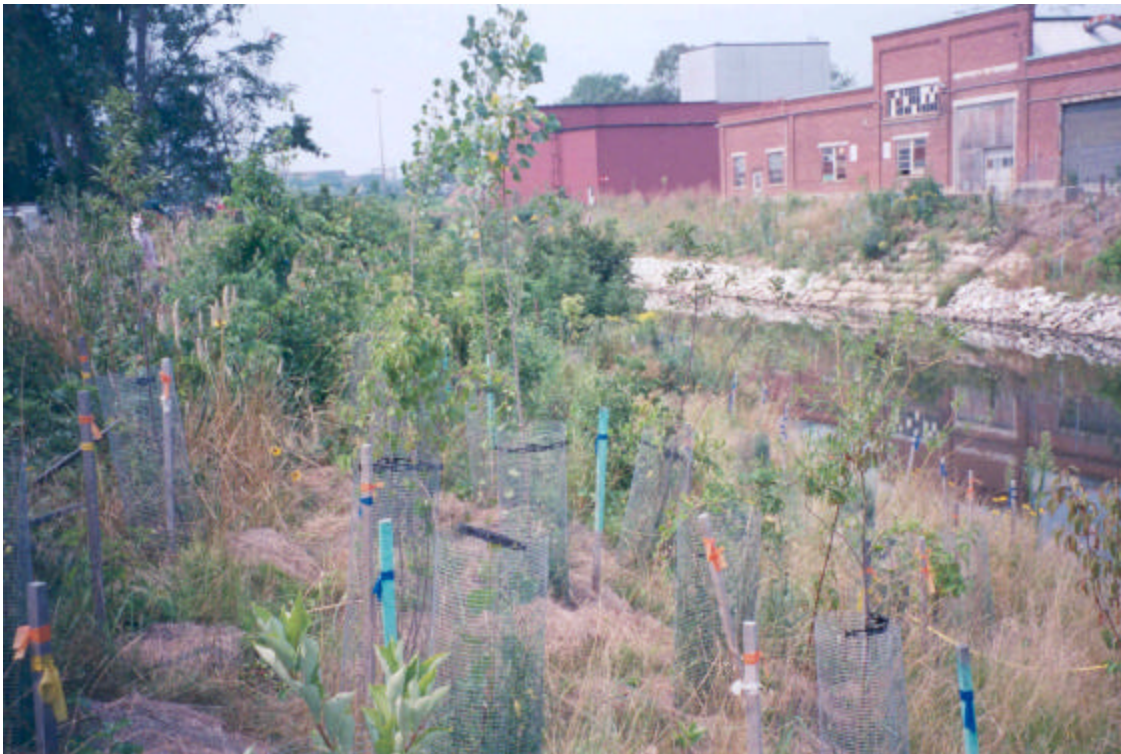
Photograph 12 **August 12, 13, 14; Area 11A Plantings**

11. Composite planting area 8, 9, 9A, 11, 11A showed poor herbaceous cover. The cause of the poor herbaceous cover is primarily existing woody debris. As a result, this material will be cleared to facilitate revegetation.
