**RE: Comments on GE's 2002 Annual Monitoring Report
Upper ½-Mile Reach Removal Action
General Electric-Pittsfield/Housatonic River Site**

**Re: GE Pittsfield/Housatonic River Site
Upper 1/2-Mile Reach Removal Action (GEC800)
Erosion Inspection Following High Flow Event (Spring 2002)**

**General Electric Company - Pittsfield Massachusetts
1/2-Mile Reach Removal Action**

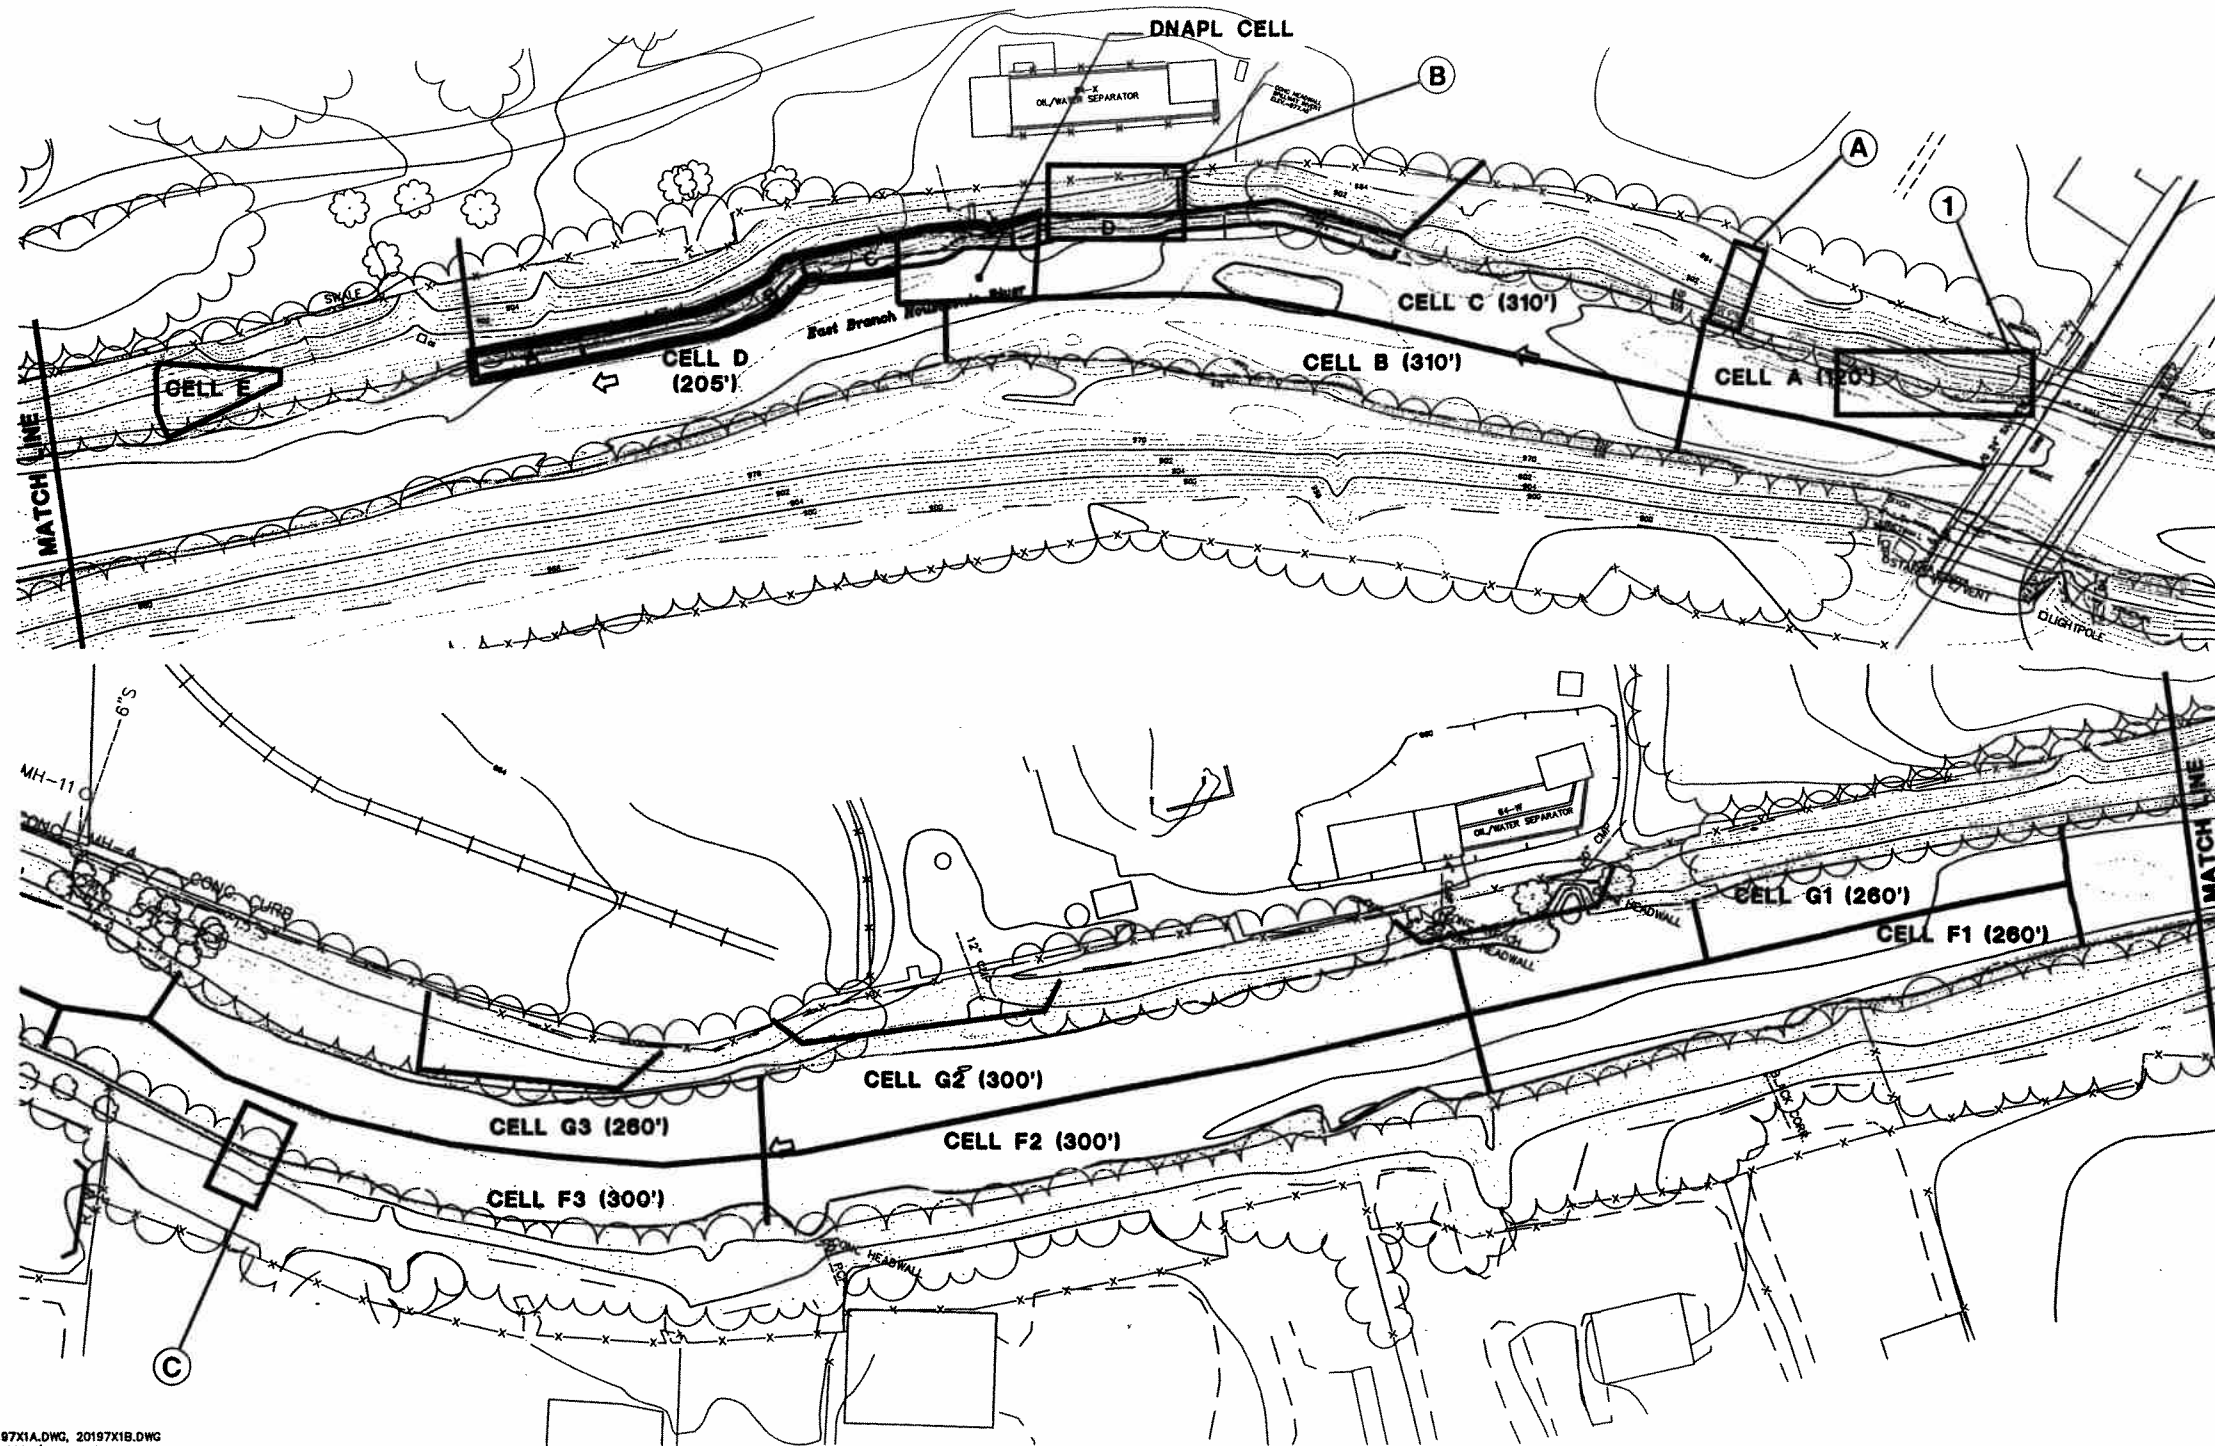
Exhibit A - Upper 1/2 Mile Reach Removal Action

Area 1 - Approximately 2.0 cubic yards (cy) of soil appears to have eroded into the River from the northern bank area downstream of the Newell Street Bridge and upstream of Cell A (see Exhibit A). The source of eroded material was from the non-removal bank area near the edge of the river. The cause of erosion appears to be the combination of a high flow event (providing scouring action) flowing over the unprotected toe of bank. No evidence of eroded soil was observed in the adjacent River and, therefore, no removal activities are planned at this location. To reduce potential for future erosion in this area, the toe of the bank will be restored by placing and consolidating 9 to 12-inch diameter rocks (rip-rap) and blending into the existing adjacent bank areas (upstream and downstream) for a length of approximately 90 feet.

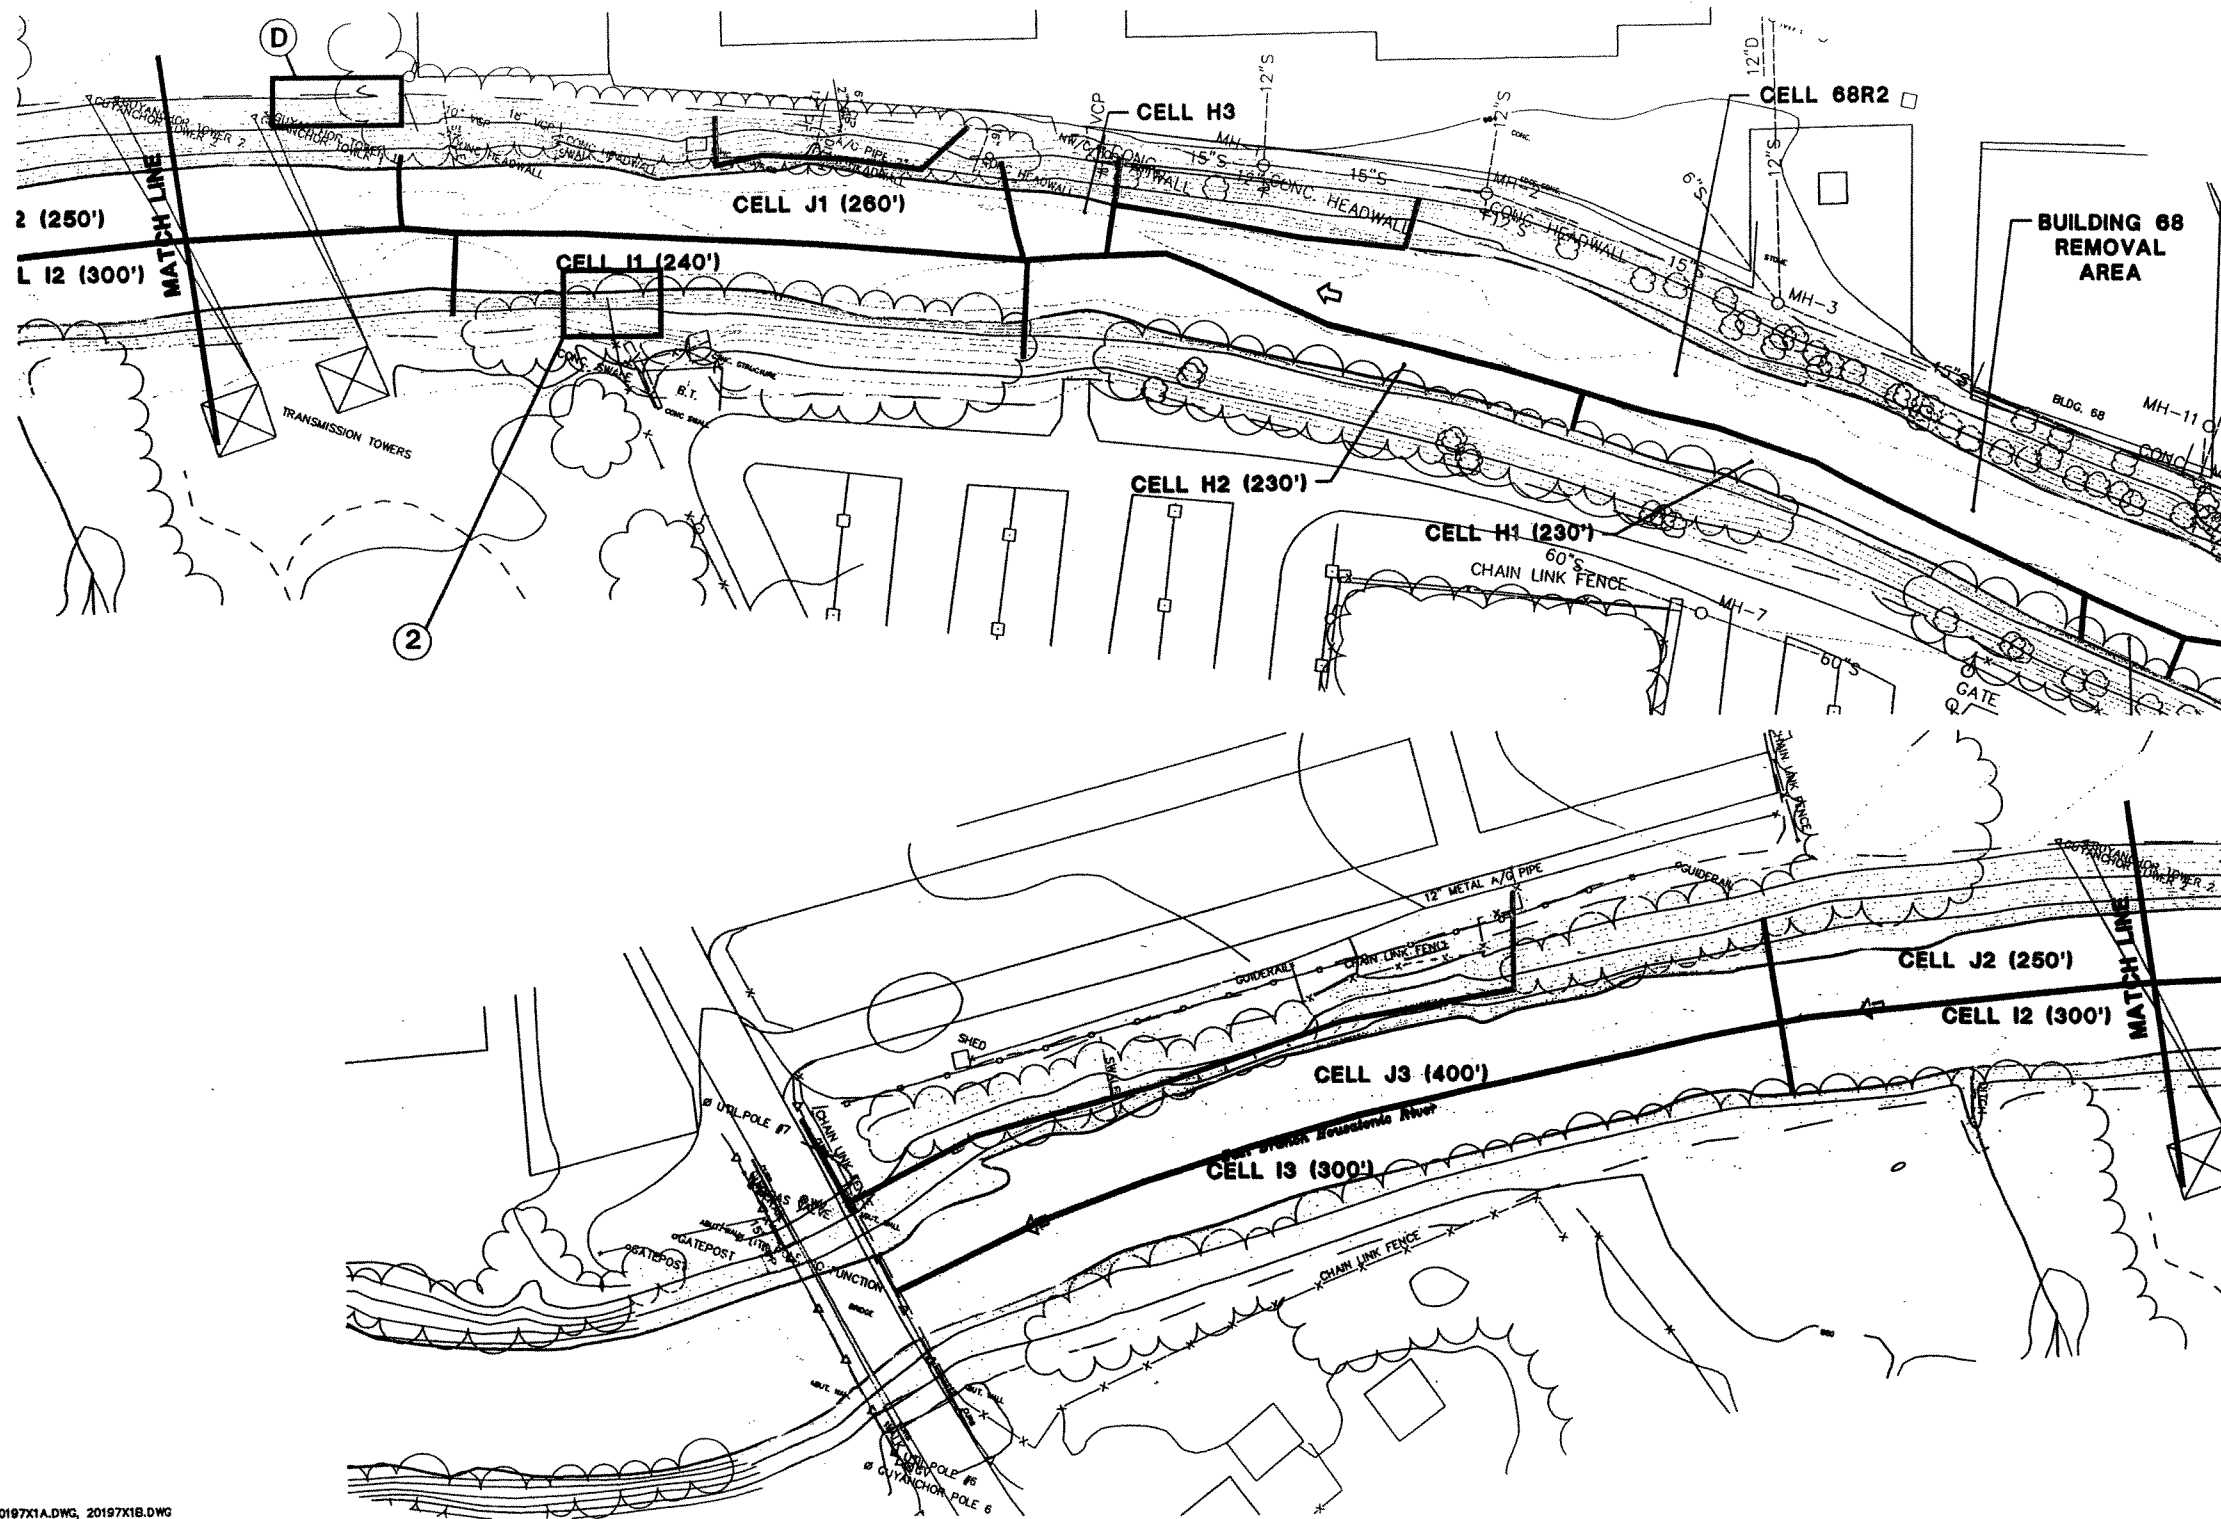
Exhibit B - Upper 1/2 Mile Reach Removal Action

Area 2 – Approximately 1 to 5 cy of soil backfill eroded into the River near swale No. 11 (Cell I-1) on the south side of the River (see Exhibit B). The source of eroded soil appears to be from the sand layer that was installed as the bottom layer (below geotextile fabric) of restored swale No. 11. The erosion appears to have been caused by stormwater runoff flow below the geotextile fabric washing the underlying sand into the River at the base of the swale. To address the eroded material in the River, GE removed the sand from the River and placed the material in a stockpile at the top of the bank. This material will be disposed off-site with the additional bank soil to be removed from the top of the bank in the same area (associated with polygon for sample point RB-7). Analytical results from in-situ samples of the eroded material are presented in Table 2. To reduce possible future erosion in this area, stone dust was placed over the swale to fill the voids between the rip-rap to reduce the flow of water within the voids and below the geotextile.
